GEND--019

EXAMINATION RESULTS OF THE THREE MILE ISLAND RADIATION DETECTOR HP-R-213

Sandia National Laboratories
Albuquerque, New Mexico 87185

November 1982

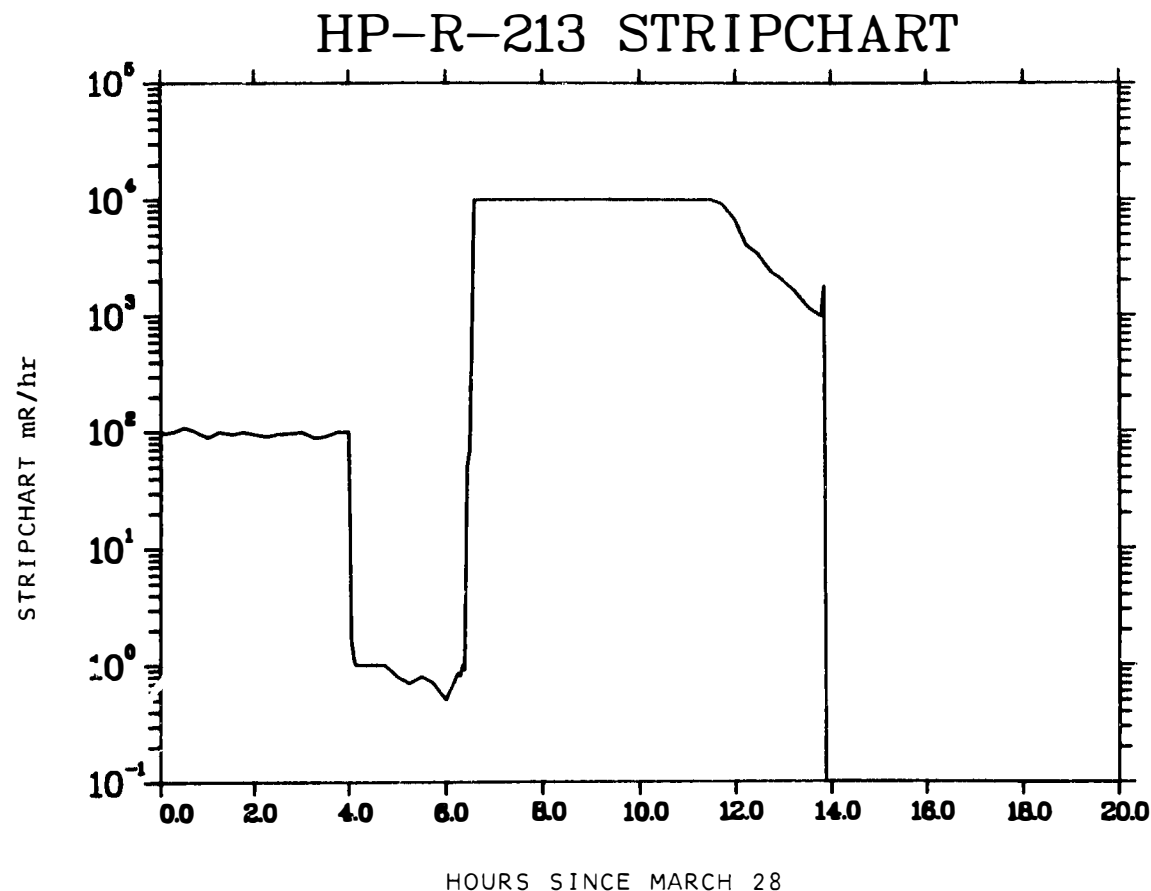
1. The stripchart recording of HP-R-213 indicates that the detector failed at or near the time of the hydrogen burn (Figure 1). The examination of the failed detector showed the cause of failure to be a cracked GM tube. Due to the presence of numerous chips and scratches around the glass-to-metal seal, the glass was apparently in a weakened state prior to the hydrogen burn. It is likely that the tube failed as a result of the mechanical shock imparted to the entire detector assembly by the hydrogen burn. It is less likely that the tube failed because of the change in atmospheric pressure. The glass thickness and printed circuit board mounting method should allow a good quality tube to withstand substantially higher shocks; i.e., no inherent weakness in the present design can be identified. It is recommended that tighter quality controls be instituted to prevent this type of failure in the future.

FIGURE 1. HP-R-213 STRIPCHART. This record shows the radiation levels measured by HP-R-213 during the first 20 hours of March 28, 1979. Reactor trip occurs at 4:00 AM, and the first evidence of fuel failure or shine can be seen at approximately 6:24 AM. Detector HP-R-213 was the first containment area monitor to indicate abnormal radiation levels. The anti-jam circuit operates properly until about 11:45 AM at which time an apparent drop in radiation level occurs. I suspect this to be caused by radiation damage to the detector resulting in "multivalued" behavior¹. The detector output drops sharply to minimum scale at the time of the hydrogen burn where it remained until it was taken out of service.

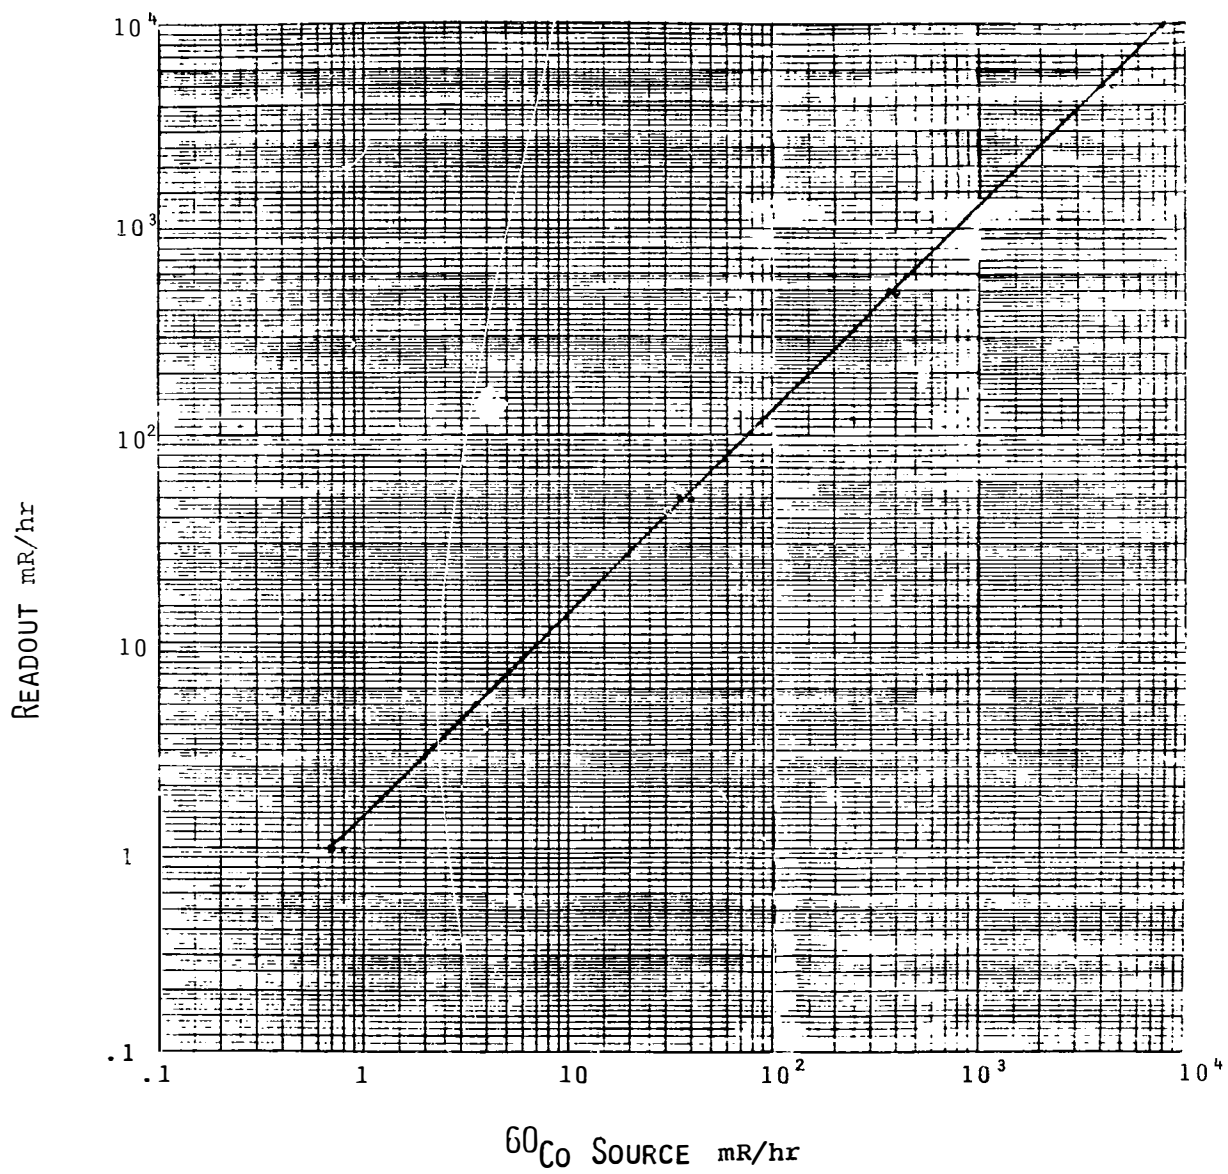
FIGURE 11. REPAIRED HP-R-213 DETECTOR RESPONSE
WITH A REPLACED GM TUBE

The faulty GM tube was replaced, and the detector was observed to function normally. Using the new GM tube, the detector was exposed to ^{60}Co at the Sandia Vertical Range Facility. The detector output reading versus input ^{60}Co source level is shown in Figure 11. The detector operates properly over its normal 0.1 mR/hr to 10 R/hr range. The error in radiation measurement is caused by not calibrating this detector with the ratemeter. The anti-jam circuit was activated at an input level of 17.5 R/hr. The detector was exposed to radiation levels as high as 600 R/hr with and without 150 meters (492 feet) of RG58 coaxial cable in the SIG output line. Appendix A shows the sequence of events performed in troubleshooting the detector.³

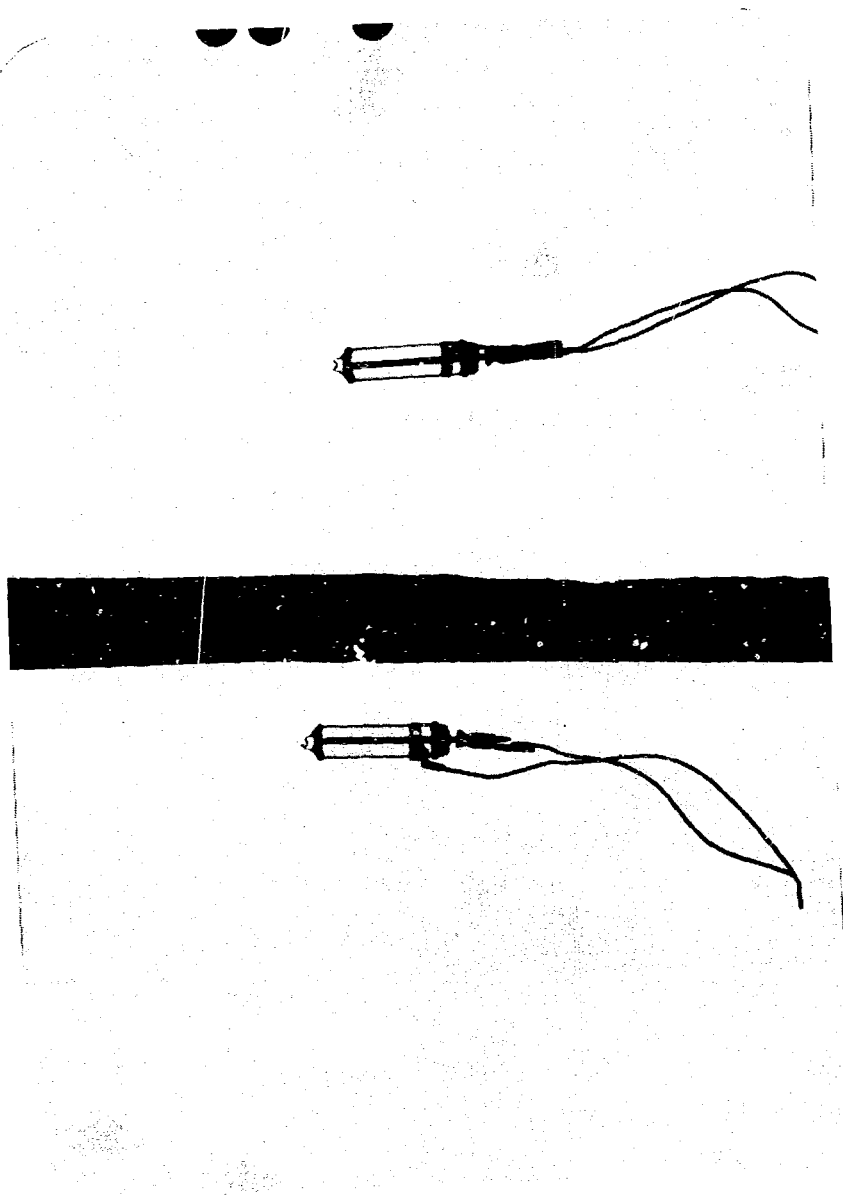
FIGURE 12. X-RAY OF GM TUBE.
TOP VIEW IS ROTATED 90° FROM BOTTOM VIEW

The GM tube was initially examined under a microscope and was found to have chipped glass around the seal between the glass and the chrome-iron cathode cylinder. Several scratches were on the glass seals also; however, no "breaks" were obvious. The tube was then x-rayed to determine if the anode was out of position. The x-ray shown in Figure 12 shows the anode to be properly positioned. A leak test was made to

determine the integrity of the tube's seal. In this test one end of the tube was exposed to helium at a pressure of one atmosphere while a vacuum was drawn on the other end of the tube. The presence of helium was then looked for. A small leak was detected in this way. When the tube was later removed from its protective housing the anode end simply fell off. It appears that one of the glass scores had weakened the glass to the point that the hydrogen burn shock caused the crack to propagate to the point of releasing the neon and helium gas and bromine or chlorine quench gas.
