TMI-2 PRESSURE TRANSMITTER EXAMINATION PROGRAM  
YEAR-END REPORT: EXAMINATION AND EVALUATION OF PRESSURE  
TRANSMITTERS CF-1-PT3 AND CF-2-LT3

February 1983

Published on Behalf of the GEND Group  
by  
EG&G Idaho, Inc.  
Idaho Falls, Idaho 83415

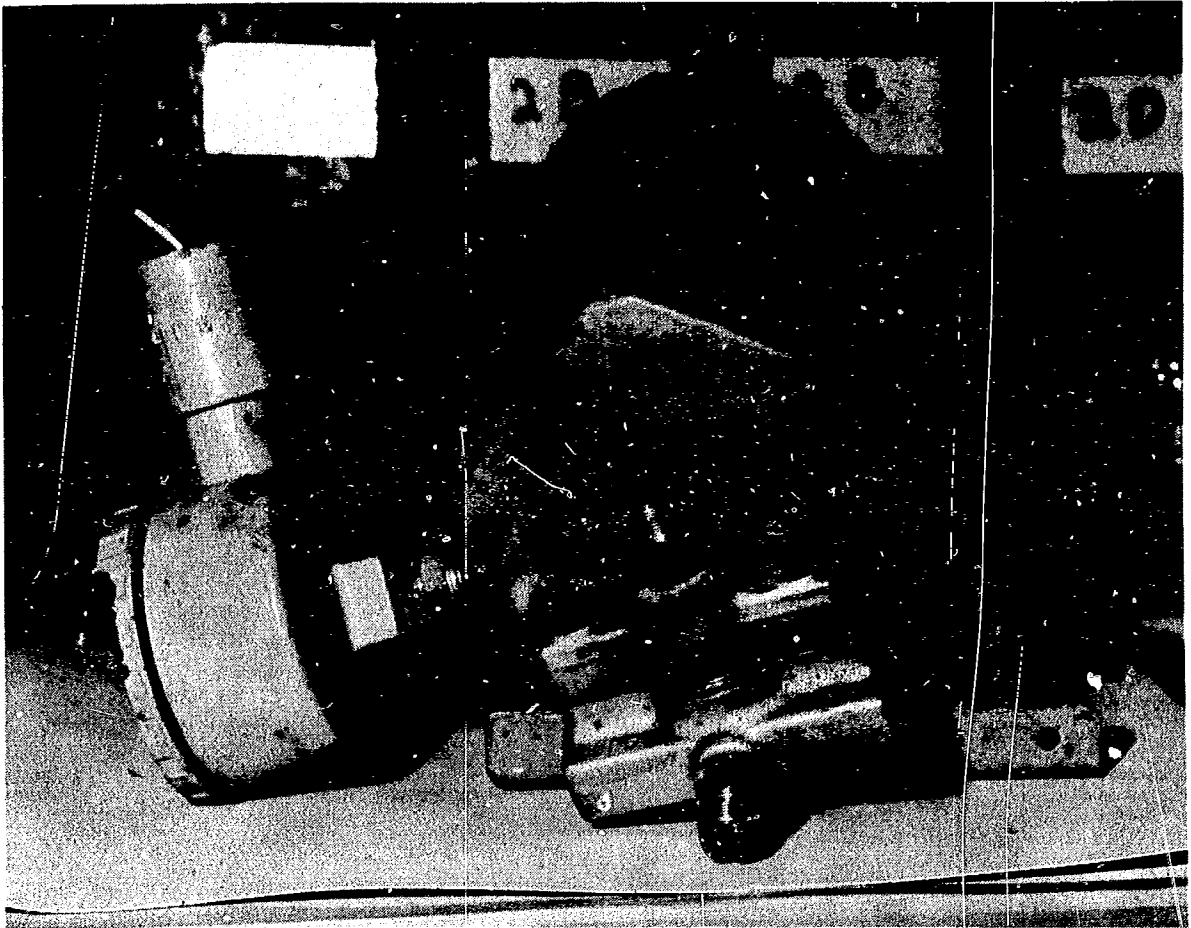
Figure 2. Photograph, Foxboro pressure transmitter.

- o The nuts and bolts holding together the flanged pressure port assembly had a heavy coating of rust; all other surfaces, painted and stainless steel, appeared fairly clean (see Figure 2).

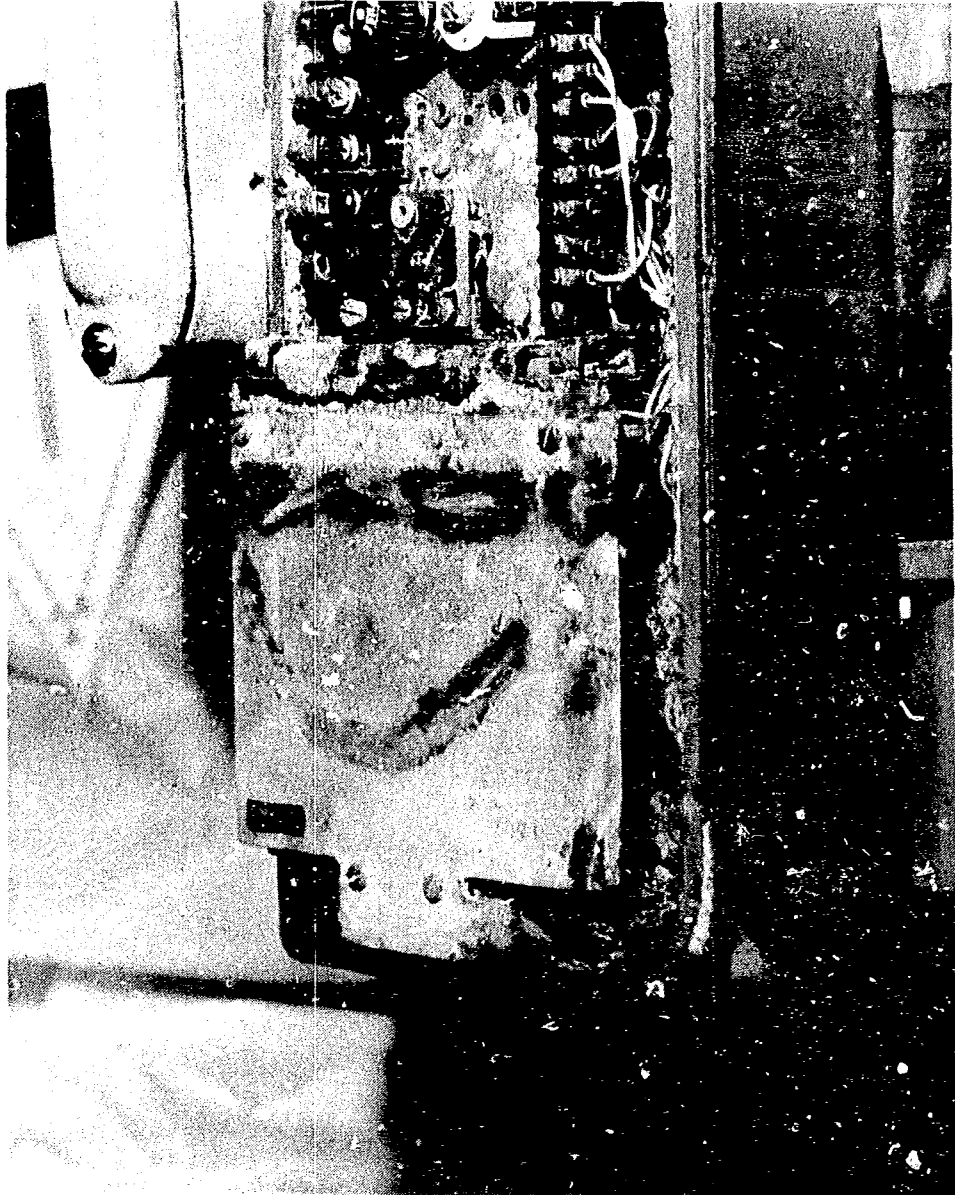
Figure 7. Photograph, Bailey pressure transmitter, internal view.

- o The interior of the housing and certain components were heavily corroded, and there was an accumulation of grit-like material at the bottom (see Figure 7).
- o The interior was radioactively contaminated. A smear count indicated about 300,000 dpm.

Spectrochemical analyses were made of the materials found in the housing and the high-pressure port. The material found in the housing was separated by colors; the results of the analysis are shown in Table 2. It is believed that this material is the result of corrosion.

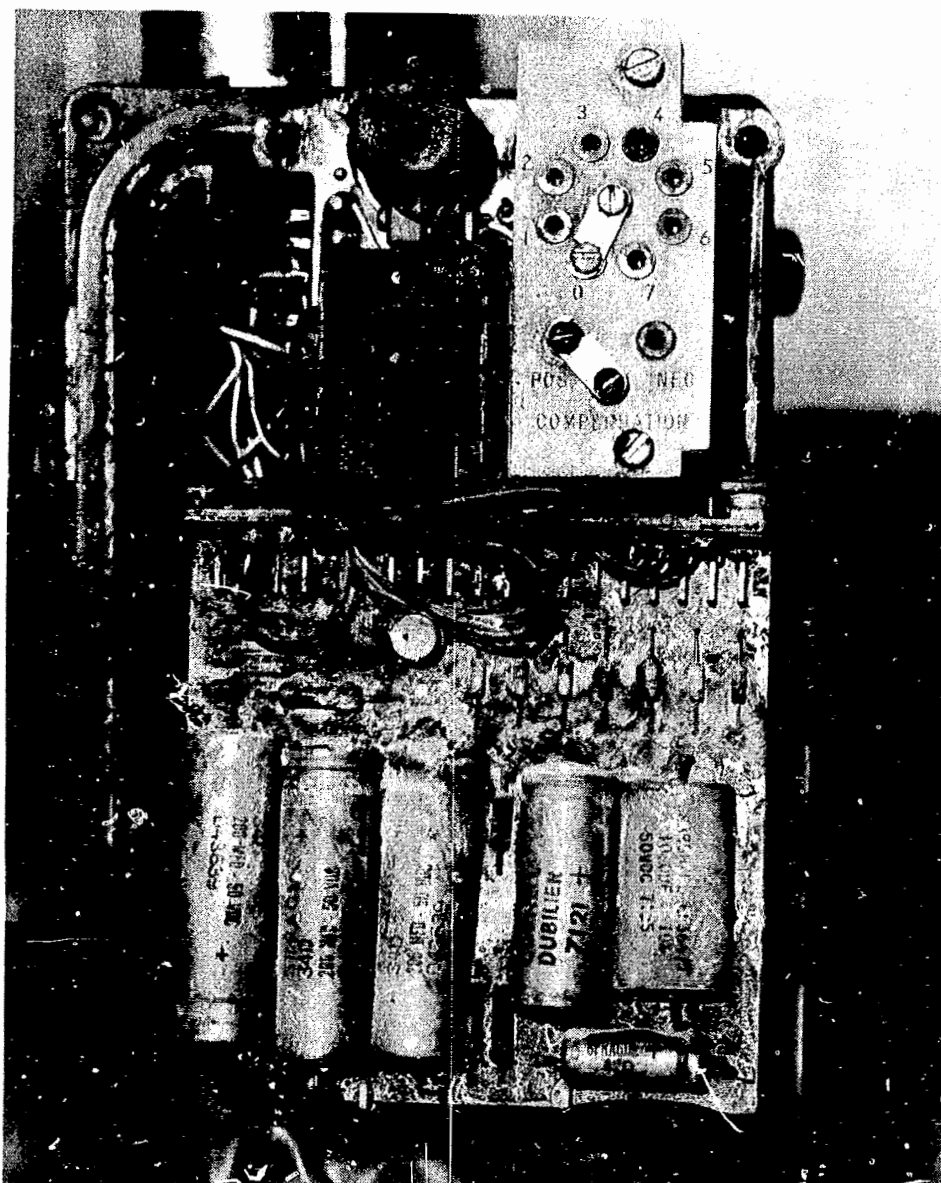
Figure 8. Photograph, Bailey pressure transmitter, circuit board, front view.

- o Some electronic components were badly corroded; some leads were completely corroded away. (See capacitors in Figure 8.)
- o A transformer, T-2 (oscillator circuit), appeared to have been badly burned (see Figure 9).
- o Regulator Power Transistor Q-2 was rusted so badly it crumbled when contacted (see Figure 10).

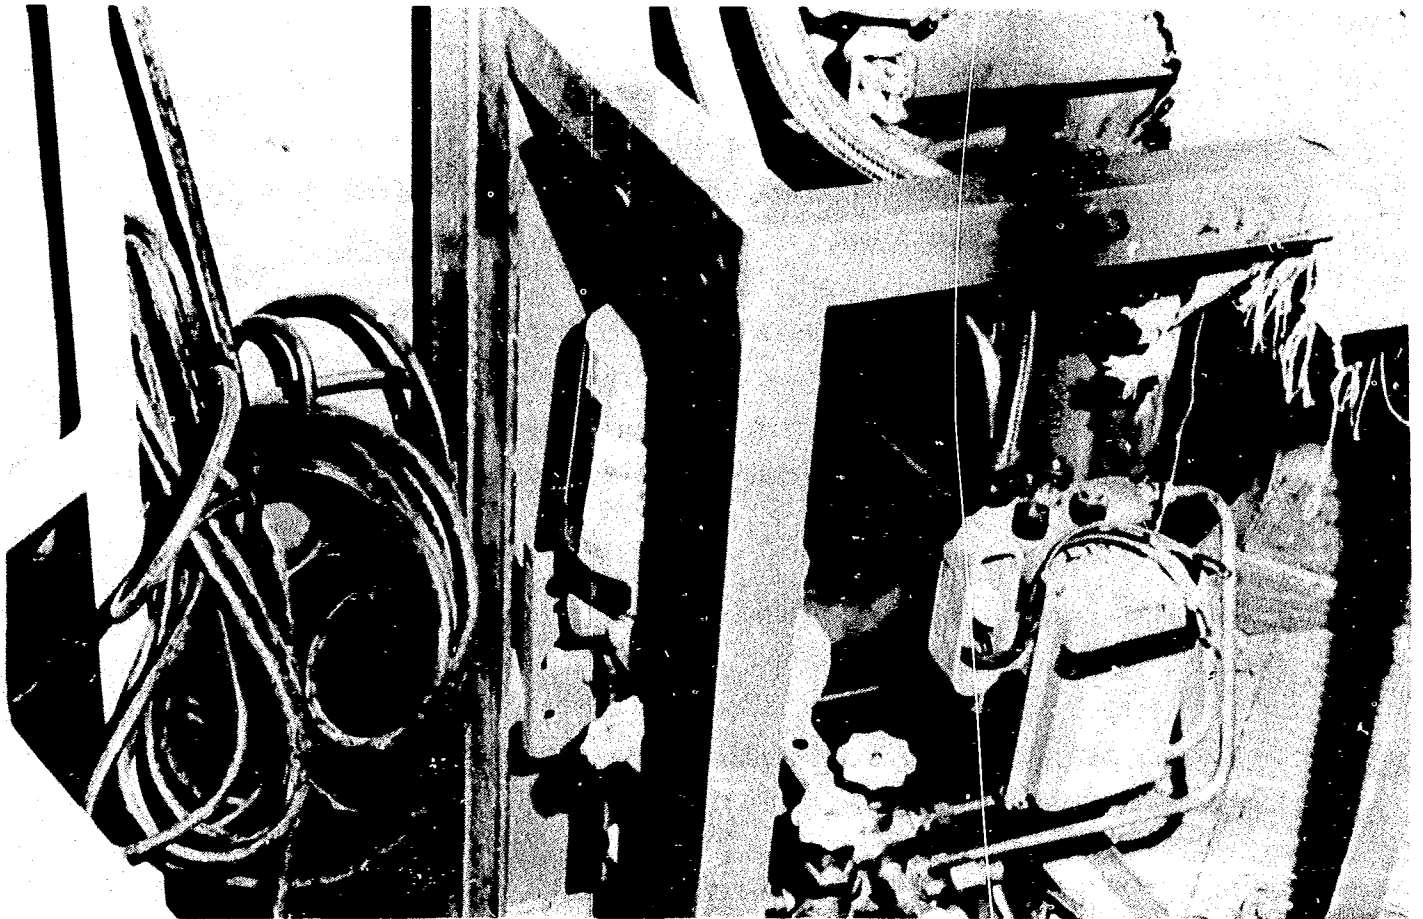
Figure 11. Photograph, typical pressure transmitter installations.

It appears that the cause of failure of the Bailey unit was due to water entering the unit and shorting the electronics. The question remains, how and where did the water enter the assembly: It is known that during and following the accident, there was steam and high humidity in the building from the reactor system with a resulting rain-like atmosphere, so all components in the building were subjected to water. Since the transmitter case cover gasket and the conduit junction box gasket were inspected and found to be in good condition, and since the water was highly contaminated, it is believed that reactor water entered the transmitter through the electrical conduit or its fittings. When the water entered the conduit is not clear. Figure 11 shows what is believed to be a typical transmitter installation. Potential sources of leakage are the flexible conduit itself, the flexible conduit fittings, and the termination point of the flexible conduit (not shown) or the junction box into which the conduit terminates. As can be seen in Figure 11, there is no drip loop in the conduit. If the fitting at the conduit junction was not sealed, any water running down the outside of the conduit could enter at this point. Unfortunately, the conduit junction was disassembled during removal of the assembly, so that whether this was

the point of leakage could not be determined. In future removals this evidence will be preserved, and more information on potential sources of leakage obtained. The Foxboro assembly appeared to have leaked in a similar manner, judging from the residue in its junction box. However, the cable seal apparently saved it from the same fate as the Bailey.
