TMI-2 PRESSURE TRANSMITTER EXAMINATION AND EVALUATION OF CF-1-PT1, CF-2-LT1, AND CF-2-LT2

GEND-INF-029
Vol. II

Published April 1984

EG&G Idaho, Inc.
Idaho Falls, Idaho 83415

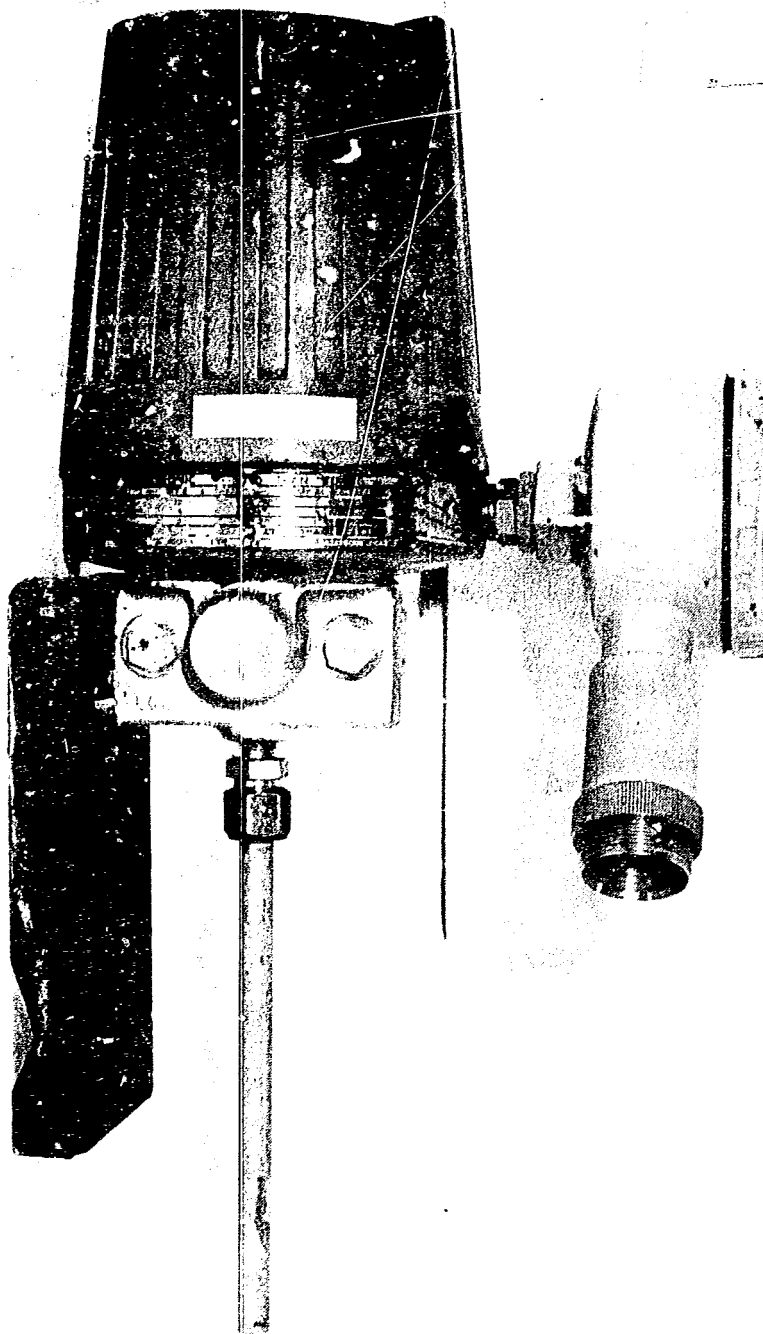
Figure 1. Foxboro Transmitter CF-1-PT1.

From initial visual examination at the INEL, it appeared that the transmitter was in good condition, except for a heavy coating of corrosion and some rust on the bolts holding the pressure port assembly together (see Figures 1 and 2). The interior of the transmitter, including the sensor/electronic module assembly, was free from corrosion and radioactive contamination. The circular junction box showed no signs of corrosion and was relatively free of radioactive contamination. The minor amount of contamination found in the junction box during the examination was probably a result of the removal process, since there was no corrosion present. It appears that the conduit installation associated with this transmitter did not permit water to enter the junction box, as was the case with the earlier Foxboro unit removed from TMI-2.

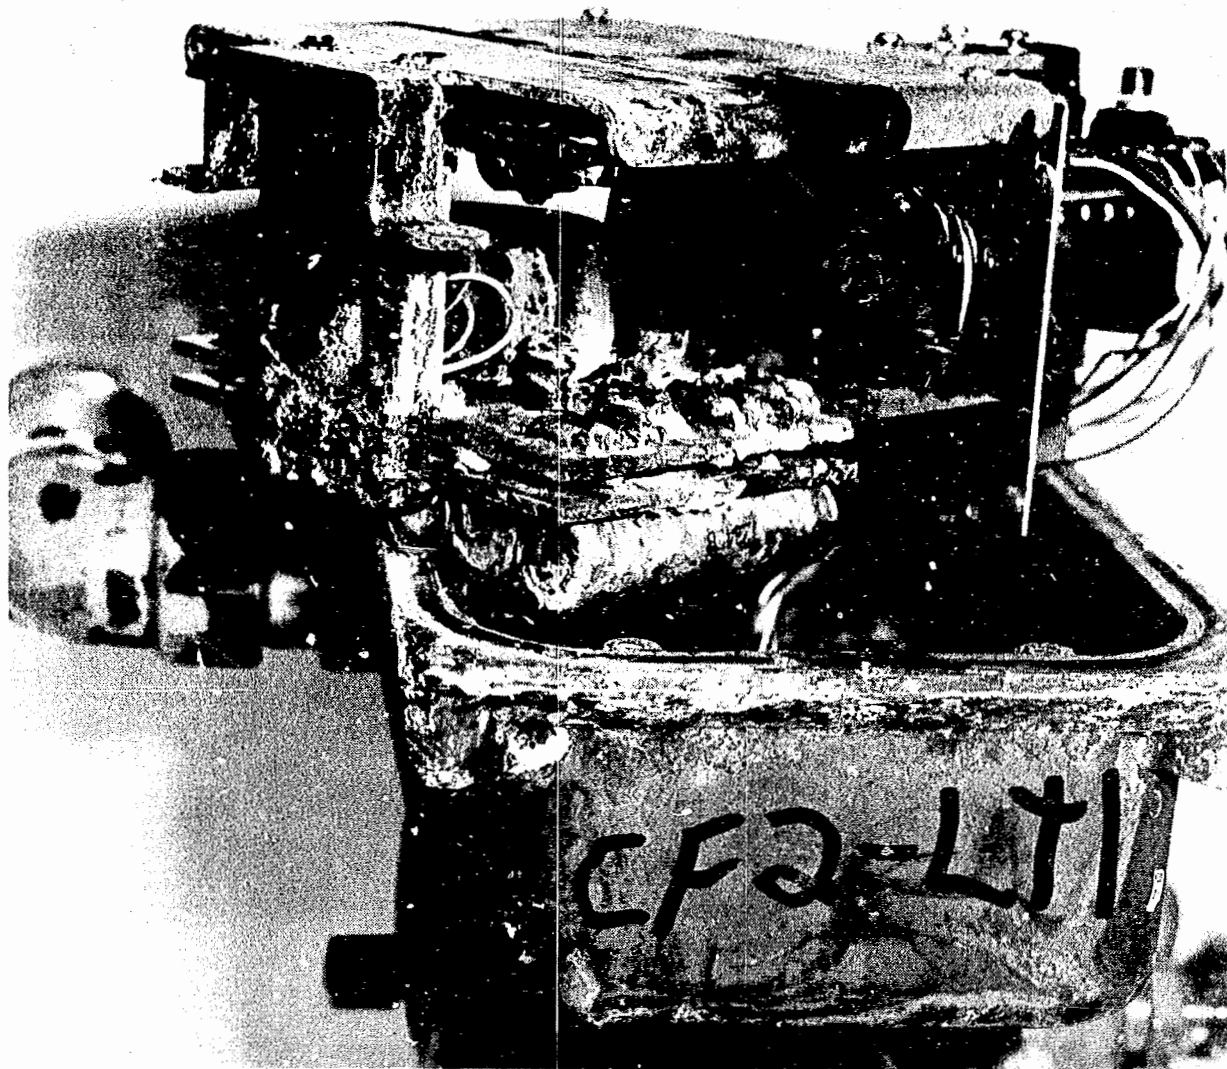
- o There was a heavy layer of rust on assembly nuts and conduit fittings.
- o There was severe corrosion and degradation of internal components rendering the units inoperable (see Figures 3 and 4).
- o The units had a high level of internal radioactive contamination, indicating leakage into the units subsequent to the accident.

- o Portions of the cover plate seal appeared to be in poor condition (see Figures 6 and 7). This may have permitted additional moisture to enter the housing.
- o The water level in the transmitter appeared to reach a depth of approximately 3-1/3 in. (see Figures 6 and 7).
- o The water inside the transmitter apparently leaked out of the housing through the seal. This is evident from the corrosion and hard water deposits around the lower exterior portion of the transmitter (see Figure 3).

Figure 3. CF-2-LT1 showing condition of the electronic module and base of housing.

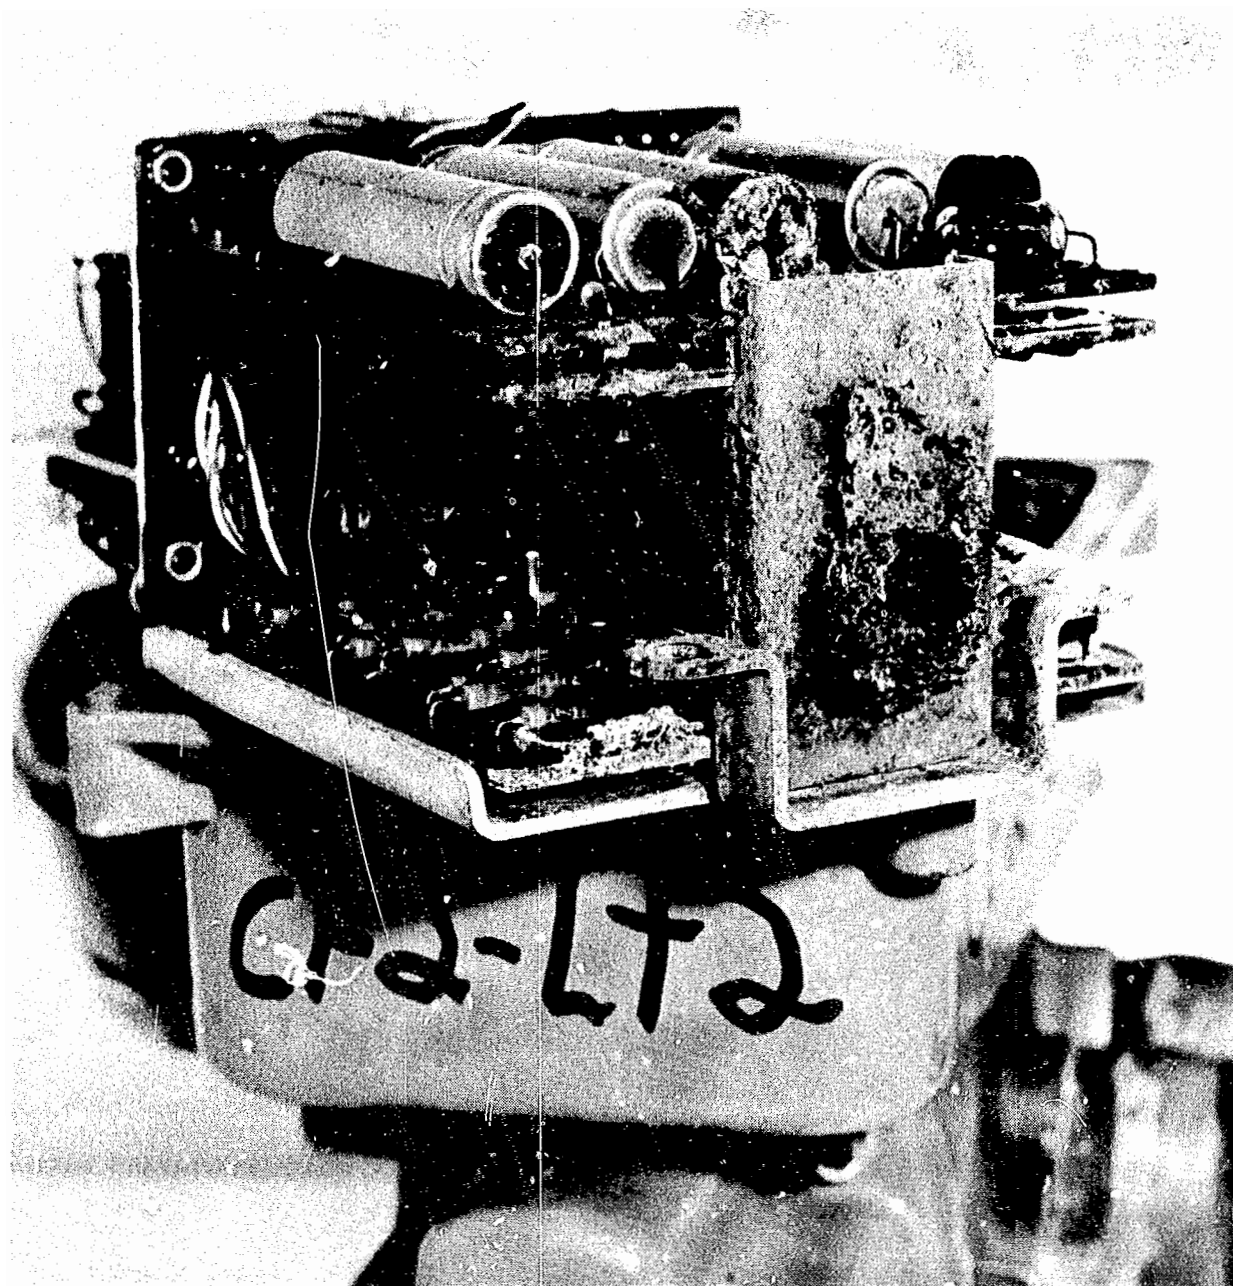
Figure 4. CF-2-LT2 showing the condition of the electronic module.

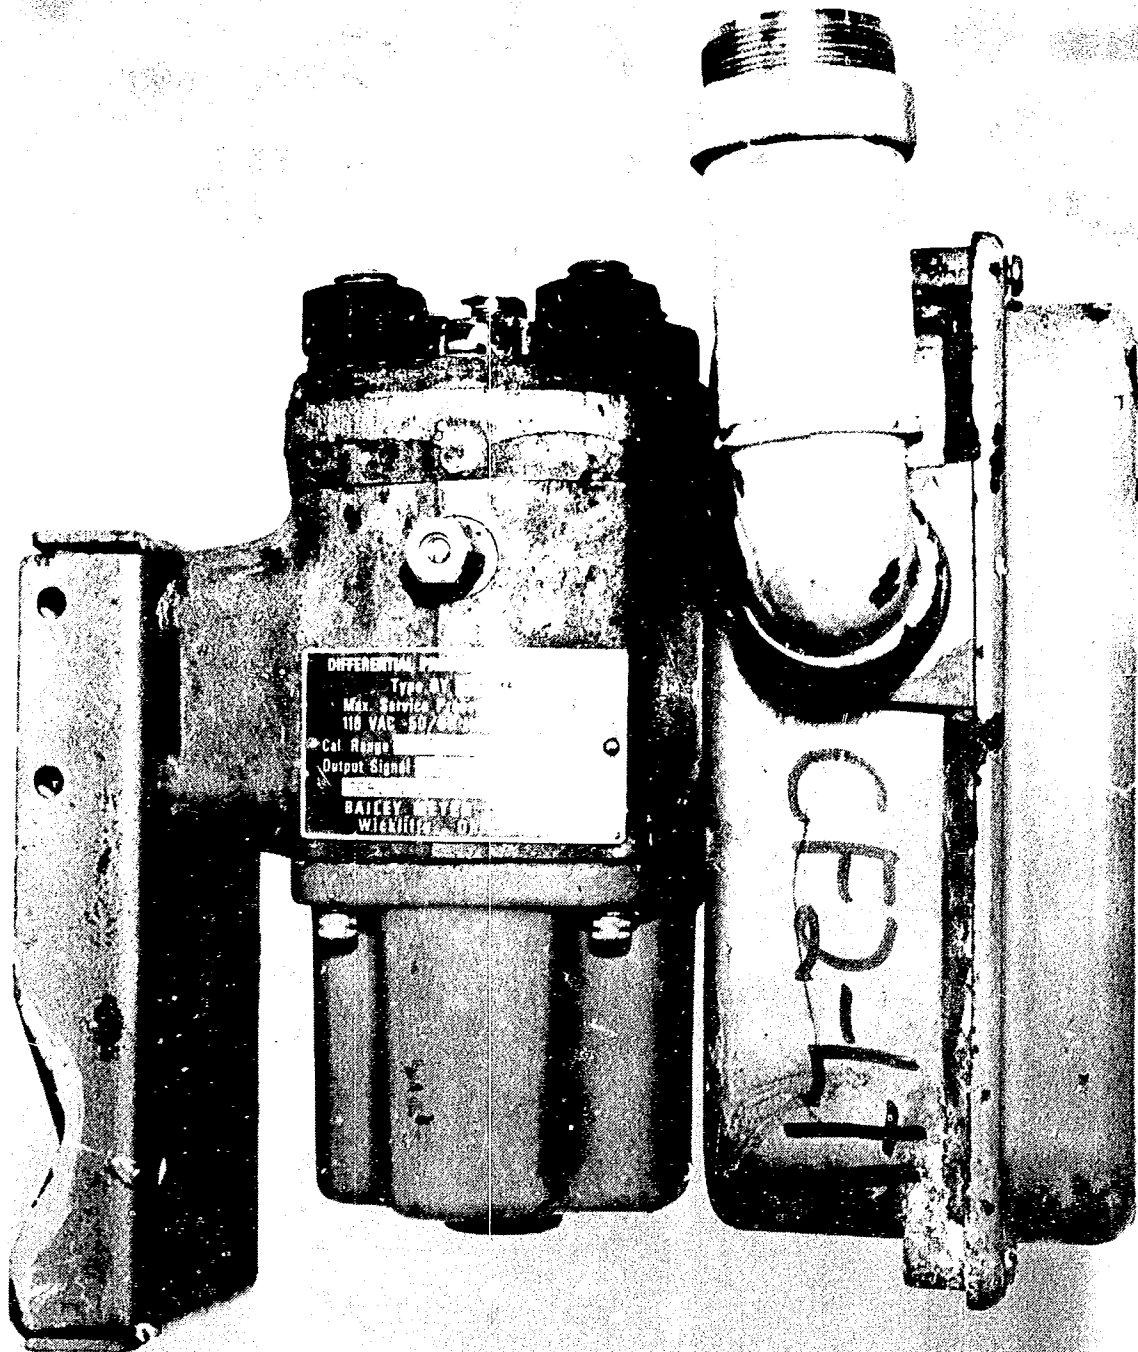
Figure 5. Bailey Transmitter CF-2-LT1.

CF-2-LT1 (Figure 5)

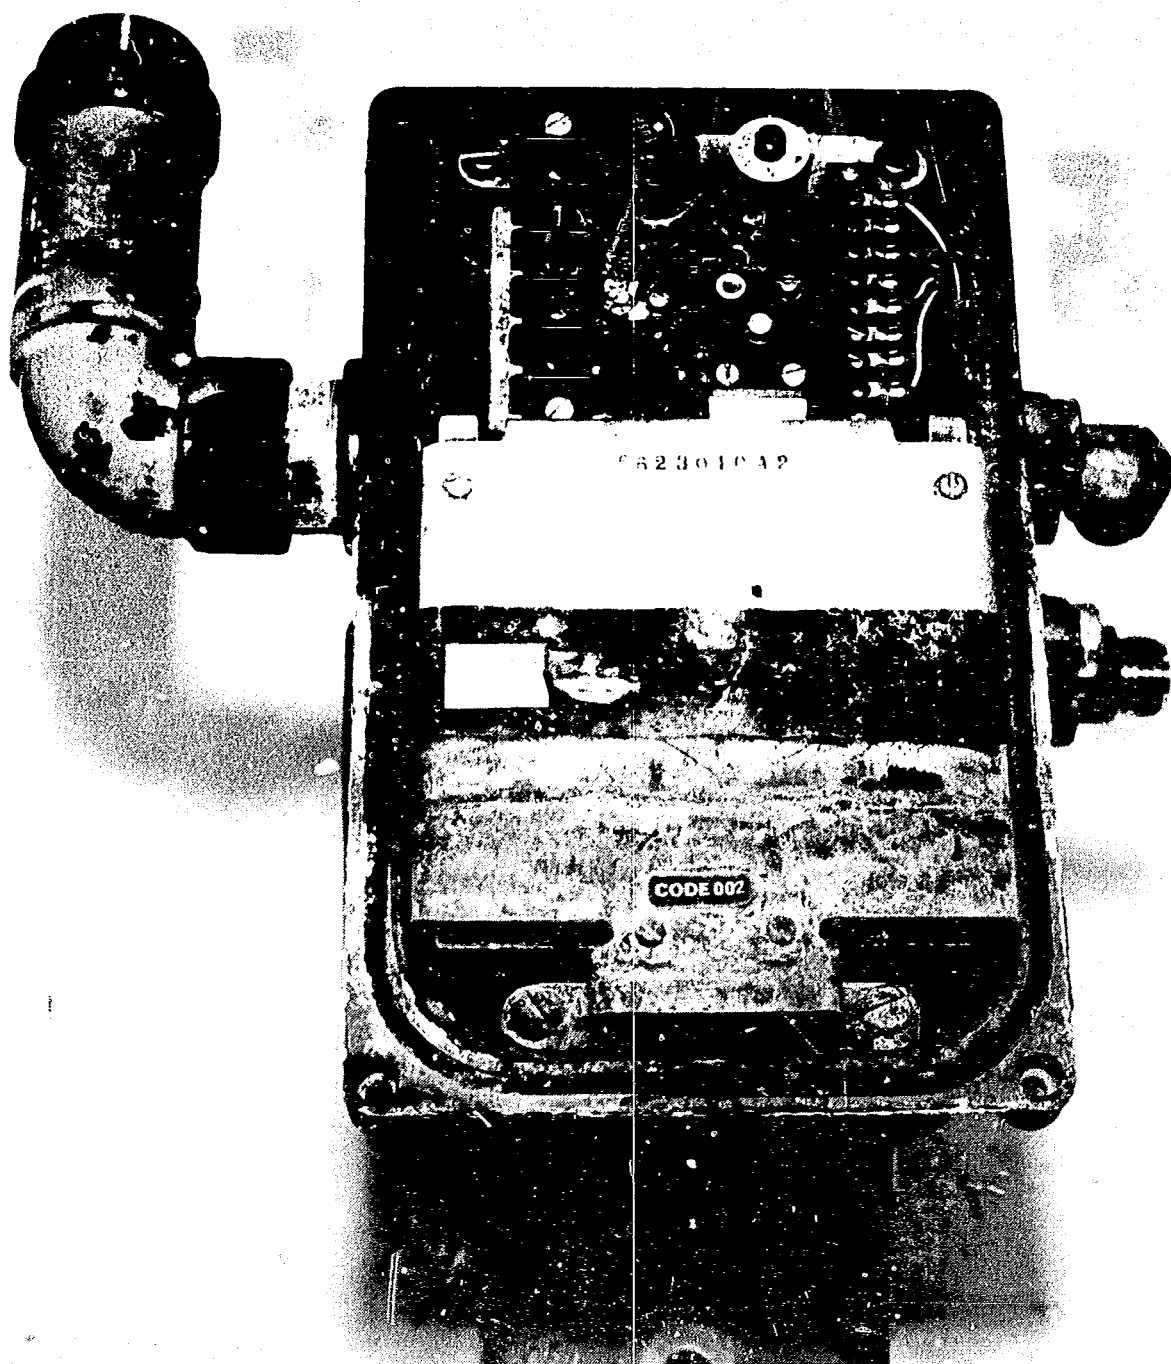
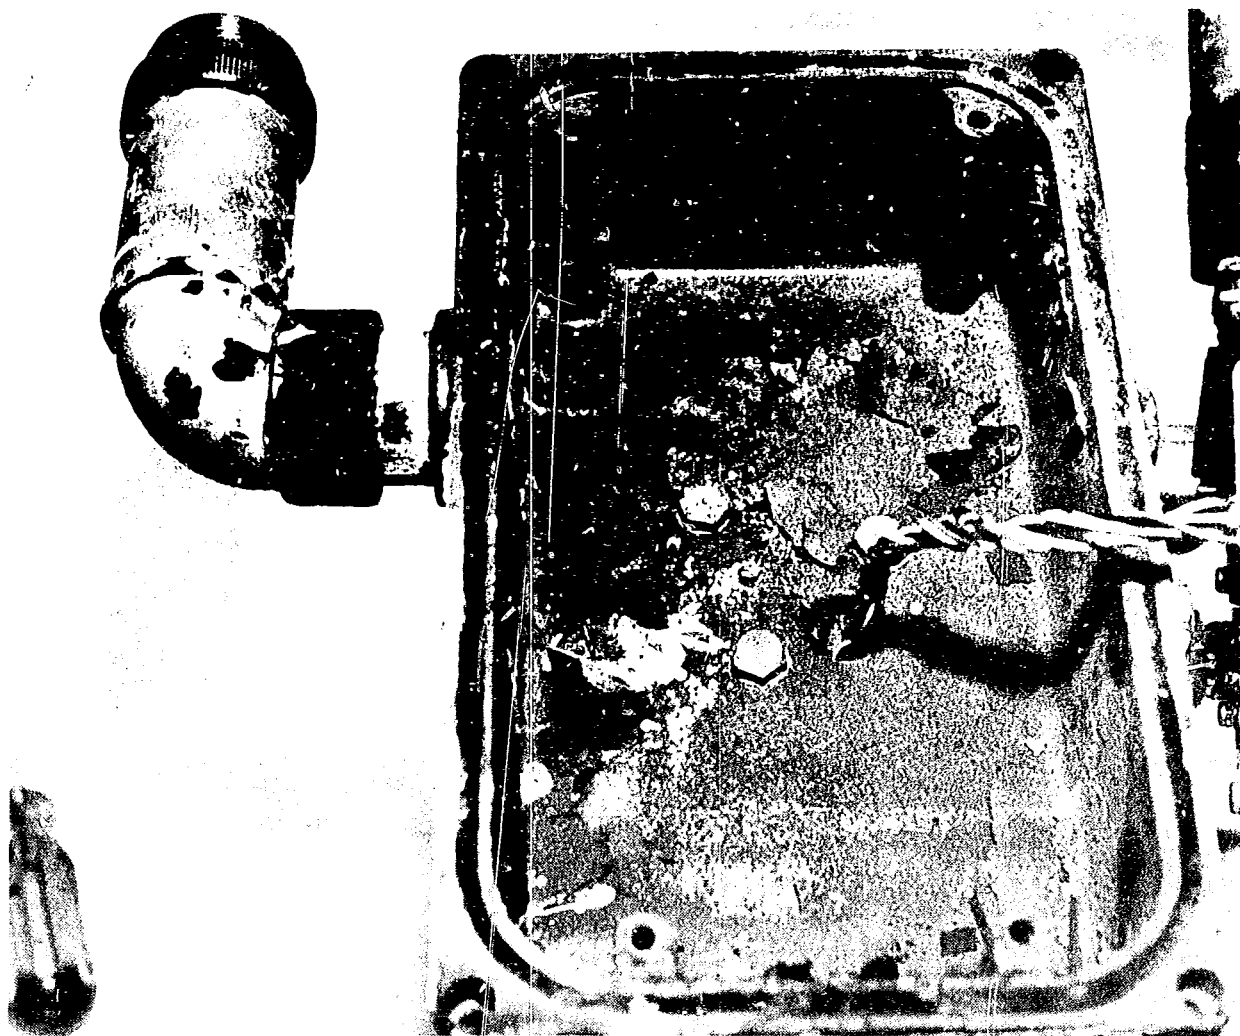
Figure 6. CF-2-LT1 with cover plate removed.

Figure 7. CF-2-LT1 with electronic module removed.

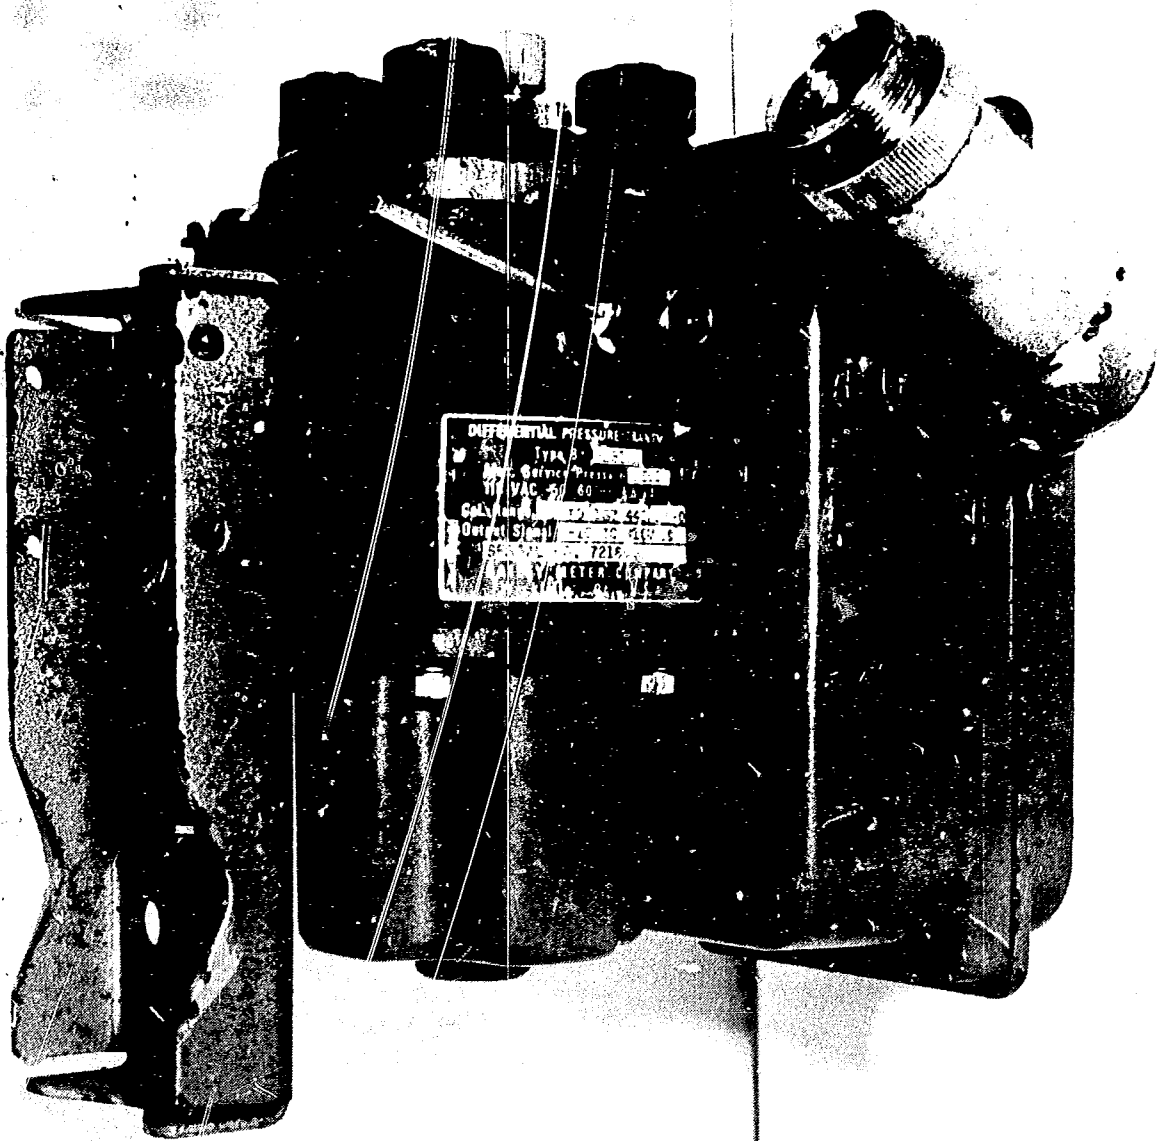
Figure 8. Bailey Transmitter CF-2-LT2.

CF-2-LT2 (Figure 8)

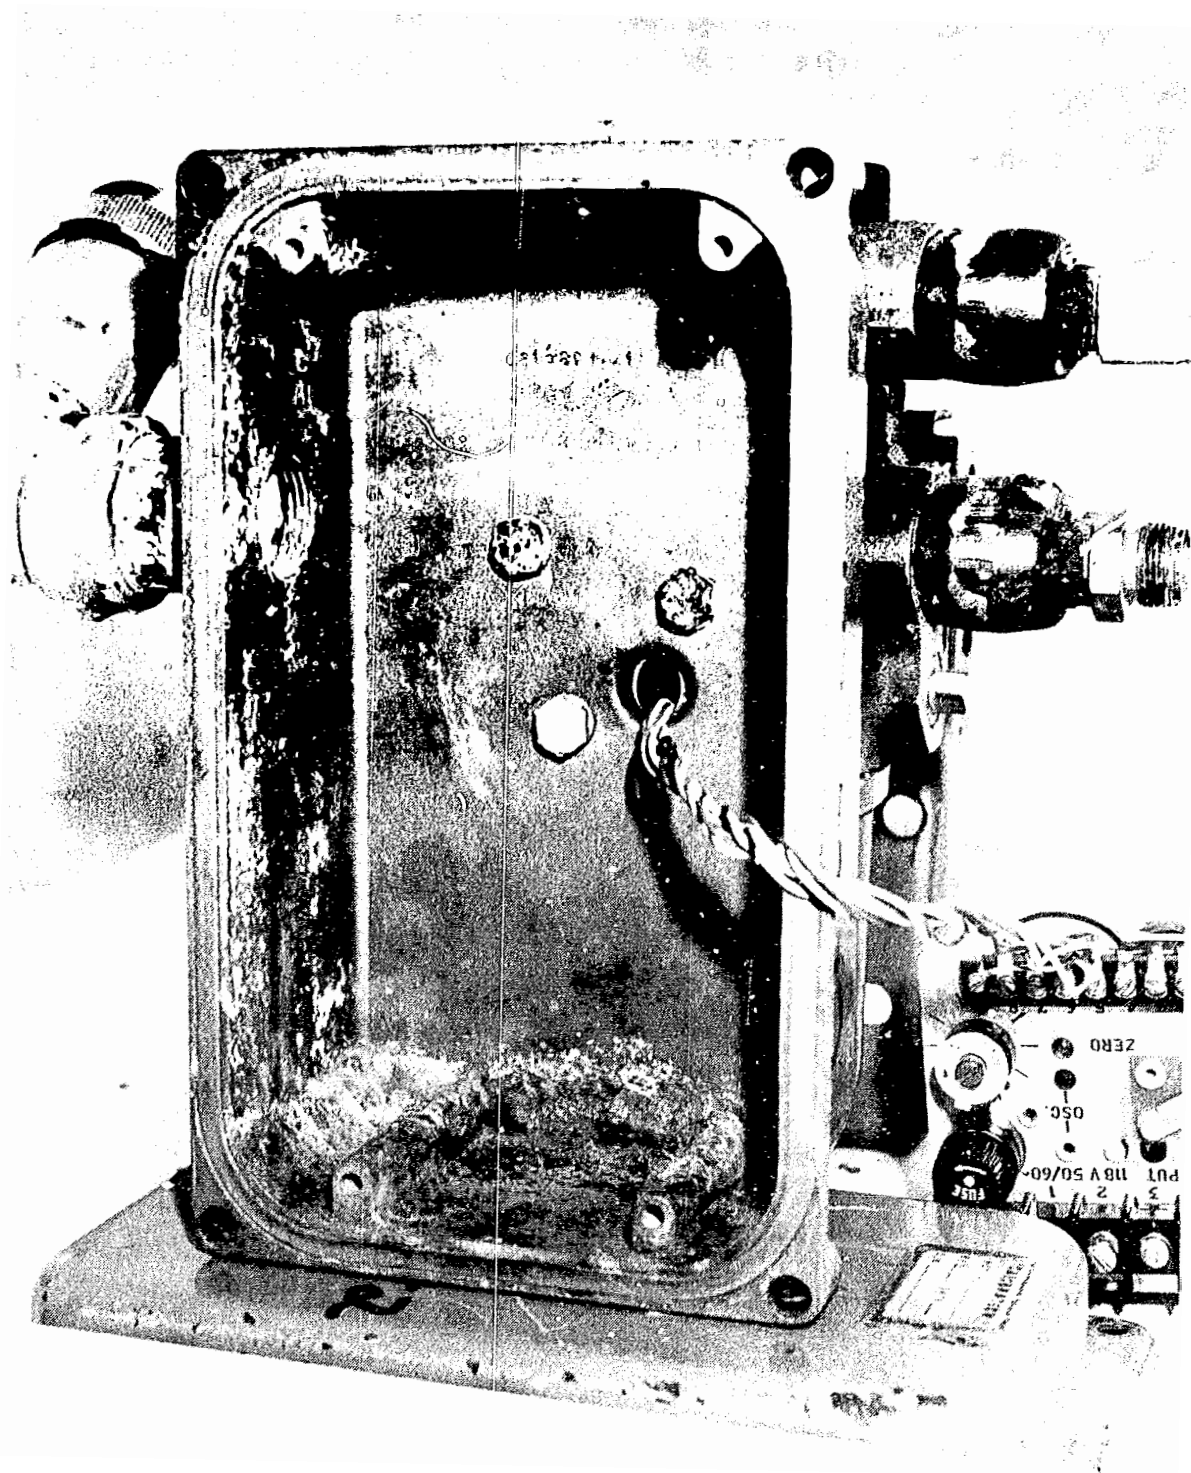
- o The cover plate seal appeared to be in good condition and there was minimum corrosion around the seal (see Figure 9).

Figure 9. CF-2-LT2 with electronic module removed.

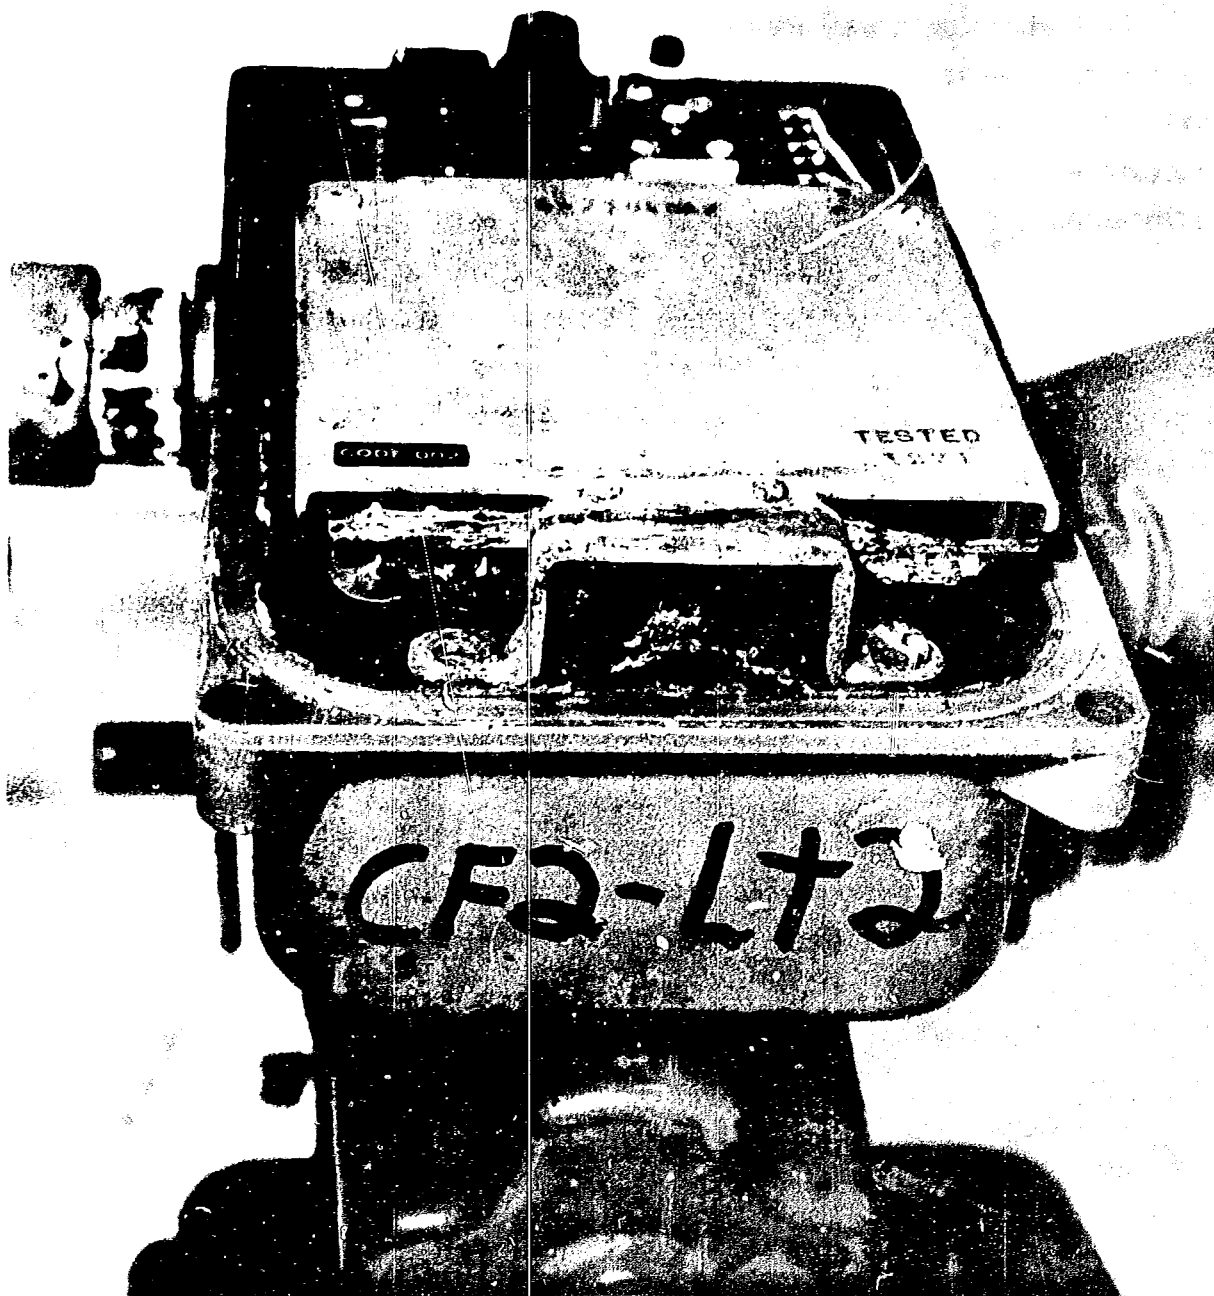
- o The water level in the transmitter appeared to have reached a depth of approximately 2/3 in. (see Figure 10).
- o It appears that the water entered through the conduit and ran down the inside of the transmitter. Internal corrosion was mainly along the side where the conduit entered the housing and the bottom area (see Figure 9).
- o The water that got inside the transmitter did not appear to leak out of the transmitter through the seal area. This is evident from the lack of corrosion on the exterior surface of the housing around the cover plate seal (see Figure 10).

Figure 10. CF-2-LT2 with cover plate removed.
