## EXAMINATION AND EVALUATION OF TH1-2 TRANSMITTERS

CF-1-PT4 AND CF-2-LT4

GEND-INF-029  
Vol. III

**Published January 1985**

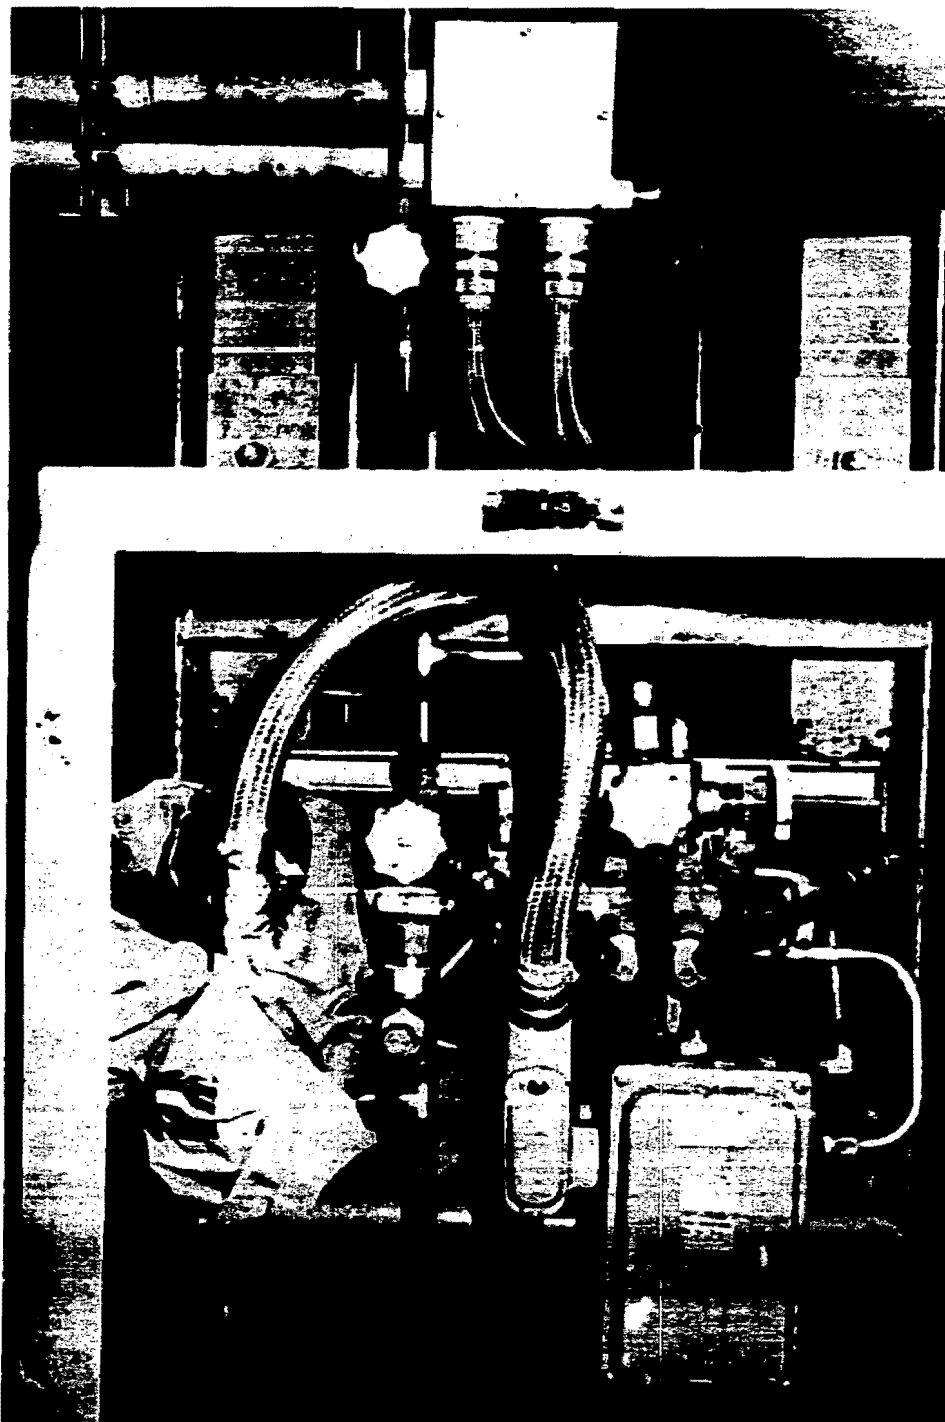
Photographs of several of the core flood transmitter installations at TMI-2 were taken during reactor building entries 92 and 342, and a general visual inspection by EG&G Idaho personnel was made of the Core Flood Tank B area during entry 499 (November 30, 1984).<sup>7</sup> Figure 1 shows the installations of transmitters CF-1-PT4 and CF-2-LT4 and their common junction box prior to their removal from the reactor building. This installation is typical of the core flood transmitter installations, in that a flexible conduit runs a short distance from each of the transmitters to a junction box where an in-line splice is made. A rigid conduit then connects the junction box (Figure 2) to the cable tray area, as shown in Figure 3.

**Figure 1. Core flood instruments CF-1-PT4 and CF-2-LT4 prior to removal (entry 342-7).**

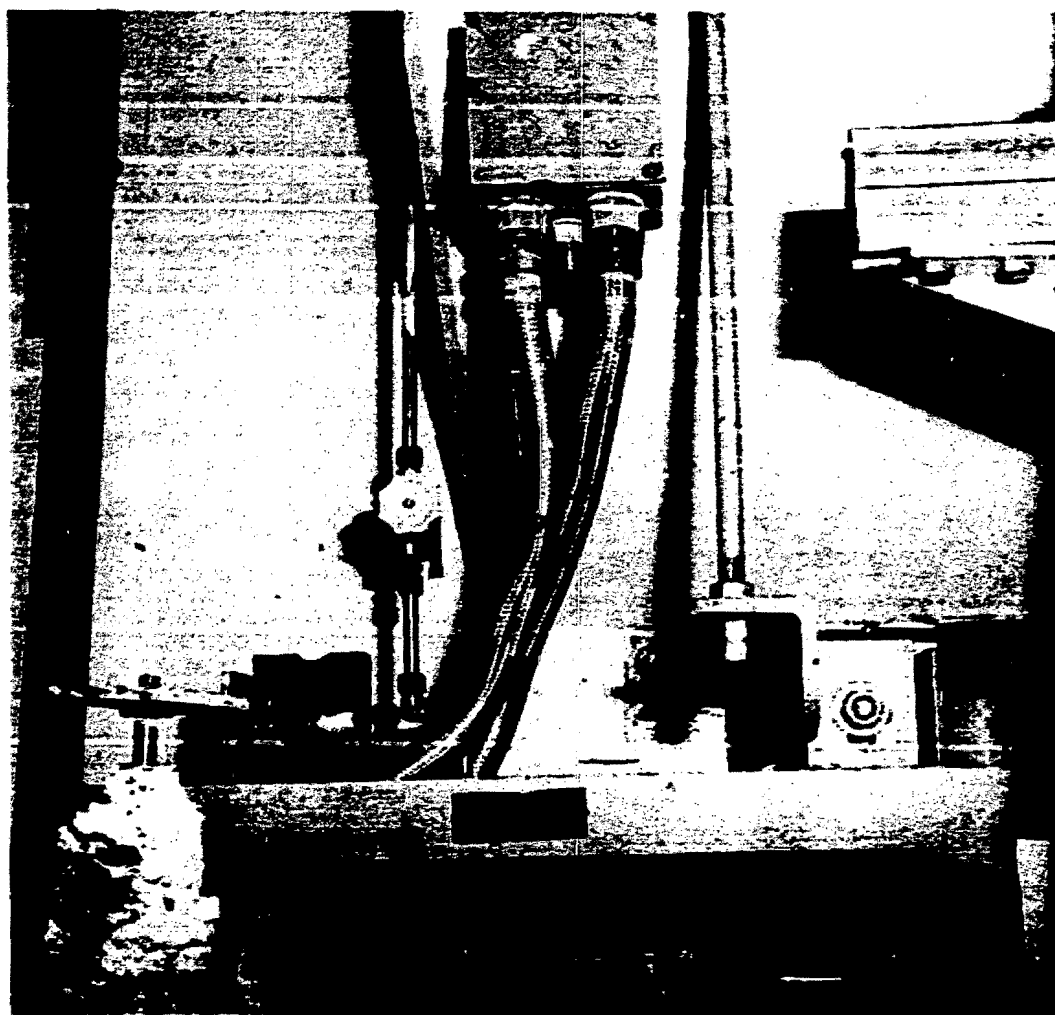
**Figure 5. Junction box associated with CF-1-PT2 and CF-2-LT2 (entry 92 2-4).**

An inspection of this junction box showed no internal moisture damage or mineral deposits, suggesting that the ends of the rigid conduit for these transmitters at the cable tray were more protected from moisture than were the other three installations, or, the breather installed in this junction box provided some ventilation which minimized condensation.

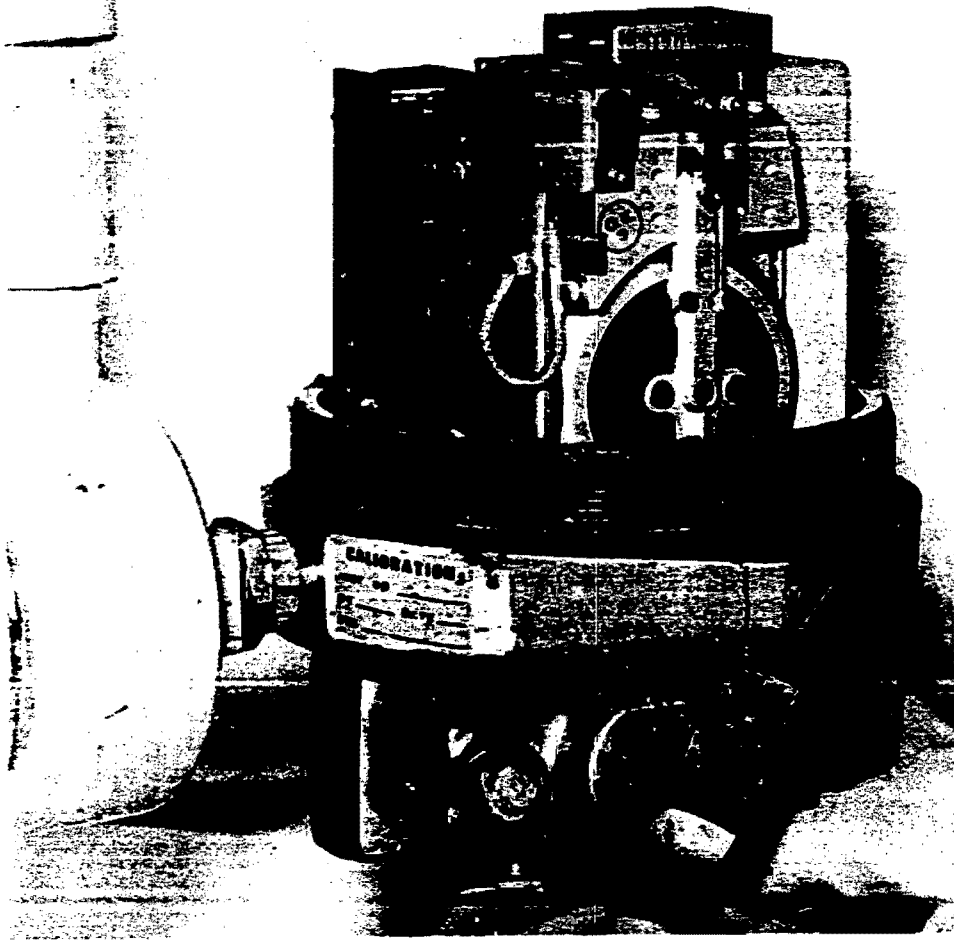
From initial visual examination at the INEL, it appears that the transmitter was in good condition except for some minor corrosion and rust on the exterior. The interior of the transmitter, including the sensor/electronic module assembly, was free from corrosion and radioactive contamination. The circular junction box showed no signs of corrosion; however, some mineral deposits were apparent, indicating that moisture had

**Figure 6. Foxboro E11GM transmitter CF-1-PT4.**

been in the junction box at some time. Radiation measurements indicated that the interior of the junction box was radioactively contaminated. Since the junction box seal appeared to be in good condition, it is likely that the water entered the junction box through the conduit. A seal located between the transmitter and the circular junction box prevented moisture from entering the transmitter itself.

The linearity for both sets of calibration data was better than 0.125%. The percentage change in both the zero and span occurring during the 81-month calibration interval was calculated. The zero shifted 1.34% of span, whereas a 0.2% increase occurred in the transmitter's sensitivity to pressure.

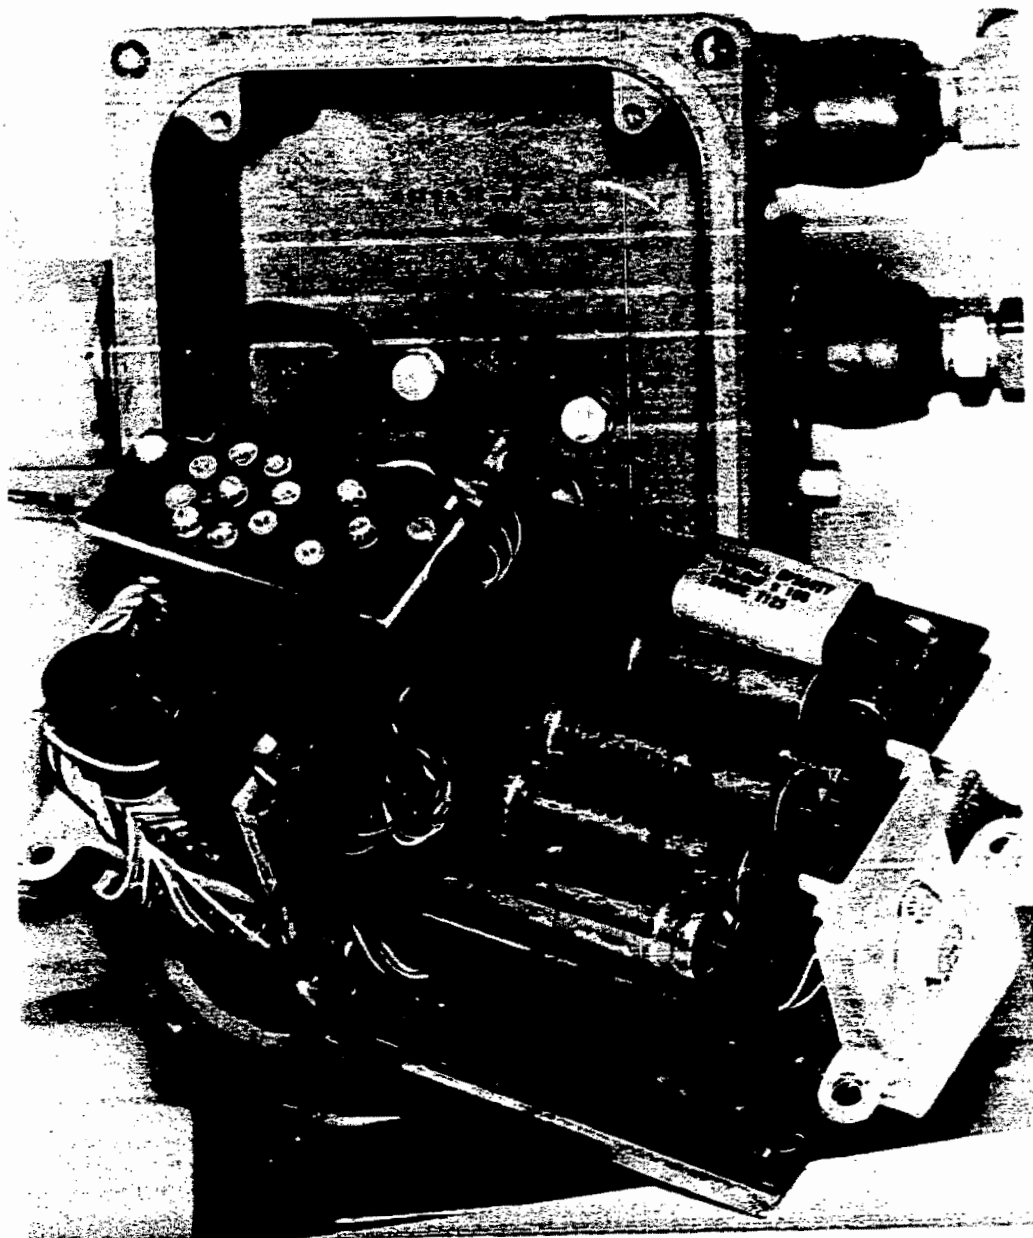
An initial visual examination of this transmitter indicated a heavy layer of rust on the unit's assembly nuts, while the remainder of the exterior surfaces had only minor or no indications of rusting. The interior of the transmitter, including the housing and the electronics, was free of corrosion and rusting (Figure 7). There was no evidence of moisture in the housing, in contrast to the other core flood level transmitters, CF-2-LT1, CF-2-LT2, and CF-2-LT3, which had extensive interior corrosion due to intrusion of water during the accident. An inspection of the transmitter housing and the conduit fittings connected to the housing indicated that no special installation or sealing procedures were used on this transmitter or on the other core flood level transmitters.

Measurements were taken to determine the extent of radioactive contamination on the interior surfaces of the transmitter. These measurements showed the contamination level was considerably higher in the area of the electronics than inside the conduit fitting. It is probable that the interior of the transmitter housing became contaminated at the

**Figure 7. Bailey BY8231X-A transmitter CF-2-LT4.**

The correlation coefficient for this data was 0.999947. An analysis of the pre-and postaccident data indicated that a zero shift of 2.9% of span had occurred during the time interval, while the gain had increased by 1.59%. A zero shift of approximately 0.4% of span occurred between each of the calibration cycles, while the gain increased an average of 0.5%.

Consideration should also be given by the manufacturer of the transmitters to providing a seal around electrical leads as they exit the transmitter housing, similar to the sealing technique used by Foxboro on their transmitters.
