EVALUATION OF TMI-2 PRESSURE SWITCHES NM-PS-1454 AND NM-PS-4174

Joseph A. Gannon

Published November 1983

EG&G Idaho, Inc.
Idaho Falls, Idaho 83415

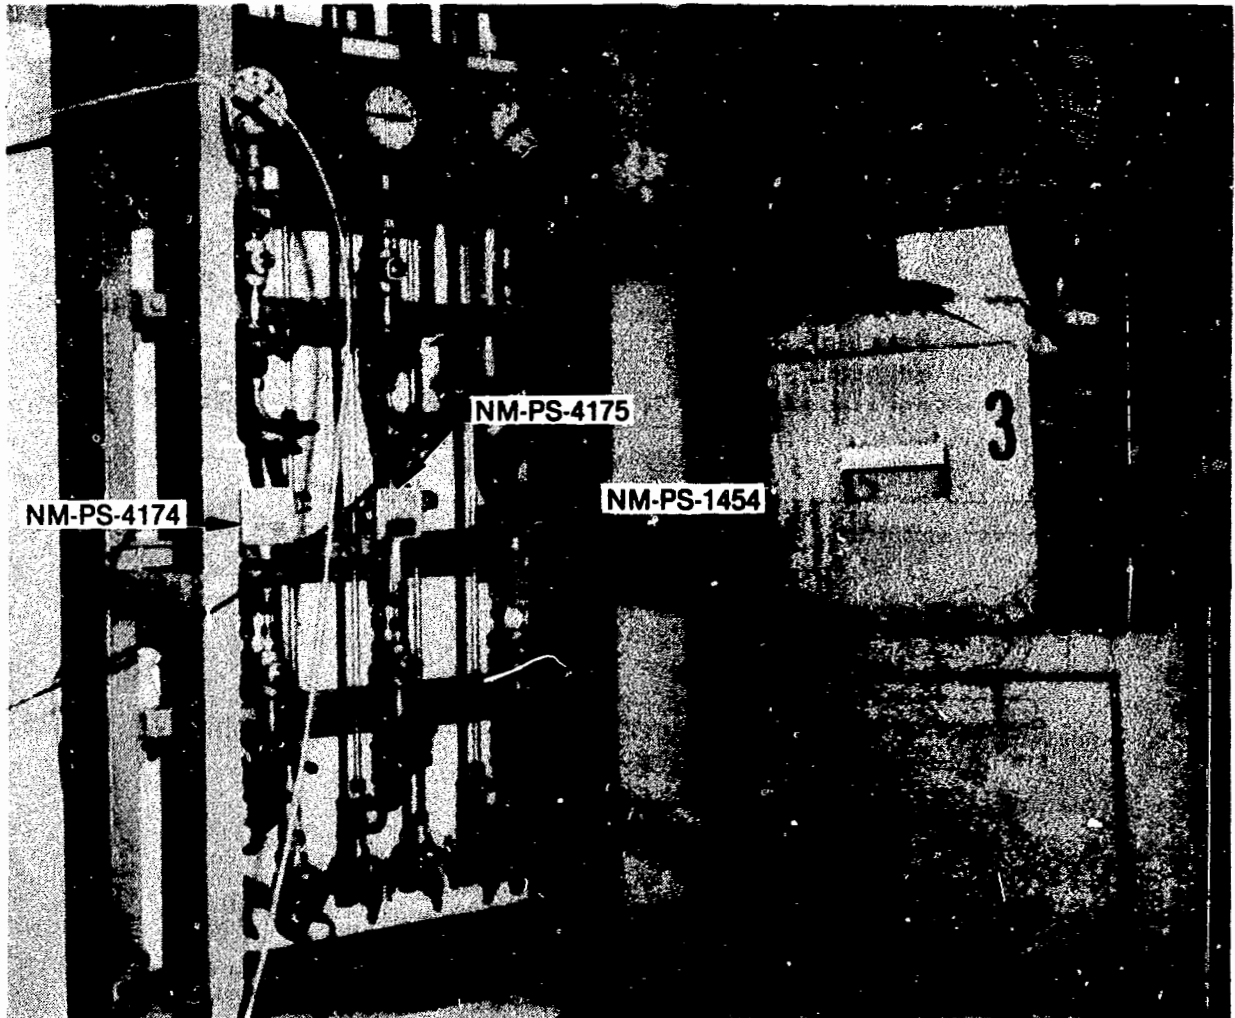
Figure 1. Instrument Rack 432 at the 347-ft elevation, showing pressure switches NM-PS-1454, NM-PS-4174 and NM-PS-4175.

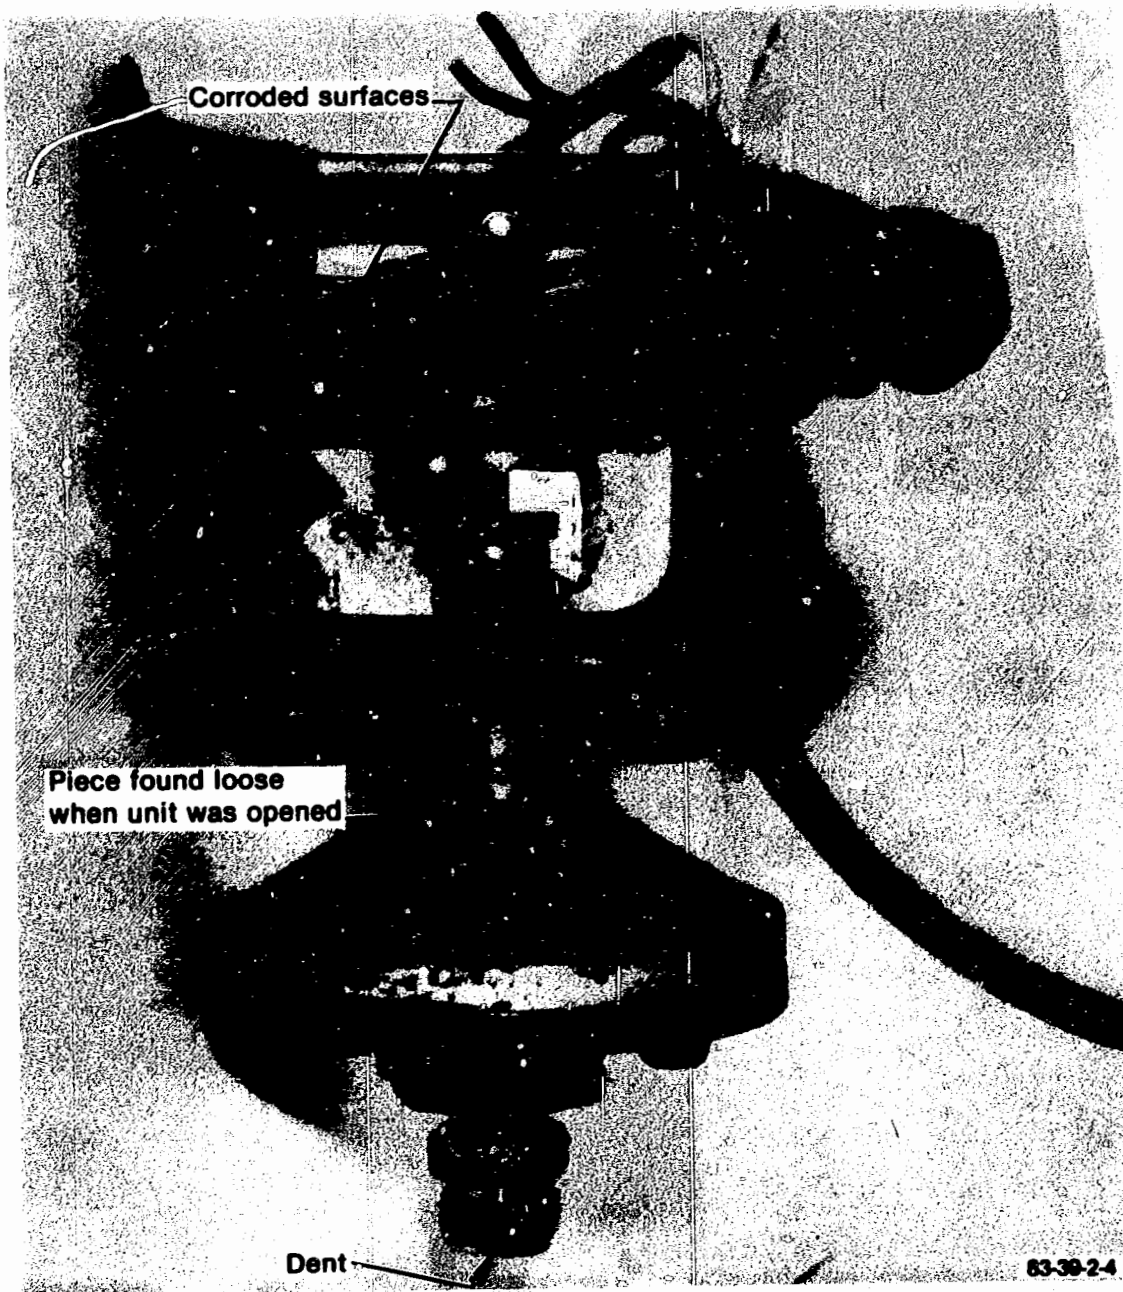
Figure 3. Pressure switch MM-PS-4174 interior.

The interior of the switch enclosure portion of NM-PS-4174 was clean but appeared to have had moisture in it at one time, as evidenced by the corrosion of ferrous metal parts (see Figure 3). The water that caused this corrosion may have been from the hot-water spraying of the Reactor Building during the gross decontamination experiment. The cover gasket appeared to be in good condition, so it is likely that water entered the enclosure through the conduit or its associated fittings.

Therefore, it is recommended that instruments such as these pressure switches be carefully sealed when installed to prevent the incursion of moisture.

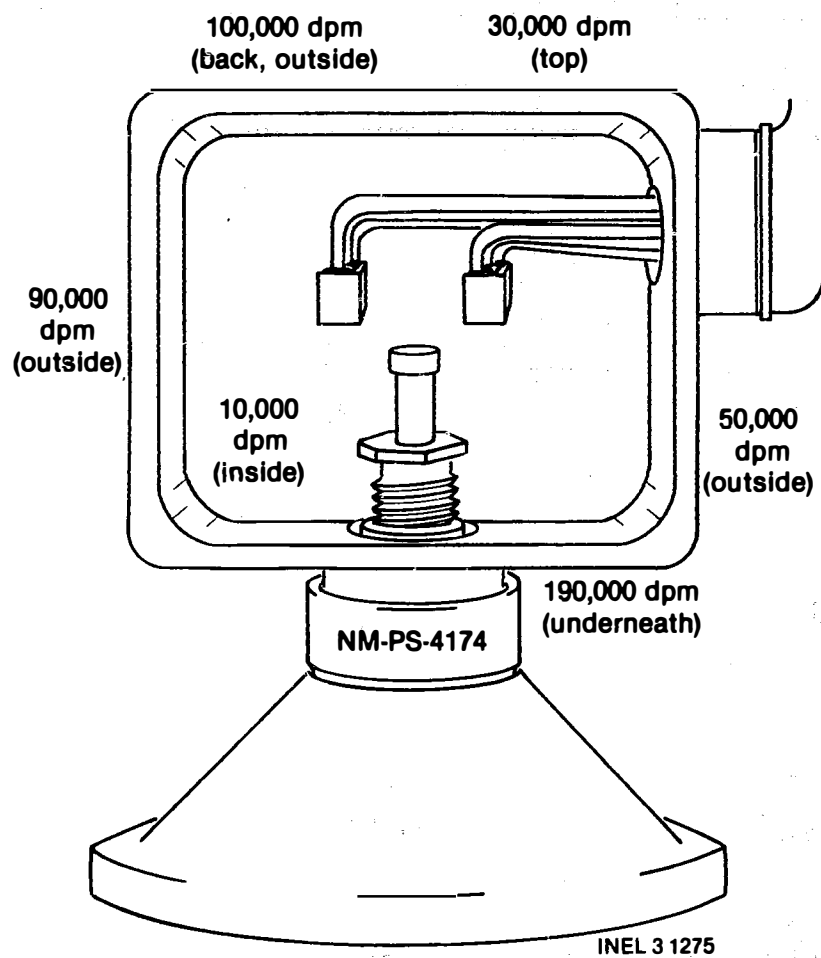
Radiological Observations. The exterior smear survey shows 30,000 to 190,000 disintegrations per minute (dpm) gross beta and gamma radiation (see Figure 6). The interior of the switch enclosure shows 10,000 dpm, indicating contaminated water or air had entered the enclosure. Cover plate gamma spectrum analysis and full smear count results are presented in Table 2.

Figure 6. Contamination smear sites for NM-PS-4174.

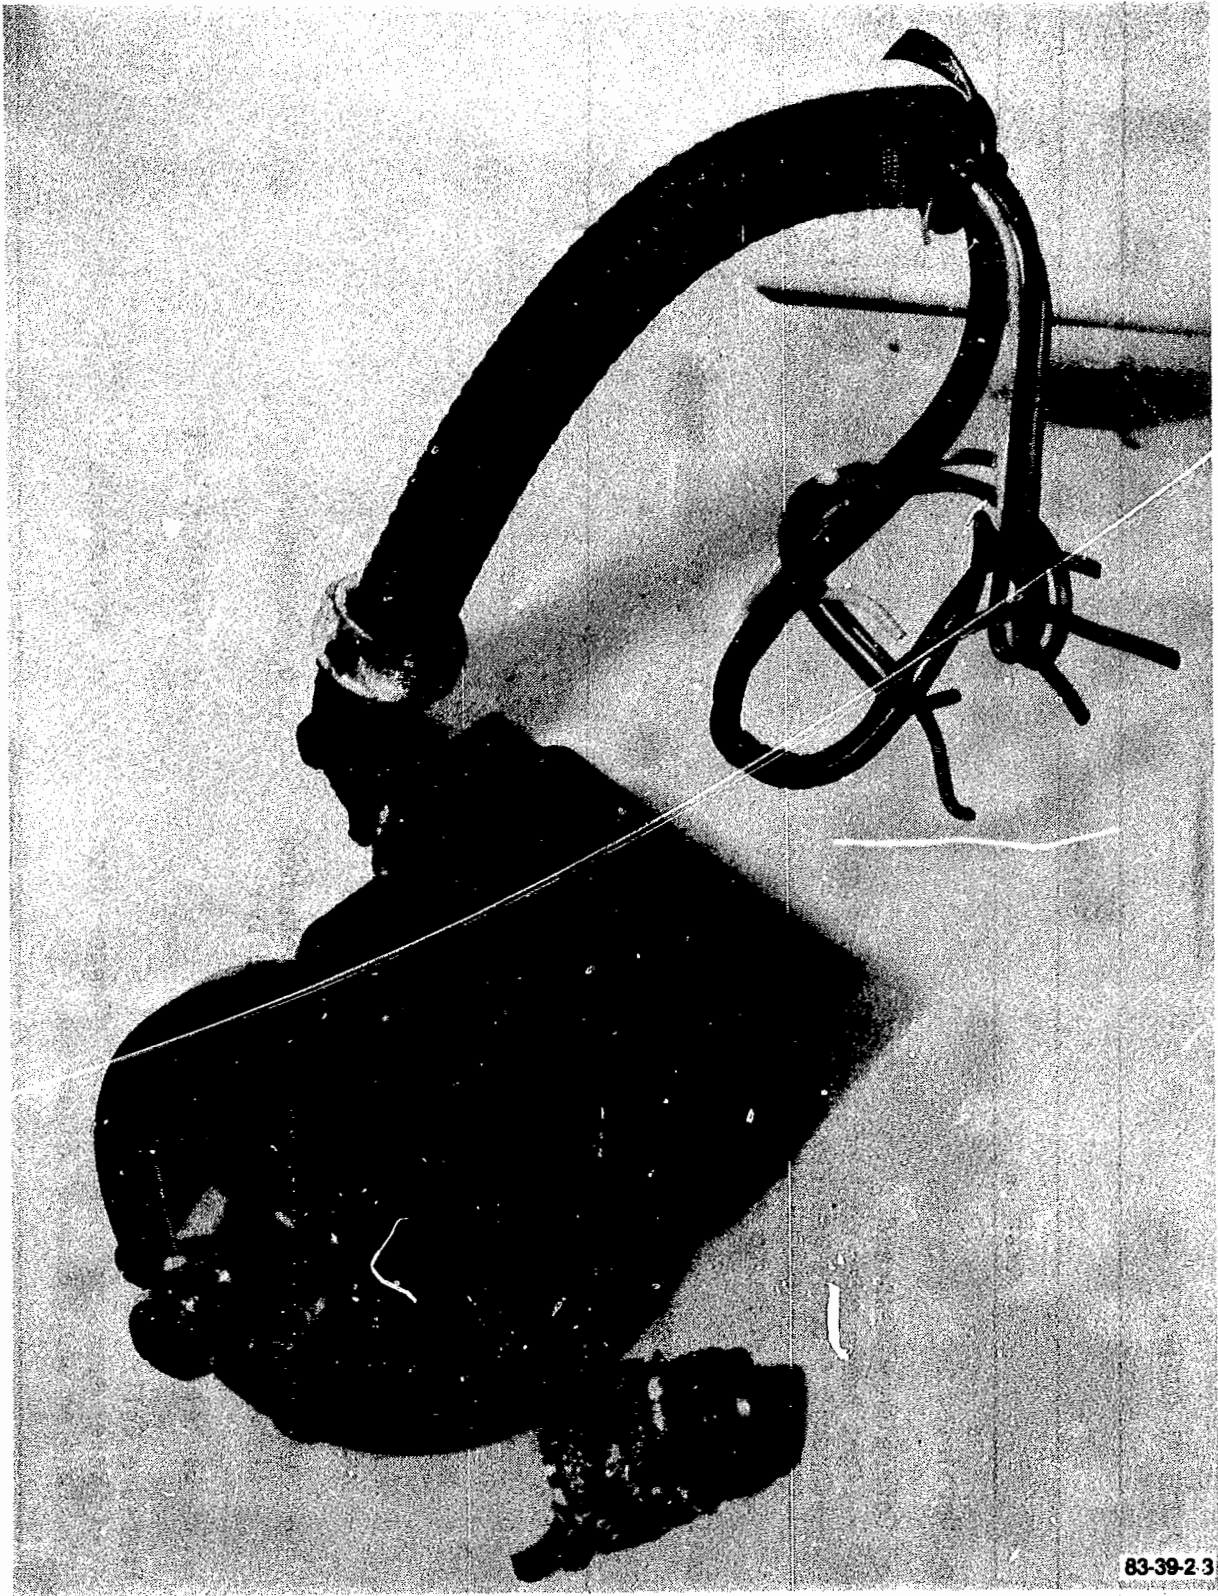
Visual Observations. The bolts holding the flanged pressure port assembly together had a heavy coating of rust; all other surfaces were lightly corroded. Table 3 provides a detailed comparison of visual observations of both switches externally and internally. (See also Figure 7.)

The unit appears to have been damaged in handling. There is a dent in the pressure fitting, and the switch actuation plate was adrift in the switch enclosure. The actuation plate was reinstalled prior to mechanical characterization.

Figure 7. Pressure switch MM-PS-4174 exterior.

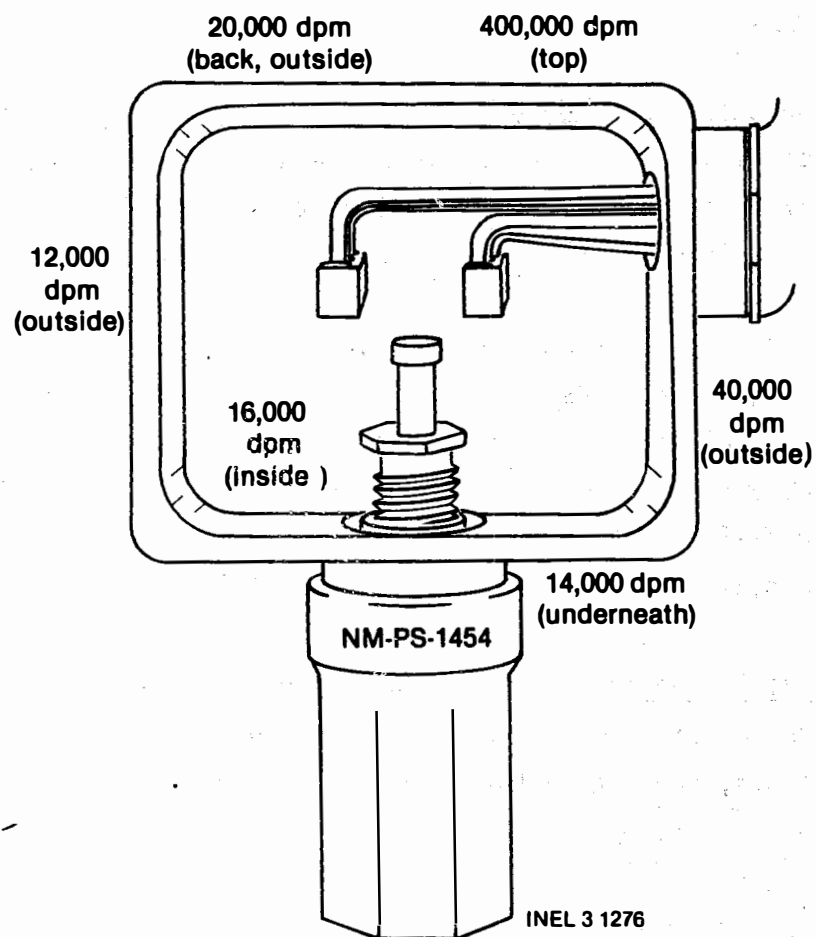
Radiological Observations. A smear survey of the switch exterior shows 12,000 to 400,000 dpm gross beta and gamma radiation (see Figure 9). The interior of the switch enclosure shows 16,000 dpm, indicating contaminated air had entered the enclosure. Cover plate gamma spectrum analysis and full smear count results appear in Table 2.

Figure 9. Contamination smear sites for NM-PS-1454.

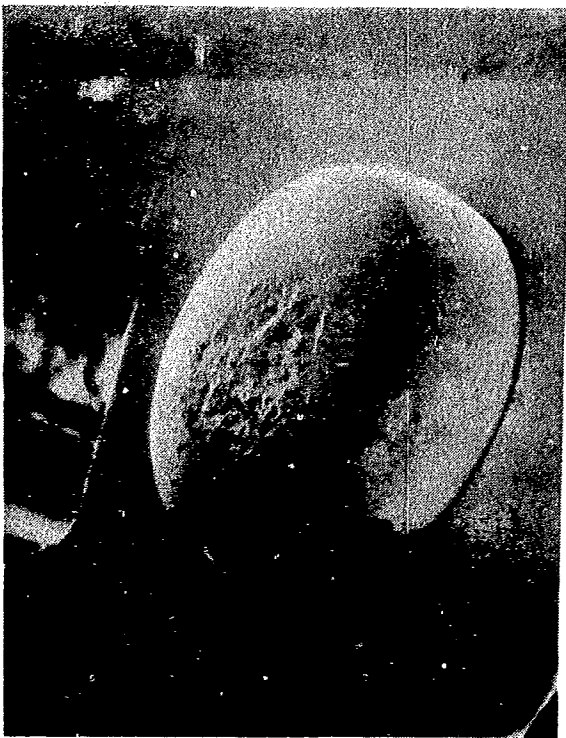
AC/DC Overload. Scanning electron microscope photographs of the right switch (ac overload) of NM-PS-4174 showed evidence of marked contact pitting (see Figures 10 and 11). Consequently, this right switch is considered unacceptable for further use. The left switch (dc overload) of both NM-PS-4174 and NM-PS-1454 showed evidence of contact arcing, but pitting appeared to be minimal (see Figures 10, 12, and 13).

Figure 11. Scanning electron microscope photographs of NM-PS-4174 right switch taken at the angles shown in Figure 10, post ac overload. (None of these contacts saw plant service.)

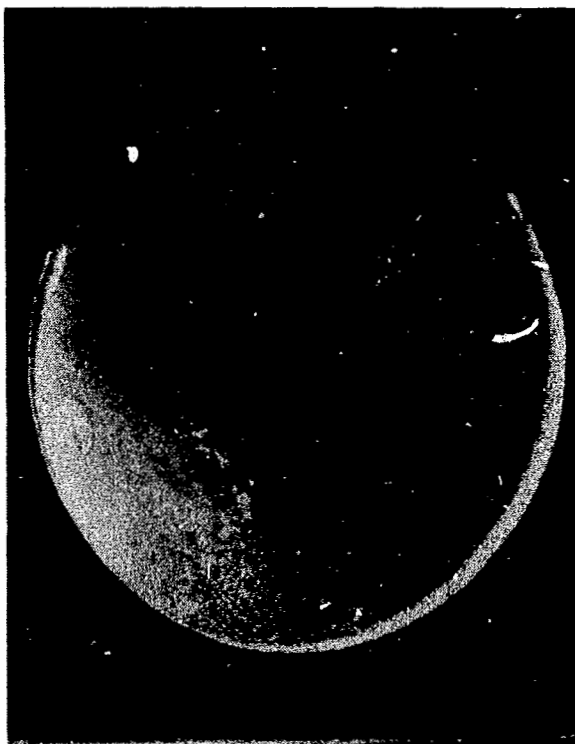
Figure 12. Scanning electron microscope photographs of MM-PS-4174 left switch taken at the angles shown in Figure 10, post dc overload.

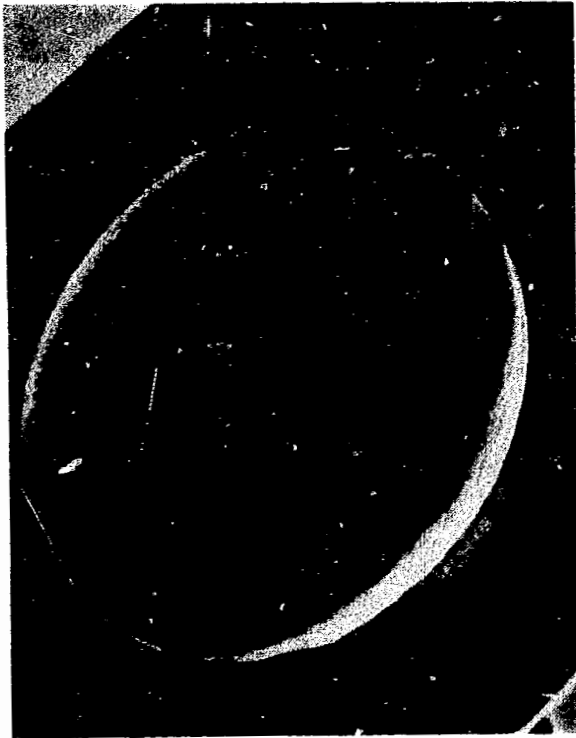
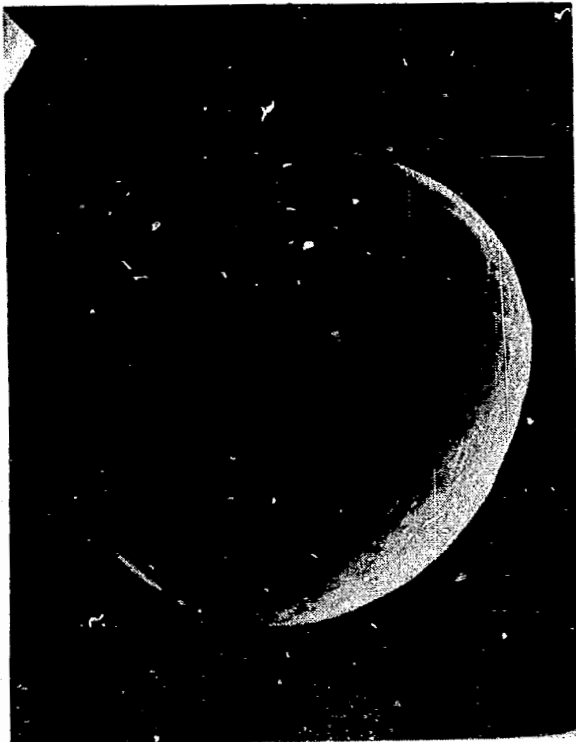
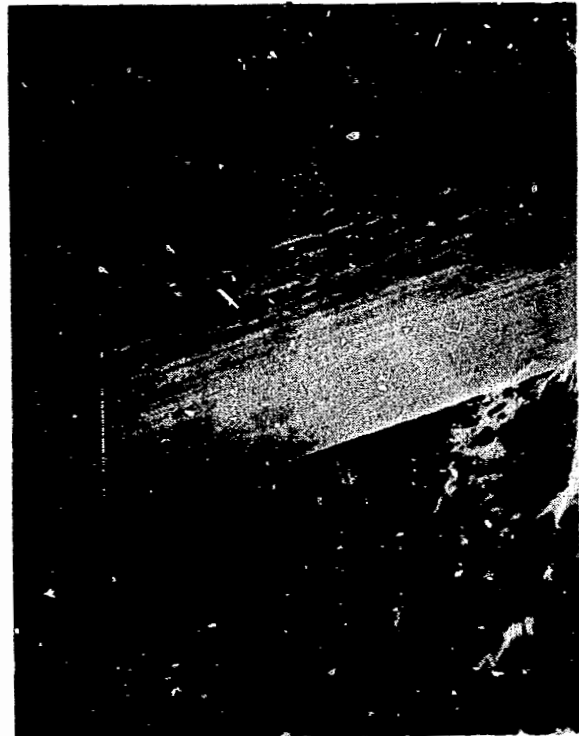
Figure 13. Scanning electron microscope photographs of MM-PS-1454 left switch taken at the angles shown in Figure 10, post dc overload.
