EVALUATION RESULTS OF TMI-2 SOLENOIDS AH-V6 AND AH-V74

Florante T. Soberano

**United Engineers and Constructors
Philadelphia, Pennsylvania**

Published January 1984

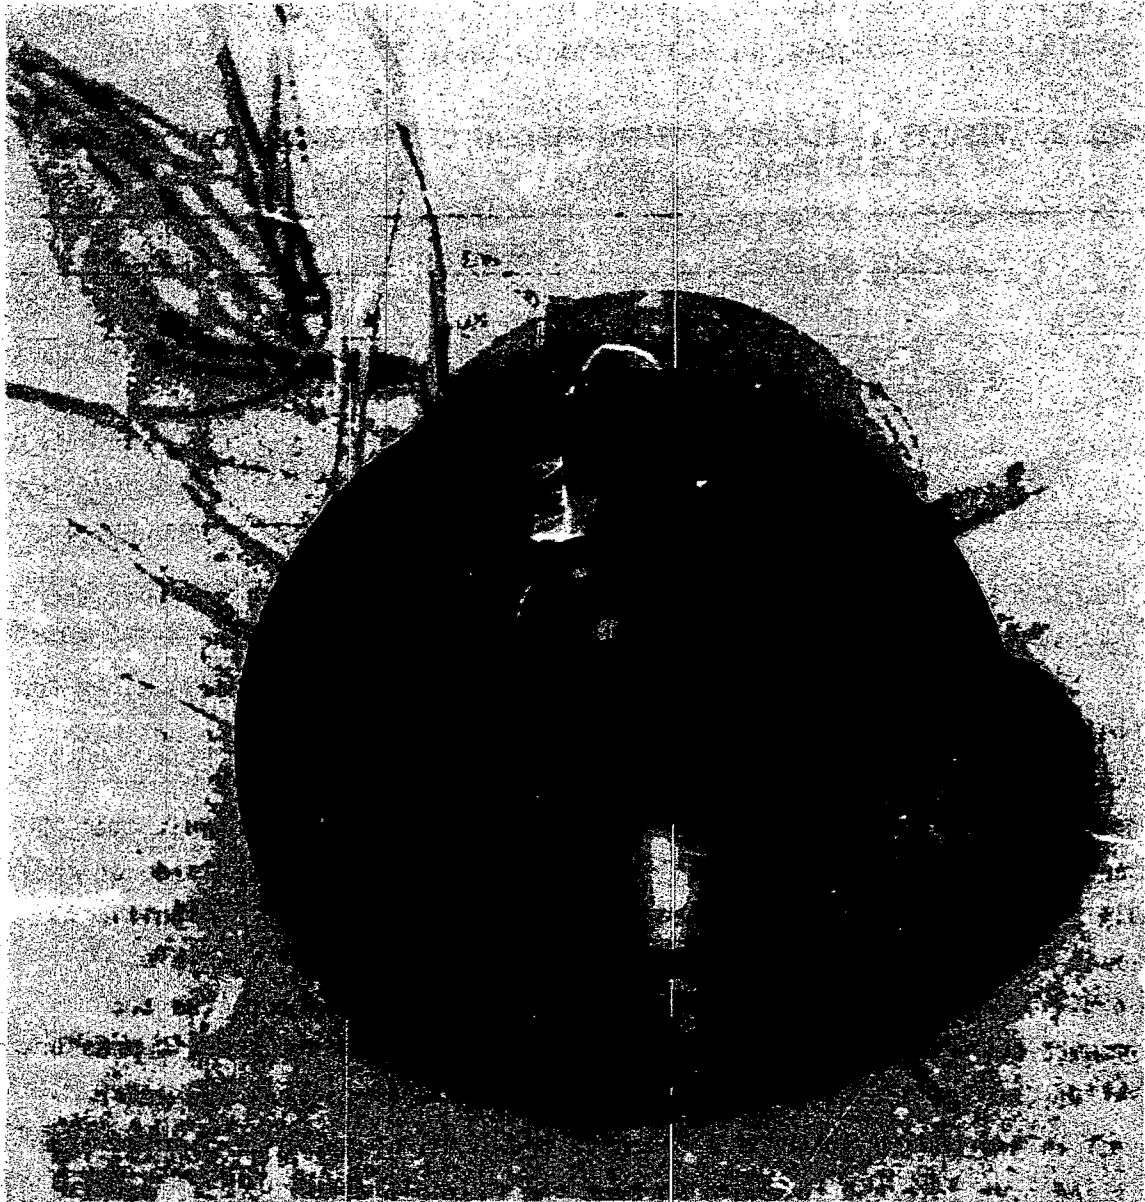
83-30-27

Although the accident did not affect the solenoids electrically, it did cause physical degradation. Figures 15 through 19 are photographs of the solenoid coil shell assemblies of AH-V6 and AH-V74. As Figures 15 through 17 reveal, AH-V6 was extensively rusted. AH-V74 was only superficially rusted on its shell base (Figure 19).

Figure 19. Base of solenoid AH-V74, which became rusted due to water seeping in from outside the unit, not through its center.

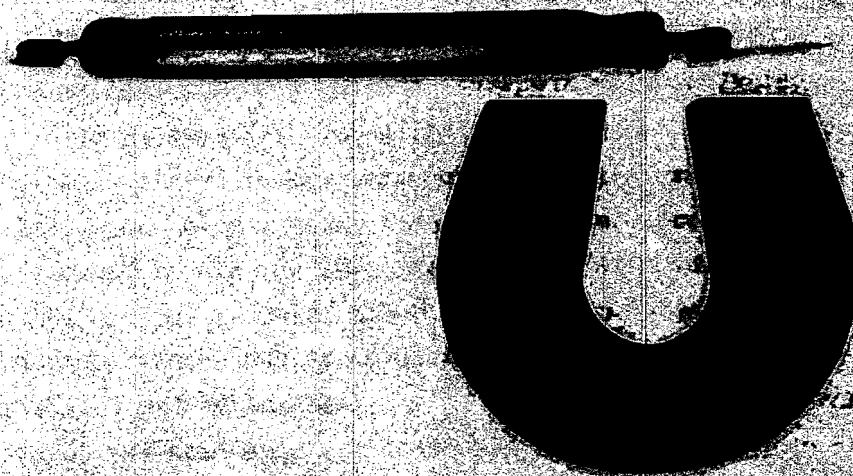
Only the limit switches of AH-V6 were examined; those of AH-V74 were not used. As mentioned earlier, the OPEN limit switch would not close even when influenced by an external magnet. Subsequent x-ray examination of the device disclosed that the tip of the movable contact, as illustrated in Figure 20, broke off from the armature. The tungsten contact of the stationary contact was also separated.

The switch was first observed by the TMI-2 Operations Department to be giving false information before any in situ test was performed. This false information was probably the result of loose parts getting wedged between the stationary contact and the armature, thereby giving a continuous closed contact indication. The loose parts finally got dislodged when the solenoid's orientation was altered during its removal from the valve. To determine the failure mode, the switch metal encapsulation was sliced open. The removal of the metal insulation revealed several facts. The switch glass envelope was discolored and broke apart as soon as the encapsulation was removed. Visual examination of the exposed components (Figure 21) revealed what appeared to be a burned end of the armature arm, presumably caused by a fabrication flaw that may have made the joint structurally weak, thereby resulting in the premature failure of the device. The tungsten contacts of the stationary and movable arms were also rusted, an unexpected condition since the reed switch was supposed to be hermetically sealed. Although rusting cannot be declared with certainty to have caused the reed switch to fail, the actual intrusion of moisture into the device is in itself considered a fault. The moisture intrusion is surmised to be either through the switch terminal seal or through a crack in the glass envelope.

Figure 20. Negative of an x-ray of the defective limit switch of AH-V6, with magnet used in an attempt to move the loose parts back to their proper positions.

Water intrusion inside the reed switch should be evaluated. The hermetic seal of the device could be improved by encasing the reed switch supporting terminal with qualified shrink-tubing from the neck of the reed switch glass encapsulation to and including a few inches of the connected lead wire. Furthermore, the present mounting design of the limit switch permits cracking of the glass encapsulation by overtightening the fastening set screw, a circumstance that may have occurred in AH-V6. To circumvent this problem, a new feature of mounting the limit switches without pinching the body should be incorporated.

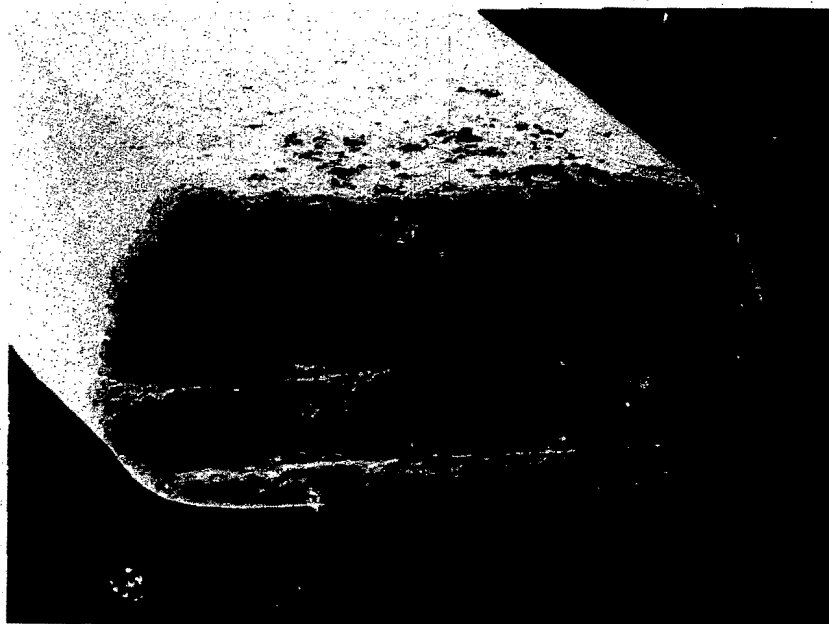
(a) Armature arm (~65x).

Burn marks

Groove where armature
arm meets tip

(b) Armature tip
(~28x).

Rust

(c) Contact (50x).

Figure 21. Damaged components of solenoid valve AH-V6.
