ANALYSIS OF THE POLAR CRANE PENDANT CABLE FROM THREE MILE ISLAND - UNIT 2

R. E. Trujillo
E. H. Richards

Published January 1986

ABSTRACT

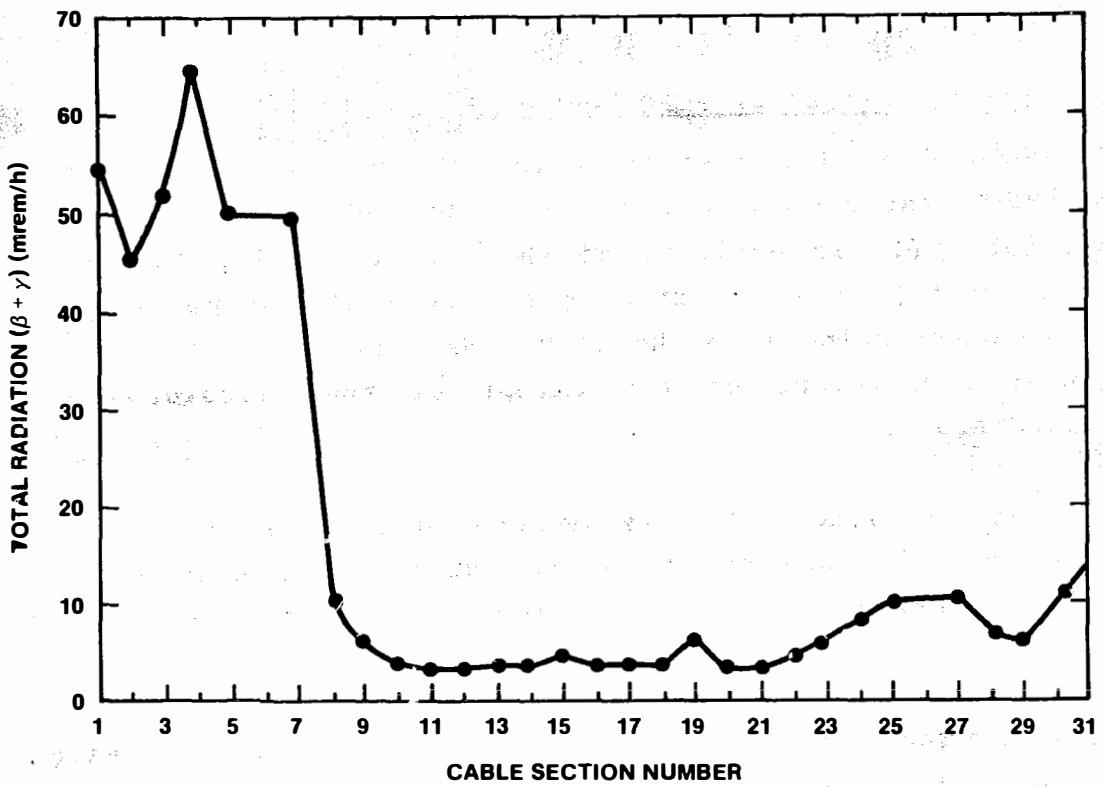
Figure 6. Measured Radiation Level as Function of PCPC Section Number.

- Figure 6 presents a plot of radiation level versus cable section number. The measured radiation level of the lower-numbered cable sections was an order of magnitude higher than that of the rest of the sections. This finding is in agreement with other radiation-level observations for TMI-2, in which horizontal surfaces have higher radiation levels than do vertical surfaces because a horizontal surface exposes more area to settling contamination than does a vertical surface. The radiation profile in Figure 6 strongly suggests that the lower end of the PCPC rested on a horizontal surface and that the transition point occurred at about cable section 8. At the time of cable removal, the polar crane control box and some length of the PCPC were observed lying on top of the D-ring. The physical abuse noted previously for the lower-numbered cable sections probably resulted from this portion of the cable lying underfoot before the time of the accident.

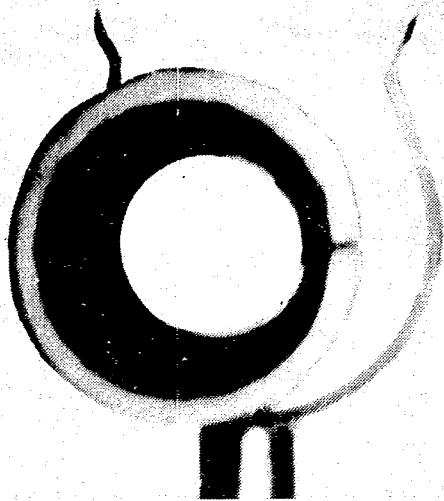
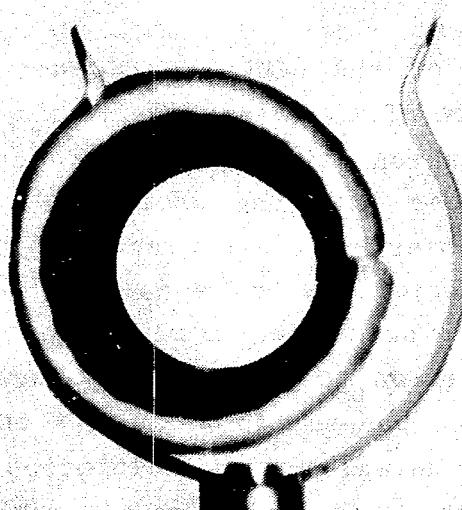
Figure 8. Photographs of Cable Showing Areas of Charring, Discoloration, and Normal Coloration.

- The PCPC can be divided into three distinct regions: a charred region, a discolored region, and an undamaged region free of charring or discoloration. The undamaged cable jacket has a dull, off-white surface, but the subsurface is bright yellow due to the presence of a yellow pigment. In the discolored region, the cable surface is a clearly delineated brown color that penetrates up to 50% of the thickness of the jacket before the bright yellow coloring appears. In the charred region, the cable surface shows black carbon char; beneath the charring is a discolored zone and then the bright yellow layer.

undamaged region of the cable, were further pinpointed by a visual examination of the cross sections of the test samples. In the charred region, the discoloration beneath the surface charring penetrates into the cable jacket. Figures 8a and 8b show test samples from cable sections 18 and 28, respectively. Test sample 18 shows a partial discoloration at the jacket surface opposite the longitudinal cut. Test sample 28 shows, in addition to surface charring, a circumferential discoloration that penetrates about 40% of the jacket thickness before the normal yellow coloration of the jacket is encountered. Each cable jacket sample was examined to determine the depth of penetration of the discoloration into the cable jacket and the circumferential extent of the discoloration.

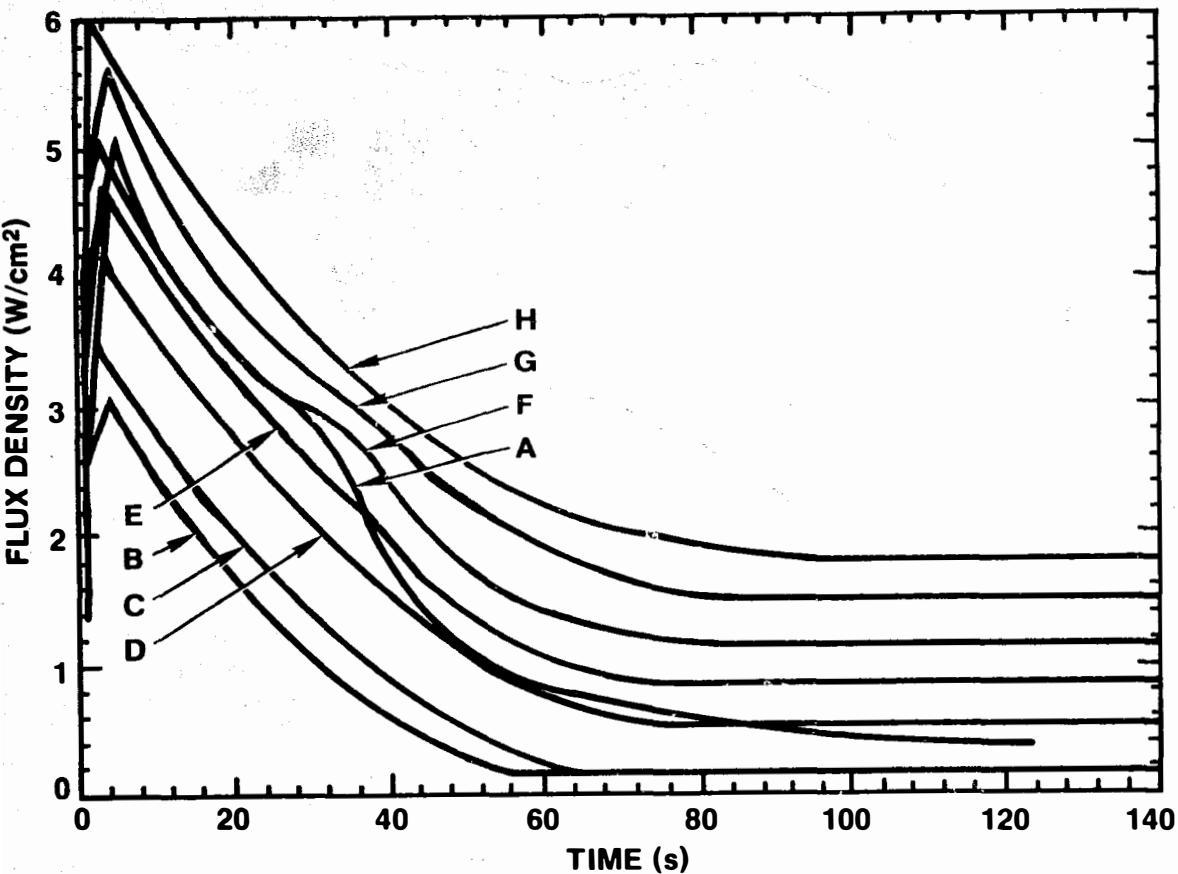
**Figure 21. Heat Flux vs. Time Profiles from Solar Furnace.
Effect on samples:**

Figure 21 shows the heat-flux profiles for a series of these exposures (smoothed for better legibility). Profile A is the calculated profile, and profile E is the solar furnace profile given in Figure 18. The samples exposed to profiles B and C showed no change. Samples exposed to profiles D and E had some discoloration, and E also produced some ash. The samples exposed to profile F had slight indications that charring may just have been starting. Profile G caused small, but definite areas of char, and profile H clearly produced char.

- A. Computer calculation
- B. No change to sample
- C. No change to sample
- D. Discoloration
- E. Discoloration and ash
- F. Char just beginning
- G. Small areas of char
- H. Char

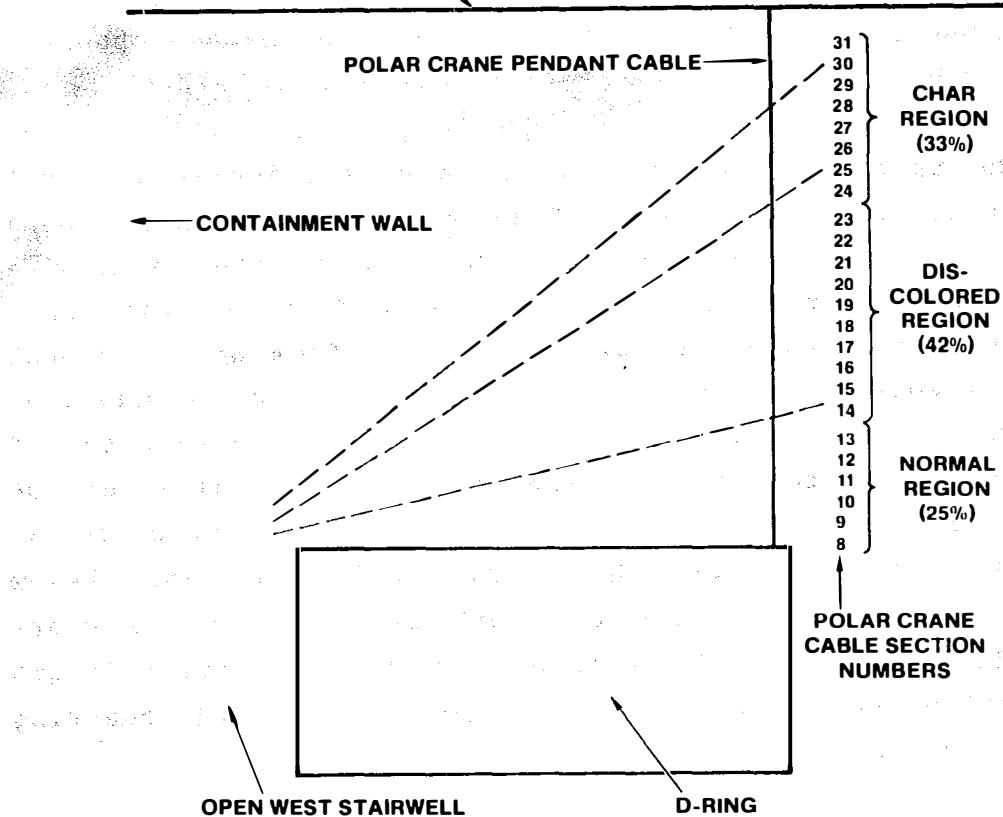
Figure 22. Cable Section Burn Pattern.

Figure 22 presents a summary of the data with respect to the regions of the PCPC, the cable sections, and their approximate dimensional relation to the polar crane, the D-ring, and the open west stairwell. Cable sections 1 through 7 are not shown because they are believed to have lain on top of the D-ring during the accident.

The shadowing of the charred and discolored regions around the PCPC point to a hydrogen-burn front that propagated from west to east. These findings are in agreement with the view that the burn originated at some lower level (below the 347-ft elevation) in containment and propagated primarily up the open west stairwell, at which point the burn emerged into the relatively open areas above the 347-ft elevation.² A localized, higher hydrogen concentration may have existed in the west stairwell due to a pressure-release operation that occurred 13 s prior to the burn. The pressure-release operation would have released a steam and hydrogen plume into the open west stairwell. Figure 22 shows schematically how this burn front may have continued up the west stairwell between the containment wall and the D-ring wall, then emerged into the large open cavity and

The uppermost charred region is of particular interest because sections 24 through 29 show either char all around the cable, while sections 29, 30, and 31 show either a directional charred pattern on the west face or else charring along three-quarters of the surface from north through west and south to east (i.e., the northeast cable quadrant shows no char). Figures 23 and 24 show that the very top of section 31 was wrapped with tape or cloth (partially held on by a tie wrap, Figure 23) that ignited and produced an apparent circumferential char. The region of cable below this burned piece of tape or cloth is directionally charred. In the absence of the tape or cloth, the entire length of section 31 would have exhibited directional charring similar to sections 29 and 30.

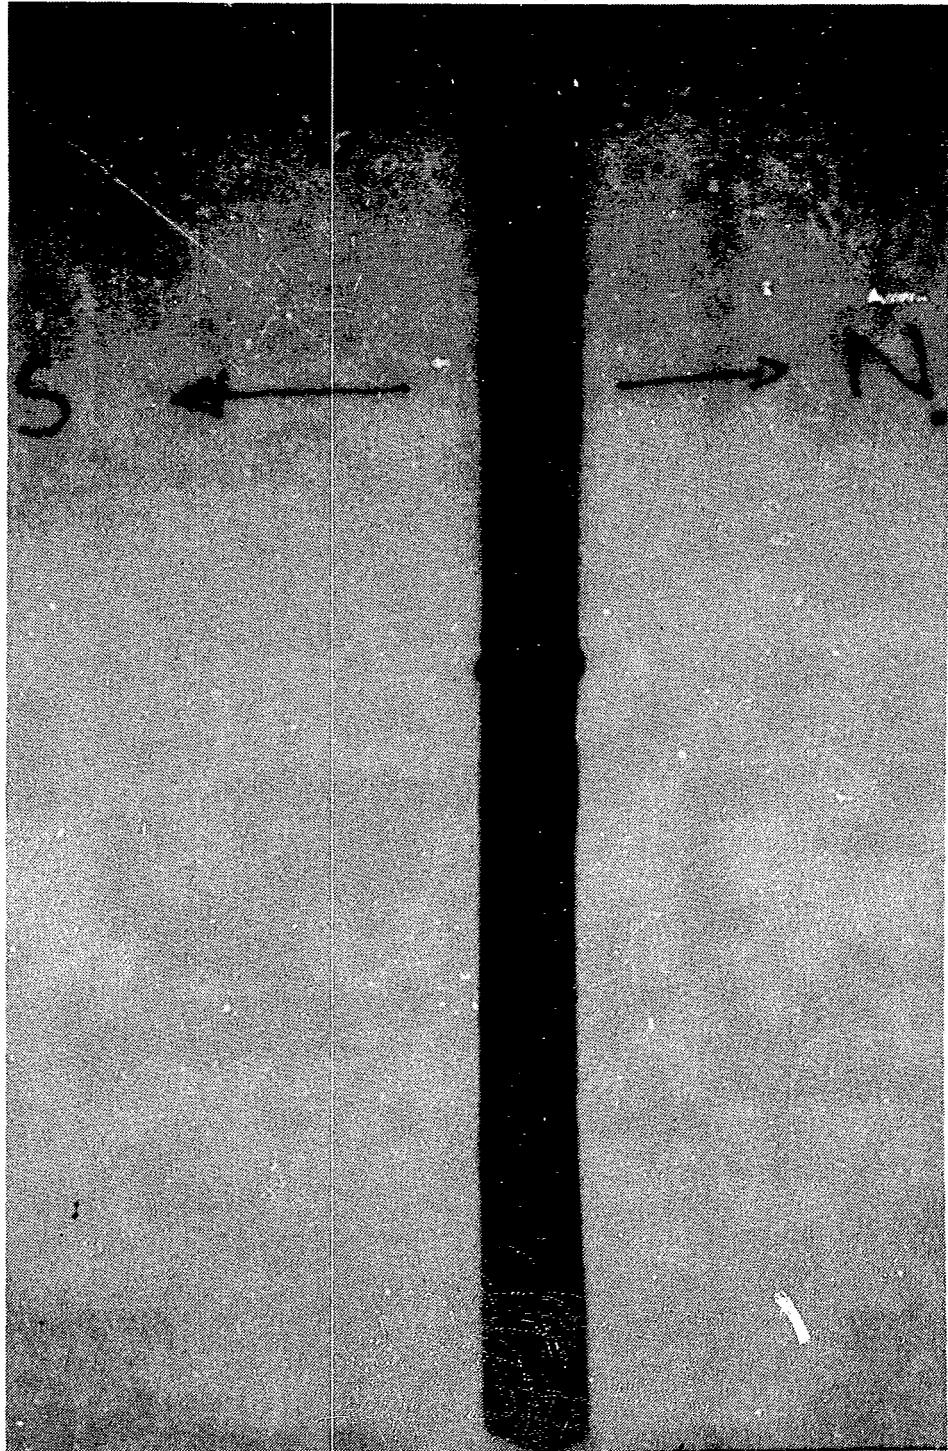
Figure 23. Photo of Cable Section 31 East View.

Possibly, the directionality of the charred pattern is a result of the proximity of the PCPC to the massive polar crane from which the cable was suspended. The upper cable portion (sections 29, 30, and 31) was closest to the crane and would be expected to be most sensitive to any thermal protection afforded by the crane. Such speculation is supported by noting that section 29 was charred from north through west and south to east (northeast quadrant not charred) and that the orientation of the crane itself was roughly northeast of the cable (Figure 2). The fact that cable sections 24 through 28 were circumferentially charred suggests that enough thermal energy was present to circumferentially char cable sections 31 to 29 but that the massive polar crane may have acted as a heat sink, absorbing enough thermal energy to prevent charring on the cable surfaces facing east.

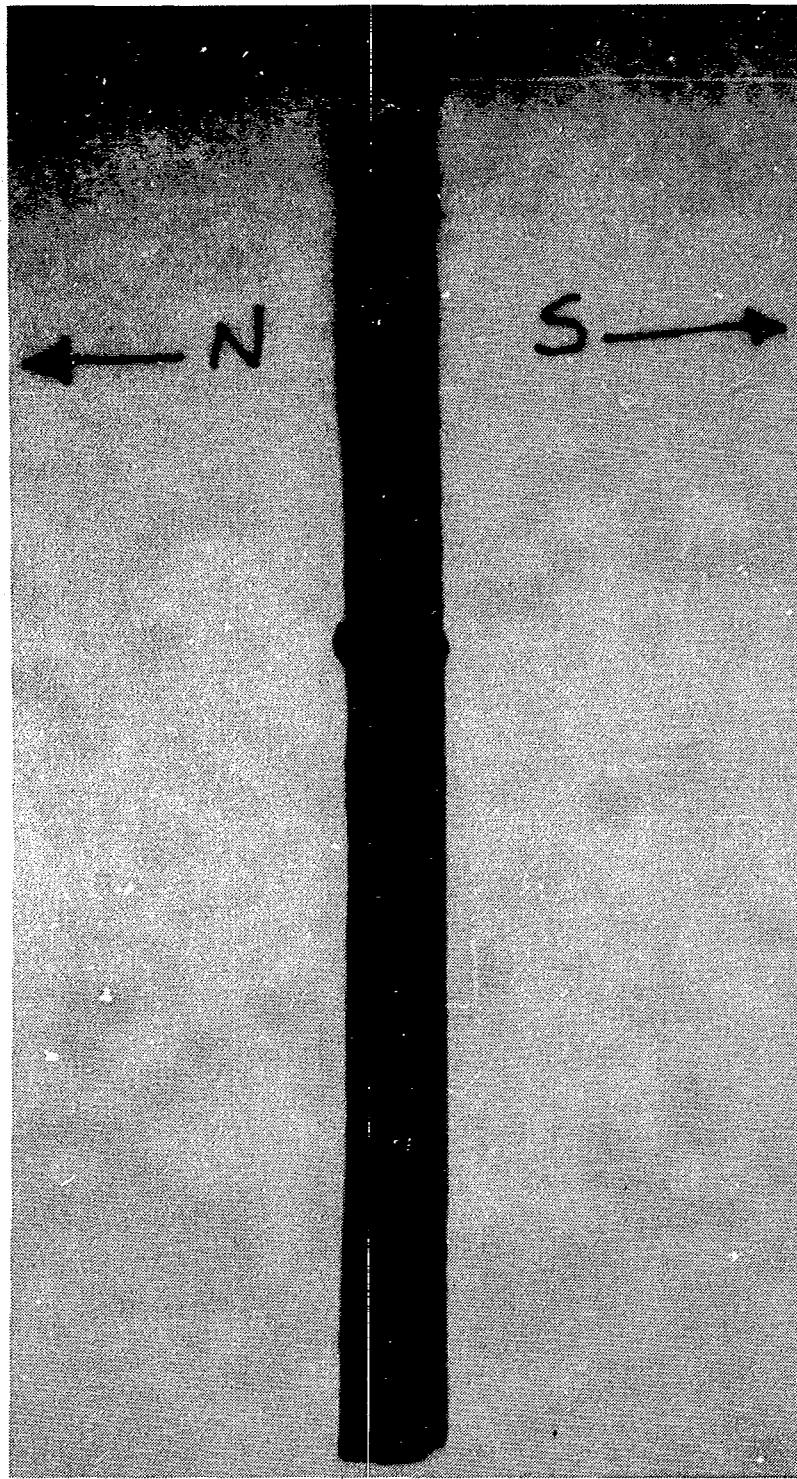
Figure 24. Photo of Cable Section 31 West View.

coloration. The west cable surfaces showed discoloration to various extents and depths, while the east-facing cable surfaces generally showed no discoloration (Table 1).
