U.S. NUCLEAR REGULATORY COMMISSION
OFFICE OF INSPECTION AND ENFORCEMENT

Report No. 50-34678-06

Facility Name: Davis-Besse Nuclear Power Station, Unit 1

Inspection Conducted: December 6-8, 1977 and March 6-8, 1978

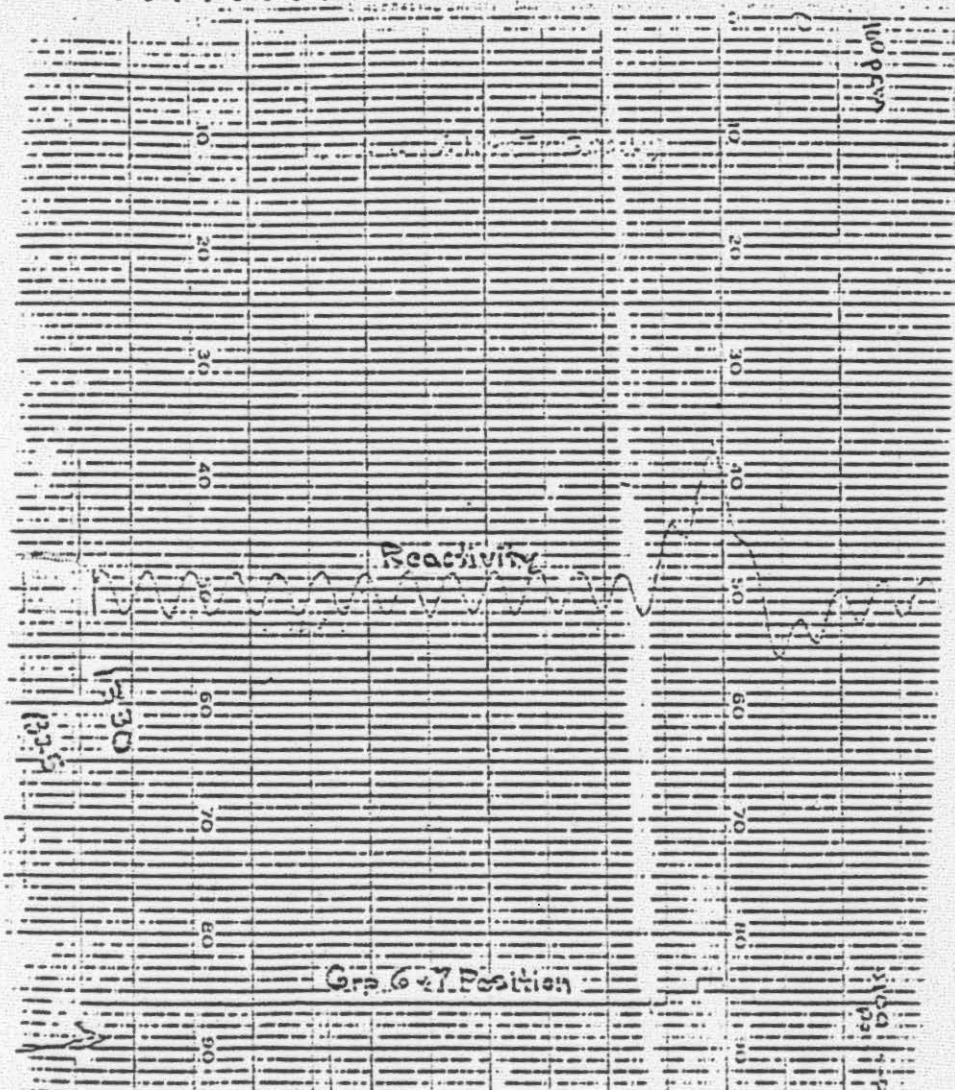
Attachment:
Reactivity Chart

The inspector reviewed data and logs associated with Test No. TP 800.05.1 which was performed November 29, 1977. Review of the reactivity traces revealed reactivity oscillations of a roughly sinusoidal form. The period of the variations was approximately 4 seconds and the amplitude was approximately 1.5 pcm. Reactor power during the test was 405%.

The licensee attributes the oscillations to fluctuations in steam generator level and to the resulting variations in water temperature and density occurring in the downcomer region of the core. A vendor representative estimated the effect to be less than 1°F variation in T cold temperature. This representative states that similar oscillations have been noted at another of the vendor's sites and that the oscillations diminish as power increases.

Because of the oscillations, the reactivity data must be corrected to remove the oscillating component. Figure 1 shows the behavior of the reactivity trace during the movement of control rod groups 6 and 7. Groups 6 and 7 movement is measured incrementally by reed switch output.
