TMI-2 Instrument Nozzle Examinations at Argonne National Laboratory*

To be submitted for publication in the Proceedings of the Symposium on Achievements of the OECD Three Mile Island Vessel Investigation Project, Boston, MA, October 20-22, 1993.

Abstract

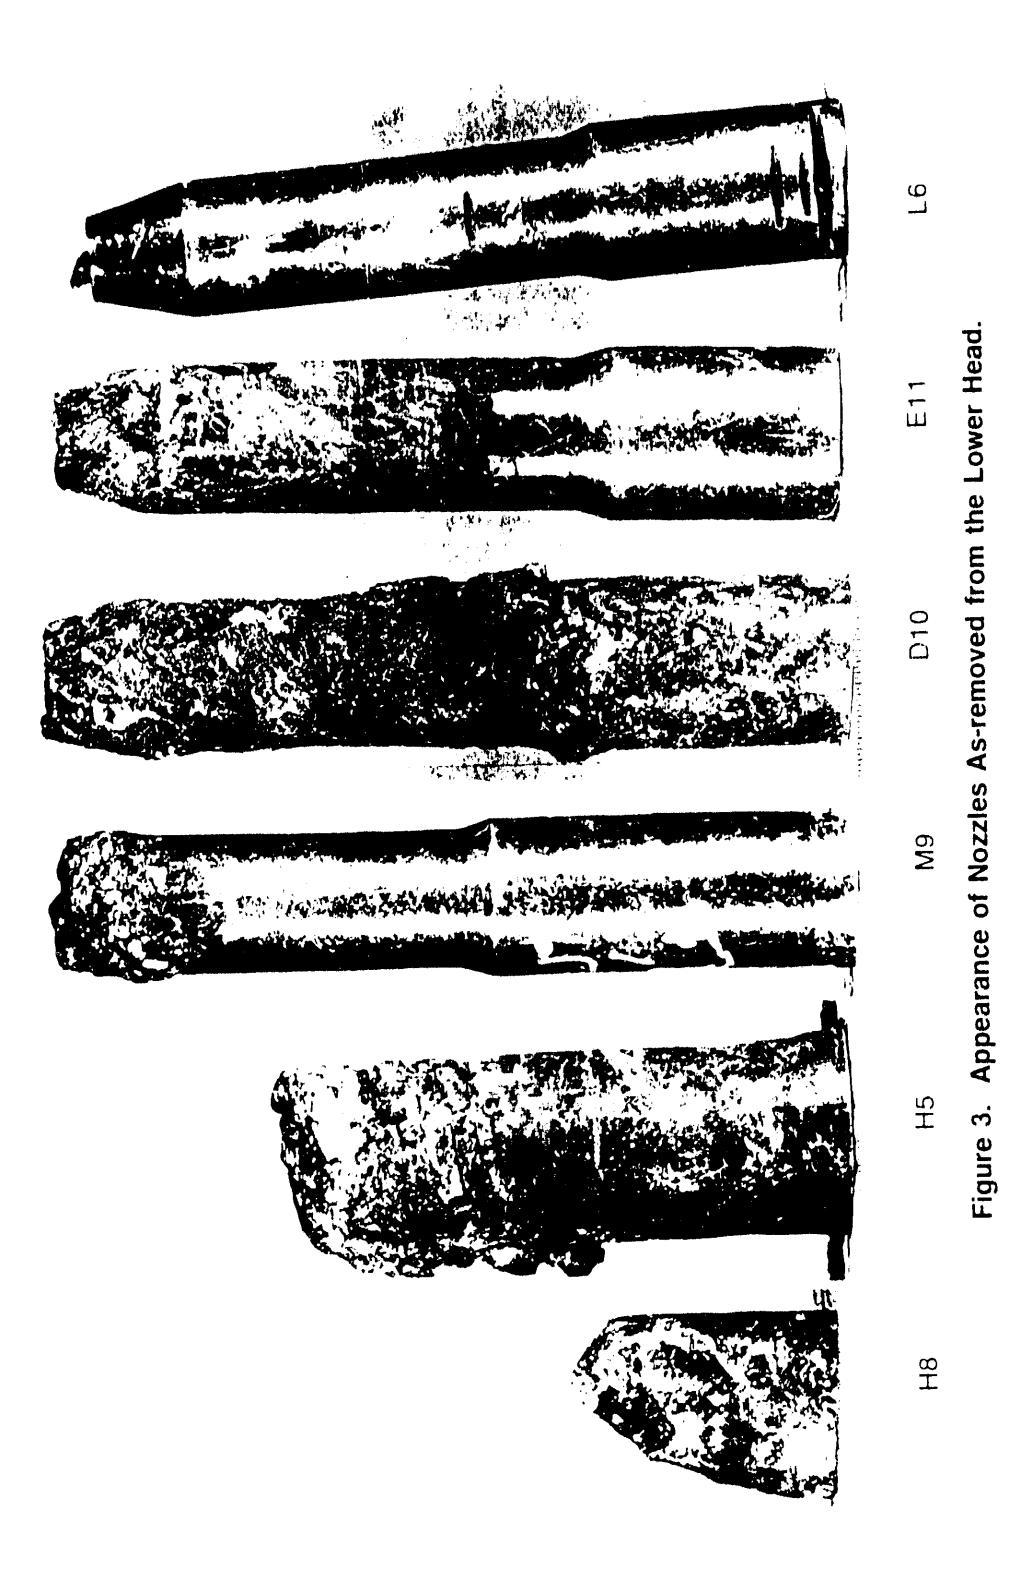
ner in which molten fuel debris moved on the lower head and caused the nozzle damage. Figure 3 shows the as-removed appearance of the six ANL nozzles. The tops of nozzles M9 and H5 were clearly melted off an appreciable amount. The transition zone between the molten region and the unaffected lower part of the nozzles was relatively narrow on M9 and more extensive on the shorter H5. These transition zones were typically covered with a thin scale that was basically an iron oxide with entrapped shards of various core debris materials (Fig. 4); the lower areas of the nozzles were clean of adherent scale and showed little, if any, effects of being in contact with very hot core debris.

The H8 nozzle segment received at ANL was only the bottom portion of a longer post-accident segment, the top of which was broken off during the removal operations. The top surface of the bottom portion, shown in Fig. 3, was smooth compared to the melted regions of M9 and H5. Upon detailed examination by SEM-EDX, it was found that this surface had been reacted extensively with a molten Zr-rich phase which contained ingots of Ag-Cd. These elements would have come from control assembly components that apparently melted early in the accident and deposited on the lower head in advance of the major fuel flow there. Intergranular penetration of Ag-Cd was found in a number of nozzles and into the surface of the vessel.²
