#### REVIEW CF TML-2 RESISTANCE TEMPERATURE DETECTORS ACCIDENT DATA AND IN-SITU TESTING

James W. Mock

November 1982

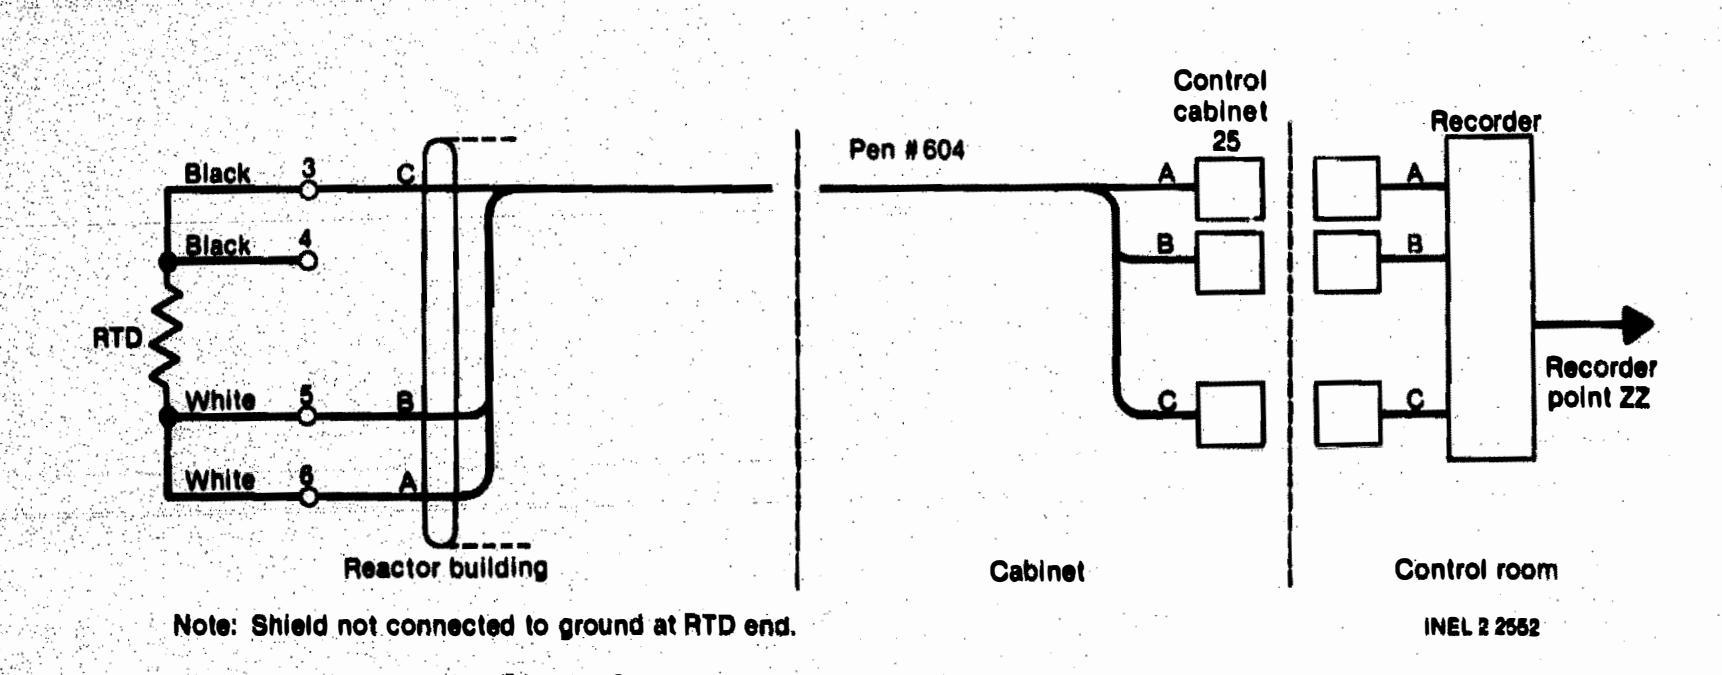
Figure 2. Detector-to-recorder interconnections.

The RTDs are connected to the recorder with three wire cables, as shown in Figure 2. An RTD is input to a commutator switch that rotates, connecting each of the RTD's three wires to the signal conditioner. Therefore, although each RTD has an individual calibration, the recorder must be calibrated to the standard IPTS-68 curve, since there is only one zero and one span adjustment.
