NUREG/CR-6198 TMI V(94)EG01 EGG-2735

TMI-2 Nozzle Examinations Performed at the Idaho National Engineering Laboratory

Prepared by D. W. Akers, B. K. Schuetz

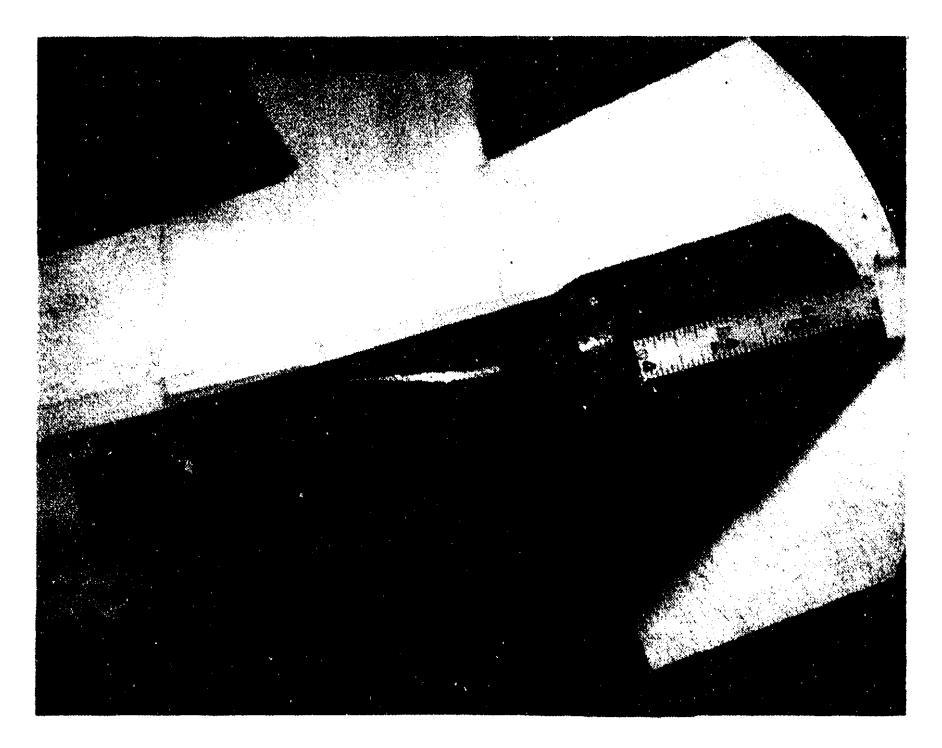
Figure 3. R-7 nozzle sample.

Figure 3 shows the R-7 nozzle, on which the instrument string was melted off and a bulb of previously molten fuel was found attached to the instrument string. Visual examination of the R-7 nozzle shows little damage except for the top edge. The gamma spectroscopy results for this sample indicate a high-activity region near the top of the nozzle; however, the probing examinations indicated that there were no blockages in the nozzle. As a consequence, only the bulb on the instrument string and the top of the nozzle were sectioned for examination. The top bulb proved to be composed of U-, Zr-, and Fe-rich interaction phases that are probably representative of the interaction zone between the molten fuel material and the guide tube or instrument string material. A quarter section of the Sub was sent to CEA-CEN for examination. As will be discussed, microstructural examinations of the R-7 bulb indicate apparent interaction between the fuel debris and the instrument string material. Formation of a number of intermediate phases composed of fuel material and constituents of the instrument string are indicated.

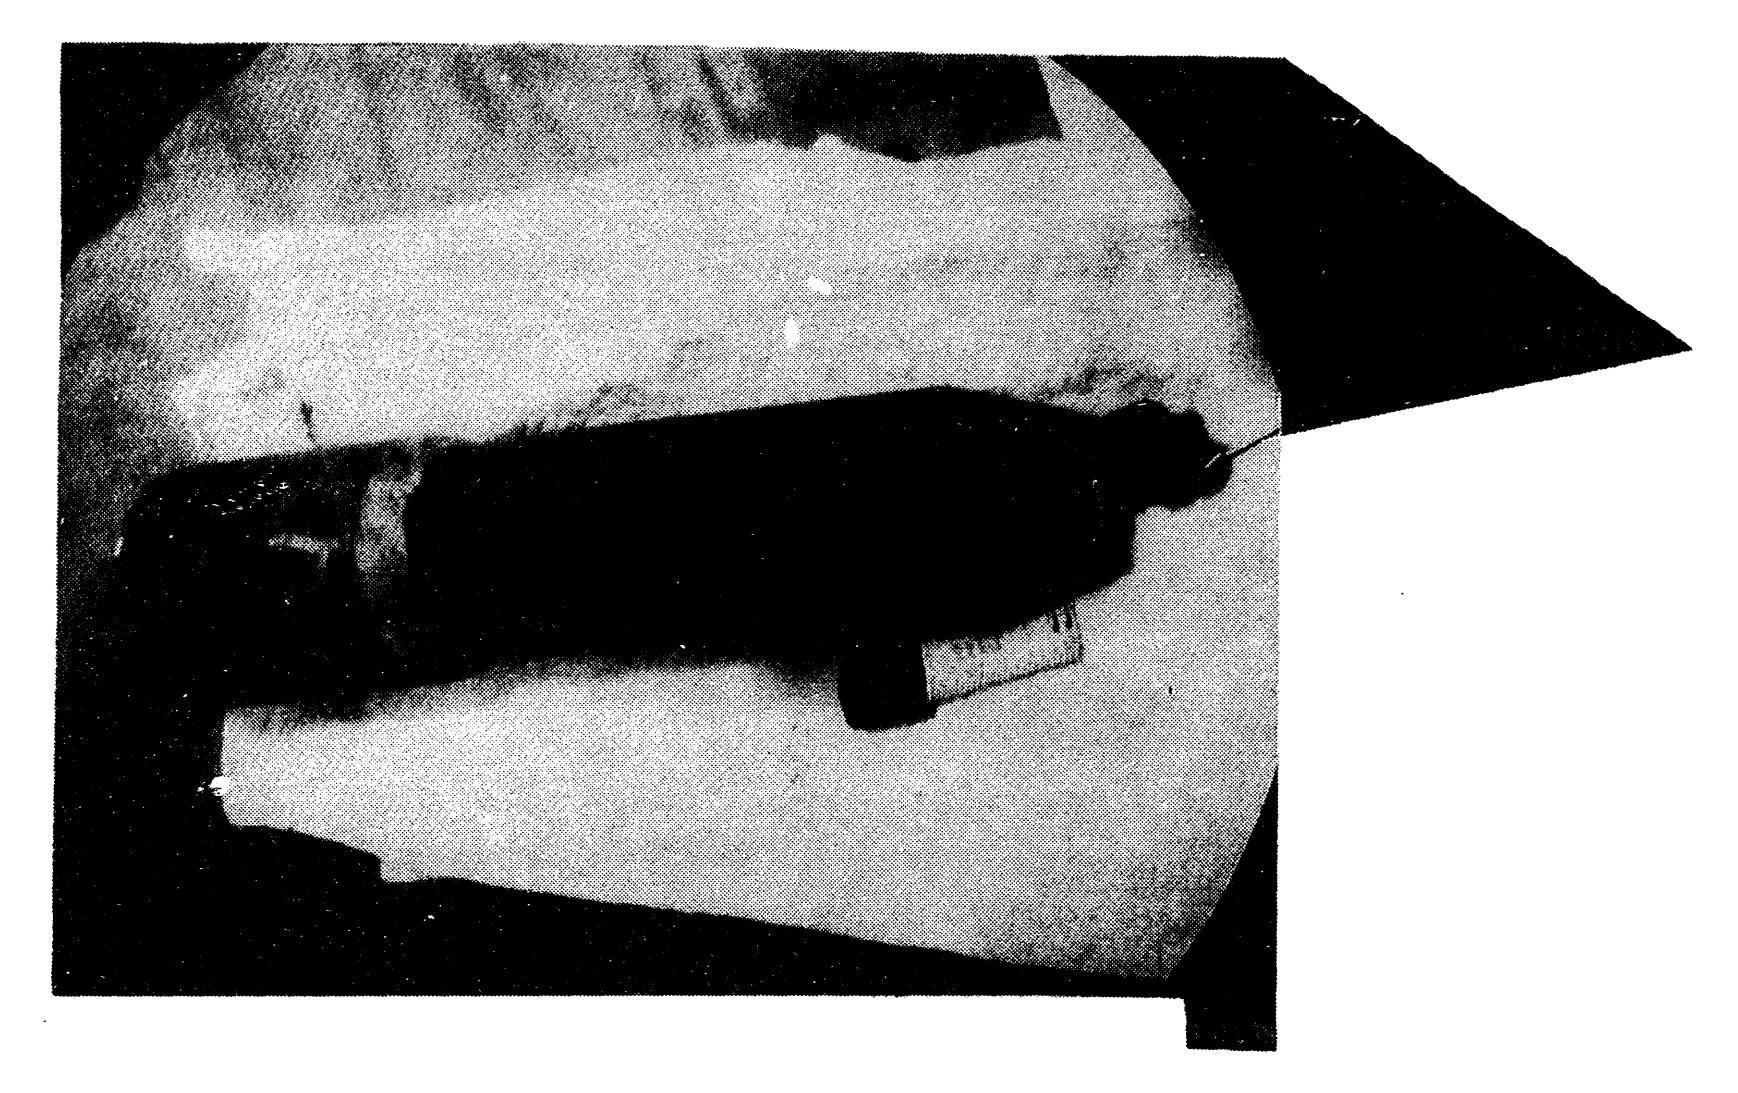
Figure B-23 shows a full-length view of the R-7 nozzle with the melt bulb and instrument core string intact. A visual examination of the nozzle indicated that it had sustained little damage except on the top surface of the nozzle as shown in Figure B-24.

Figure B-23. Full-length view of the R-7 nozzle with the instrument core string and melt bulb still attached.

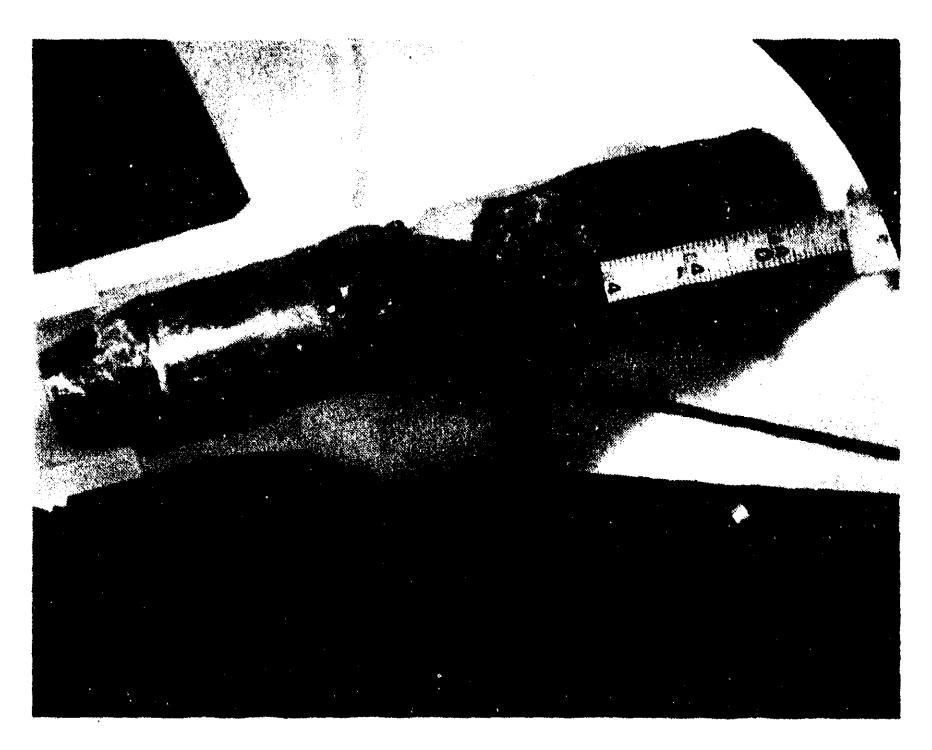
A visual examination and measurement of the K-11 nozzle showed that it was 23.5 cm (9-1/4 in.) long and suffered extensive damage to the majority of its surface. Figures B-30 and B-31 are full-length views of the front (0-degree) and back (180-degree) surface, respectively. They give an overall view of the K-11 nozzle. The major damage extends from about 1.9 cm (0.75 in.) from the bottom end to within 7.6 cm (3 in.) of the top of the nozzle. A magnified view of the top of the nozzle shows cracking and melt interaction (see Figures B-32 and B-33, which show the 0- and 180-degree reference views, respectively).

Figure B-30. Full-length (9-1/4 in.) view of K-11 nozzle at a 0-degree reference.

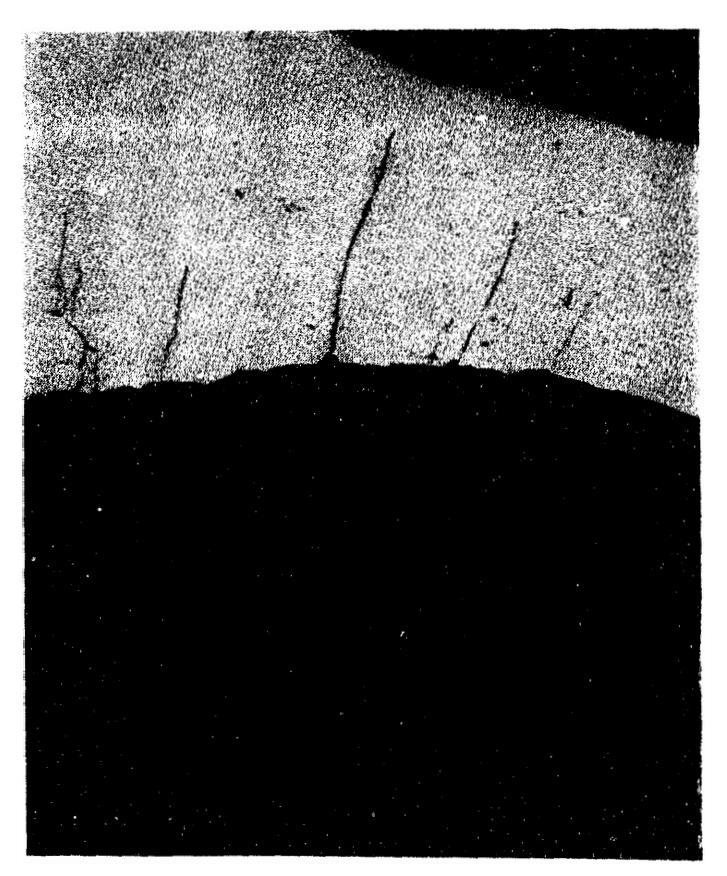
Figure C-9. ROI 91M214, showing evidence of cracking of the guide tube material.

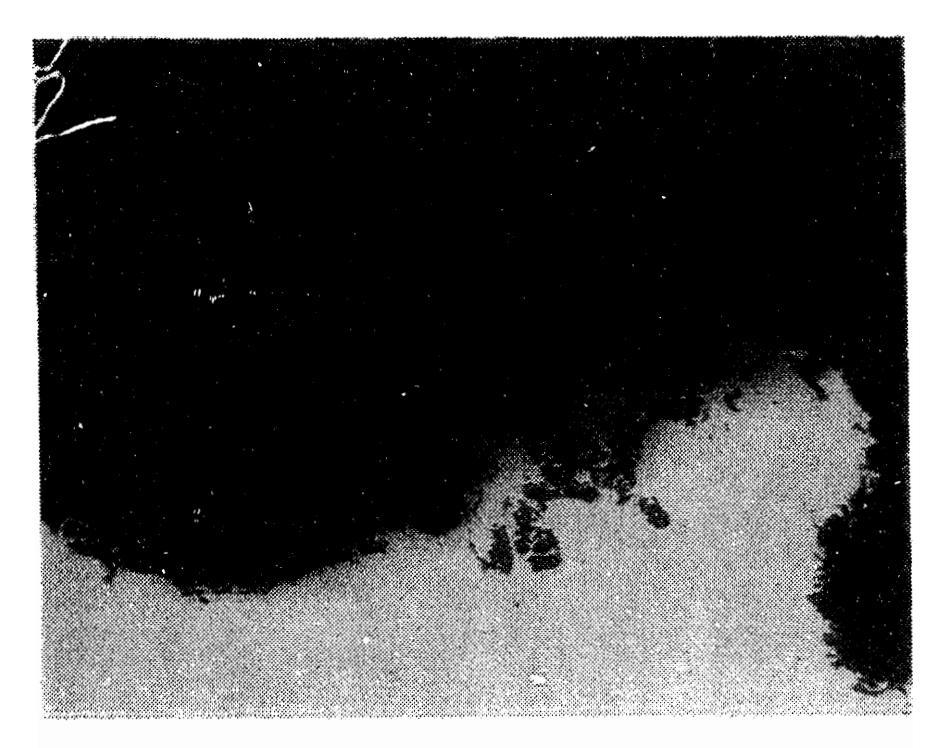
Figure C-14. Fuel adjacent to instrument leads at ROI 91M198.

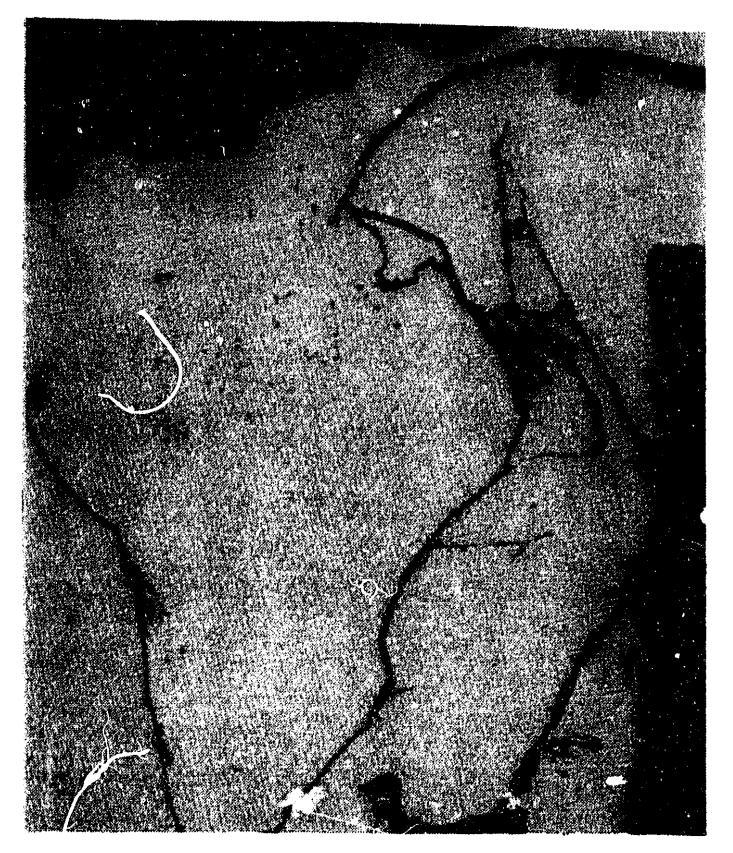
Figure C-27. ROI 91M228, exhibiting material cracking.

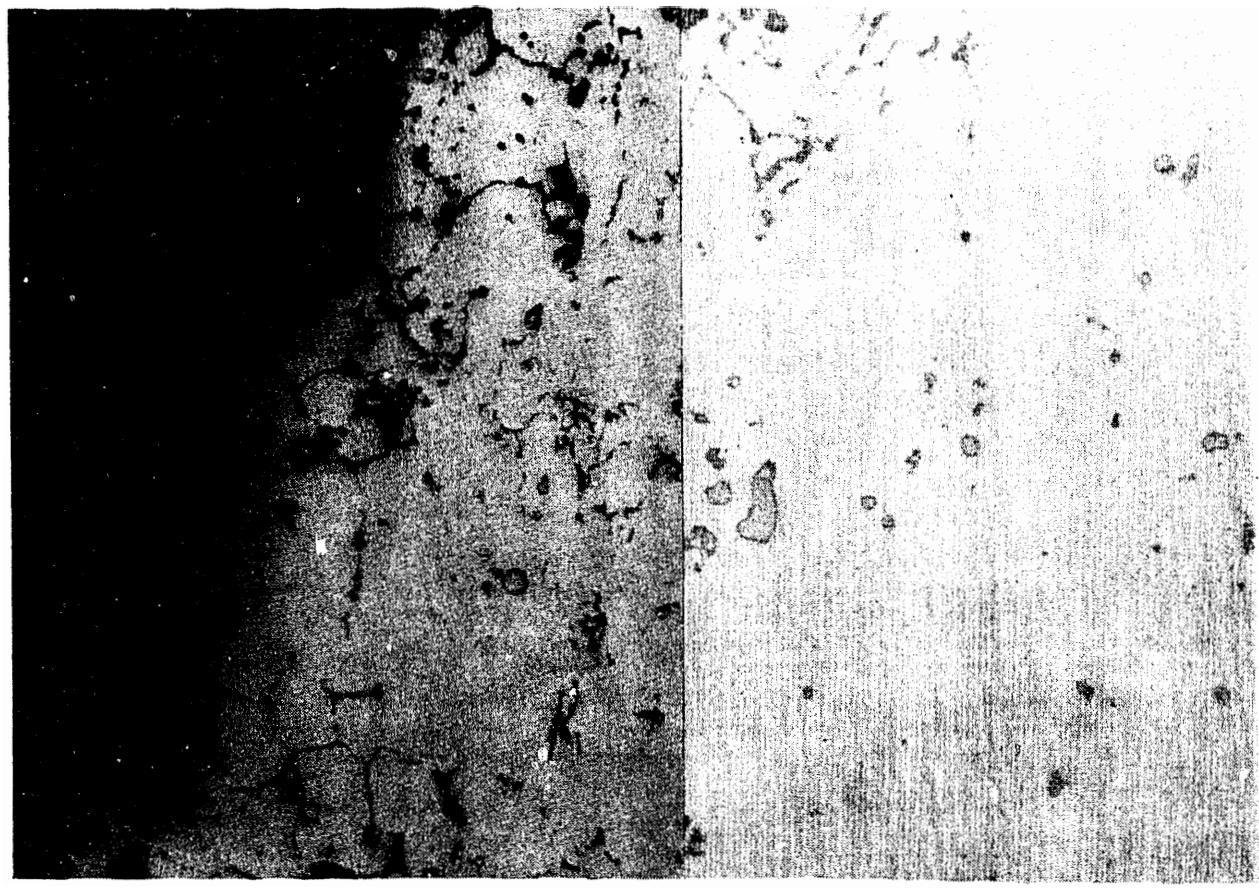
Figure C-32. ROIs 91M175 and 91M176, showing possible cracking (two-photo composite).

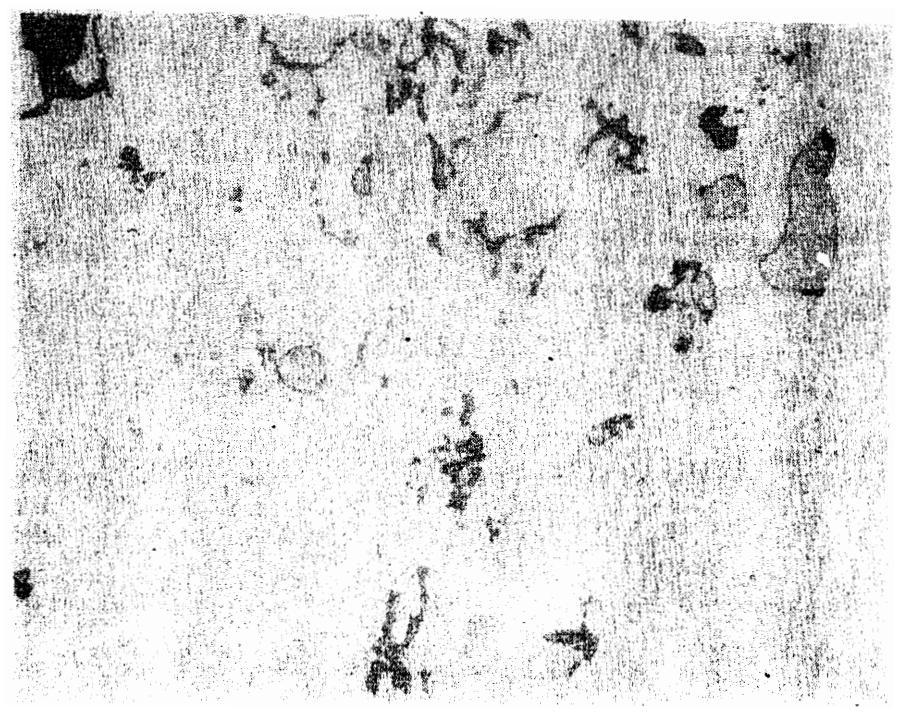
Figure C-33. ROI 91M177, showing higher magnification (200x) view of possible cracking.

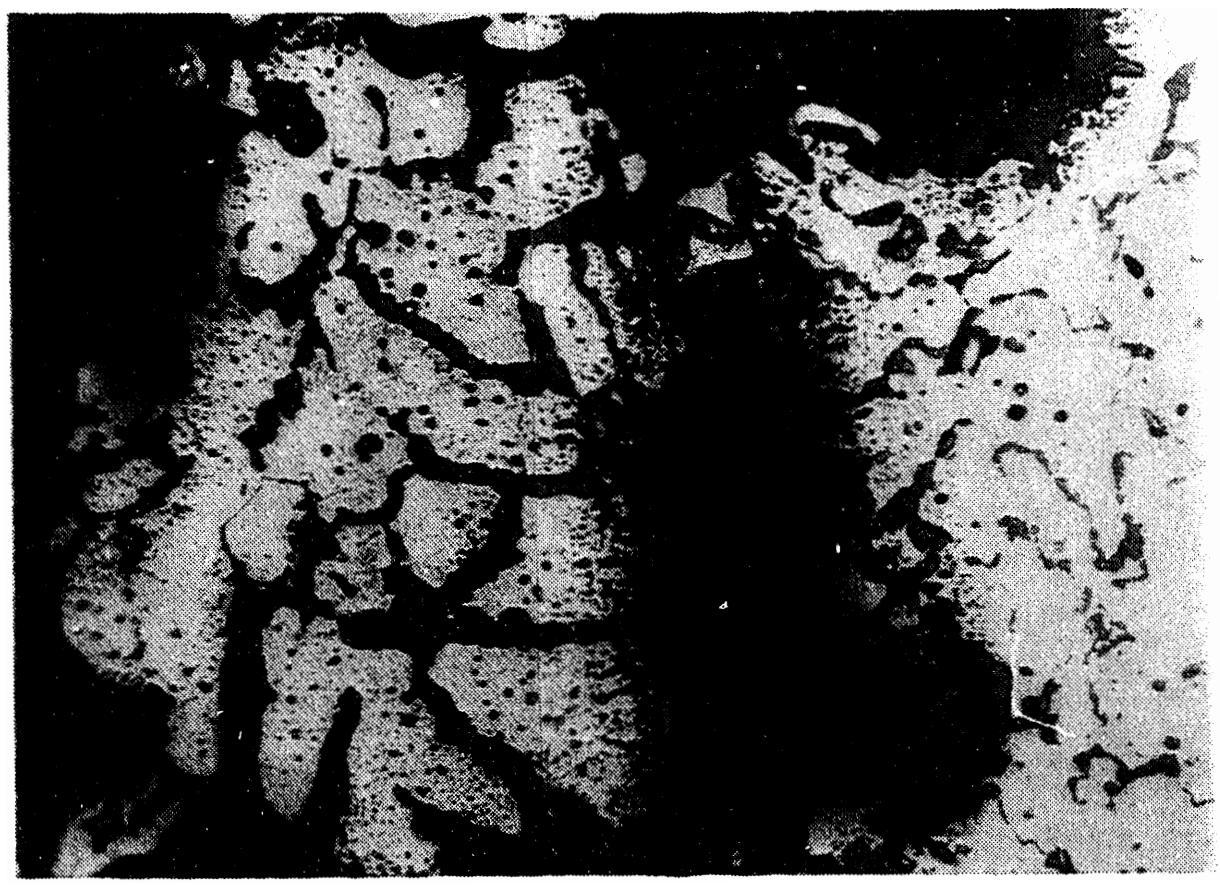
shown in Figure C-31. Figures C-32 through C-40 show the ROIs (91M175 through 91M188) for sample E-7-1. Figures C-34 and C-35 show melt interaction between the nozzle material and the apparent fuel material. Figure C-35 indicates the presence of an intermediate phase, which suggests that some molten interaction occurred.

Figure C-34. ROIs 91M178 and 91M179, exhibiting fuel melt interaction (two-photo composite).

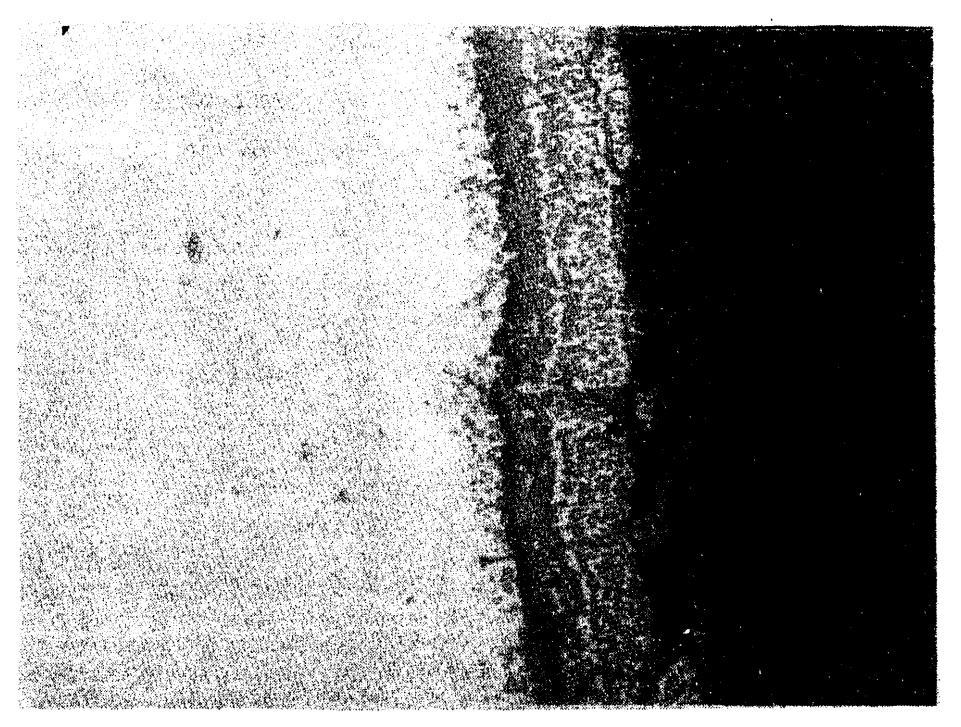
Figure C-40. ROI 91M188, showing 200x magnification of surface oxide layer.
