FINAL REPORT ON THE IN SITU TESTING OF ELECTRICAL COMPONENTS AND DEVICES AT TMI-2

Florante T. Soberano

Published June 1984

United Engineers & Constructors, Inc. Philadelphia, Pennsylvania

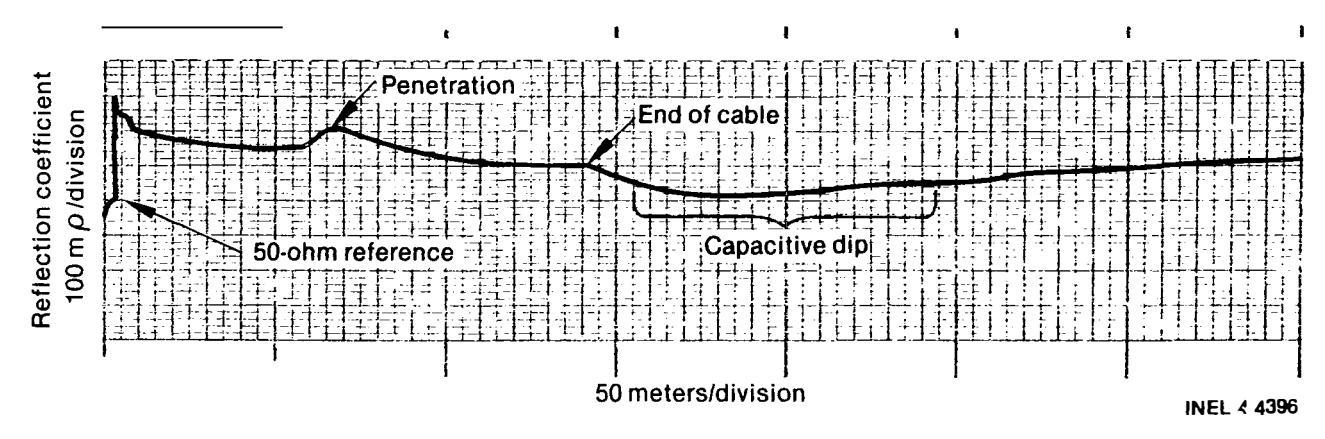
The devices were tested before and after gross decontamination. In predecontamination testing, AH-LS-5007 and AH-LS-5008 were normal in all aspects while AH-LS-5006 exhibited an elevated real resistance of 554 ohms and a capacitive dip at the device end of its circuit TDR signature, as seen in Figure 3. This anomaly of AH-LS-5006 was attributed at the time to water in the circuit, specifically in the device proper or very close to the device. Postdecontamination testing revealed basically the same abnormality but with some changes.

Figure 3. Predecontamination TDR signature of the circuit of AH-LS-5006.

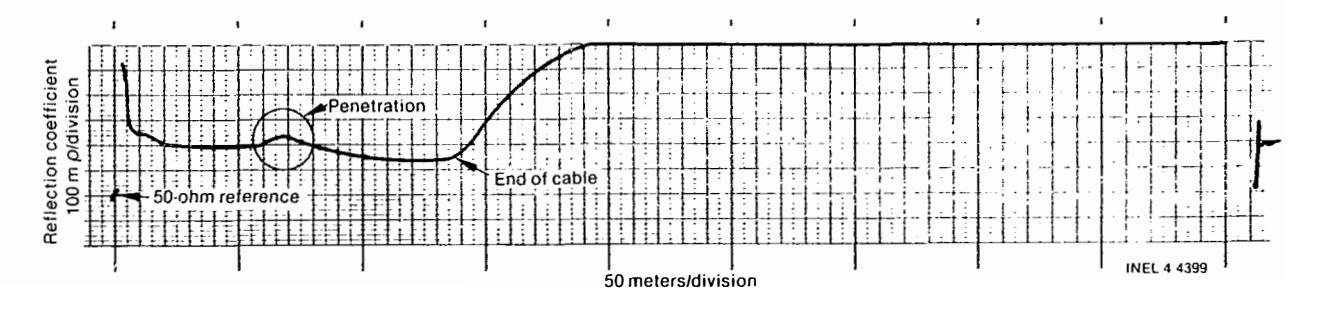
As in the predecontamination test, AH-LS-5006 was still characterized by the high circuit resistance, which further increased in postdecontamination testing to 560 ohms. In the latter test, however, the switch exhibited a pattern devoid of the capacitive dip at the end of the cable termination, an indication that the wet termination dried before decontamination (see Figure 4). The anomaly, likewise, did not affect the device function.

Figure 4. Postdecontamination TDR signature of the circuit of AH-LS-5006.

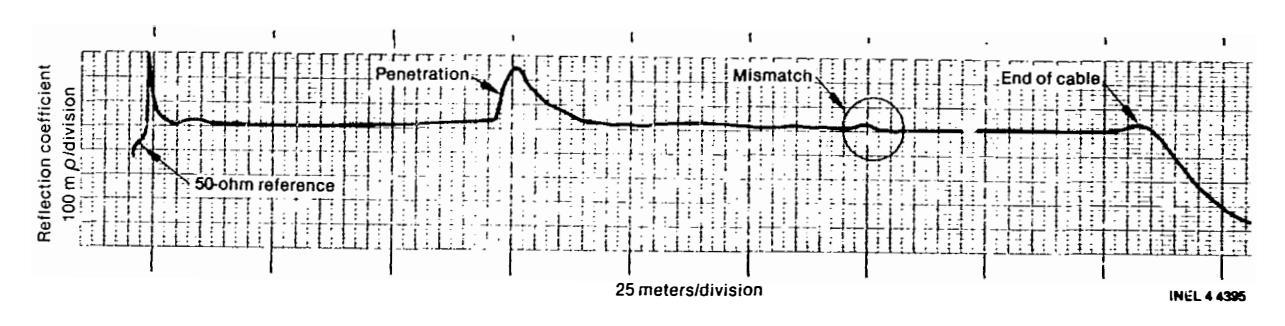
Figure 6. Predecontamination TDR signature of the circuit of oil level switch RC60-LS2.

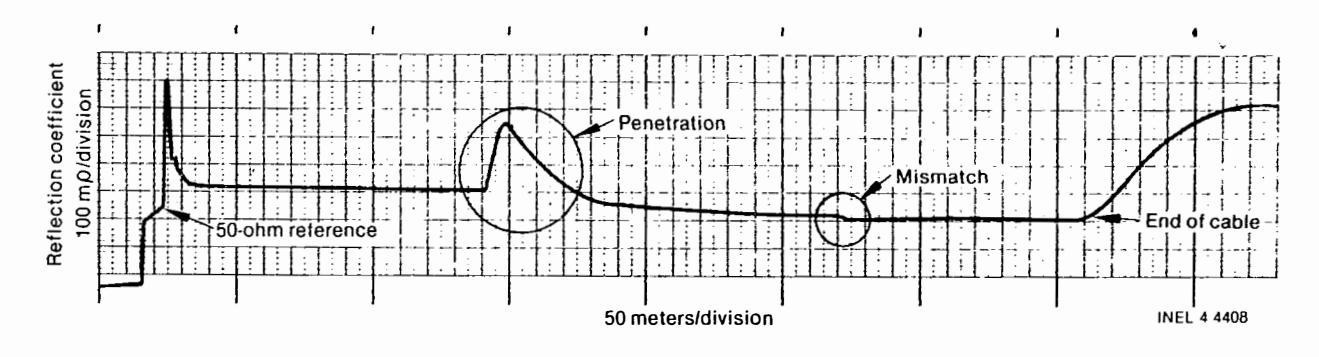
In addition to the circuit crosstalk in the penetration, an impedance mismatch was observed just past the midpoint of the incontainment cable of the RC-P-2A instrument H3O3I (see Figure 7). The pattern was identical to that of RC-P-1A instrument cable H291I, which again was evident in the retest (see Figure 8). The pattern is characteristic of a wet cable.

Figure 8. Postdecontamination TDR signature of the circuit of flow switch RC58-FS1.

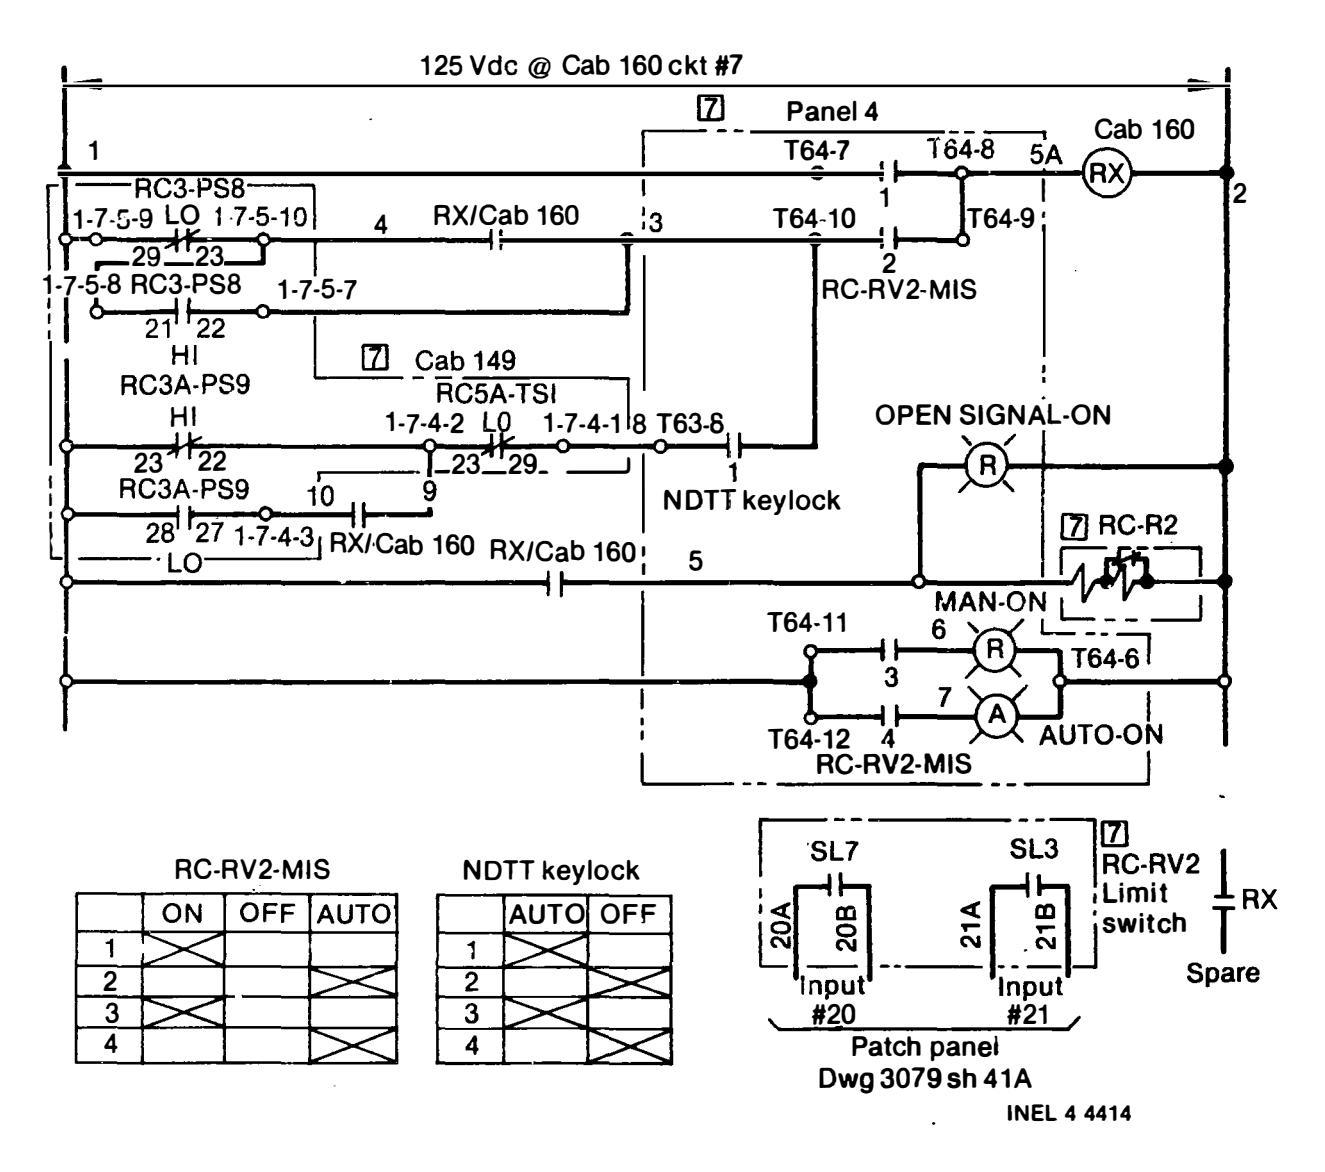
Figure 13. Control wiring diagram of RC-R2.

The failure of the valve solenoid cutout switch prompted an evaluation of the device control and indication scheme. Under the present scheme, as shown in Figure 13, the only indicating light available to the control room operator is the "OPEN COMMAND." This indicating light signifies that a

command to open the valve has been initiated and the solenoid is energized. With the kind of fault noted during the in situ test, the lighting of the indicating light will have no significance because the solenoid will not pick up, even though it is energized. With the absence of any position indication, the control room operator will not know if the pilot valve actuated.

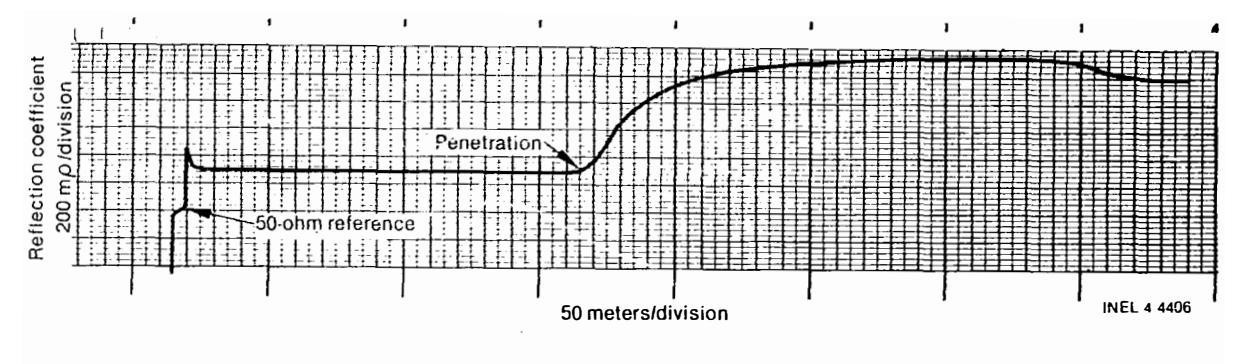
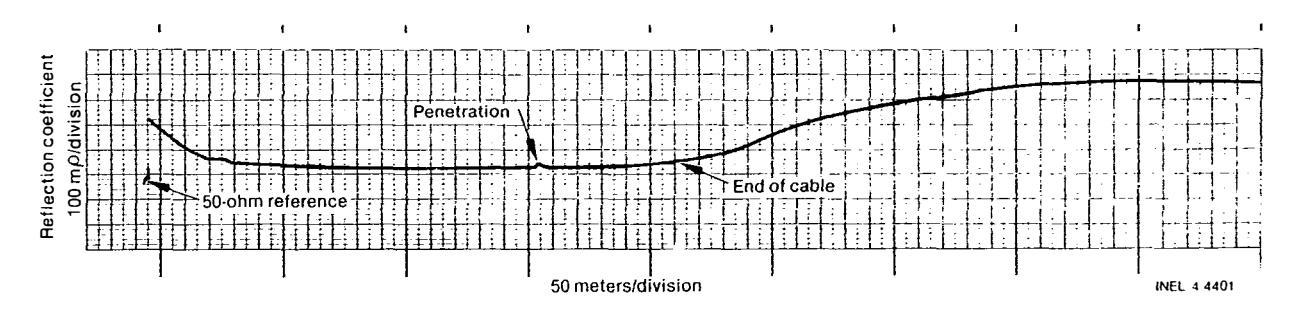
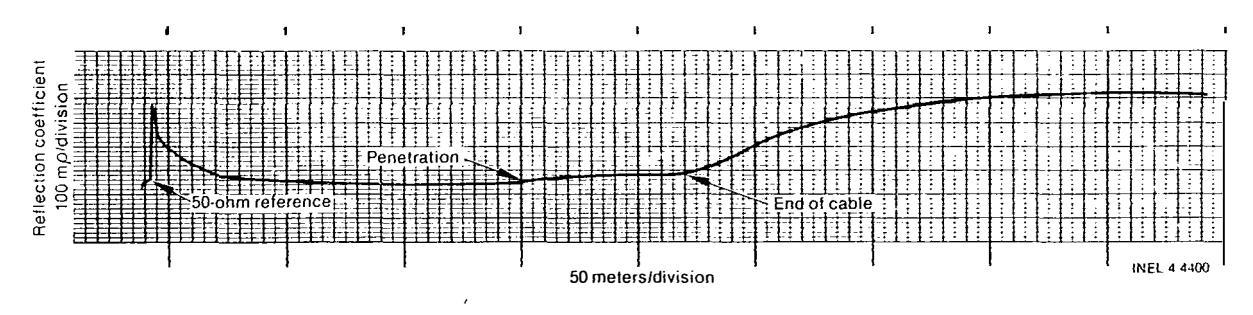
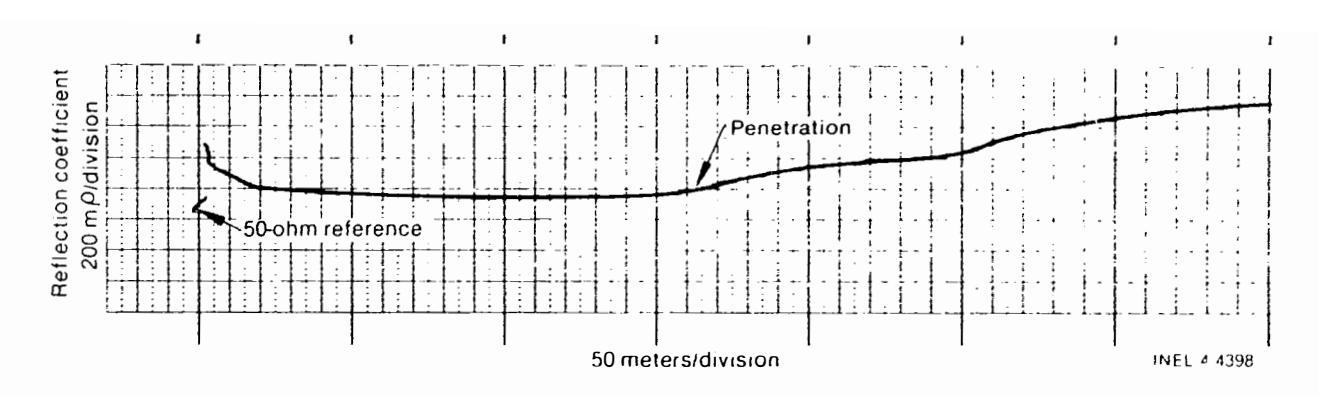
In contrast with the condition of the RC-P-2B differential CTs, those of RC-P-1A and RC-P-2A exhibited more severe abnormalities. The RC-P-1A CTs were broken on circuit A3CM1 (see Figure 14). The break is shown on the TDR traces (Figures 15 through 18) to be in the inner termination box of penetration R405. In addition, the test showed a slightly elevated resistance in circuit A3CMO, the high resistance point likewise being in the inner penetration box. Another anomaly that was observed on the RC-P-1A CT is the absence of the ground wire from the neutral of the transformers. No significant change in the characteristic impedance of the CTs' in-containment cable was observed. In the case of the RC-P-2A differential CTs, a circuit break on phases T2 and T3 CTs also exists. The TDRs show wires B4CM2 and B4CM3 broken in inner penetration box R405 (see Figures 19, 20, and 21).

Figure 15. Postdecontamination TDR signature of wires A3CMO(+) and A3CM1(-) of reactor coolant pump motor RC-P-lA.

Figure 16. Postdecontamination TDk signature of wires A3CMO(+) and A3CM2(-) of reactor coolant pump motor RC-P-1A (differential CT).

Figure 17. Postdecontamination TDR signature of wires A3CMO(+) and A3CM3(-) of reactor coolant pump motor RC-P-1A (differential CT).

Figure 18. Postdecontamination TDR signature of wires A3CM2(+) and A3CM1(-) of reactor coolant pump motor RC-P-1A (differential CT).

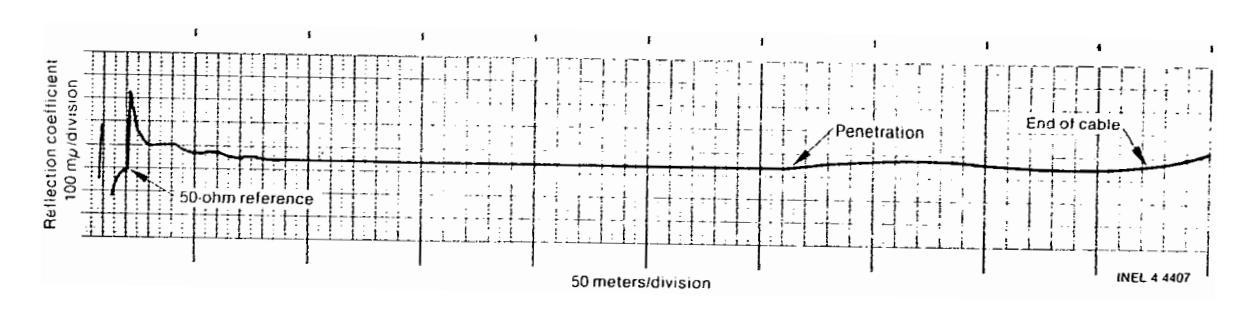
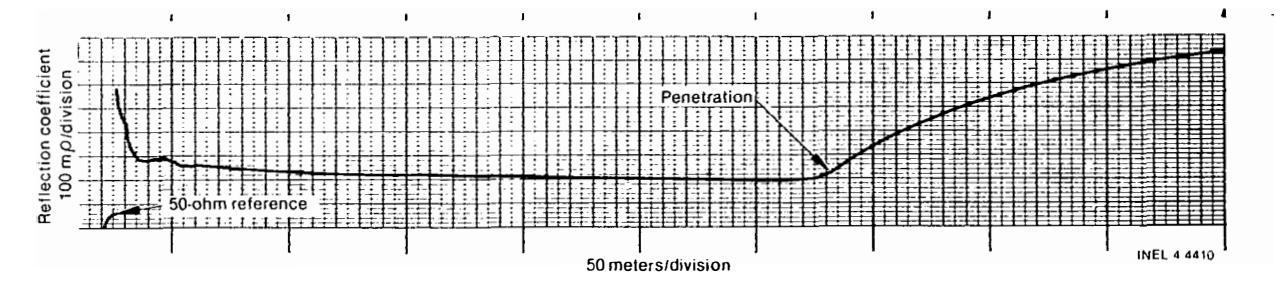
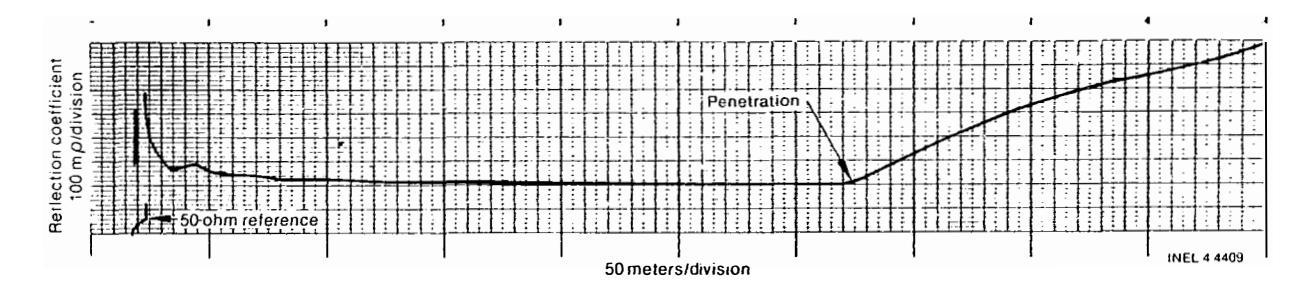
Figure 19. Postdecontamination TDR signature of wires B4CMO(+) and B4CM1(-) of reactor coolant pump motor RC-P-2A.

Figure 20. Postdecontamination TDR signature of wires B4CMO(+) and B4CM2(-) of reactor coolant pump motor RC-P-2A.

Figure 21. Postdecontamination TDR signature of wires B4CMO(+) and B4CM3(-) of reactor coolant pump motor RC-P-2A.

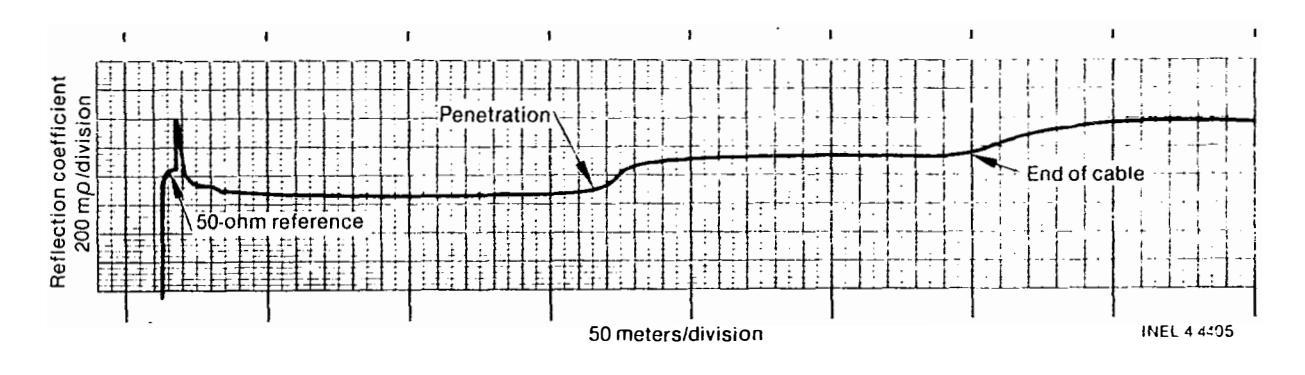
The backup oil lift pump motor of RC-P-1A exhibited the same phenomenon that was observed in the predecontamination test. Its armature circuit resistance remained very high and the associated TDR (Figure 22)

Figure 22. Postdecontamination TDR signature of wires Al(+) and A2(-) of the RC-P-1A backup oil lift pump motor.

Based on obtained data, the motor failure can be classified as catastrophic, and theoretically the equipment will not operate. This inference, however, does not take into account the fact that the measurement was made with instruments putting out low-voltage excitation signals. Since the high resistance path could be merely a film of oxides, the application of full rated voltage could possibly break down the insulating interface, enabling the motor to operate.

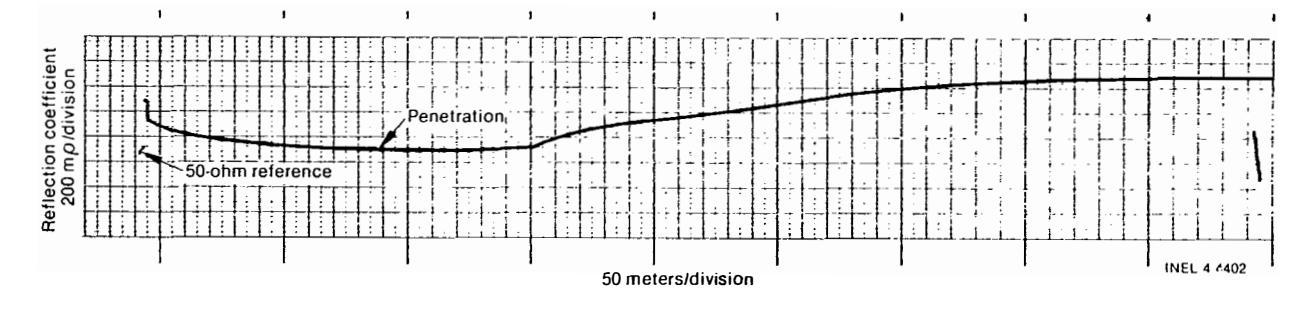
still showed the point of high resistance to be at the equipment. The field circuit also had a high loop resistance, and the location of the fault is seen on the TDR (Figure 23) to be in inner penetration box R400. The test also revealed the absence of the jumper on the Al and A2 circuits (Figure 24) in the inner box of penetration R400.

Figure 23. Postdecontamination TDR signature of wires Fl(+) and F2(-) of the RC-P-1A backup oil lift pump motor.
