EXAMINATION OF SOLENOID VALVES AH-EP-5037 AND AH-EP-5039 AND LIMIT SWITCHES AH-KS-5037 AND AH-KS-5039

GEND-INF-018

Published December 1984

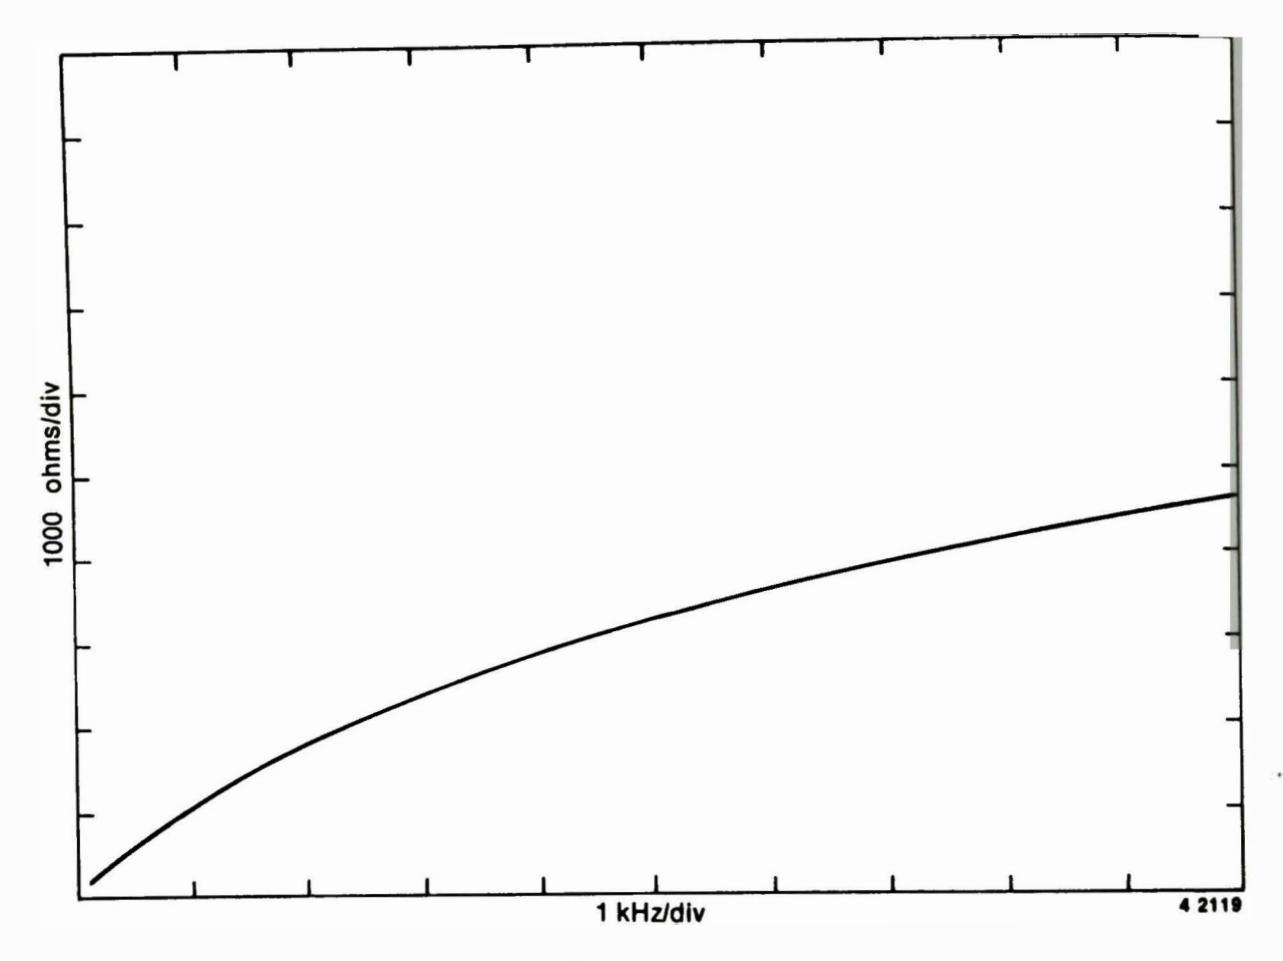
Figure 8. Equivalent series resistance pattern of solenoid valve AH-EP-5039.

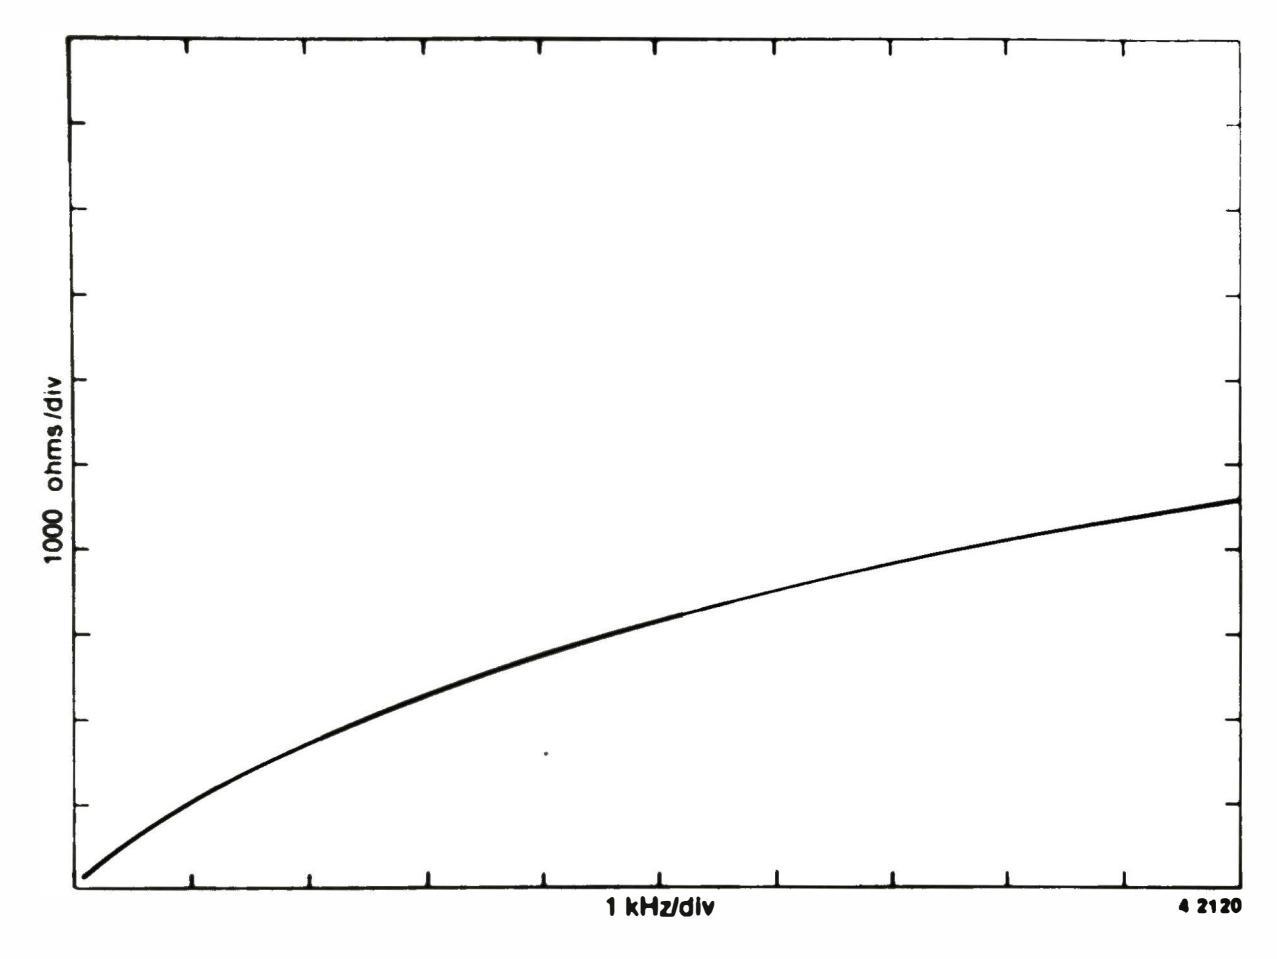
Figure 9. Equivalent series resistance pattern of solenoid valve AH-EP-5037.

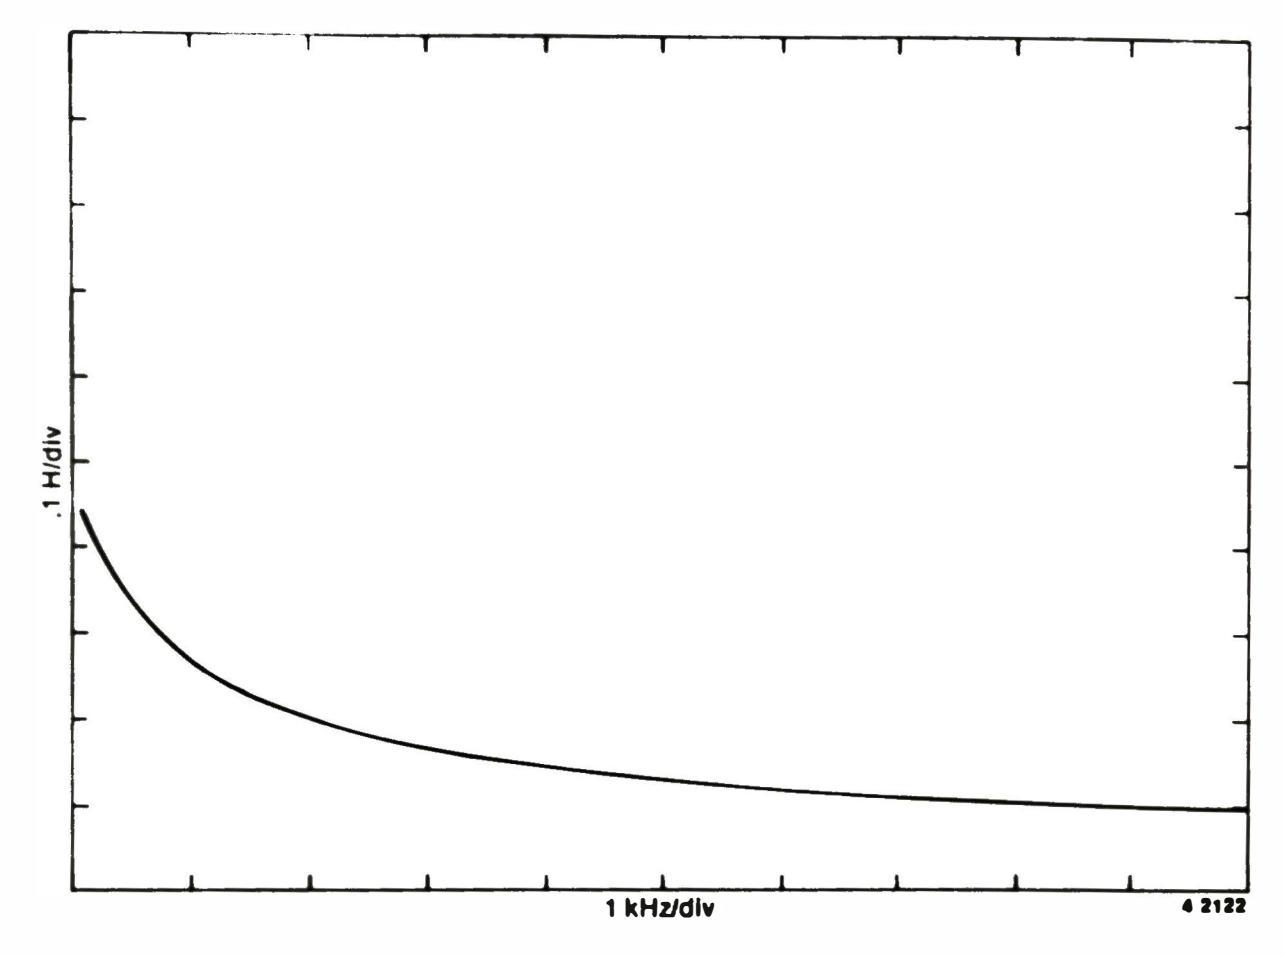
Figure 11. Effective inductance pattern of solenoid valve AH-EP-5039.

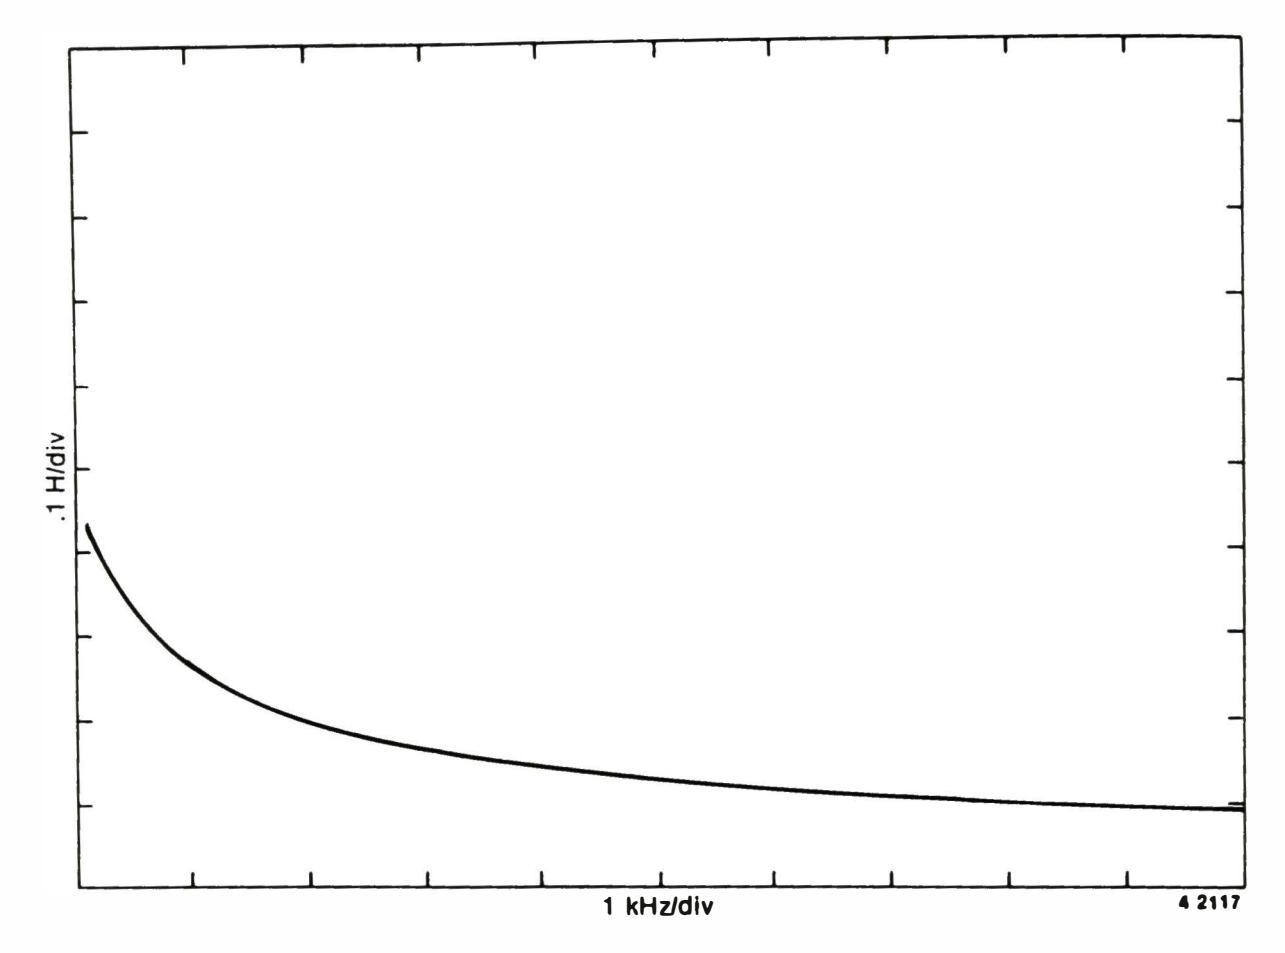
Figure 12. Effective inductance pattern of solenoid valve AH-EP-5037.

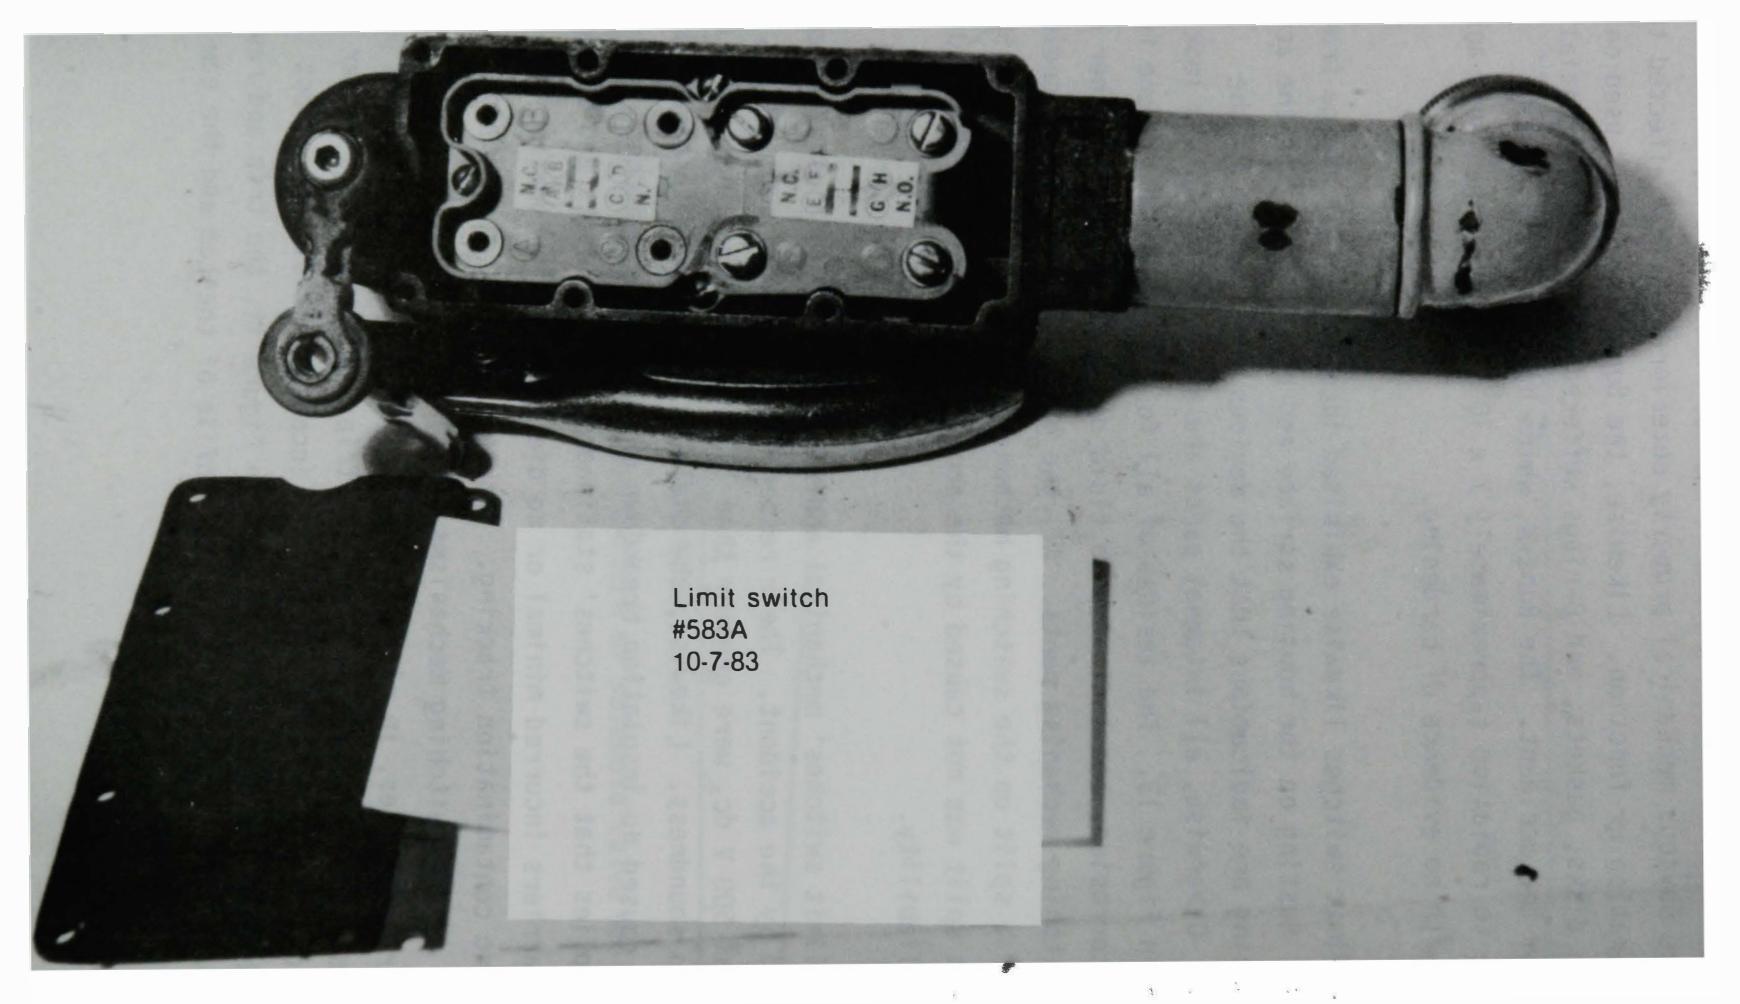
The limit switches likewise exhibited inconsequential damage from the accident. Rusting on the housing surface and embrittlement of the actuator shaft bushing are indications that the devices were exposed to the accident. Otherwise, all internal parts are shiny and clean and look new, as shown in Figure 13. The insides of all four limit switches were free of dirt and corrosion, and indicated no fluid damage, warping, or other damage to the switching mechanism parts. All the gaskets were in good condition except for a split on the switching mechanism cover gasket of AH-KS-5039. The gasket split was not caused by the accident--the gasket exhibited no loss of pliability.

Figure 13. Exposed terminal block of limit switch AH-KS-5037A.

A break of the contact barriers on the contact block of three limit switches was also noted, as seen in Figure 13. Judging from the way the limit switches were wired in the field, with AWG #12 conductors terminated on terminals C and D by AMP PIDG ring torque terminal lugs, it appears that the barriers were probably intentionally broken by construction electricians to provide room for the wires and lugs and allow ease of termination. The action degraded the dielectric property of the device; however, it did not cause degradation below the minimum requirement of 2200 V ac.
