ANALYSIS AND TESTING OF THE HP-R-214 DOME MONITOR CABLE FROM THREE MILE ISLAND UNIT 2

E. H. Richards V. J. Dandini

Sandia National Laboratories Albuquerque, New Mexico 87185

Published March 1986

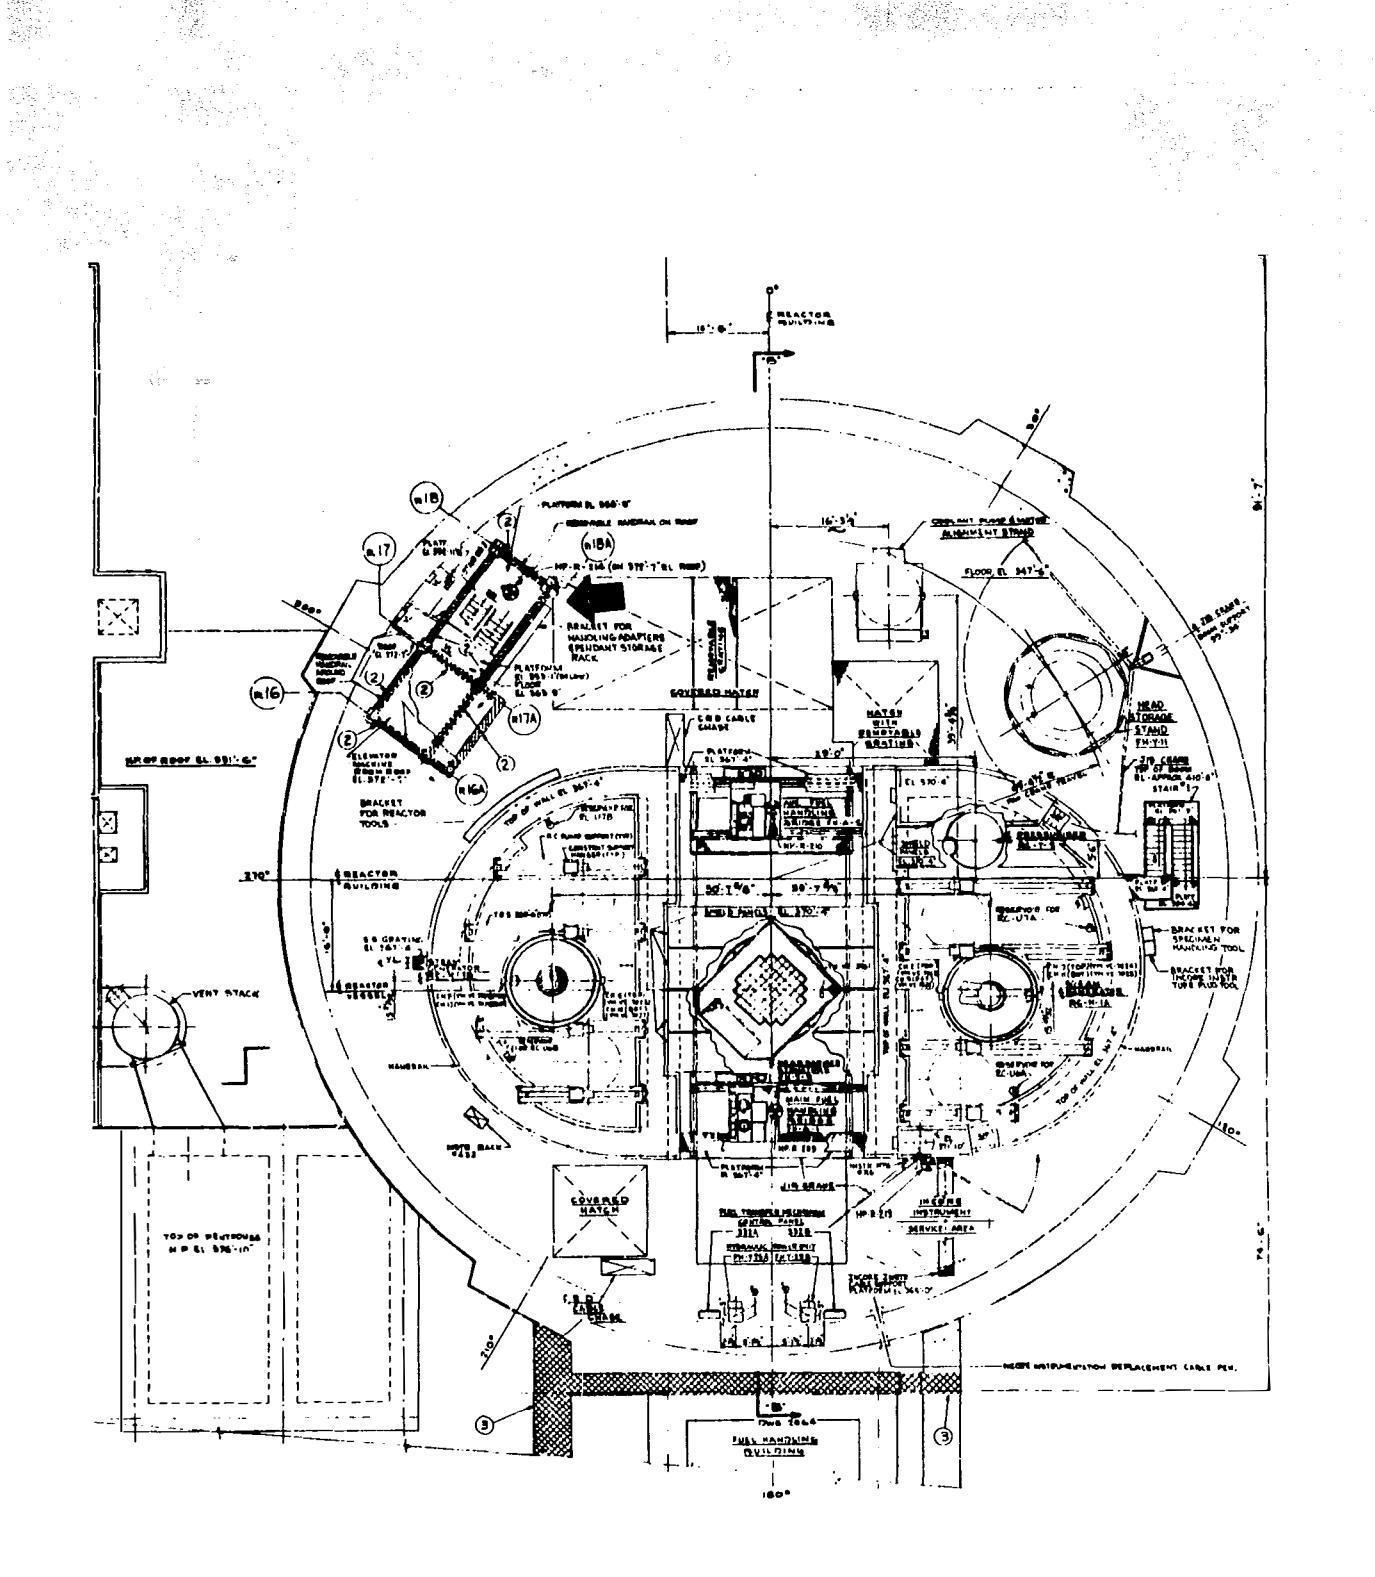
Figure 1. TMI-2, 345-ft Plan Layout. Dome monitor HP-R-214 is located on top of elevator shaft as shown by bold arrow (Ref. 1).

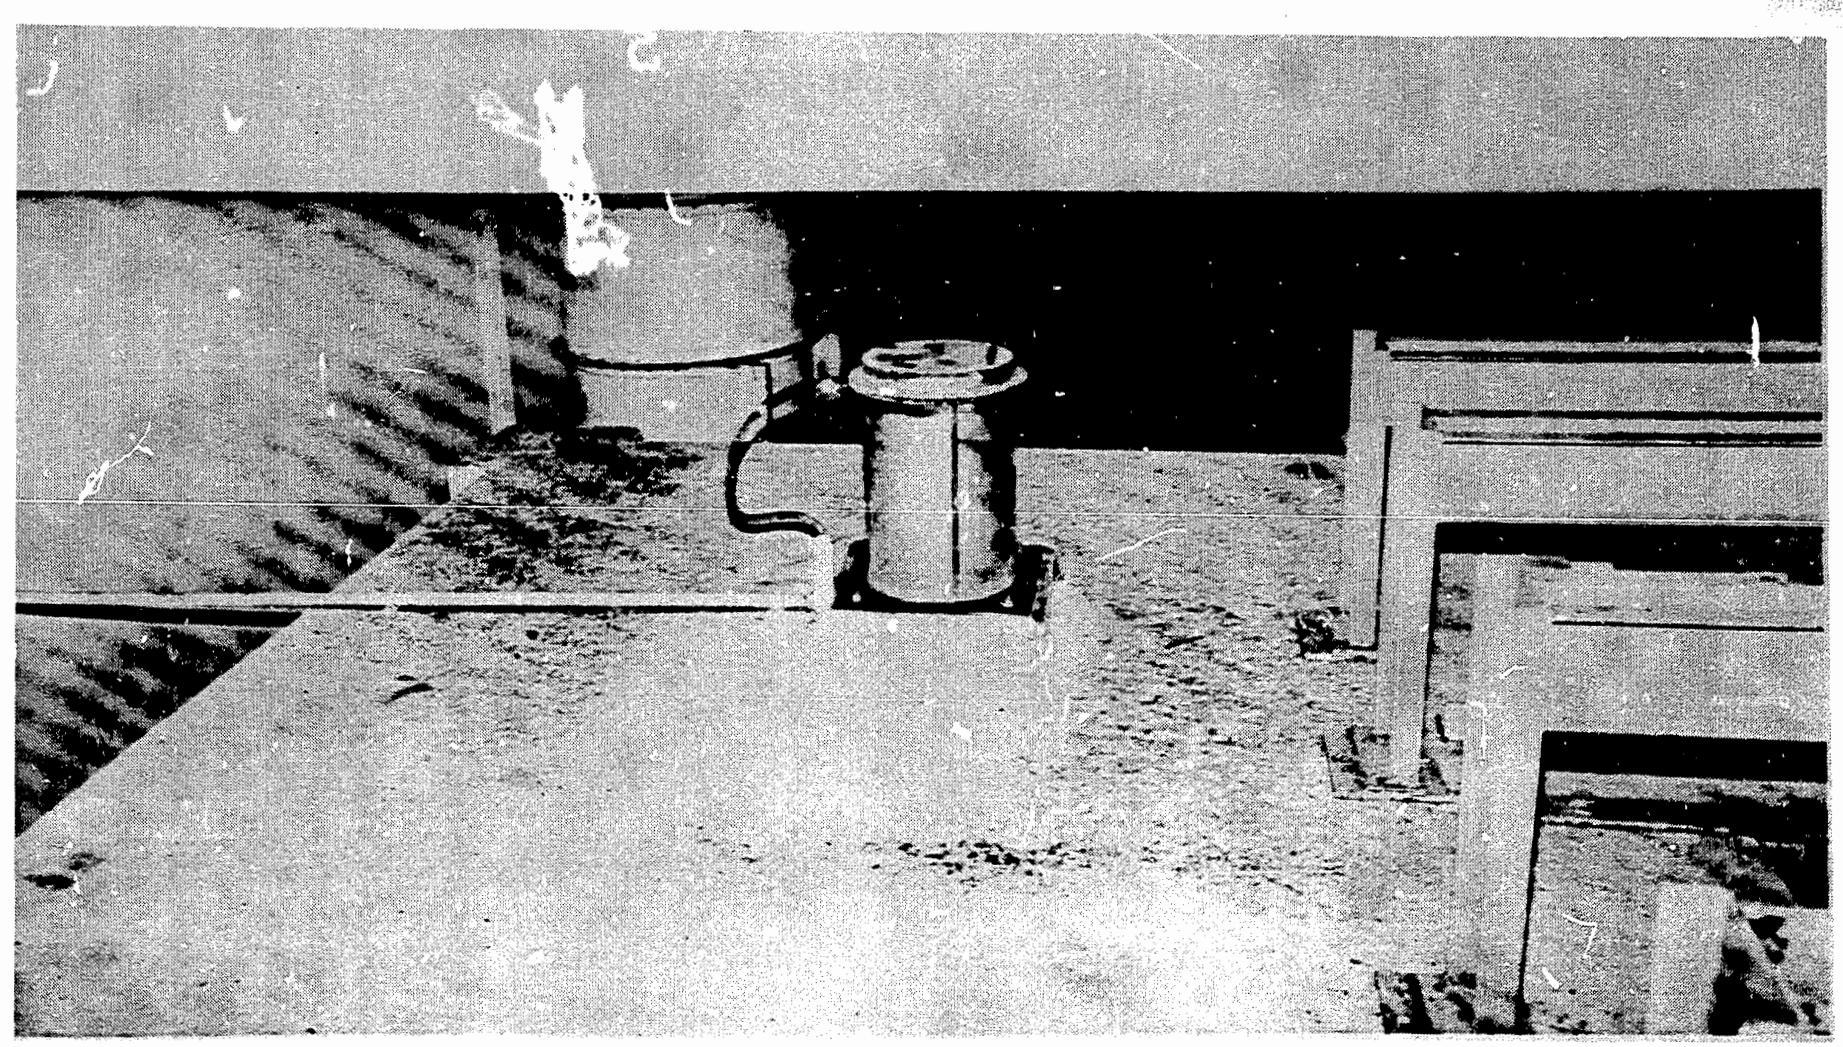
Figure 3. HP-R-214 Dome Monitor and Cable in Place on Top of Elevator Shaft in TMI-2 (Ref. 1).

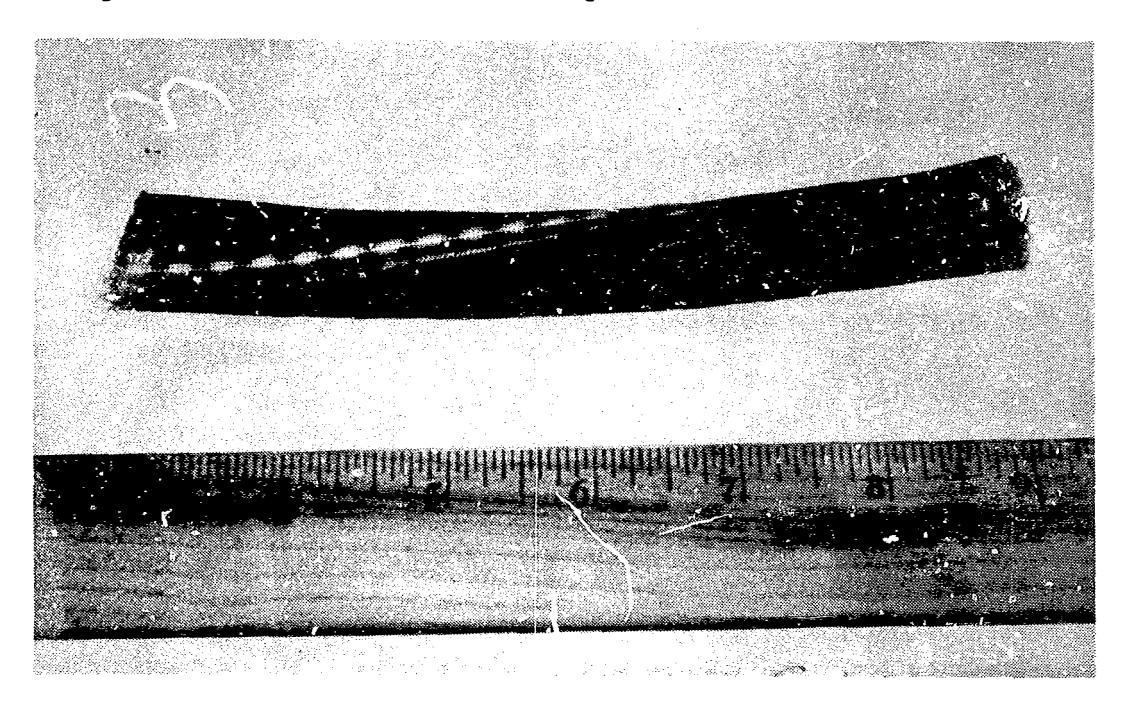
Figure 4 shows the bundle of conductors with the jacket and wrap removed. The fiberglass sheaths are color coded to easily distinguish each conductor (however, on some areas the colors had faded). We used a numbering system to identify individual conductors: conductor #1 is the center conductor, #2 through #7 are in the middle layer, and #8 through #20 are in the outer layer.

Figure 4. Conductor Bundle from Dome Monitor Cable from TMI-2.

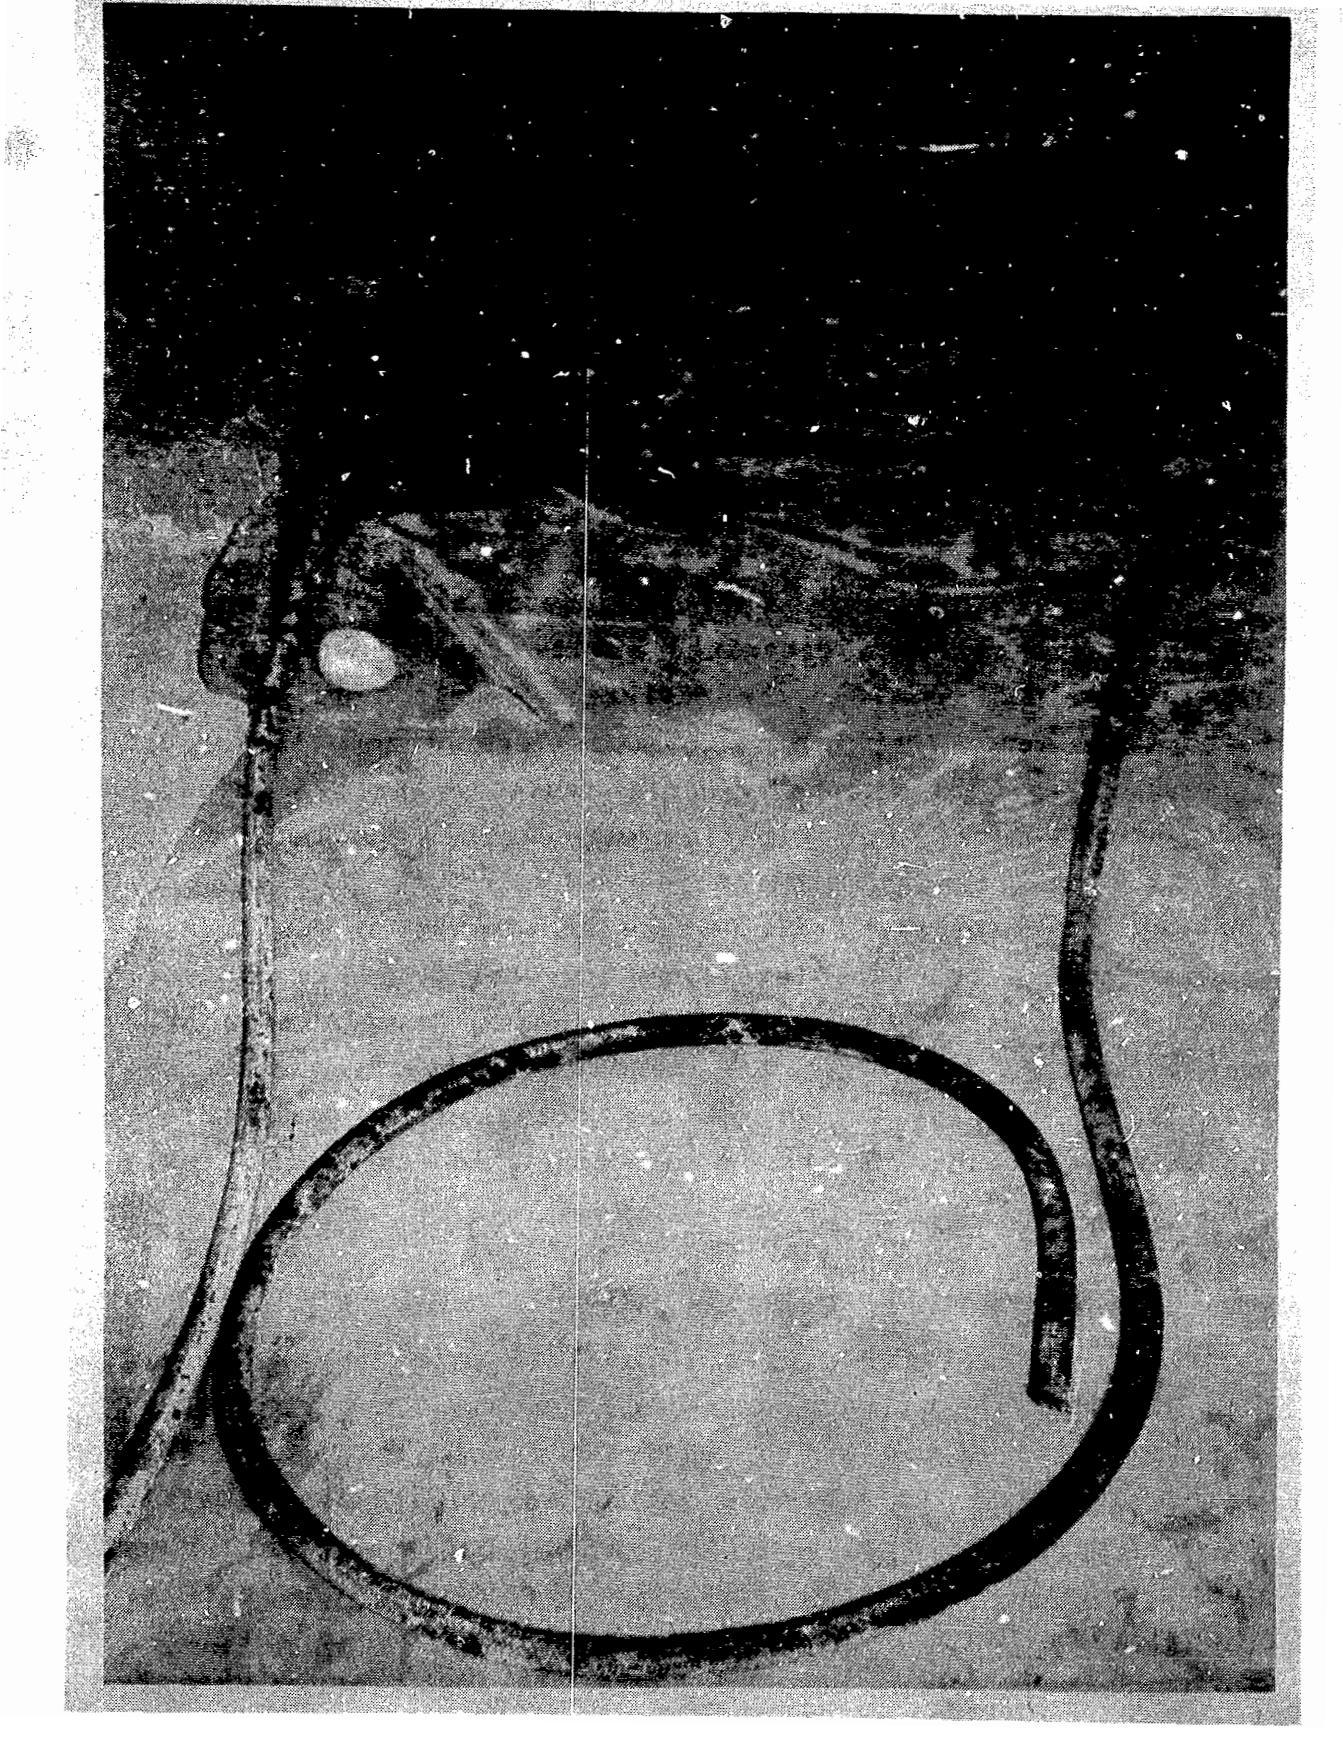
Figure 5. Section of Dome Monitor Cable Installed In Conduit in TMI-2.

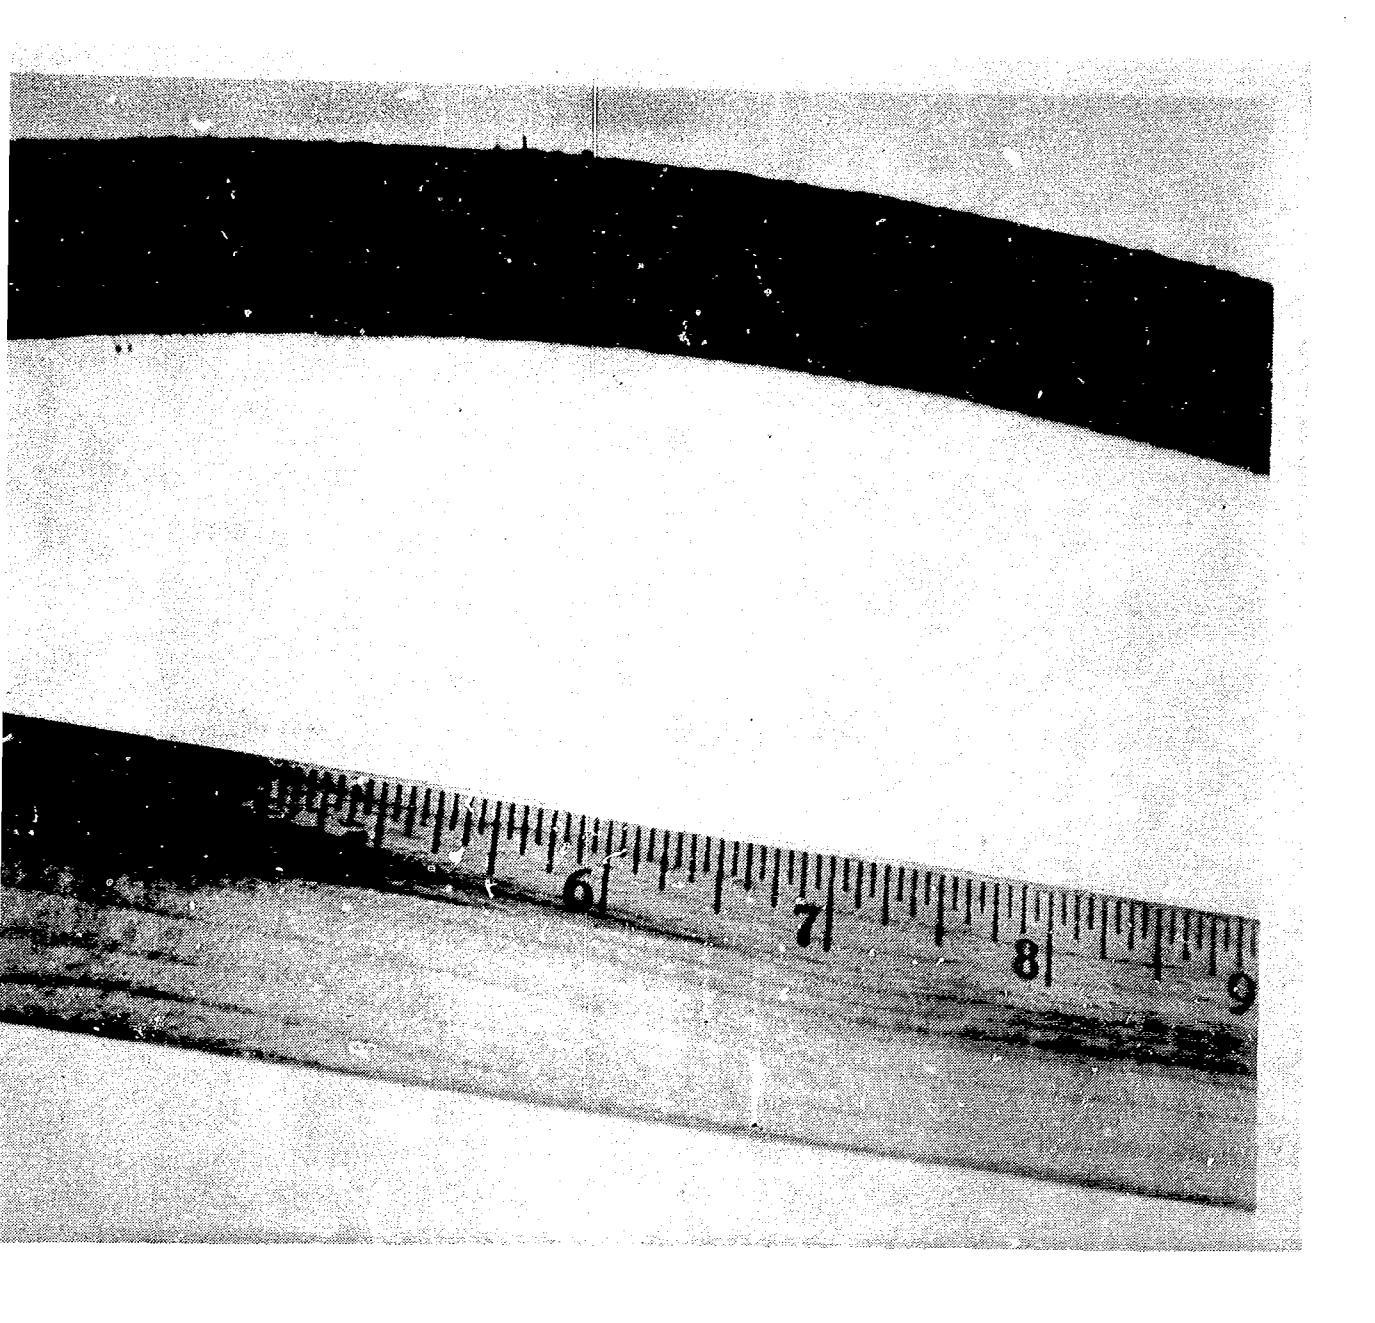
Figure 7. Control Sample of Dome Monitor Cable Taken from TMI-2 Reel.
