The 35th Anniversary of the Three Mile Island Nuclear Power Plant Accident of 1979:

Working at TMI During and Following the Accident

March 25, 2014 Presentation to the NRC by
Gordon R. Skillman

A Special Video Event in Volume 1 of NUREG/KM-0001,
Three Mile Island Accident of 1979
Knowledge Management Digest

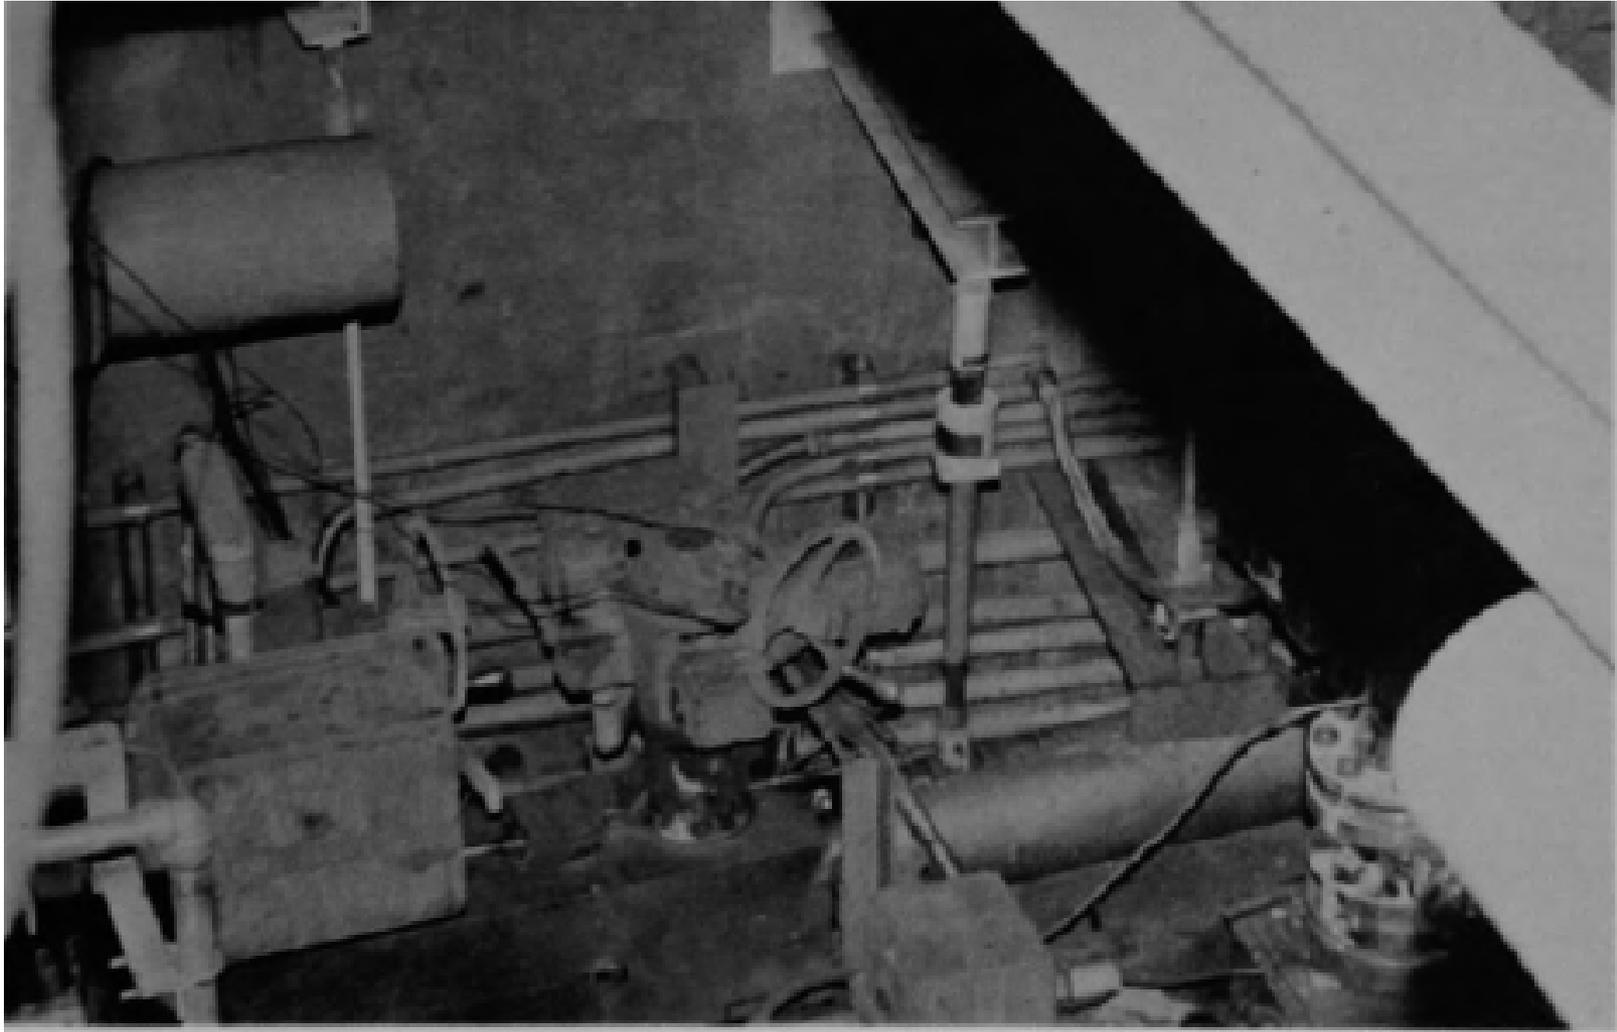
TMI-2 Pressurizer Pilot-Operated Relief Valve (PORV)

PORV Block valve was on the main control room panel immediately in front of the operators; the indication for the Reactor Coolant Drain Tank, into which the PORV blow-down discharged, was on the back-side of the control room cabinets, on a waste disposal panel, not visible from the control room operators facing the main horse-shoe panels.

As the consequence, the open PORV 'flowed' from ~0400 hours to ~0620 hours, approximately 140 minutes, from the Pressurizer to the Reactor Coolant Drain Tank. In time the Reactor Coolant Drain Tank overpressured and the pressure blew out the rupture disk on the Reactor Coolant Drain Tank and flowed ~220,000 gallons of primary coolant to the Reactor Building basement floor. While the transient presented itself as a RCS leak, or a Small-Break Loss-of-Coolant Accident, the RCS and Emergency Core Cooling System responded exactly as designed, analyzed and anticipated.

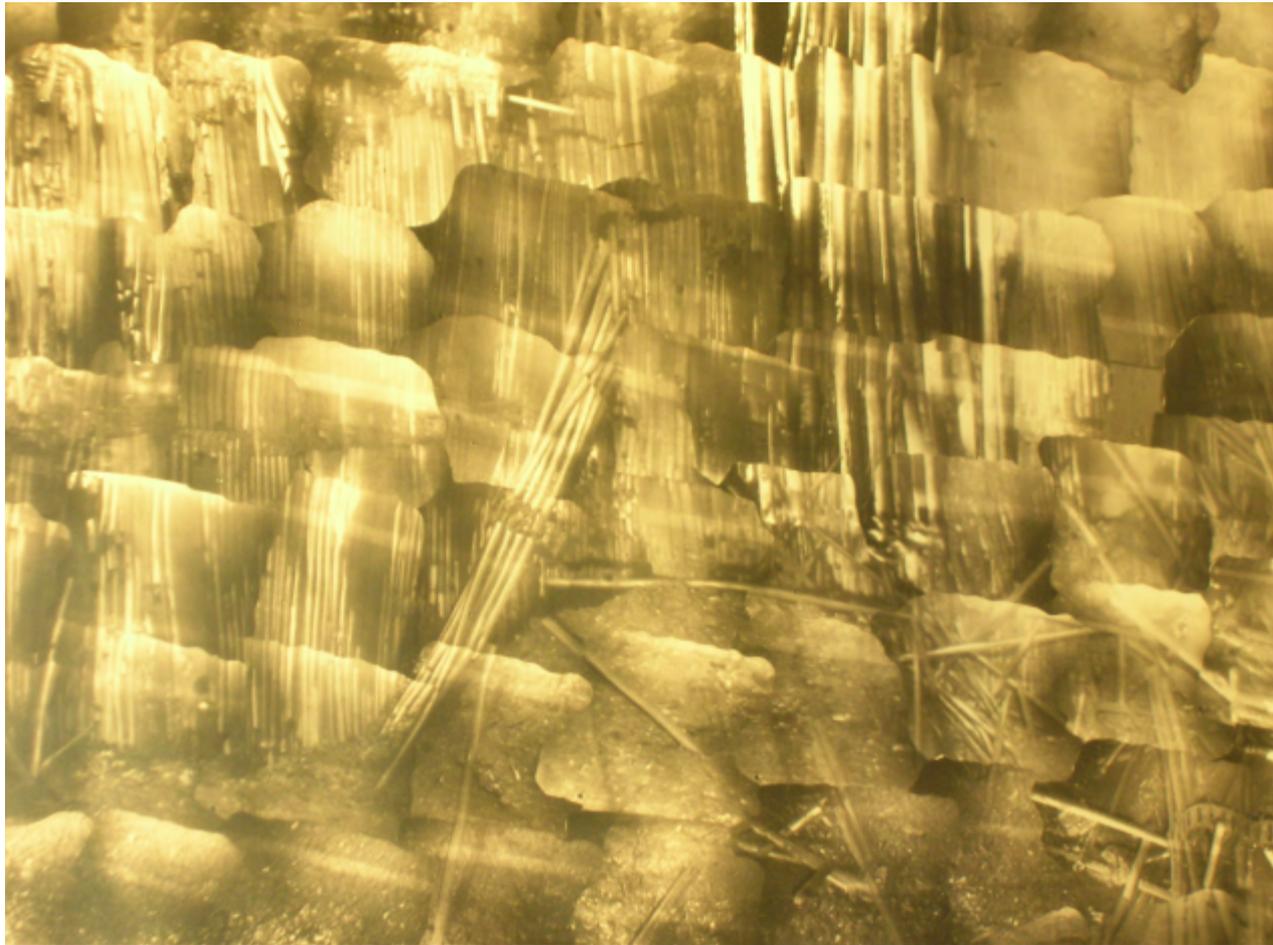
Mosaic Panorama View of Reactor Core Cavity

(Axial Power Shaping Control Rod Hanging at Top)

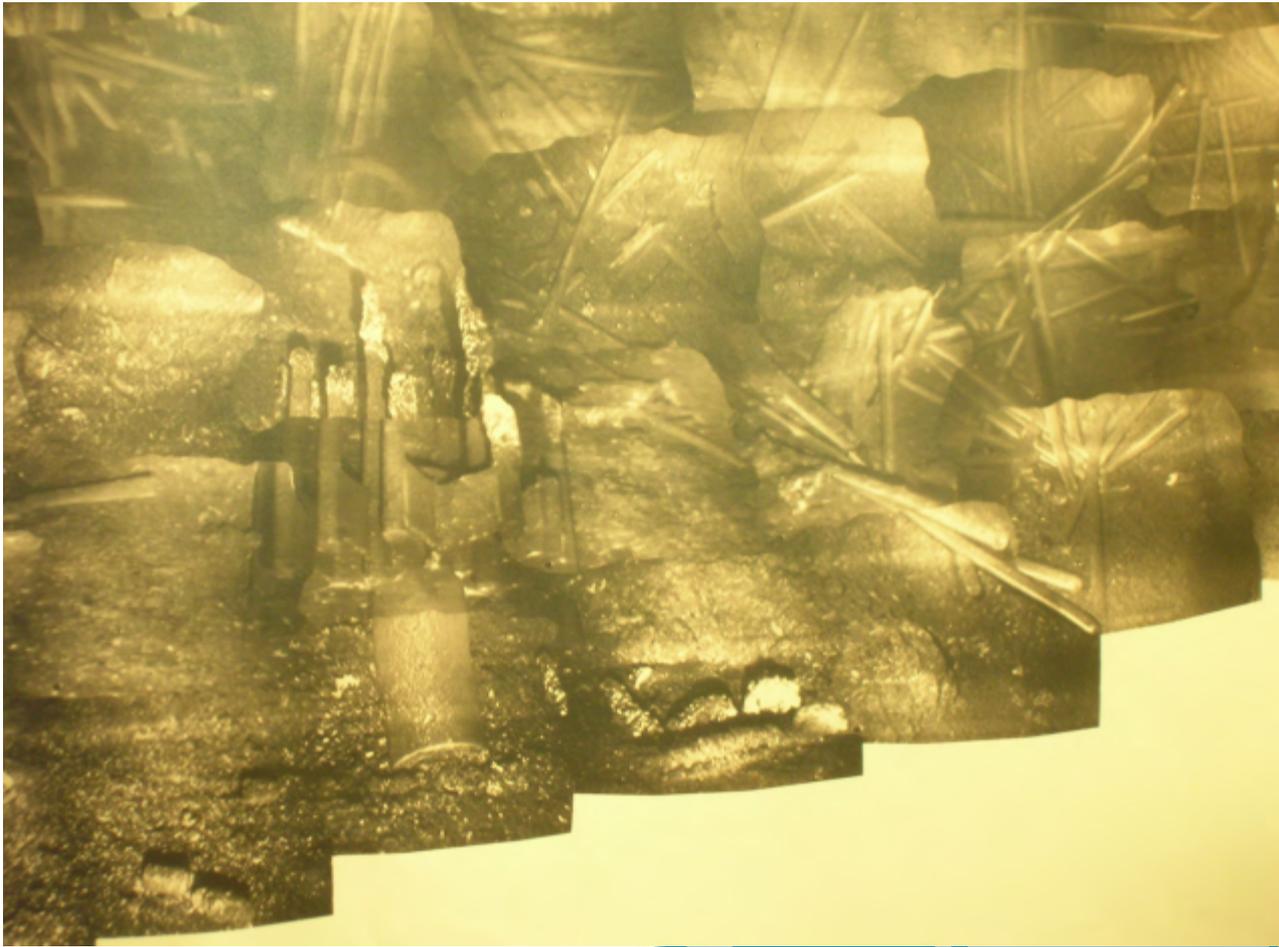
(Control Rod Spider Fitting on Rubble Bed)

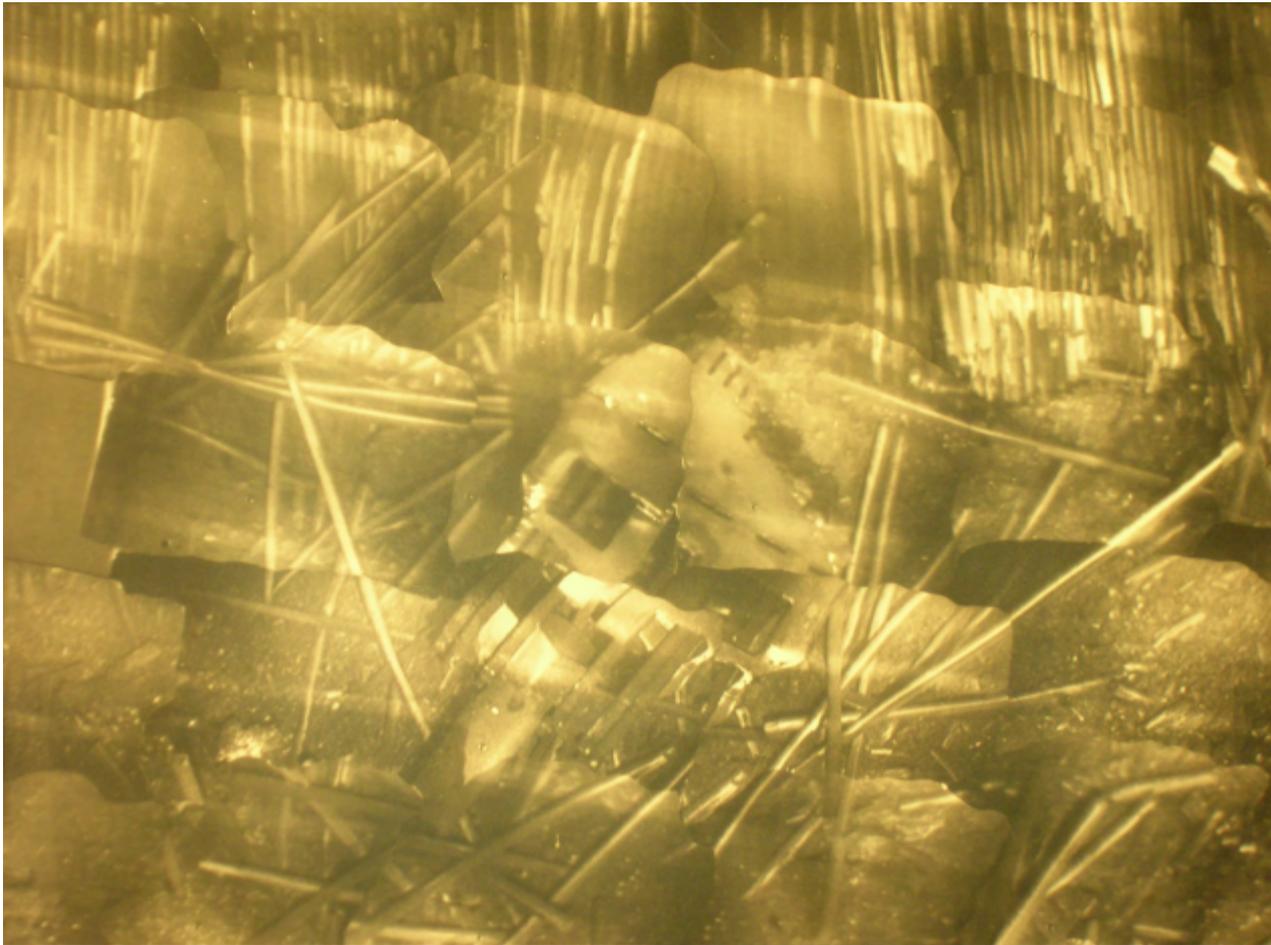
Mosaic Panorama View of Reactor Core Cavity (Broken Fuel Rods on Rubble Bed)

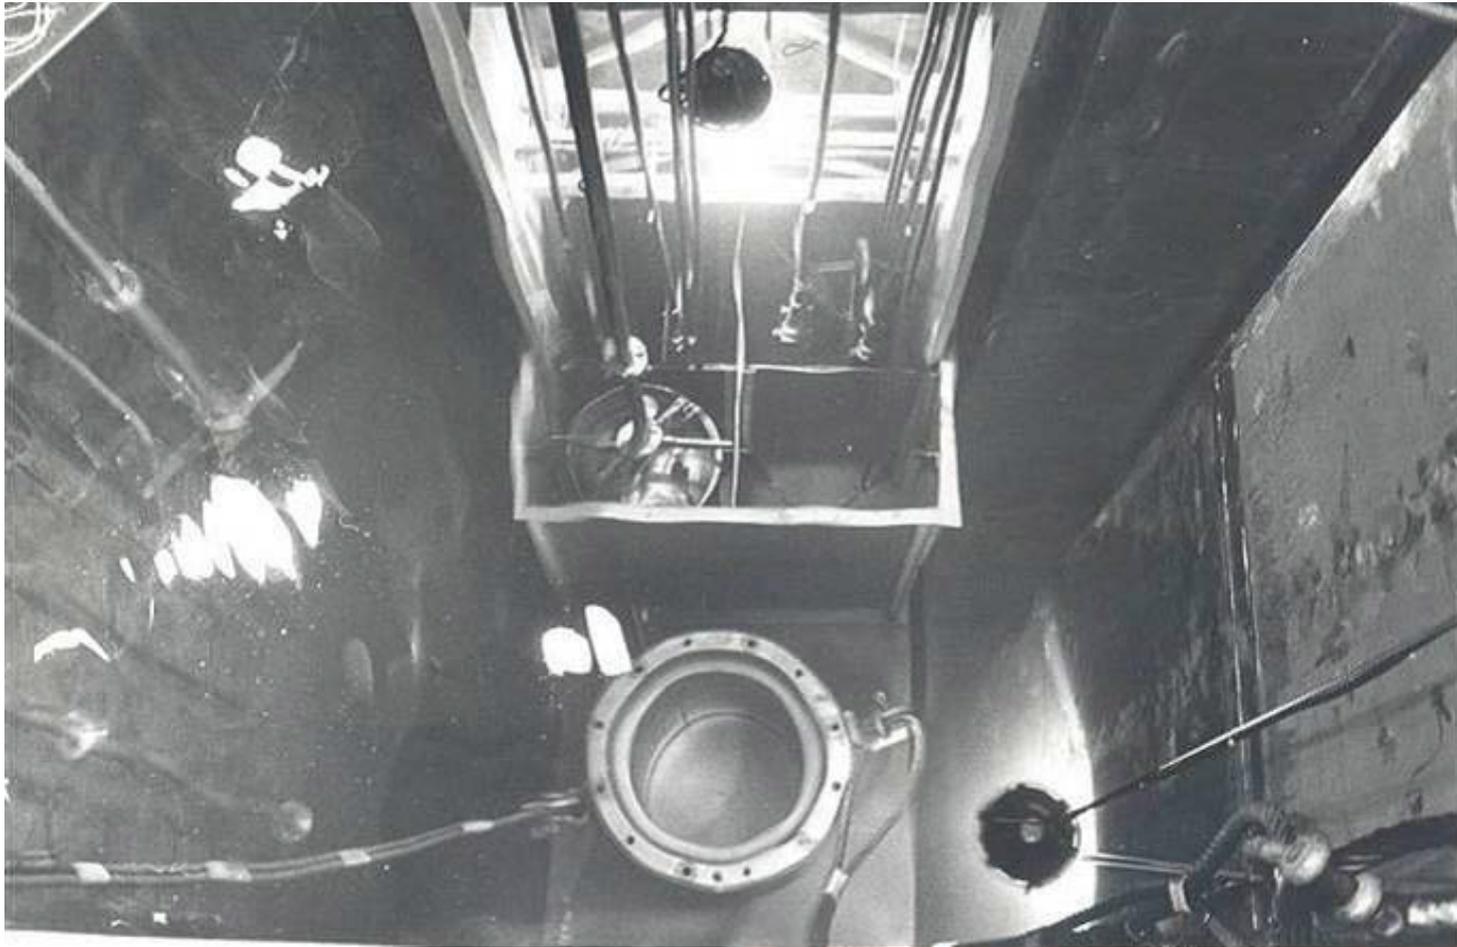
Loading Spent SDS Liner into Empty Shipping Cask

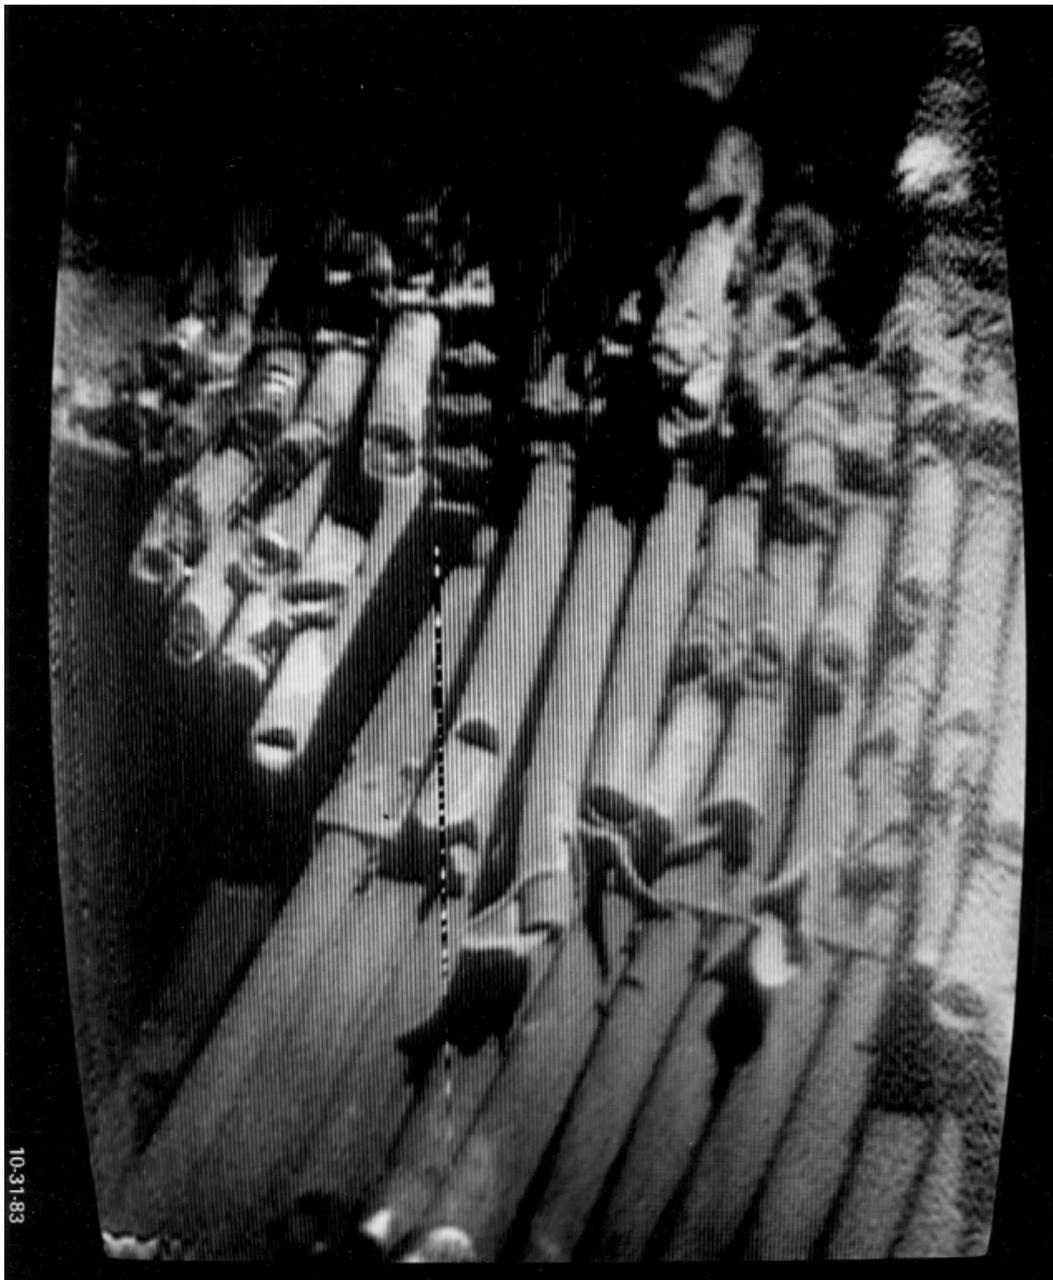
(Stubs of Fuel
Assemblies Hang
from Underside of
Plenum Assembly)

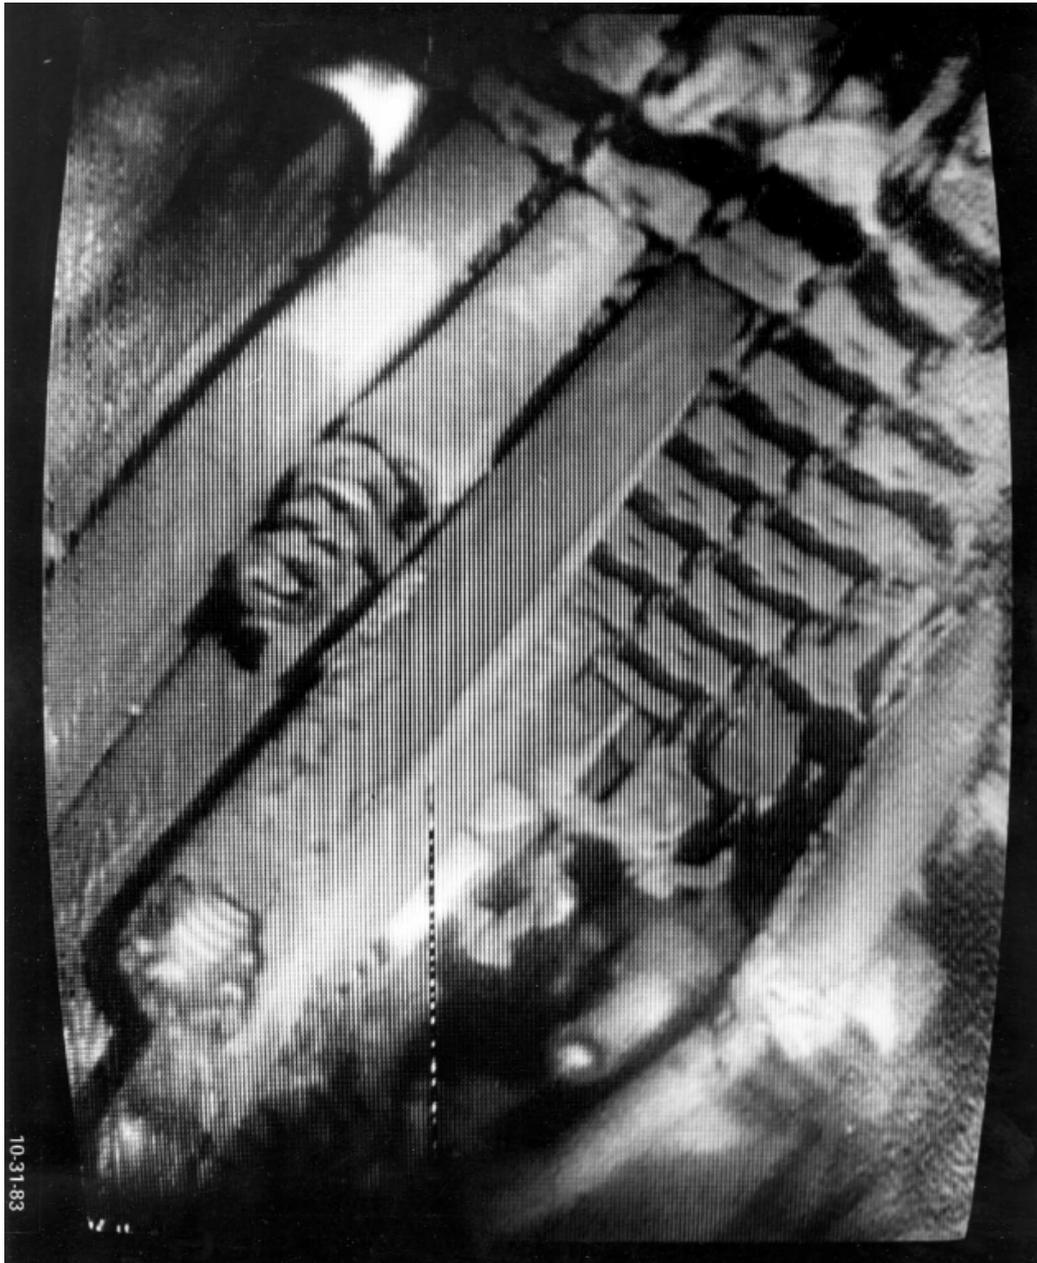
View Inside Reactor Core Cavity

(Close-up of
Damaged Fuel
Assembly Showing
Broken and Missing
Fuel Rods, End
Fitting Exposing Fuel
Rod Plenum Spring)

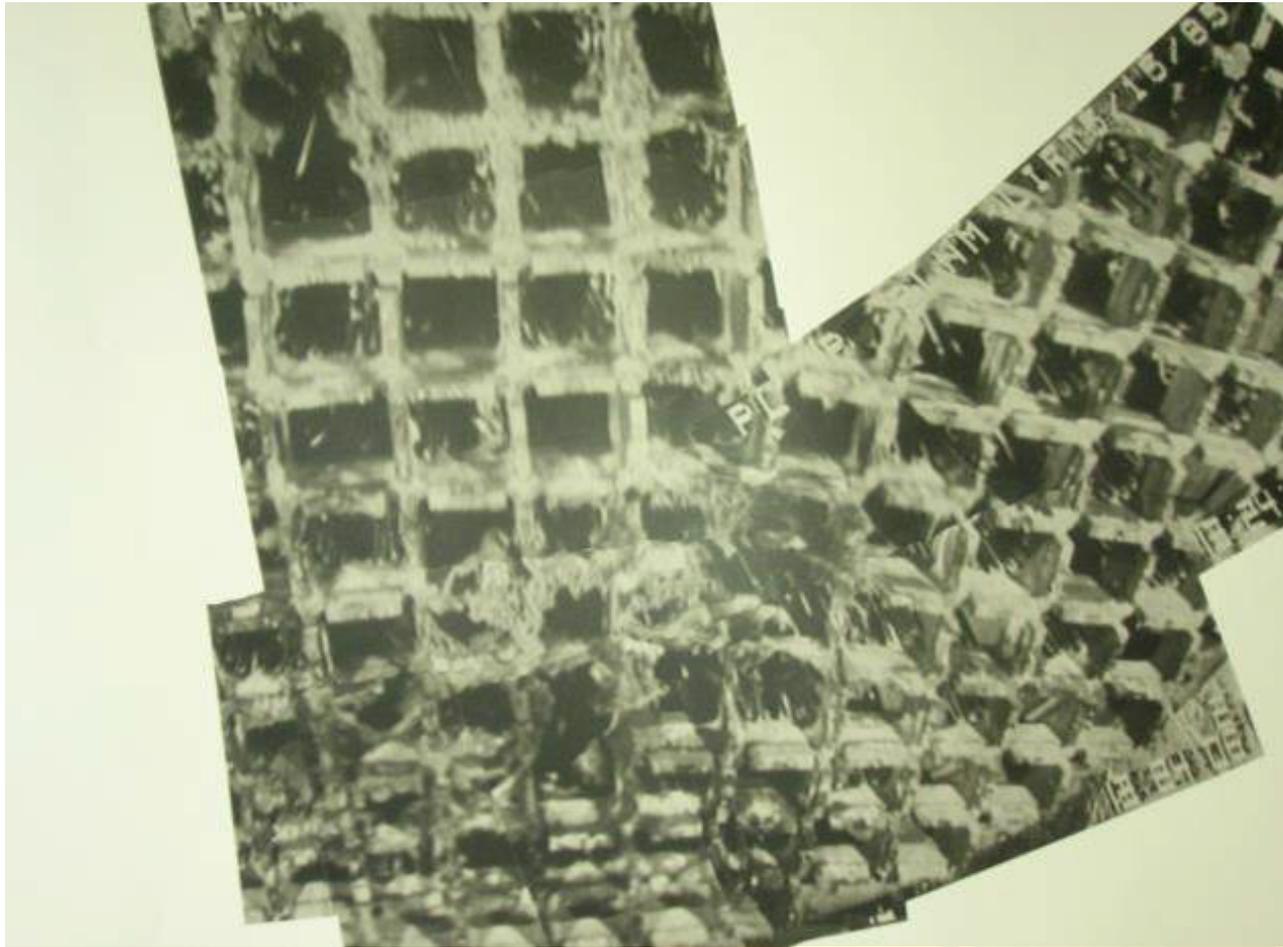
Upper Grid Damage at TMI-2

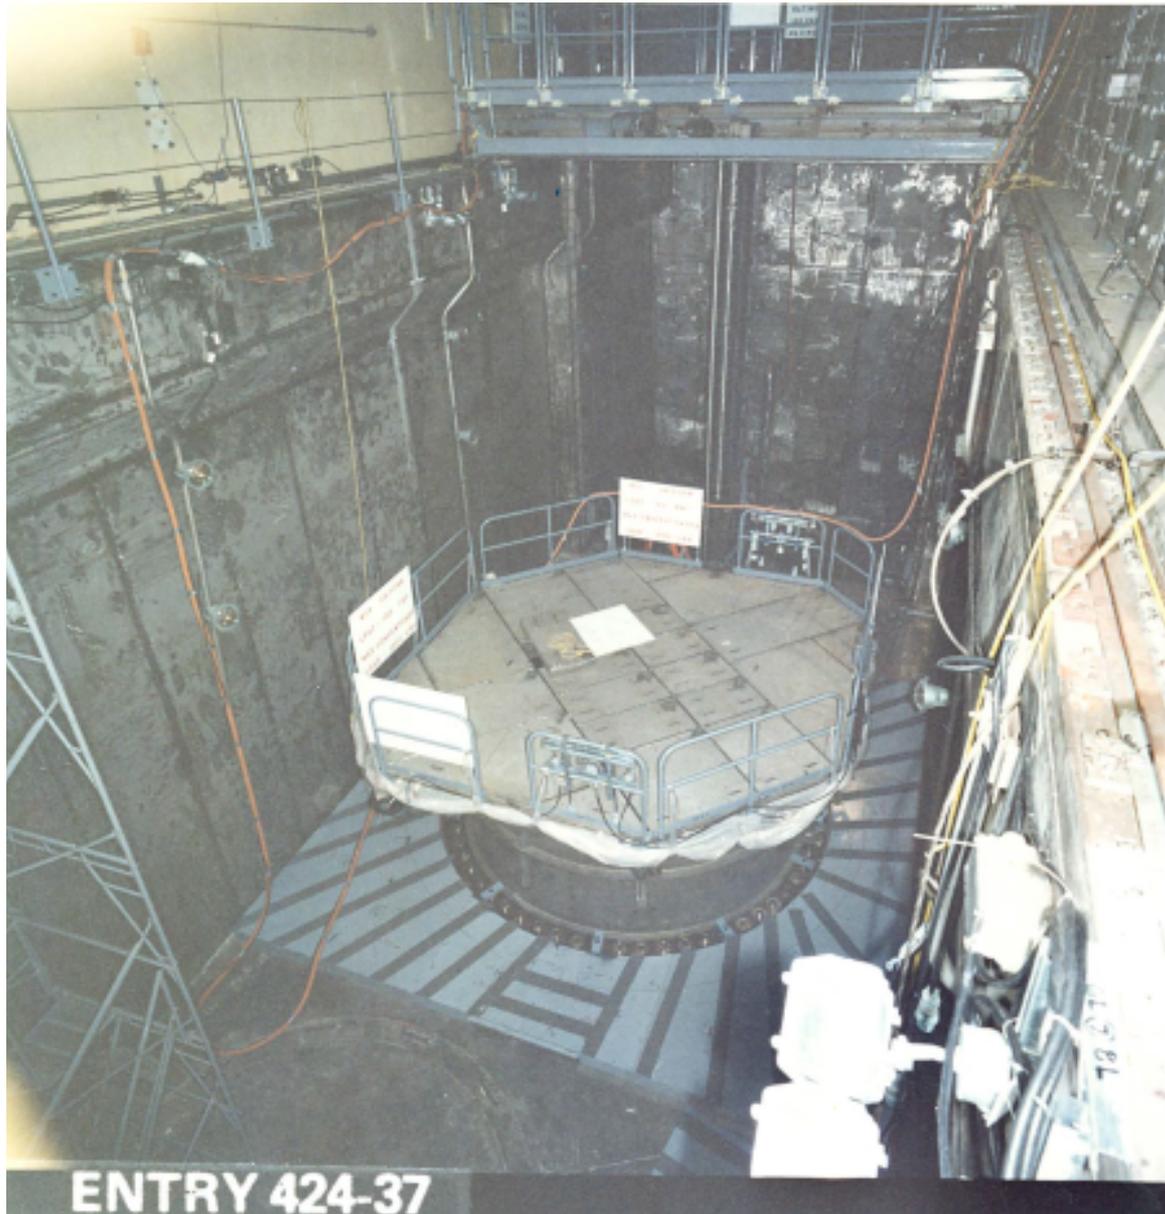
Defueling Work Platform (Installed Over Reactor Vessel)

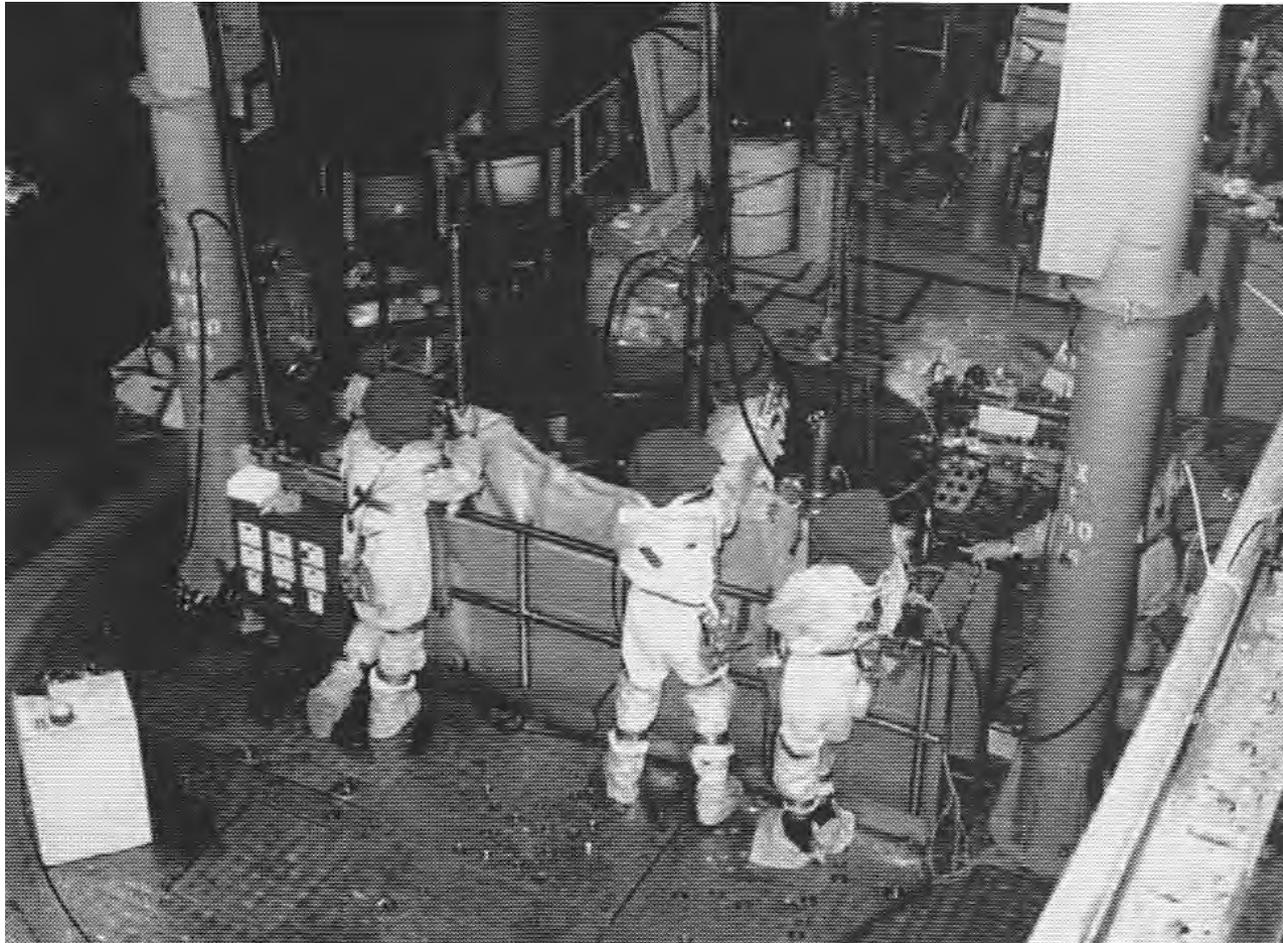
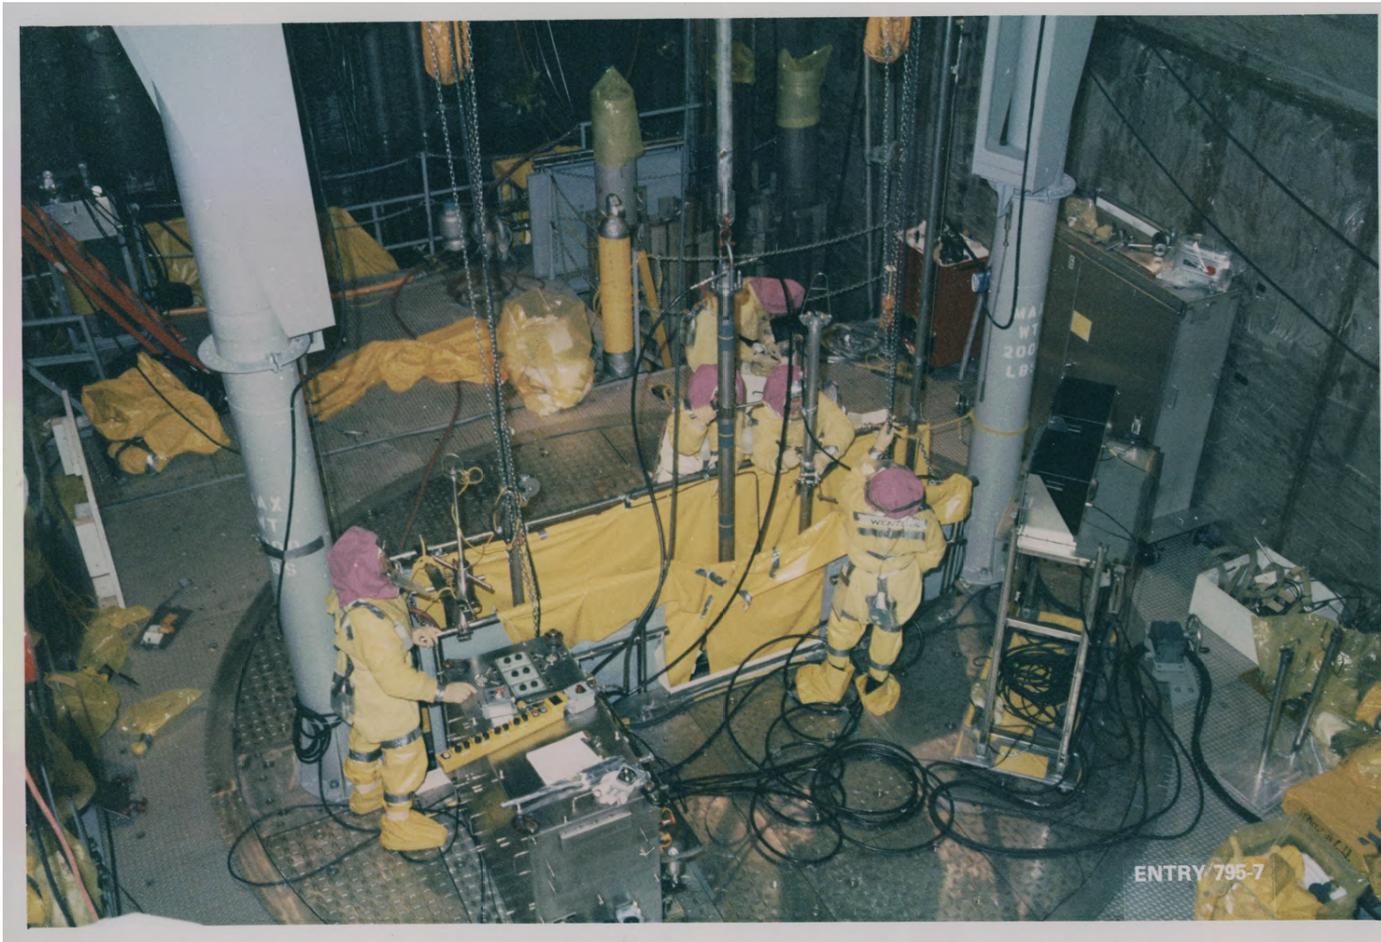
Defueling, Removal of Fuel Debris Using Long-Handled Tools
