**U.S. DEPARTMENT OF ENERGY AND GPU NUCLEAR  
CORPORATION  
RESEARCH AND DEVELOPMENT ACTIVITIES ON  
THREE MILE ISLAND UNIT TWO  
ANNUAL REPORT FOR 1985**

**Published April 1986**

**GPU Nuclear Corporation  
Middletown, Pennsylvania 17057  
and  
EG&G Idaho, Inc.  
Idaho Falls, Idaho 83415**

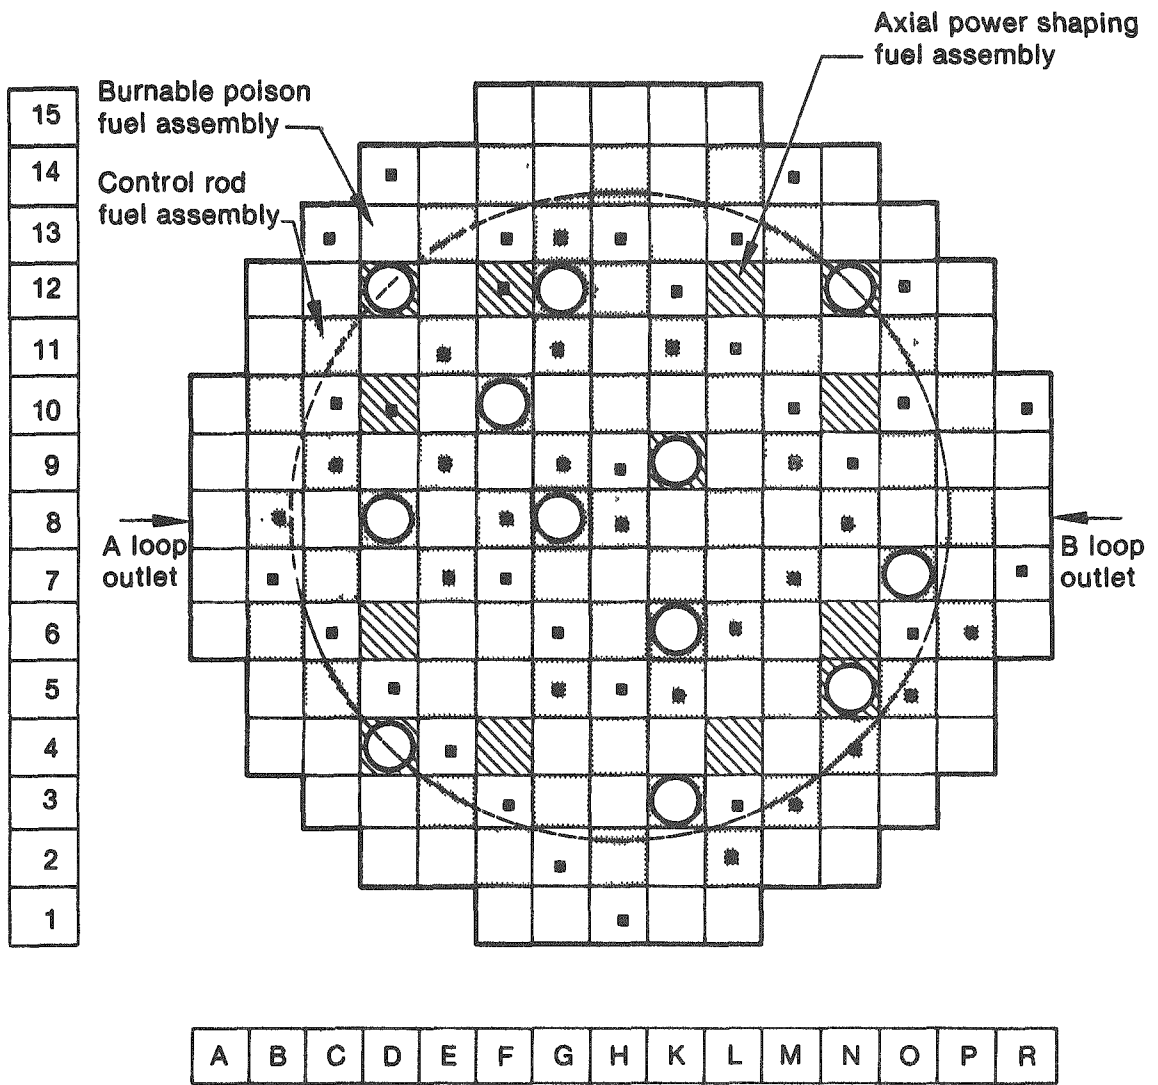
6 0471

Figure 14. Core bore locations.

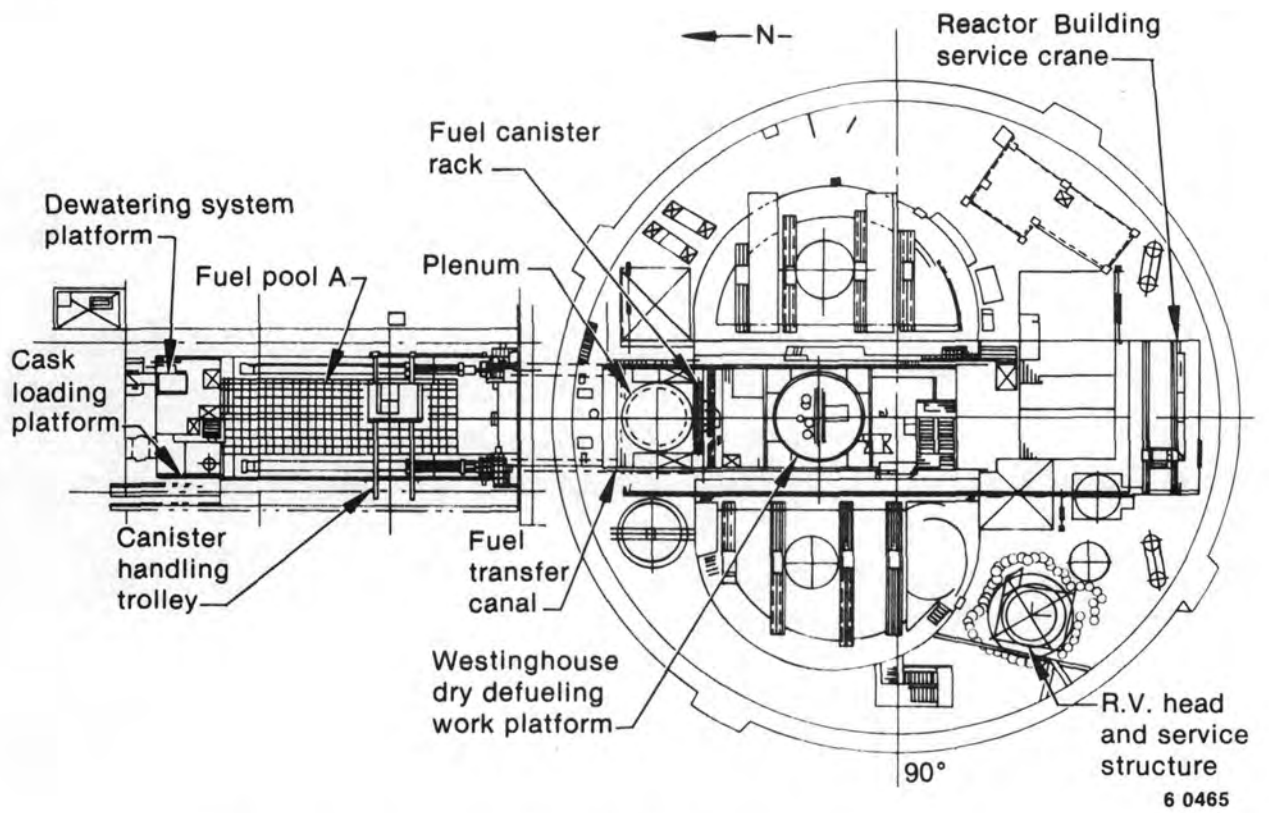
Figure 17. TMI-2 defueling general arrangement.

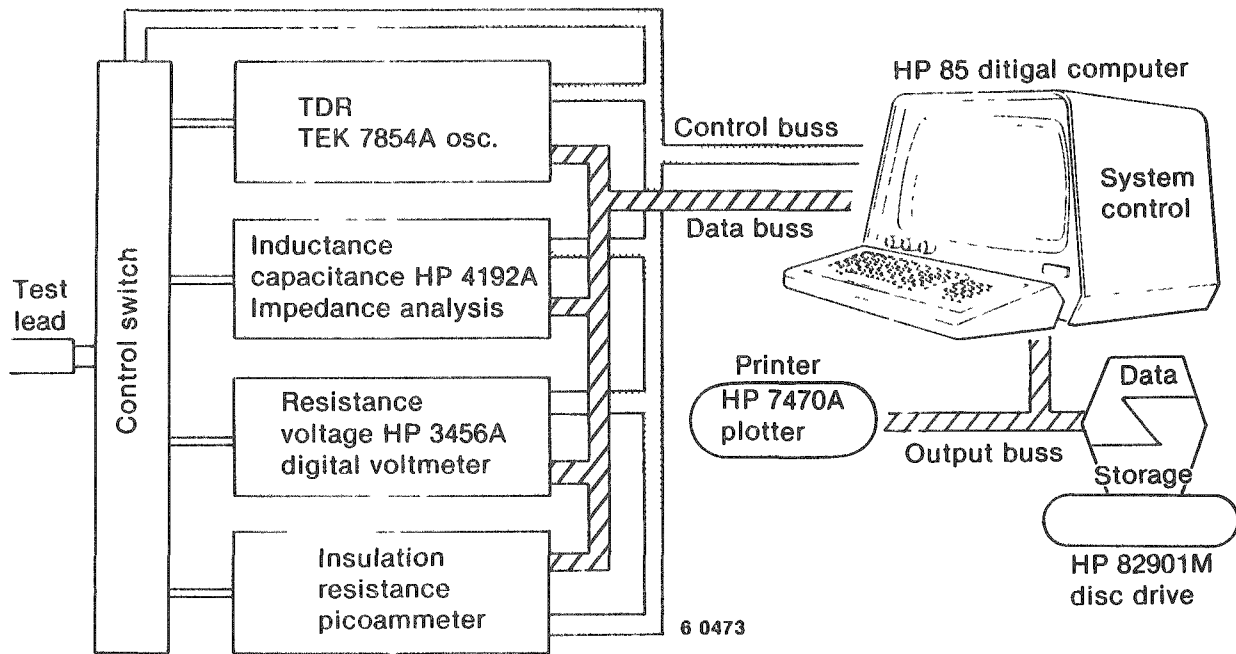
Figure 19. ECCAD system configuration.

The ECCAD system uses standard test equipment under computer control to quickly acquire meaningful data to analyze a circuit. The computer removes human errors that can be introduced in data acquisition and provides a repeatable and trendable data base. This data base can indicate circuit condition and is useful in maintenance and plant life planning.

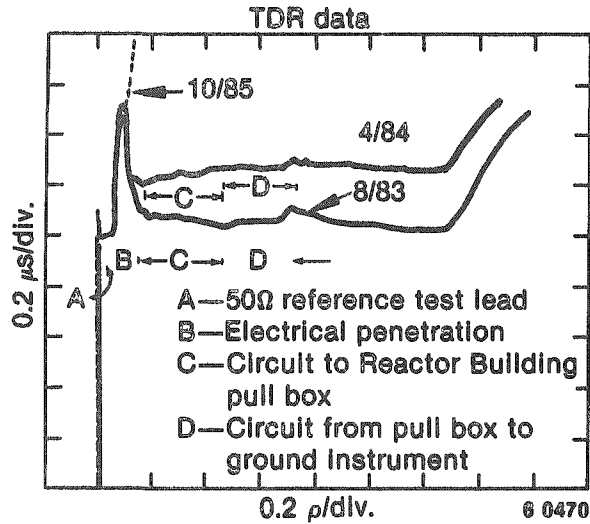
Figure 21. Time-domain reflectometry plot of circuit connecting to relay contacts at reactor coolant pump, showing continuing degradation.

All of the evidence for this example strongly indicates that the problem was initiated by the water during the LOCA, but that degradation was slow and due to corrosion of the circuit connection at the Reactor Building inner-liner penetration box. This evidence of damage is consistent with known environmental effects at this location.
