TMI Unit 2 Technical Information & Examination Program UPDATE

Publication by EG&G Idaho, Inc. for the U.S. Department of Energy

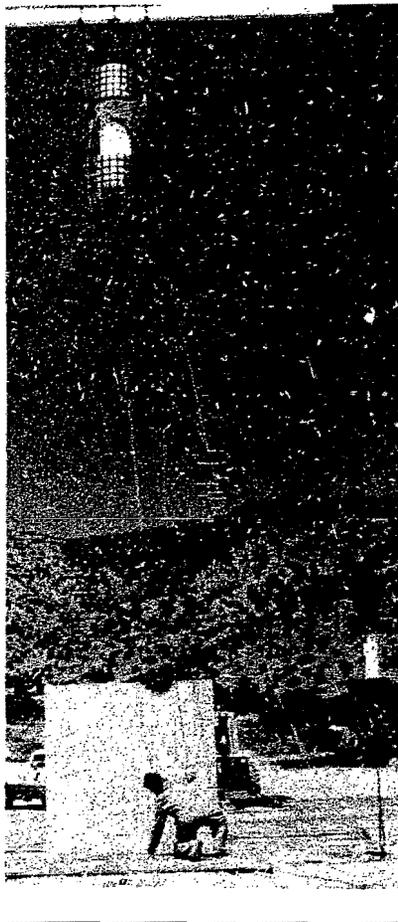
Figure 2. Height and orientation check before end drop.
