UPDATE

Volume 3, Number 1

November 1, 1982

Initial Quick Look Conducted to Assess Unit 2 Core Damage

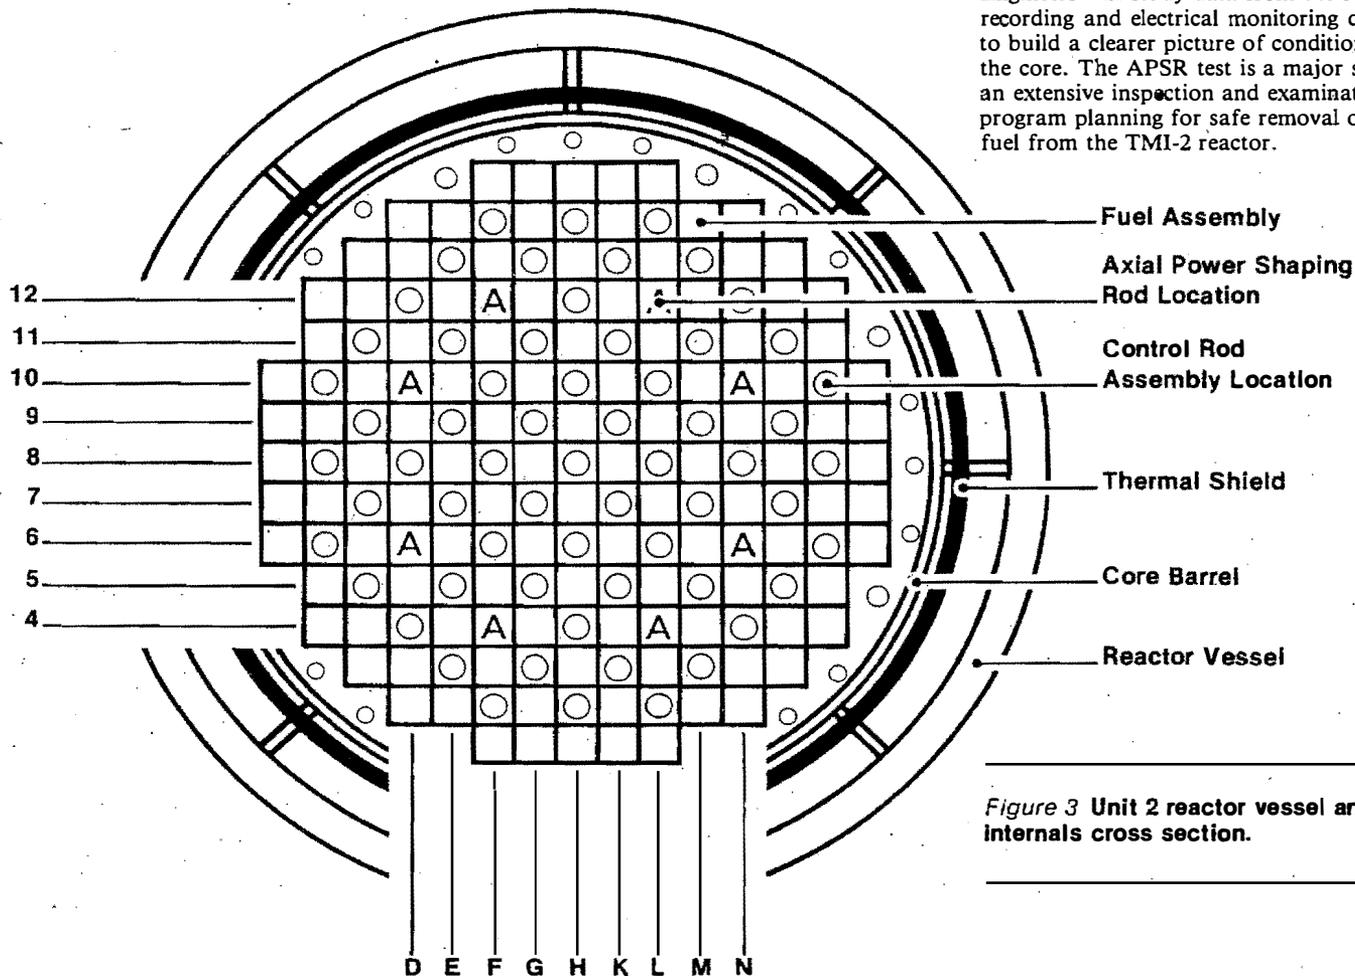
Figure 3 Unit 2 reactor vessel and internals cross section.

a. See Figure 3 for map of the core.

The distance from full APSR removal (100%) to full rod insertion (0%) is approximately 139 in. Before the testing, all the rods were at 25%, with approximately 35 in. extending above the top of the core. When testing ended on June 25, the positions of the eight APSRs were as shown in *Table 1*. The configuration of maximum to minimum inserted rods did not follow any observable pattern, although further study may show some relationship between APSR movement and apparent internal core damage indicated by other data gathered at TMI-2. *Figure 3* shows the locations of the APSRs and the 61 control rods in a cross-sectional view of the TMI-2 reactor vessel internals.

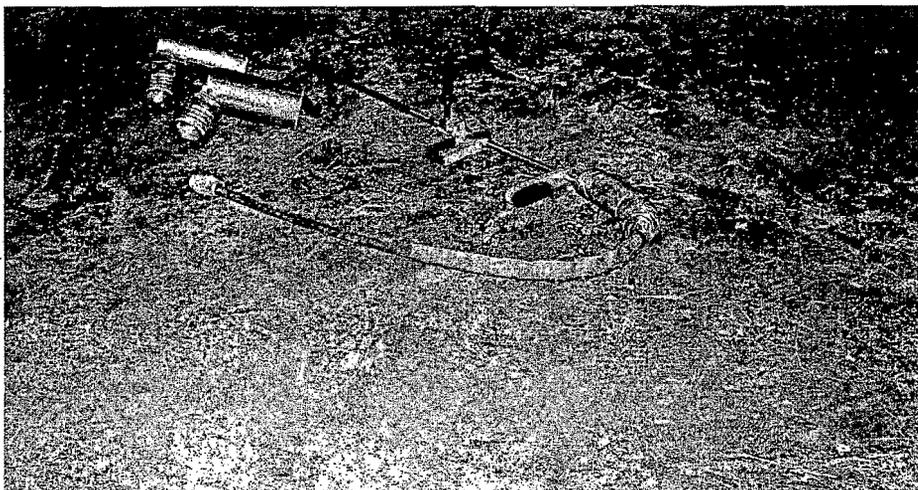
Figure 5 Hydrolasing blaster nozzle and safety equipment.

Figure 4 shows technicians hydrolasing the top of the D-rings. Water was sprayed over surfaces from a blaster lance (see Figure 5) with various size fan nozzles under pressures ranging from 2,000 to 6,000 psi and temperatures from ambient to 140°F. The portable high-pressure pump and temporary hot water heater system located outside of the Reactor Building are capable of supplying water heated to 140°F at flow rates up to 25 gpm and pressures up to 10,000 psi (see Figure 6).

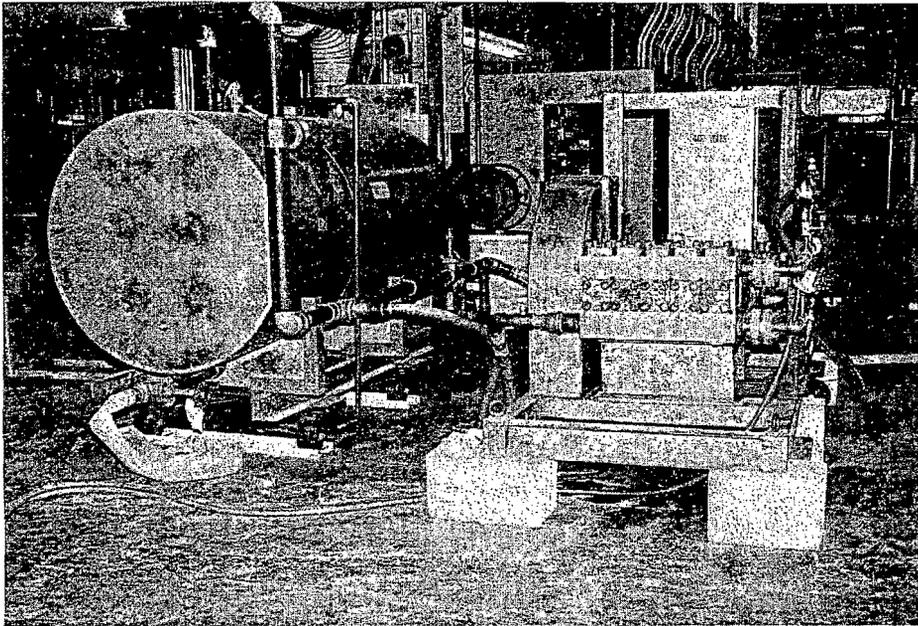
Figure 6 Gross decontamination experiment hot water heater and high pressure pump.

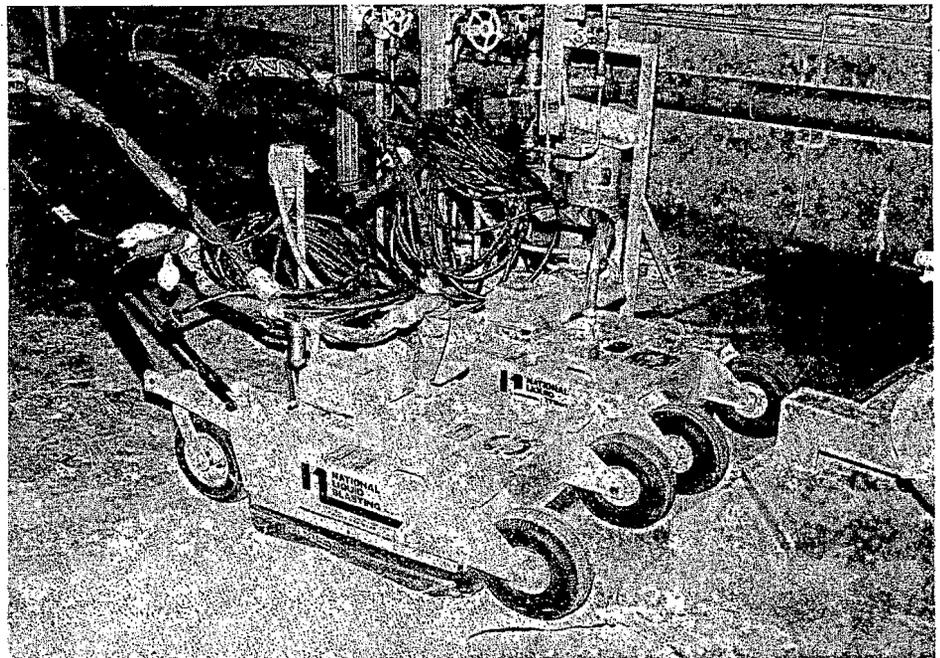
Figure 7 Gross decontamination experiment spinjet sprayers.

Other methods in the gross decontamination included the use of wheeled spinjets, mechanical floor scrubbers and detergents, and strippable silicon coatings. The spinjets look much like domestic lawn mowers with water jets instead of blades (see *Figure 7*); they provide easy mobility and an even spray application over floors. The mechanical scrubbers are similar to floor buffers, but are equipped with abrasive pads, apparently highly effective in removing contaminant-bearing rust. However, because the chemical detergents used with the scrubbers might have affected the functioning of the Submerged Demineralizer System, a specially designed vacuum gathered the detergents into barrels after scrubbing. This wet/dry vacuum picked up contaminated material without contaminating the basic internals of the vacuum equipment, using a series of special throwaway filters. The mechanical scrubbers proved to be a very effective decontamination technique and will undergo further testing using zeolite and abrasive pads without detergents.

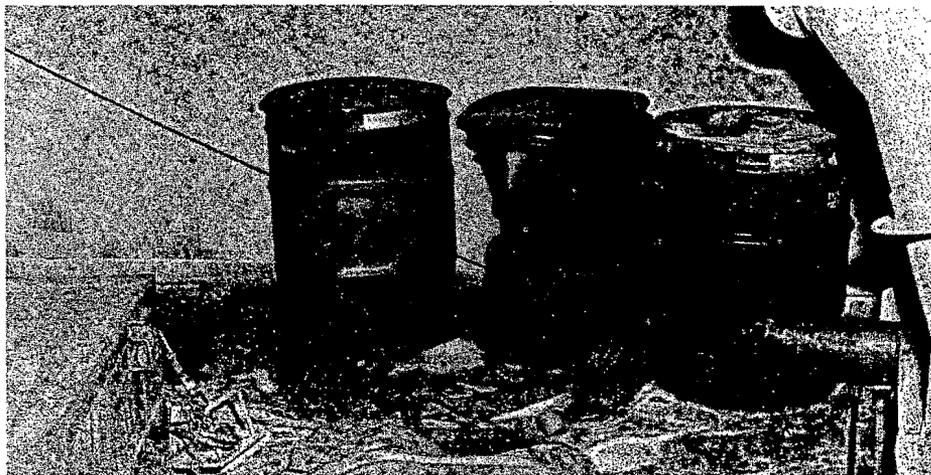
Figure 11 Damaged 55-gal barrels on the 347-foot elevation.

Discussed below are some examples of the damage evident in the TMI-2 building caused by the hydrogen burn. Damage caused by a sudden increase in pressure appears to be restricted to areas near the elevator and enclosed stairwell complex on the 347-foot elevation. The elevator door and stairwell door both were bent out of shape, indicating a buildup of pressure to levels the door materials and structure could not withstand. These distorted doors, as well as the crushed or imploded barrels pictured in *Figure 11* could both have been affected by a pressure pulse, or possibly by heating followed by rapid cooling.

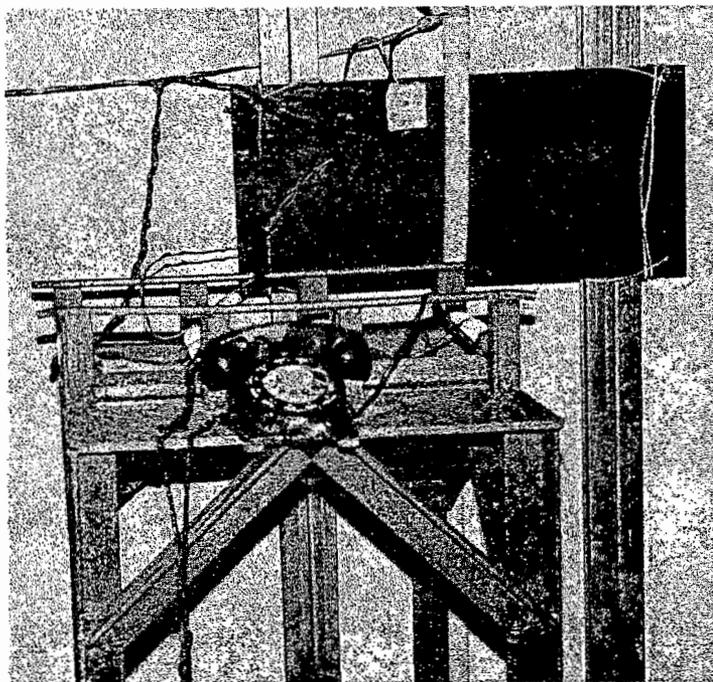
Figure 13 Deformed telephone on the 347-foot elevation.

Plastic and polyethylene materials demonstrated the most dramatic evidence of thermal damage. Control panel buttons on the auxiliary fuel handling bridge melted out of shape, and telephone cord wire softened and lost its shape. A telephone on the 347-foot elevation, pictured in *Figure 13*, deformed from the heat; experimental results and manufacturer's data indicate that temperatures above 221 °F would cause a telephone to deform under its own weight.

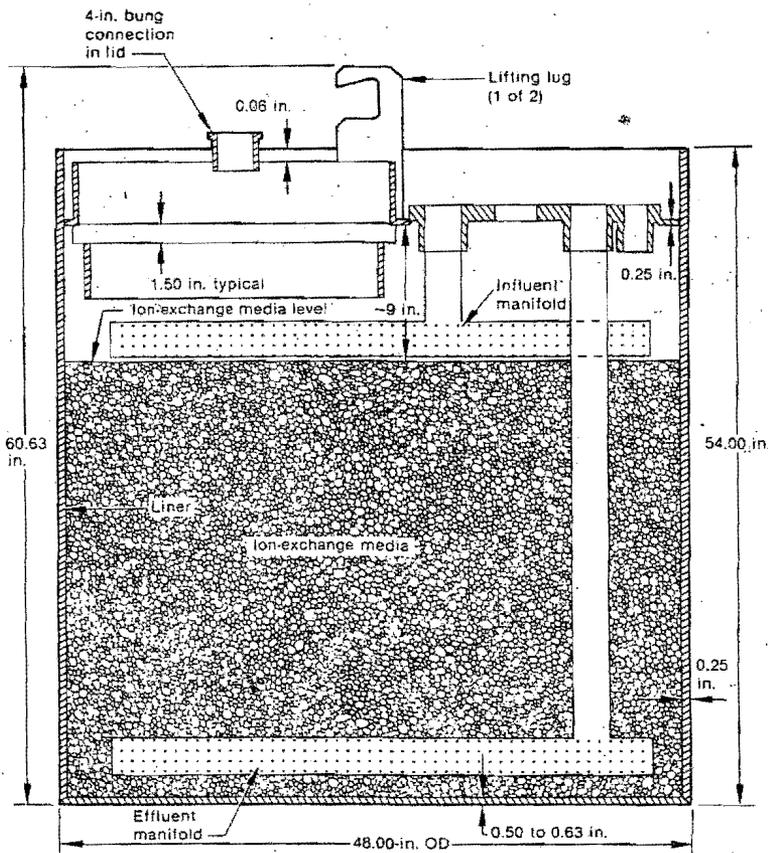
Figure 14 Cutaway sketch of EPICOR II prefilter liner.

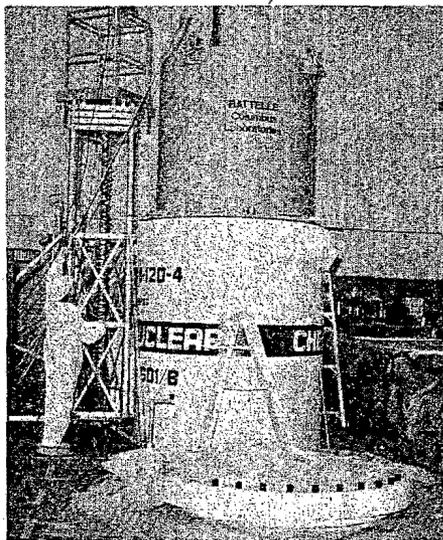
Figure 15 BCL transfer and storage device atop the PF-16 shipping cask.

The PF-16 was shipped to BCL on May 19, 1981 (See article November 30, 1981 *Update*) where characterization tasks were performed. After completing acceptance radiological surveys and cask internal gas sampling, technicians removed the shipping cask lid and hoisted the liner into the heavy element hot cell using a shielded transfer and storage device pictured in *Figure 15*.

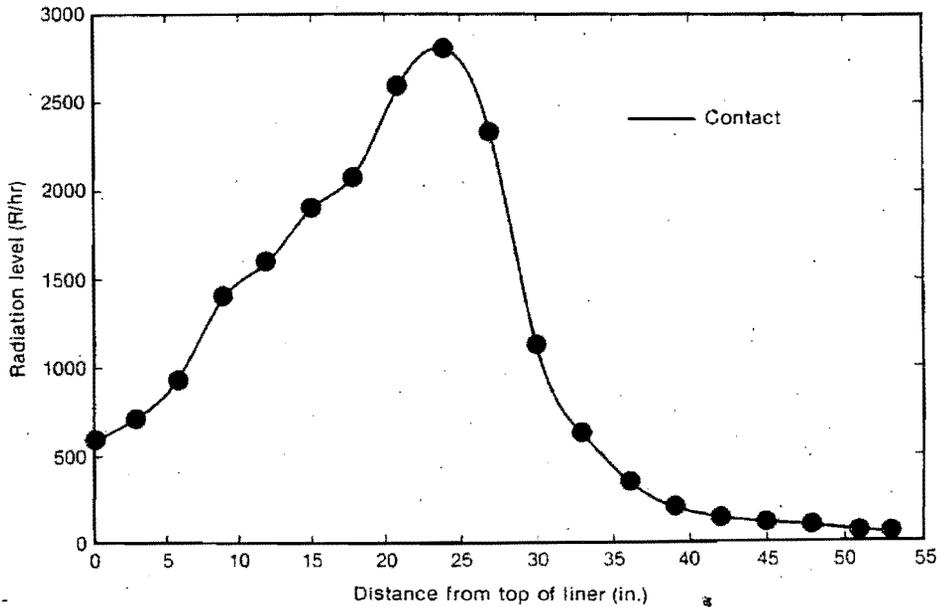
Figure 17 Plot of PF-16 contact gamma radiation readings.

External gamma scans were performed to determine the relative deposition of gamma-emitting radionuclides throughout the liner. Most of the activity was concentrated in the top 3 to 6 in. of the ion-exchange media bed. Technicians performed gamma spectroscopy at the location of the peak activity and, consistent with the radiochemical analysis of the core sample, found that ^{137}Cs and ^{134}Cs contributed most of the gamma activity. The maximum external radiation readings were 2800 R/h on contact, 1000 R/h at a distance of 1 ft, and 410 R/h at 3 ft. Figure 17 shows a plot of the contact external gamma scan.

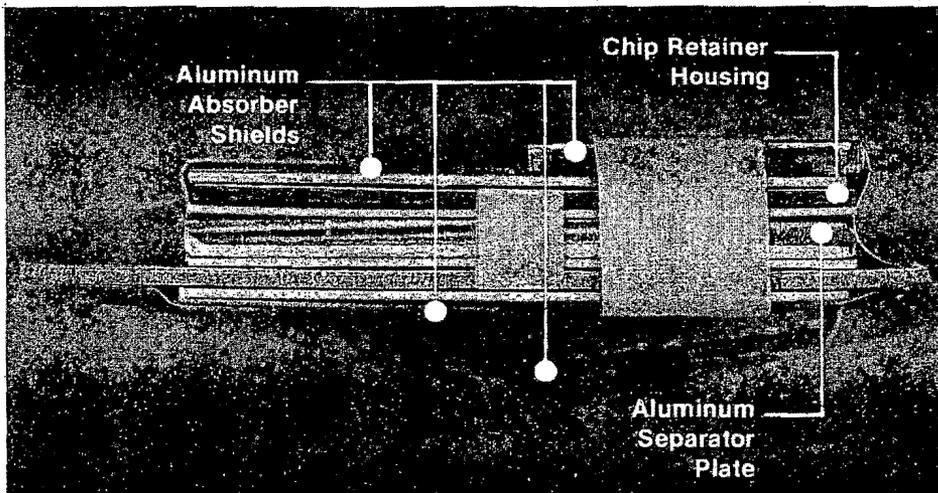
Figure 18 TLD side view.

Each dosimeter contains 24 LiF chips that are oriented so that 12 chips face the front and 12 chips face the back. The front and back sections are separated by a 0.125-in.-thick aluminum separator plate (see Figure 18). The chips are clustered in groups of three under four different thickness absorber shields (see Figures 19 and 20) encased with two wraps of 0.005-in. aluminized Mylar and a 0.005-in. anticontamination plastic bag. The laminated construction of the shields allows the use of varying thicknesses of shielding over each cluster of chips. There are three aluminum absorber shields and one thin aluminized Mylar film shield. The thickest aluminum shield is 0.125-in. thick and prevents all beta radiation from penetrating to the TLD chips. The other two aluminum shields are 0.020- and 0.032-in. thick and allow only those beta particles with sufficiently high energy levels to penetrate the aluminum to reach the TLD chips. The aluminized Mylar shield is thin enough to allow virtually all except very low energy beta particles to penetrate to the TLD chips. This design provides the capability for determining the relative beta energy distribution as well as providing an accurate measurement of the gross gamma field.

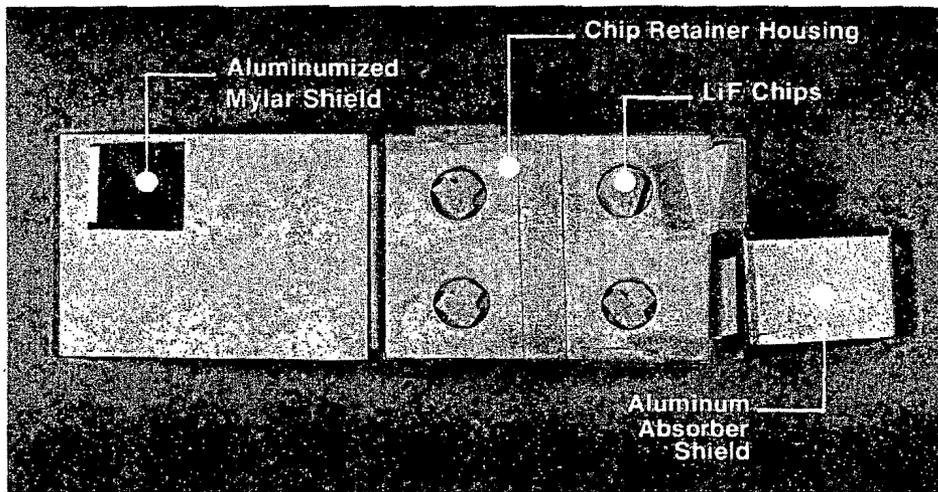
Figure 19 TLD center section

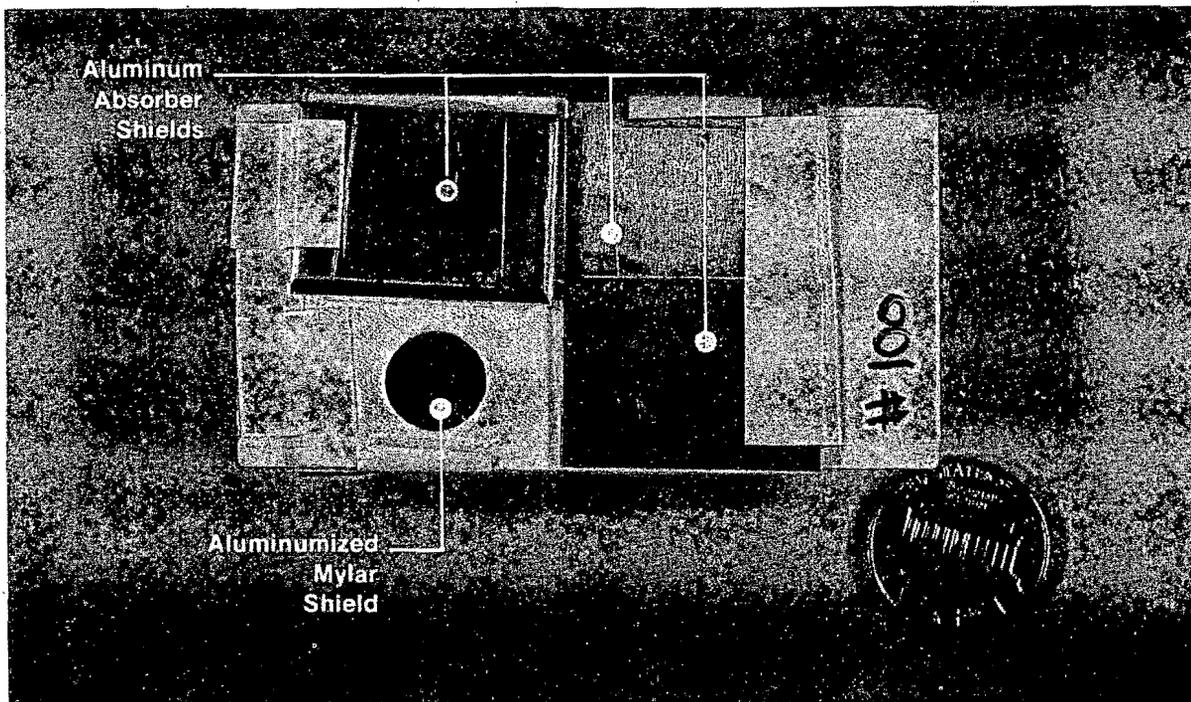
Figure 20 TLD top view.

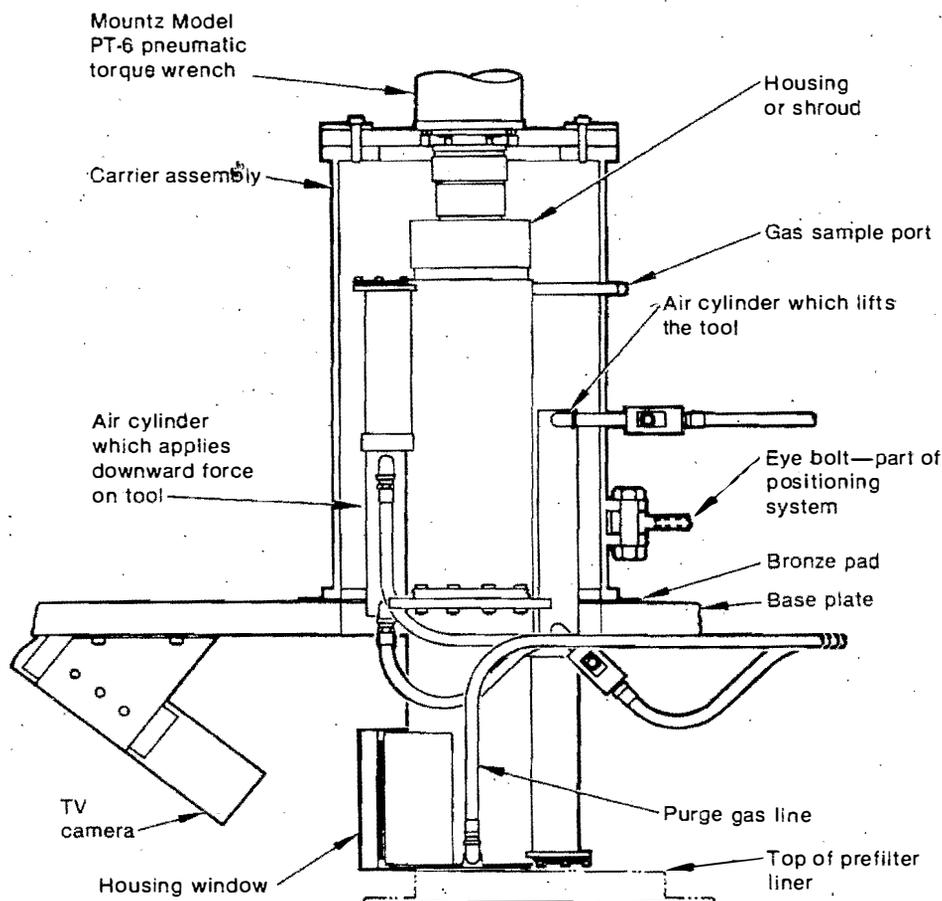
Figure 22 Cross-sectional view of the prototype gas sampler.

Major components of the PGS system include a portable, 18-in.-thick concrete shielding structure (blockhouse) and a remote support facility that is the command center for all operations. The sampler, a pneumatically operated device, consists of a platform, sample housing, position and rotation drive assemblies, and a closed-circuit television monitoring system. To reduce the possibility of combustion, PGS surfaces that have relative motion are made of nonsparking material and the sampler is electrically grounded to the liner. A lifting fixture attaches the sampler to the hoist system of the blockhouse. A 100-ft umbilical cable carrying television camera signals, power, lighting, compressed air, and gas handling lines connects the PGS to the command center.

Using a mirror-window arrangement in the blockhouse, initial alignment of the PGS over the liner vent port is accomplished using the liner lifting lugs as indexing guides. The position of the vent plug relative to the lifting lugs varies from liner to liner, therefore precise positioning of the sampler drive shaft over the vent plug is made using air-driven threaded adjustments on the sampler. An adjustment range of ± 1 in. in all directions from the nominal position is provided at a rate of approximately 1 in. per minute. PGS operators monitor final alignment of the tool tip to the vent plug with the closed-circuit television system mounted on the PGS.

The ball bearing spline allows the drive shaft to move vertically during unthreading and threading. In addition, two air cylinders mounted on the housing allow the tool tip to be raised to lift the plug clear of the port after unthreading or lowered to reinsert the plug.

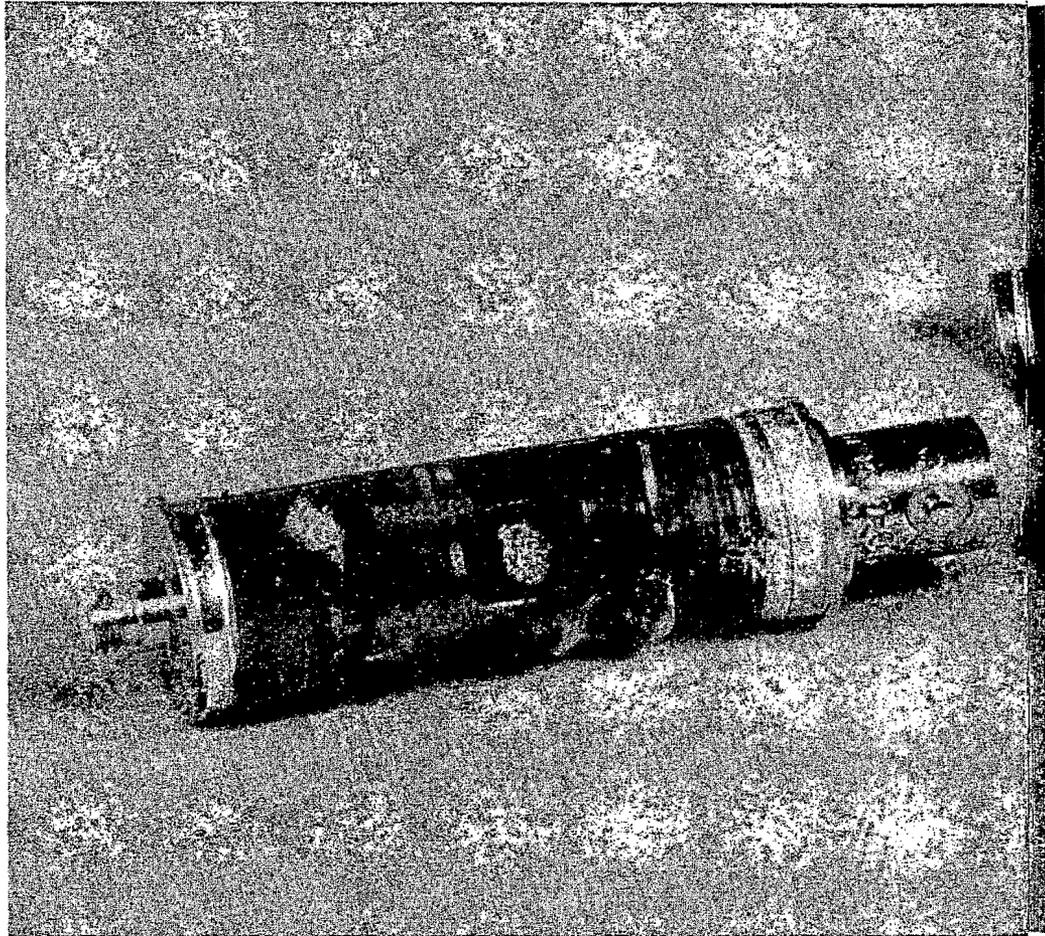
Figure 24 Failed charge converter after disassembly.

Degradation of the Endevco charge converters has also been observed at Tennessee Valley Authority's Sequoyah 1 plant where they were mounted within 10 ft of the transducers, thus putting them in high radiation areas near the reactor vessel and steam generators. The MOS transistors were damaged after less than 1 year of reactor operation. The charge converters used at TMI-2 and Sequoyah 1 were Endevco models 2652M4 and 2652M3, respectively. *Figure 24* is a photograph of a failed TMI-2 charge converter with the covering sleeve cut away for removal and testing of suspect components.

Radiation damage to the MOS transistor did not cause a sudden failure, but rather caused its gradual deterioration. Bias adjustments could appear to correct for deterioration of the transistor, meaning that the system might not have responded correctly to a loose part noise after adjustment.
