# UPDATE

Volume 5, Number 1

November 1984

## TMI-2 Head Safely Lifted

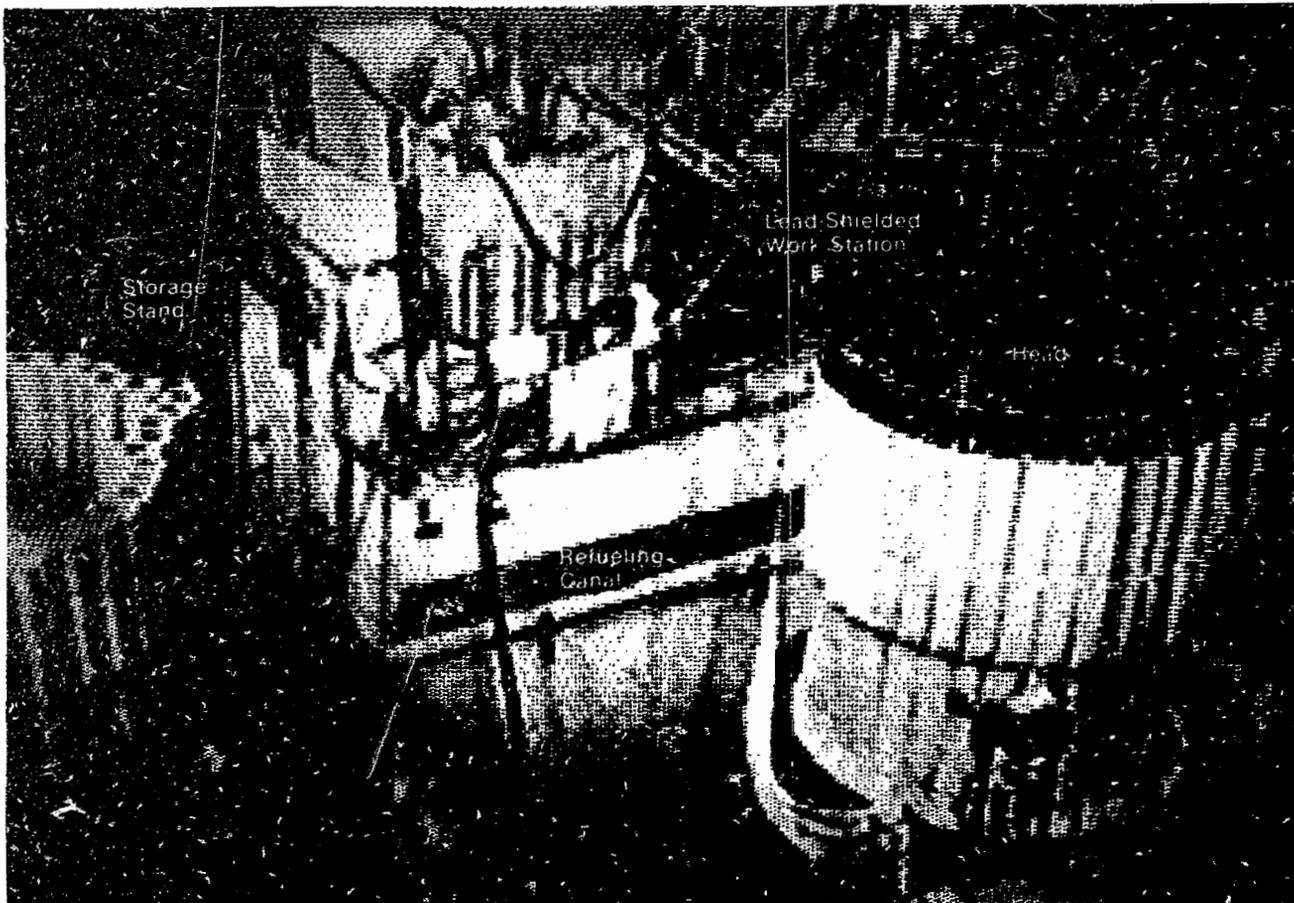
Figure 1. Section view of reactor vessel head removal.

The head was lifted on the evening of July 24 and was seated on its storage stand shortly after midnight the next day. The head, including the service structure, lead blanketed shielding, and lift rigging, weighs approximately 159 tons. The head consists of two major components: the domed cap of the reactor vessel and the head service structure (see Figure 1).

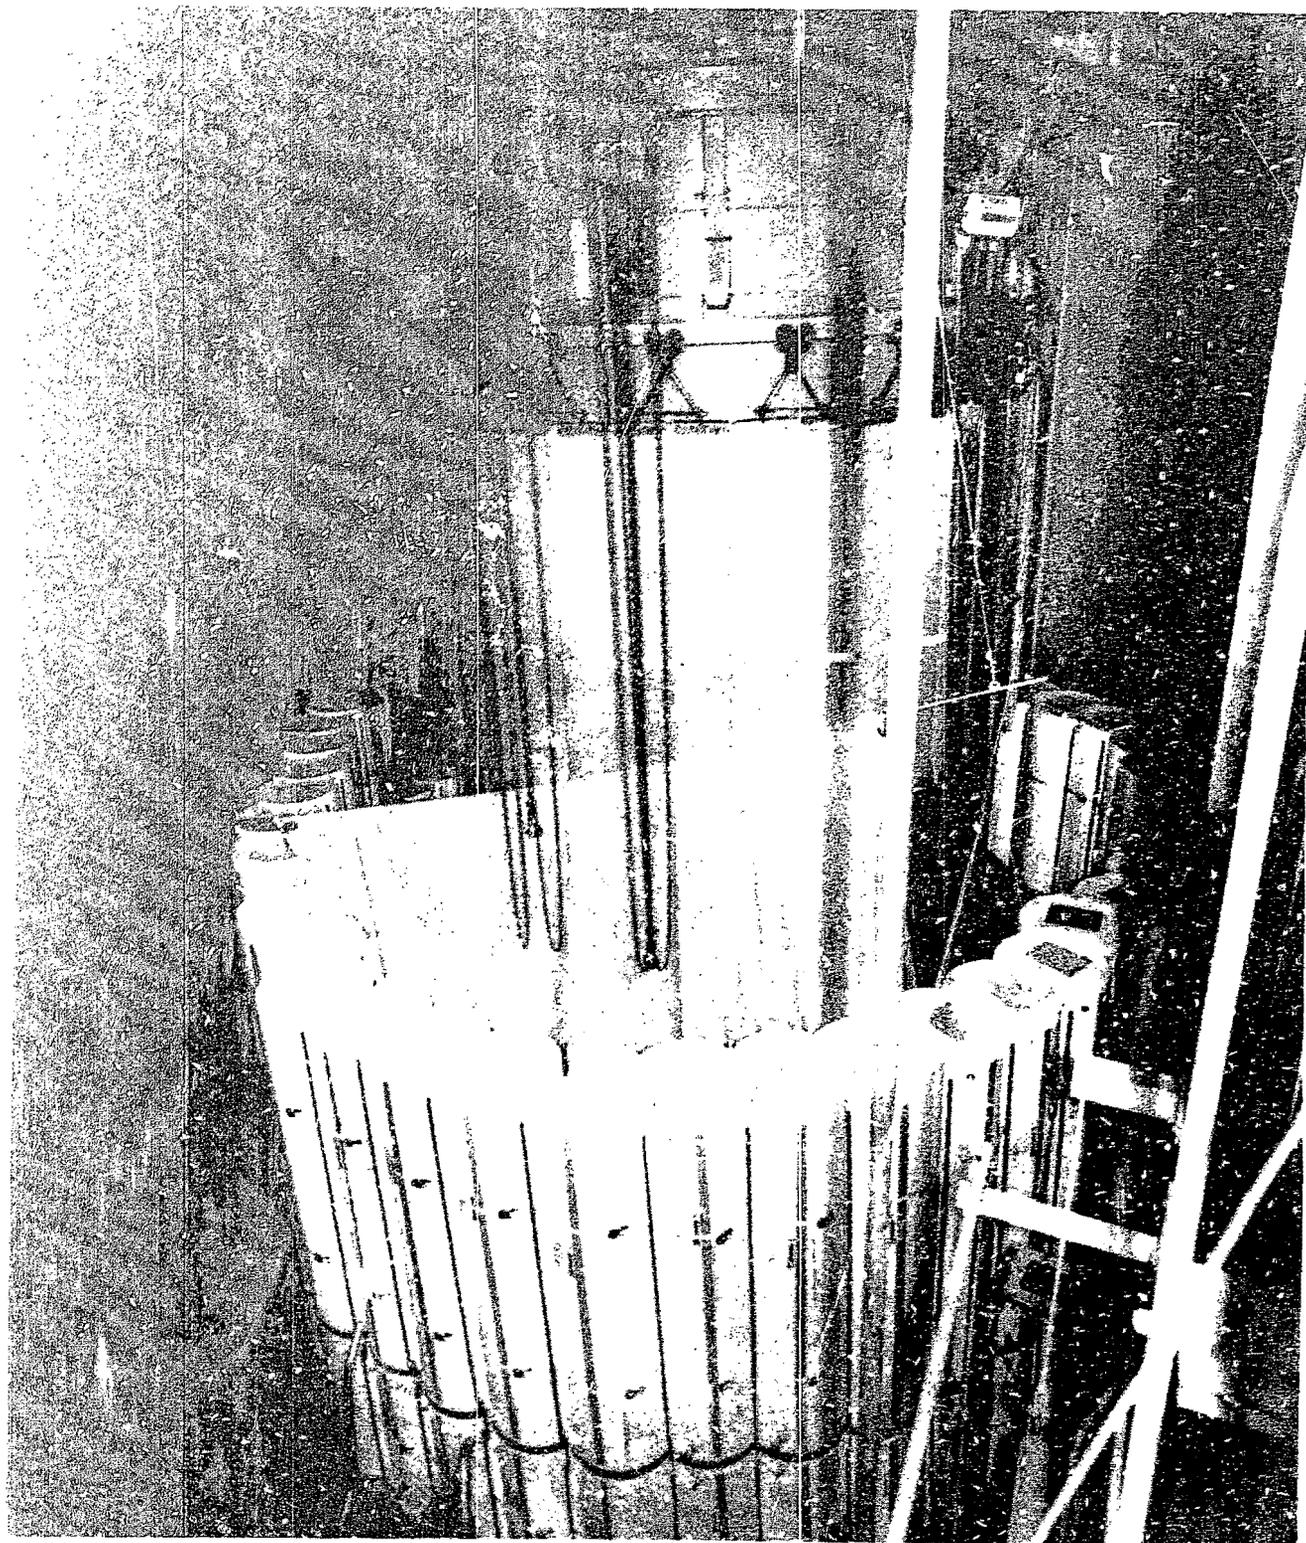
**Figure 2.** Photo taken from television monitor of the head traveling toward the head storage stand.

Attached to the polar crane with three cables and lifting tripod, and covered with 13 tons of lead blankets, the head was first lifted a fraction of an inch so that workers could ensure that the head was level. With the head then raised 3 feet above the reactor vessel, workers wrapped a plastic "diaper" underneath to prevent contaminants there from being spread during travel. Moving at a rate of 1 to 2 feet per minute, the head was raised 38 feet and then moved south and east towards its storage stand (see Figure 2).

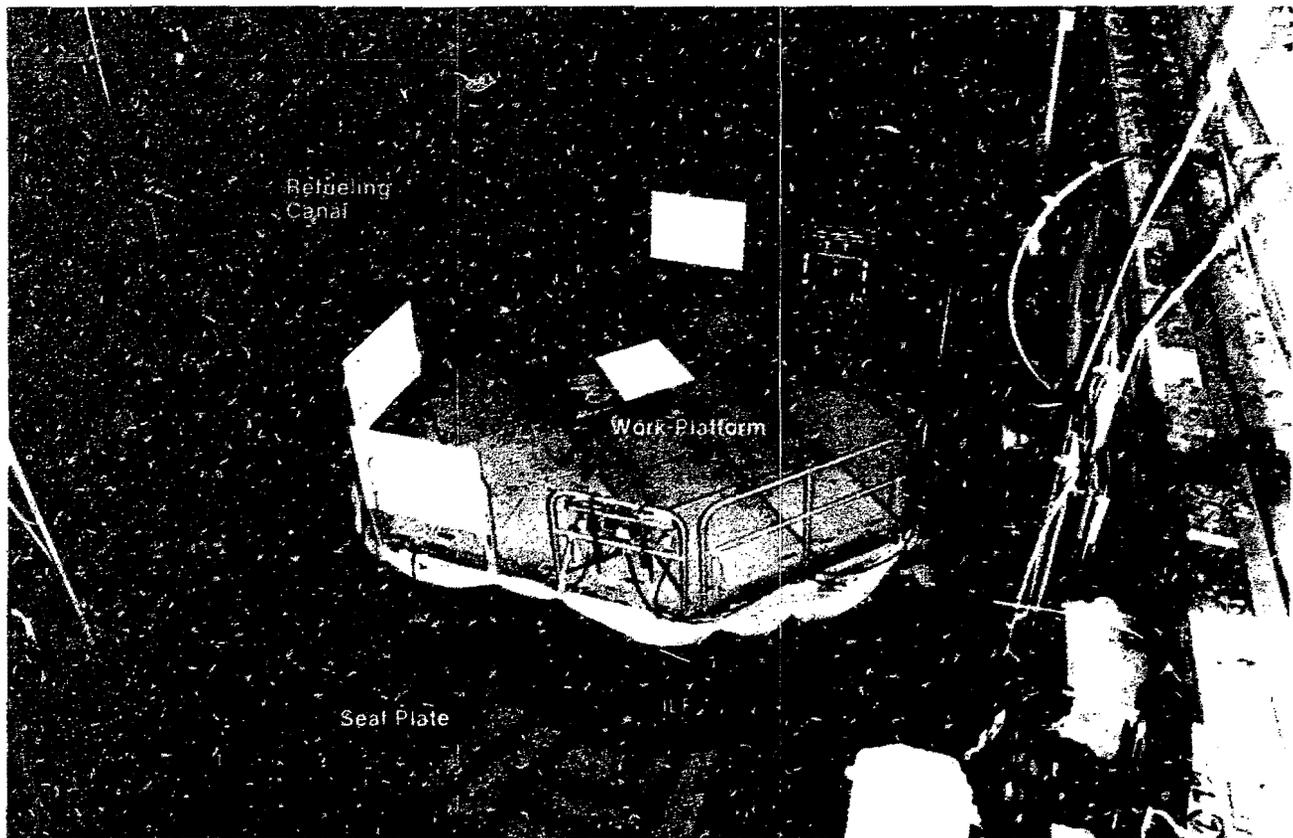
**Figure 3.** Reactor vessel head seated on storage stand.

The final lowering of the head was delayed while the guide holes in the head were aligned with the guide pins on the storage stand. Surrounding the head storage stand are 12-foot-high columns filled with sand that act as radiation shields. The columns were originally filled with water but were drained and refilled with sand because of leakage. Figure 3 shows the head seated on the storage stand.

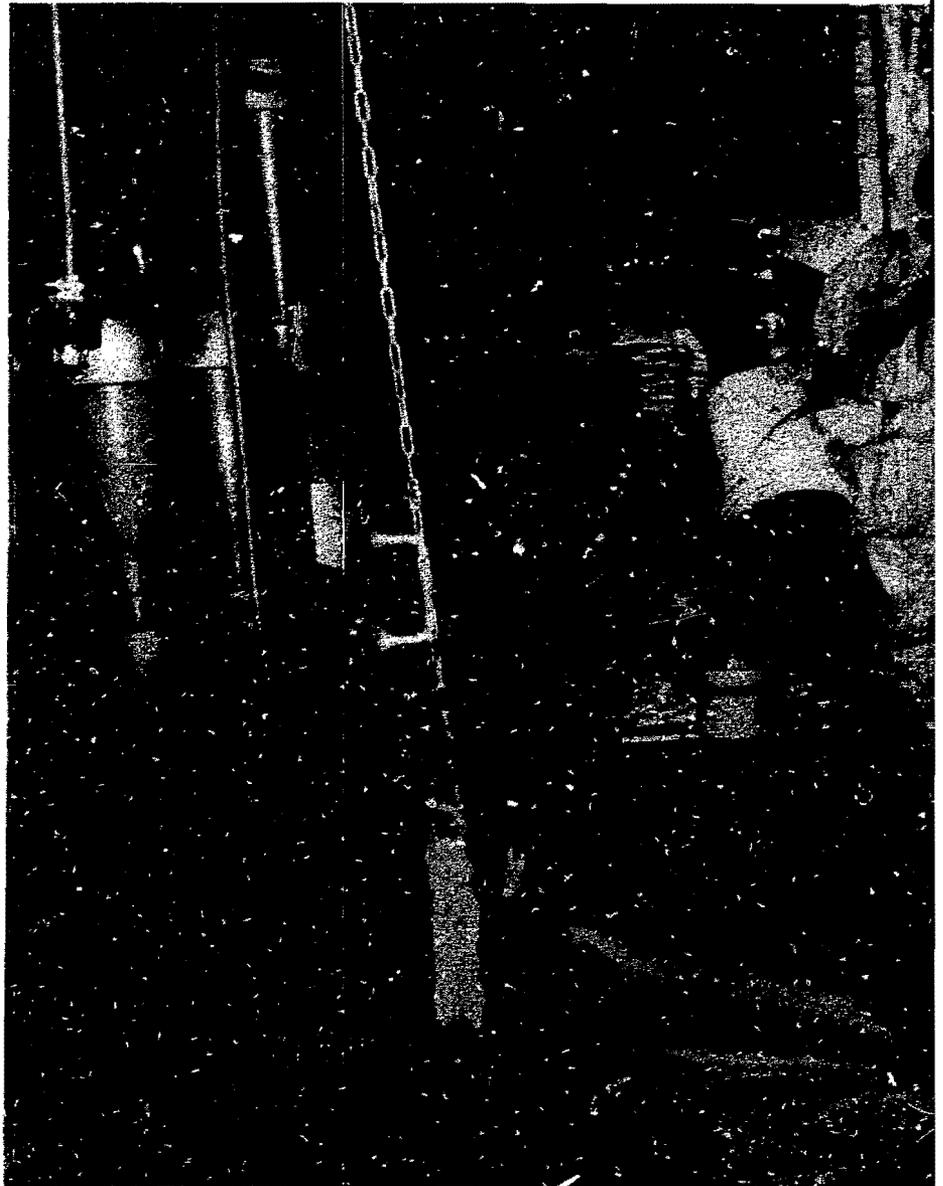
*Figure 5. This closeup shows some of the 60 studs that fastened the TMI-2 reactor head to the reactor vessel. The nut on the lower portion of each stud maintains tension on that stud.*

Major preparations were conducted in the five months preceding the actual lift. The 60 studs that fastened the head to the reactor vessel were partially detensioned to identify the studs that might have been stuck as a result of corrosion. Studs are detensioned by first stretching the studs and then loosening the nuts on them (see Figure 5). As expected, workers encountered some difficulty turning the stud nuts but succeeded using penetrating oil and a striking bar and hammer. Two of the studs were removed at that time, leaving holes in the head flange that later were lined up with the two guide pins on the storage stand on which the head was seated. In a later entry, the workers fully

detensioned and removed the other 58 stud and nut assemblies, each weighing 670 lb, and placed them in storage racks. Finally, the stud holes were filled with a preservative and sealed, preventing them from corroding.

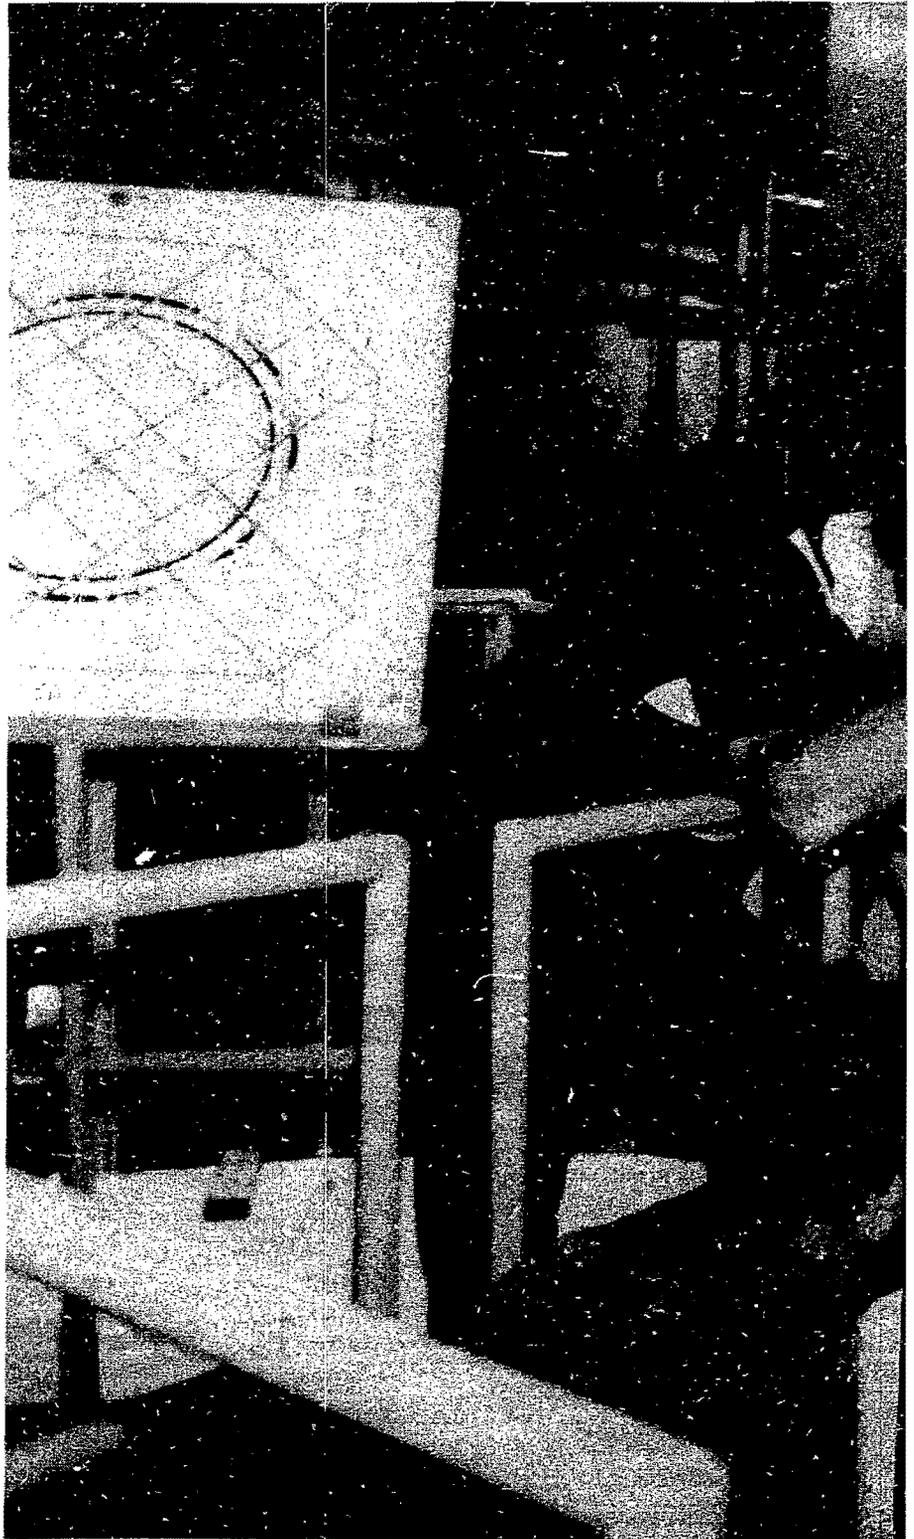
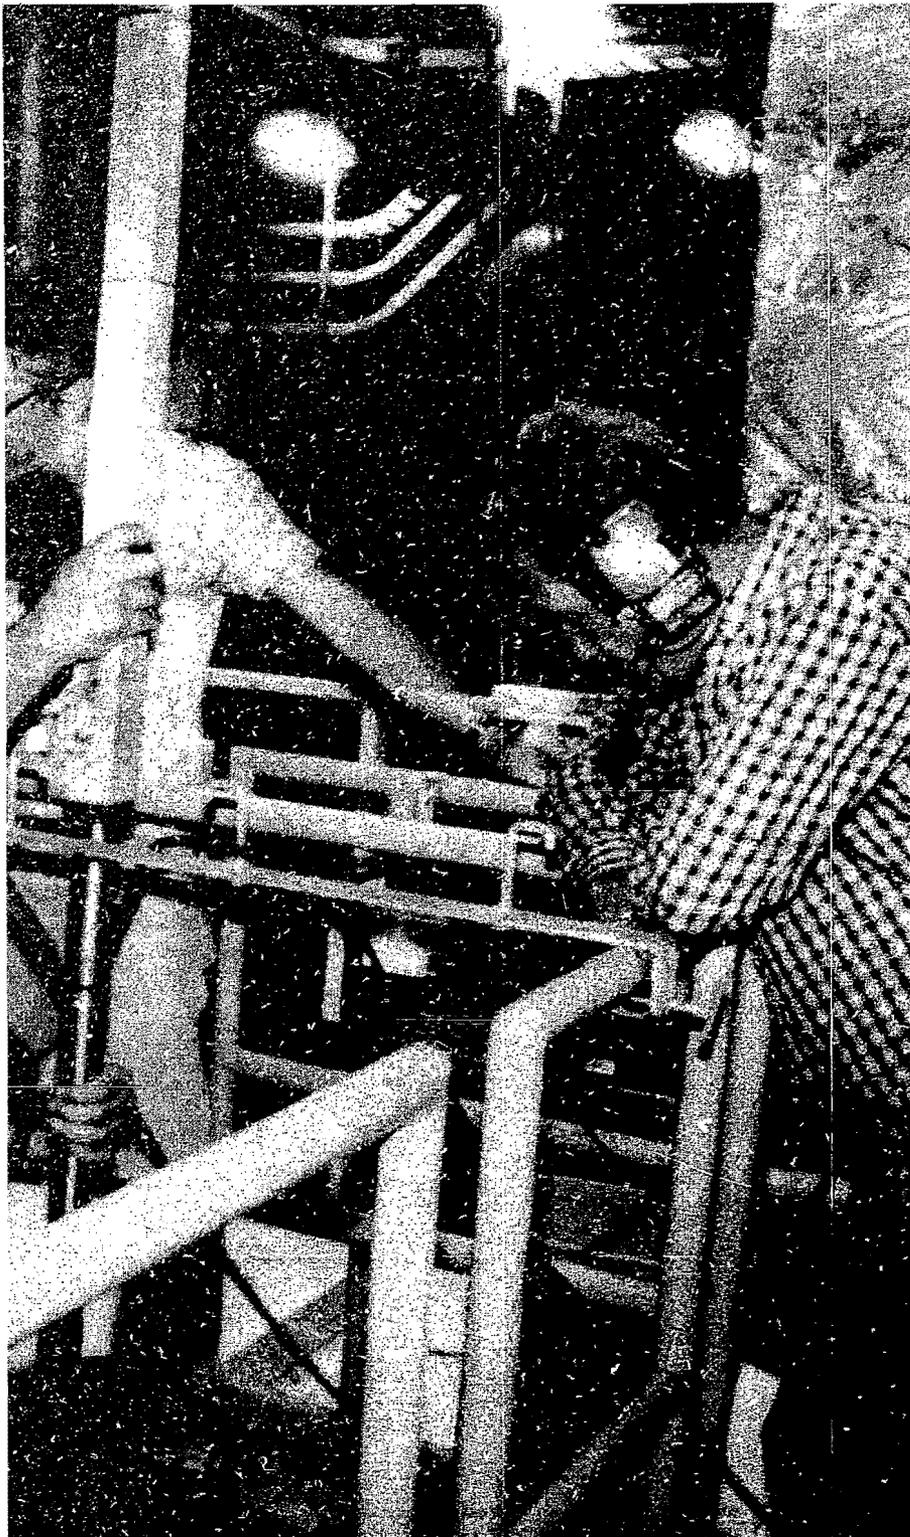
**Figure 7. Workers lower new plenum inspection equipment into a large model of the TMI-2 reactor as they receive training in the plant's Turbine Building. The grid on the map of the plenum (left) provides guidance.**

As a preparation, technicians are visually inspecting the plenum, using specially designed underwater cameras, recorders, lighting, and long-handled camera-positioning tools, to determine the amount of debris on the underside and peripheral surfaces of the plenum, as well as on top of the fuel assembly end fittings (see Figure 7). If a great amount of debris is found and considered to be a possible hindrance to the plenum lifting operation, the technicians may remove it by water lancing or vacuuming.

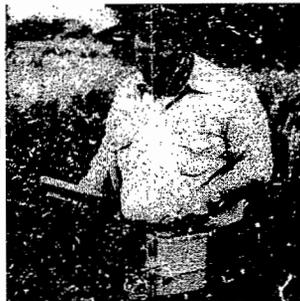
**Community Monitoring Program**

The first major step toward defueling the damaged reactor occurred in July 1980 when the first manned entry into the Reactor Building occurred. To support this activity, the TI&EP established a Citizens' Radiation Monitoring Program, which proved to be one influential factor in alleviating the fears of local residents regarding adequacy of monitoring during
