GEND-032
Distribution Category: UC-78
TMI Supplement

TMI-2 TECHNICAL INFORMATION AND EXAMINATION PROGRAM 1982 ANNUAL REPORT

Published April 1983

EG&G Idaho, Inc.
Idaho Falls, Idaho 83415

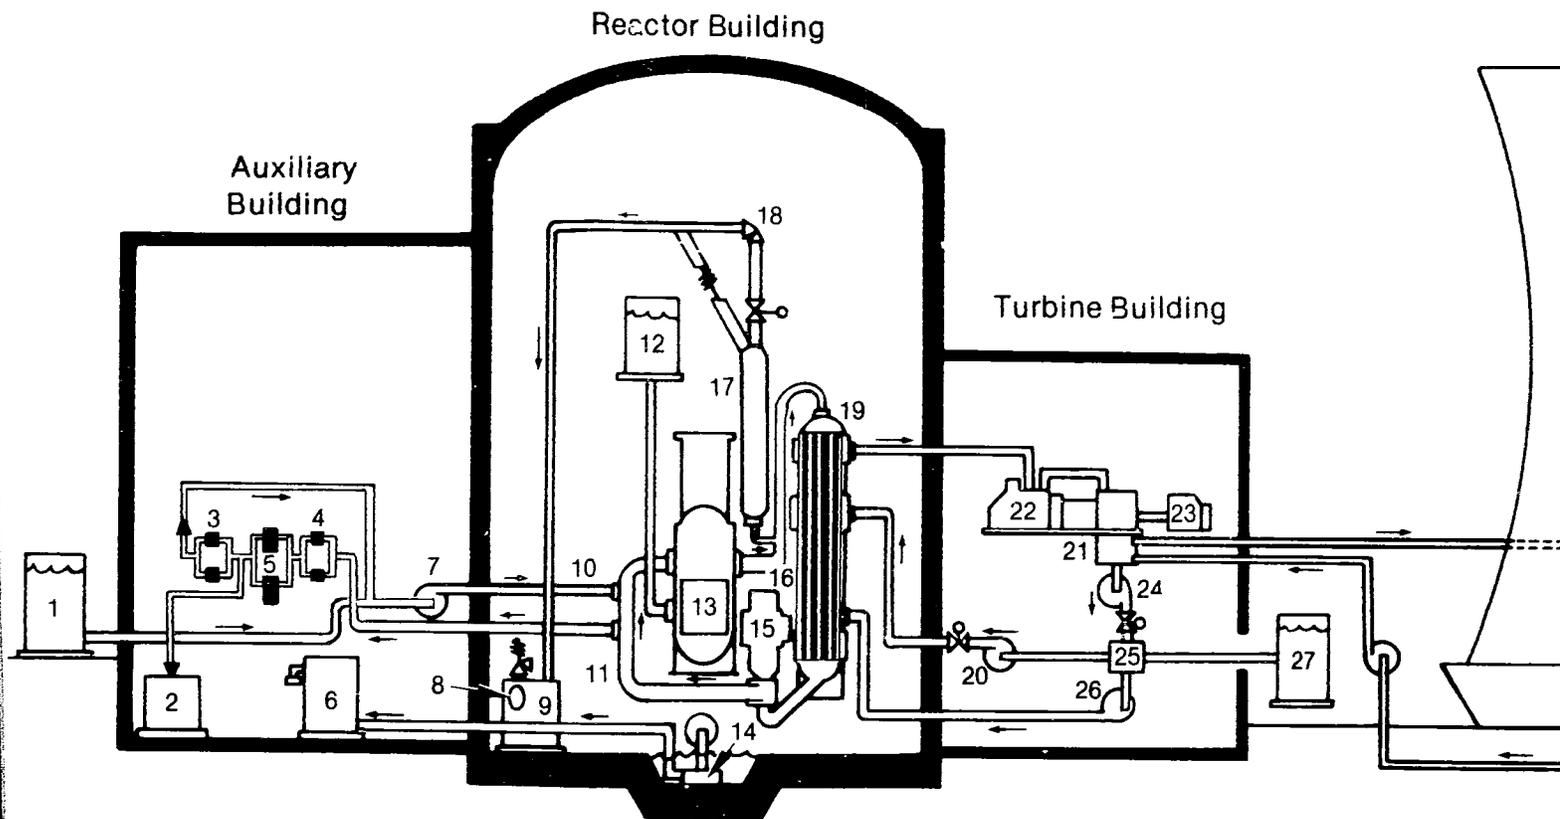
Figure 1. Arrangement of reactor and main components at the TMI-2 nuclear

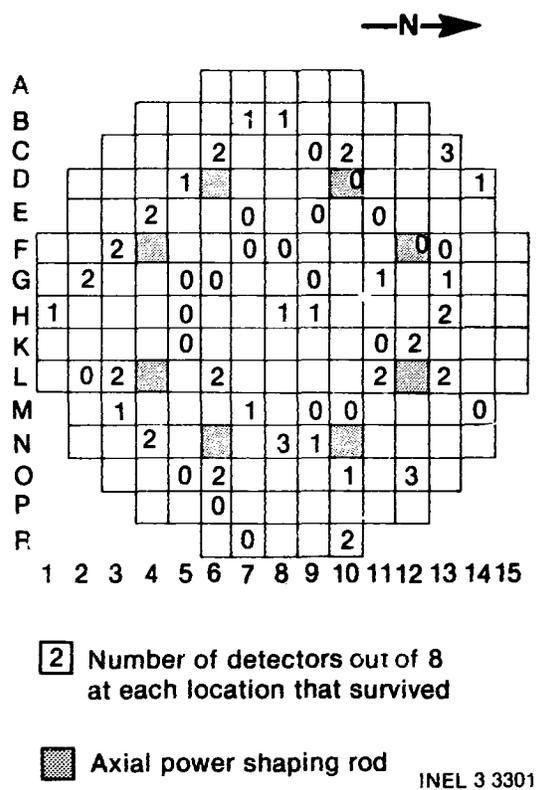
Figure 2. Map of TMI-2 core showing the number of incore instruments which survived at each location.

The evaluation of the in situ test data indicated the incore instrumentation was significantly damaged and that the most severe damage probably occurred in the upper central region of the core although damage also occurred in the lower core region. Figure 2 maps the location of incore instrumentation. The figure shows the number of detectors at each location that survived the accident.

The 364 SPNDs and 52 background detectors were evaluated together as a group of 416. Only 22 of these detectors appeared to be operational and these were located mainly in the lower areas of the core. While 331 detectors still exhibited the open circuit condition they need to operate, test data indicate that moisture had entered the insulation in these 331 so their output could not be considered reliable. Fifty-six detectors had short circuits and were not operational. The remaining seven detectors appeared to have an open circuit, but the insulation resistance was not high enough for the detectors to be considered operational. As a group, the majority of the detectors failed under the core accident or postaccident conditions. Their failure indicates that the lower regions of the core, not yet visually accessible, also sustained damage during the accident.

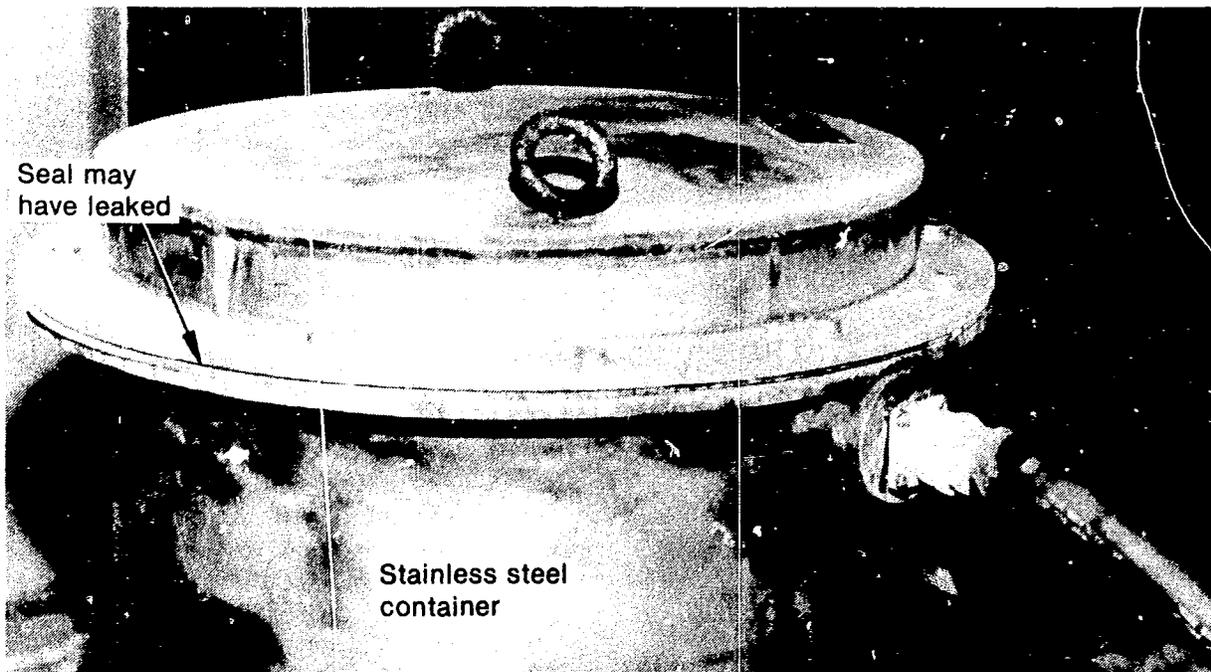
Figure 4. Close-up of hermetically sealed stainless steel canister containing dome monitor HP-R-214 in place in the Reactor Building.

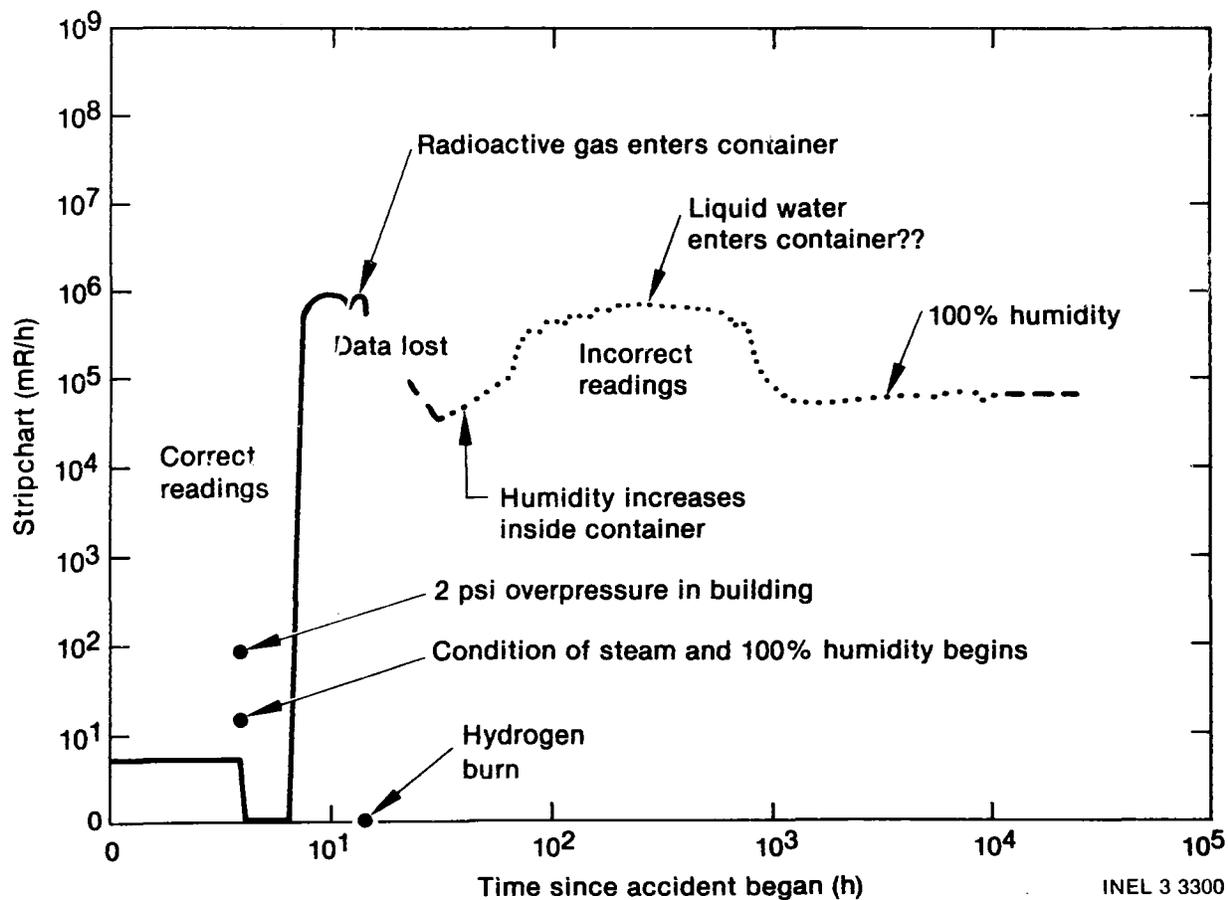
Figure 5. Dome monitor strip chart showing when incorrect readings began and when significant events occurred.

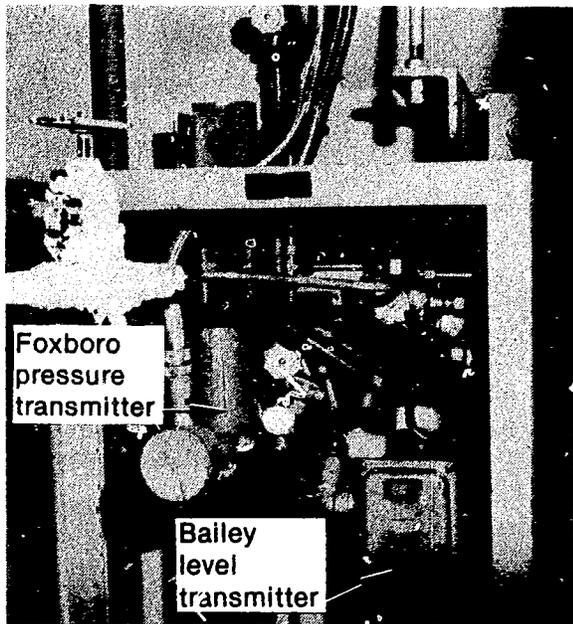
Figure 6. Two pressure transmitters in place in the TMI-2 Core Flood Tank A.

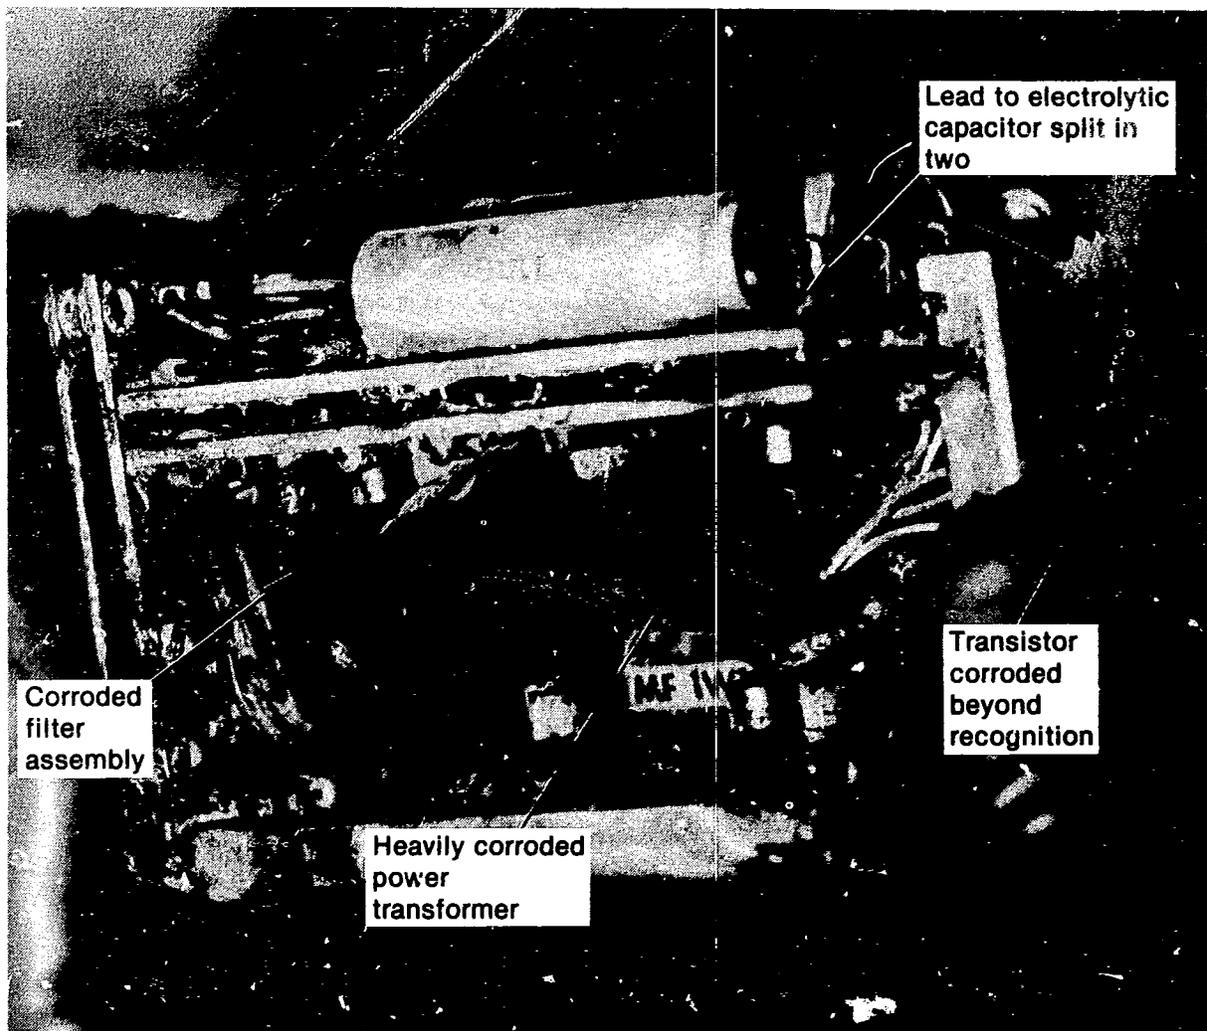
Figure 7. Badly corroded internal components of TMI-2 level transmitter damaged by moisture.

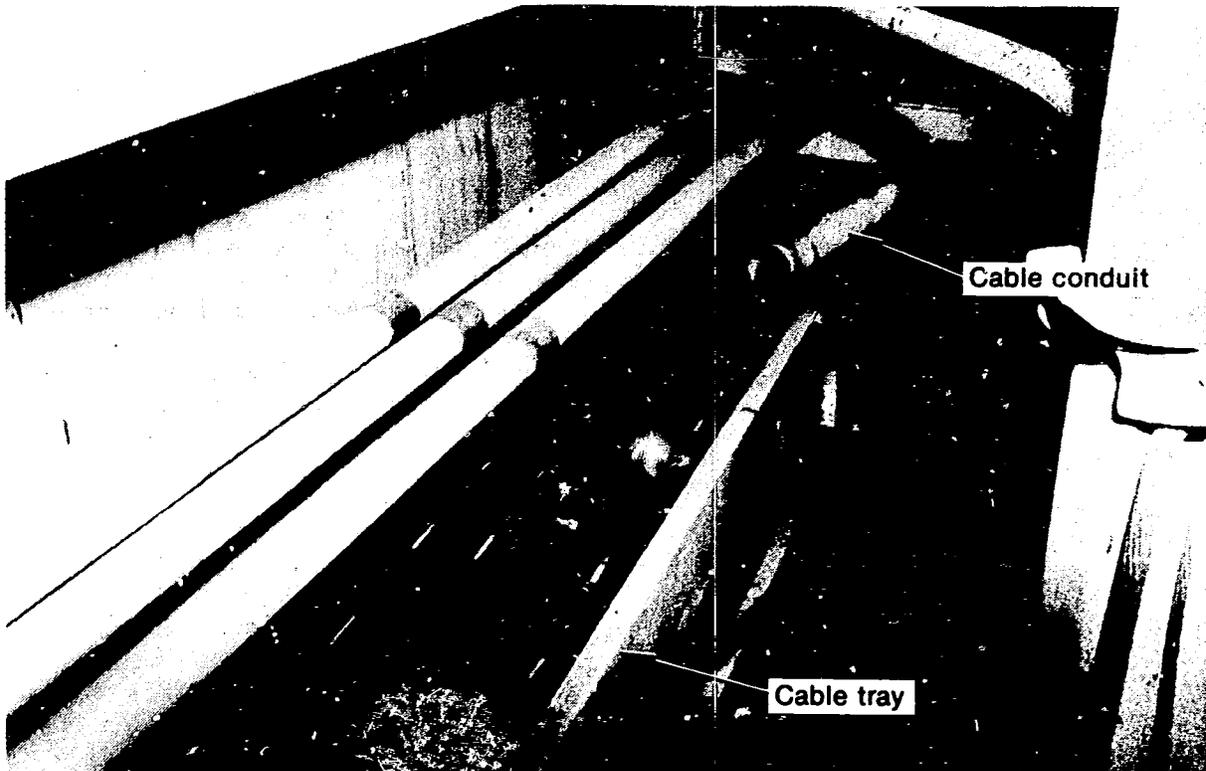
Figure 8. Cable in conduits and cable tray in the Reactor Building.

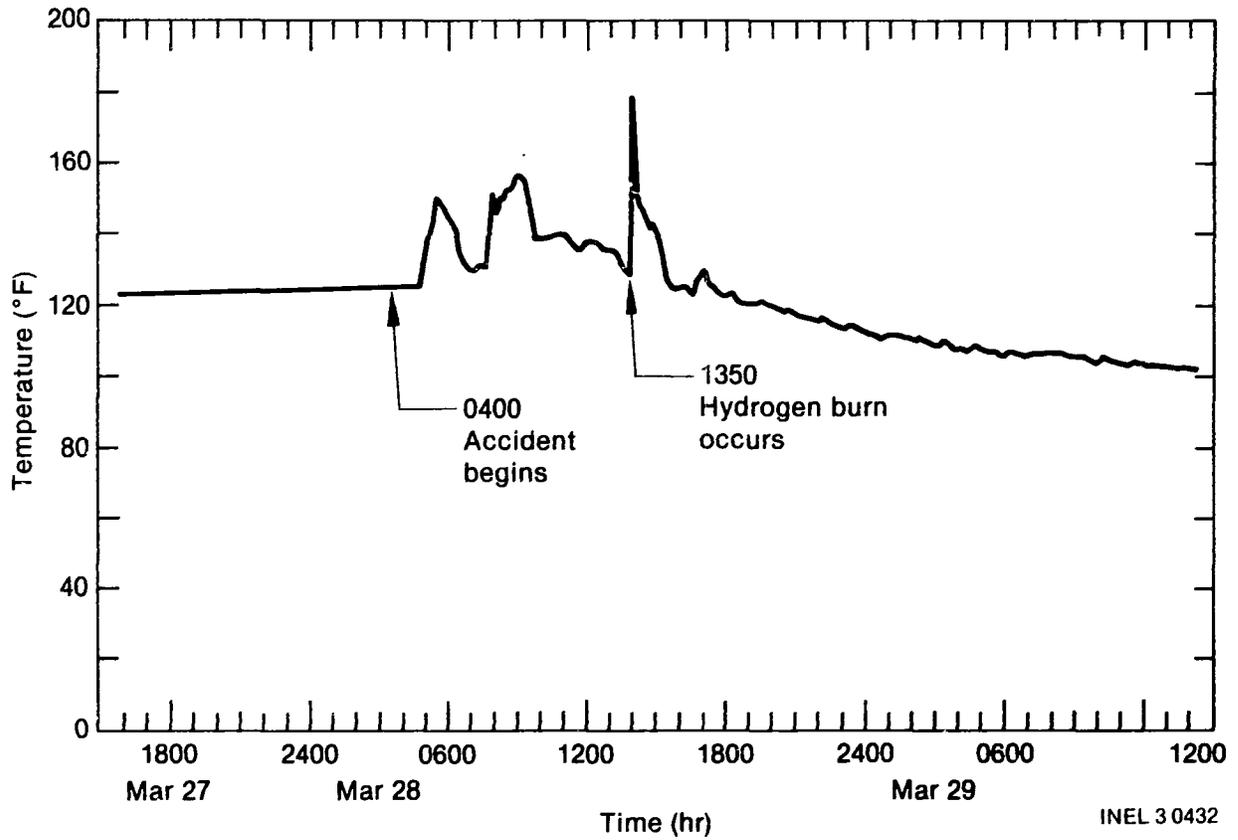
Figure 11. Plot of Resistance Temperature Detector data compiled from investigation of top-ceiling RTD at the 353-ft elevation.

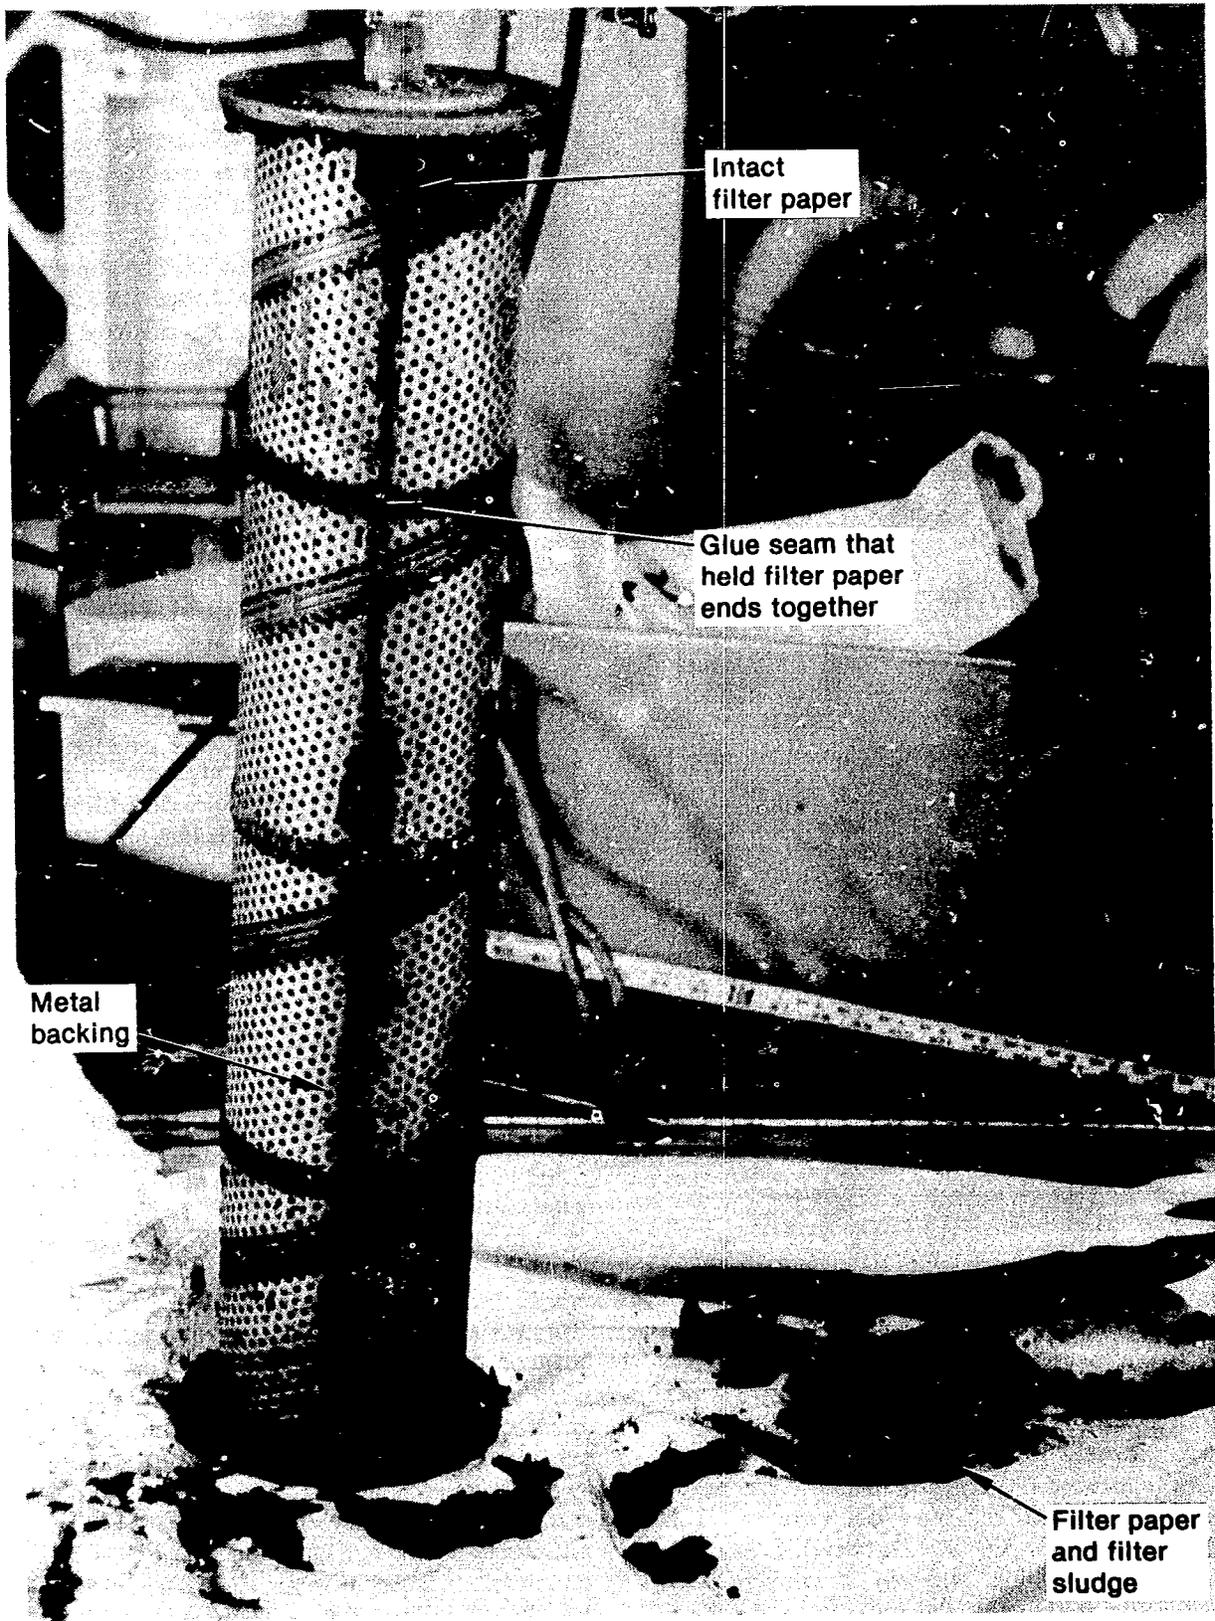
Figure 13. Makeup filter MUF-5B in hot cell for analysis.

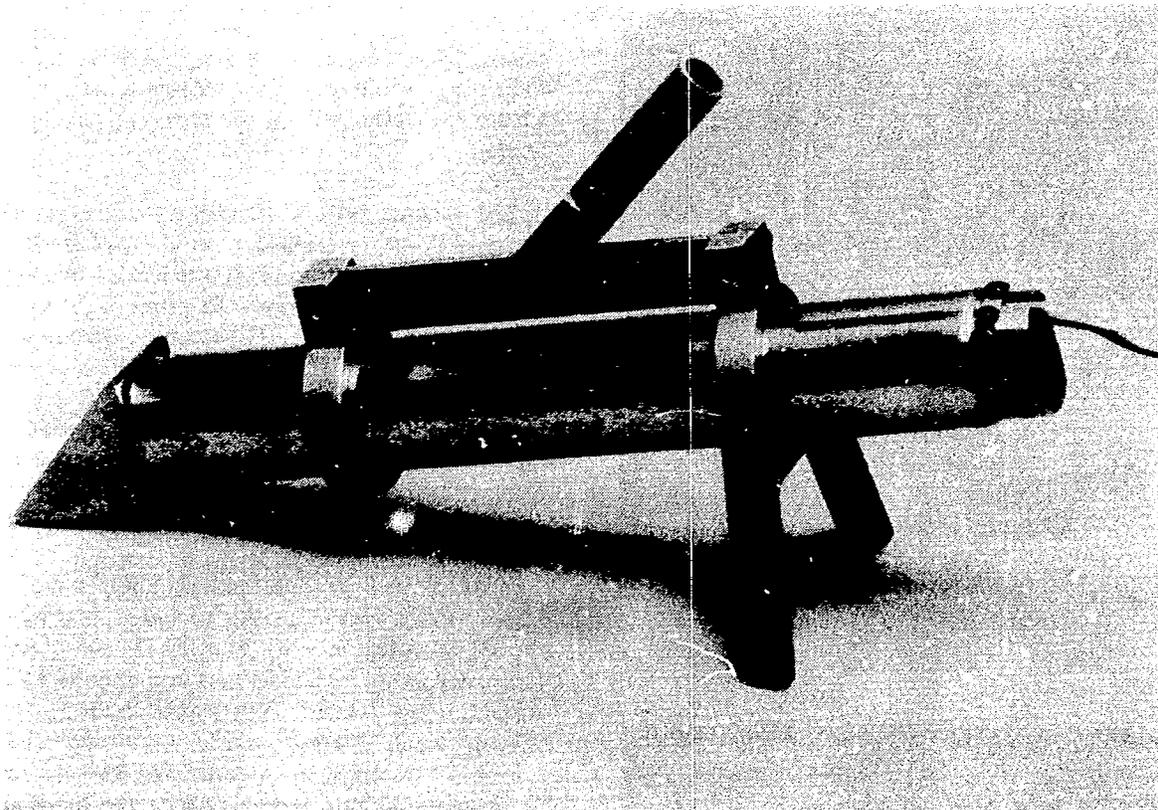
Figure 15. Solenoid-operated sampler used to obtain sludge samples from basement floor.

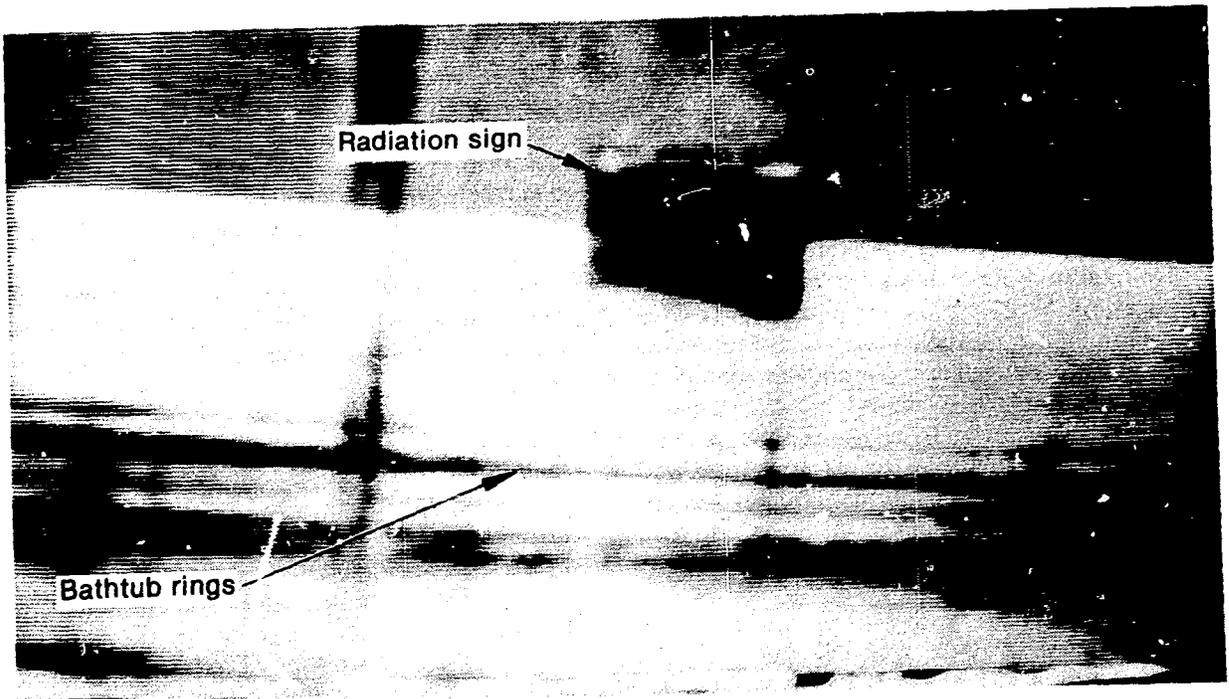
Figure 19. Wall of the Reactor Building basement shows bathtub rings left by changes in water level. Note the deteriorated radiation sign on the wall.

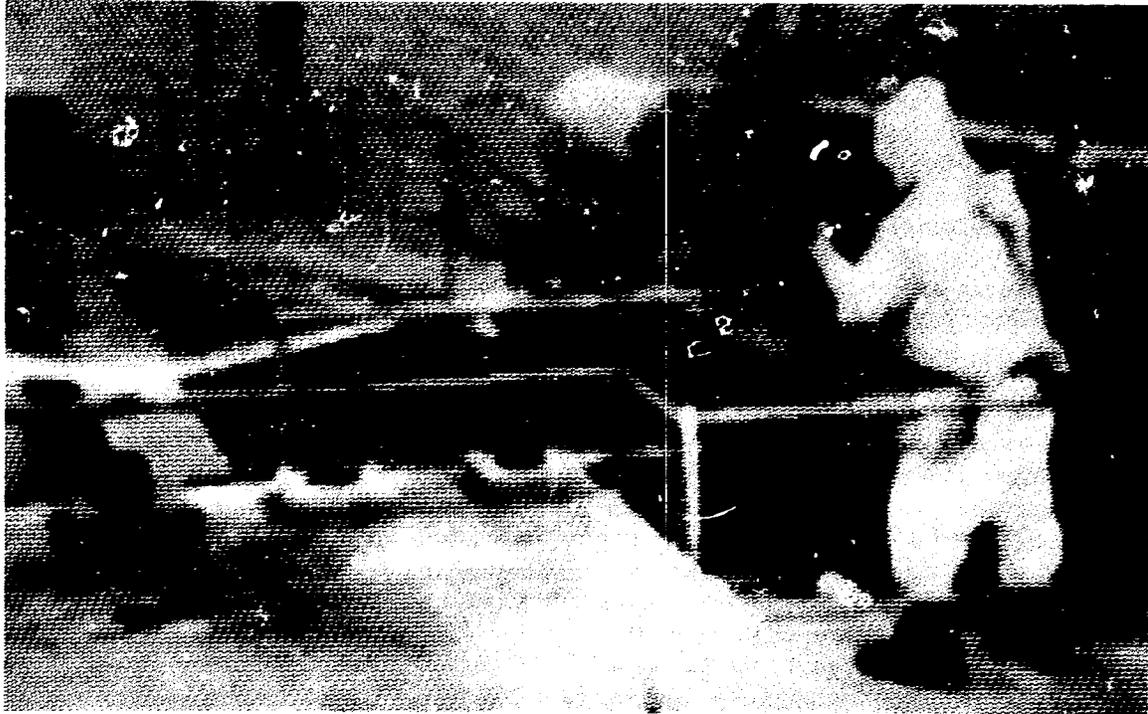
Figure 20. Worker uses hydrolaser to decontaminate surfaces in the Reactor Building during the Gross Decontamination Experiment.

Water sprays, the principal decontamination technique, used accident-generated water previously processed with the EPICOR II ion exchange system. A pressure spray probe called a hydrolaser, shown in Figure 20, was used to apply water sprays to the floor and walls of the Reactor Building. A portable high pressure pump and water heating system located outside the Reactor Building was capable of supplying water heated to 60°C at flow rates up to 25 gpm with pressures up to 10,000 psi.

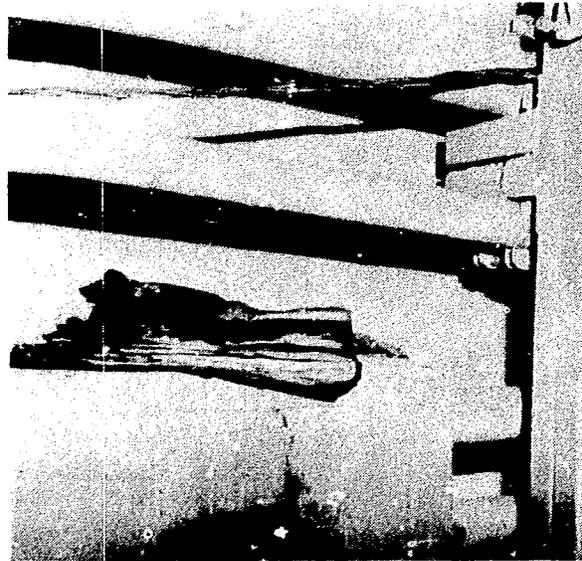
Figure 22. Charred manual lying on top of electrical box.

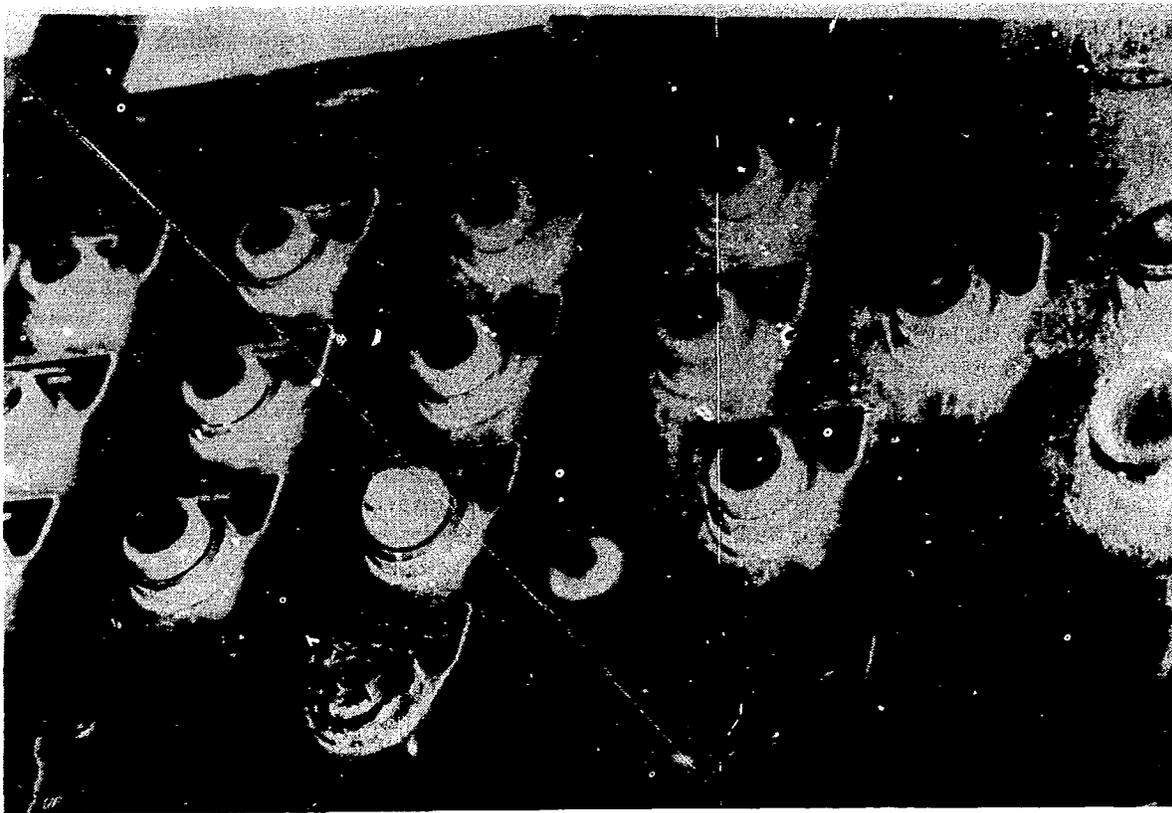
Figure 23. Softened buttons on the auxiliary fuel handling bridge control panels.

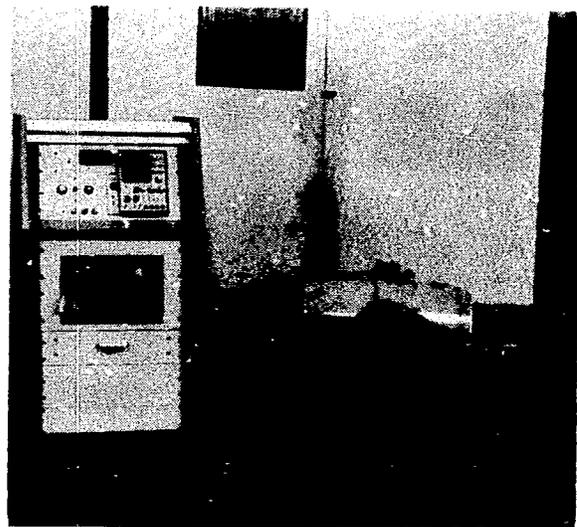
Figure 27. Mobile gamma spectrometer on cart. Control panel on left permits remote operation.

Portable Gamma Spectrometer. EG&G Idaho designed and built a portable cart-mounted germanium-lithium (GeLi) gamma spectrometer, shown in Figure 27, for use at TMI-2. The

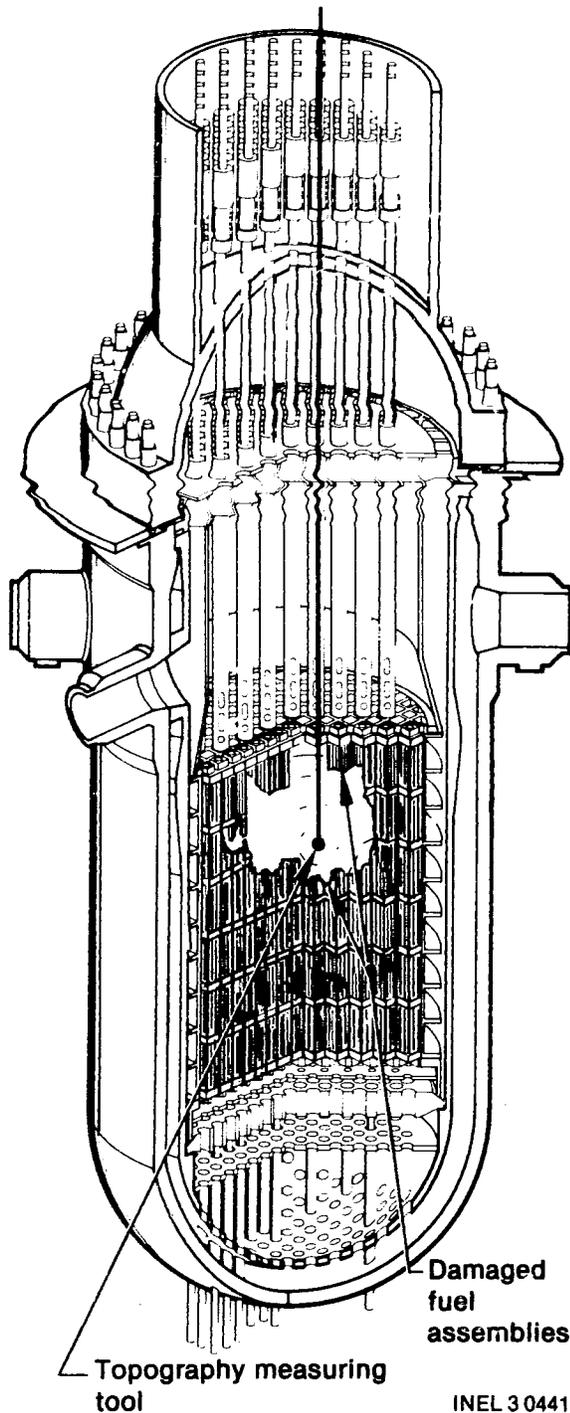
Figure 28. Core topography system measuring tool lowered through a control rod leadscrew opening into the core debris cavity.

damage symmetry. Because the CTS will be remotely operated from outside the Reactor Building, worker radiation exposure will be minimized. The CTS is presently undergoing acceptance testing and is scheduled to be used at TMI in the spring of 1983.

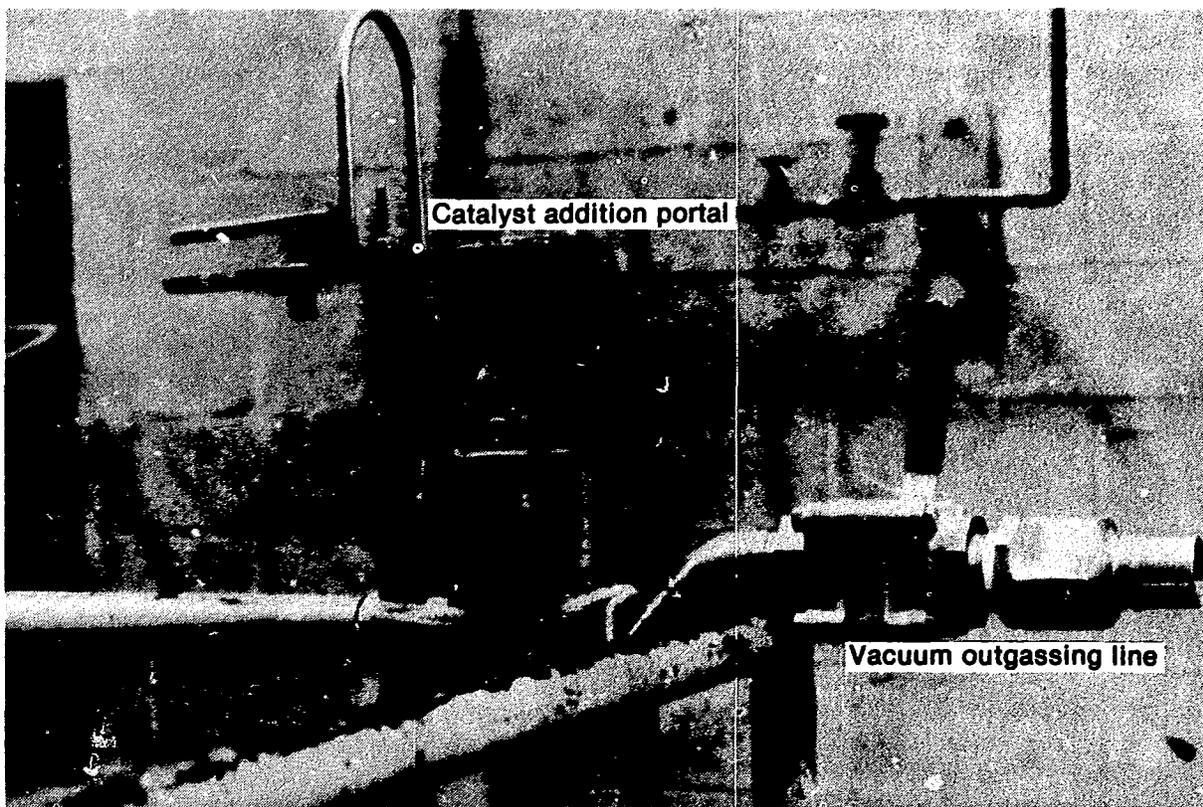
Figure 30. Catalyst addition tool and vacuum outgassing line which are part of the system which controlled radiolytic gas generation in SDS liners.

RHO also developed the tool shown in Figure 30 which allows operators to first vacuum outgas and then add pellets to the liners at TMI. After successful testing at RHO the vacuum outgassing-catalyst recombiner system was installed at TMI. In a demonstration on a nonradioactive liner, vacuum outgassing removed 4.5 kg of water per day from the liner and catalyst pellets were successfully added to the liner.

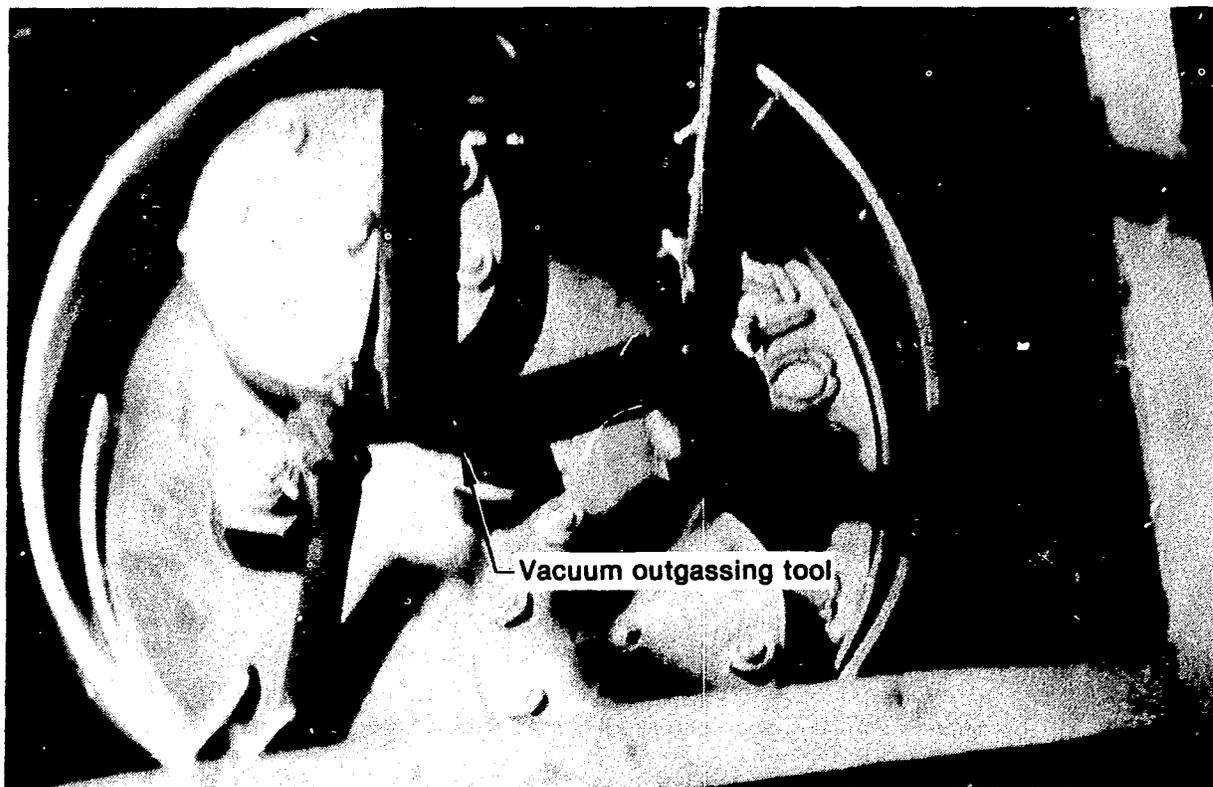
Figure 31. SDS liner D10012 underwater with the vacuum outgassing dewatering tool attached.

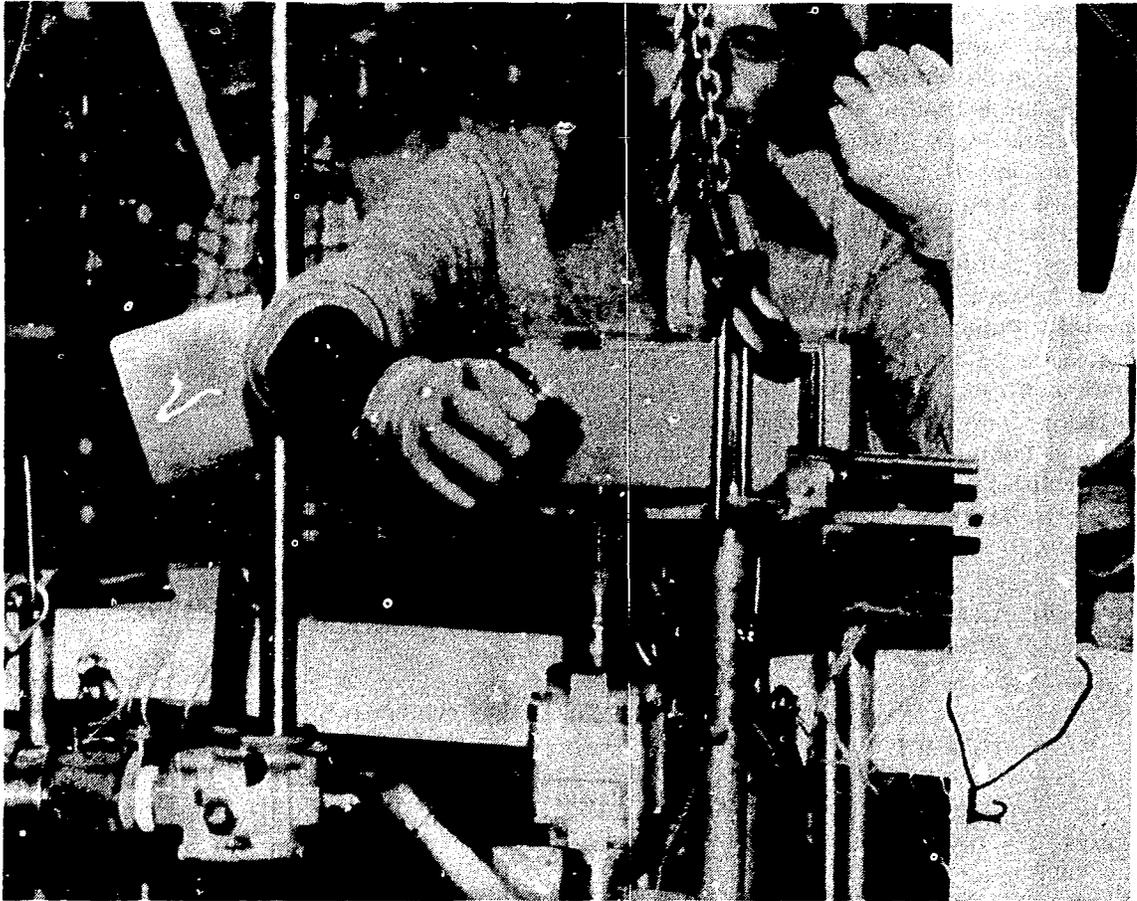
Figure 32. Technician adds catalyst pellets to SDS liner through catalyst addition portal.

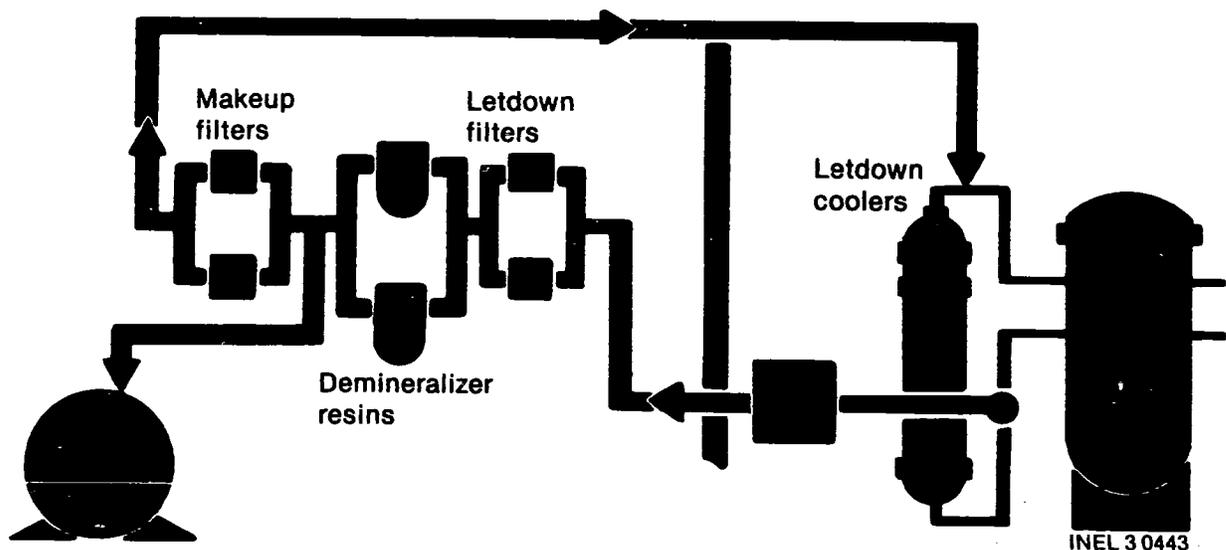
Figure 35. Makeup and Purification System which maintains RCS quality and chemical limits.

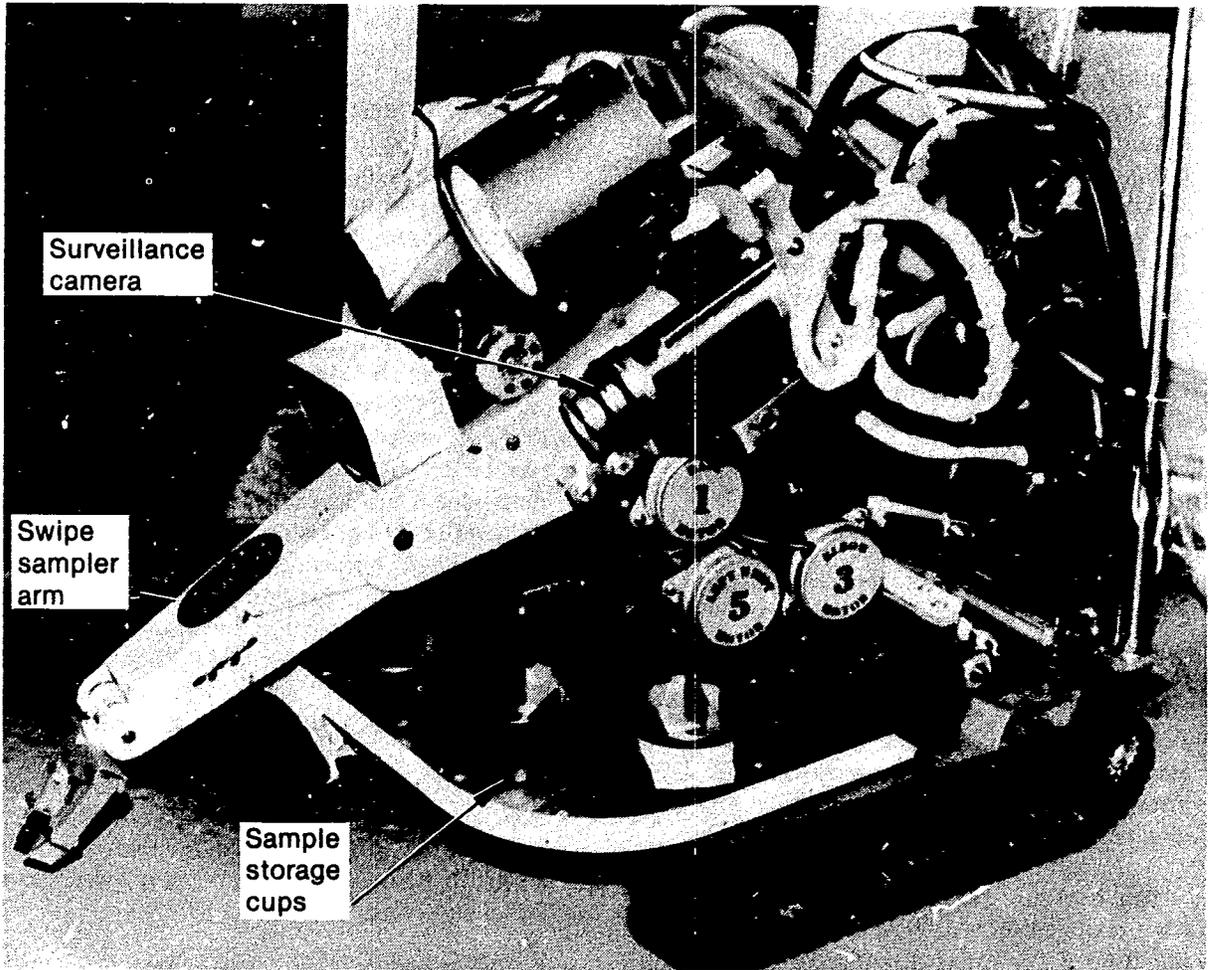
Figure 36. Mechanical transporter used to inspect the demineralizer cubicles and take samples.

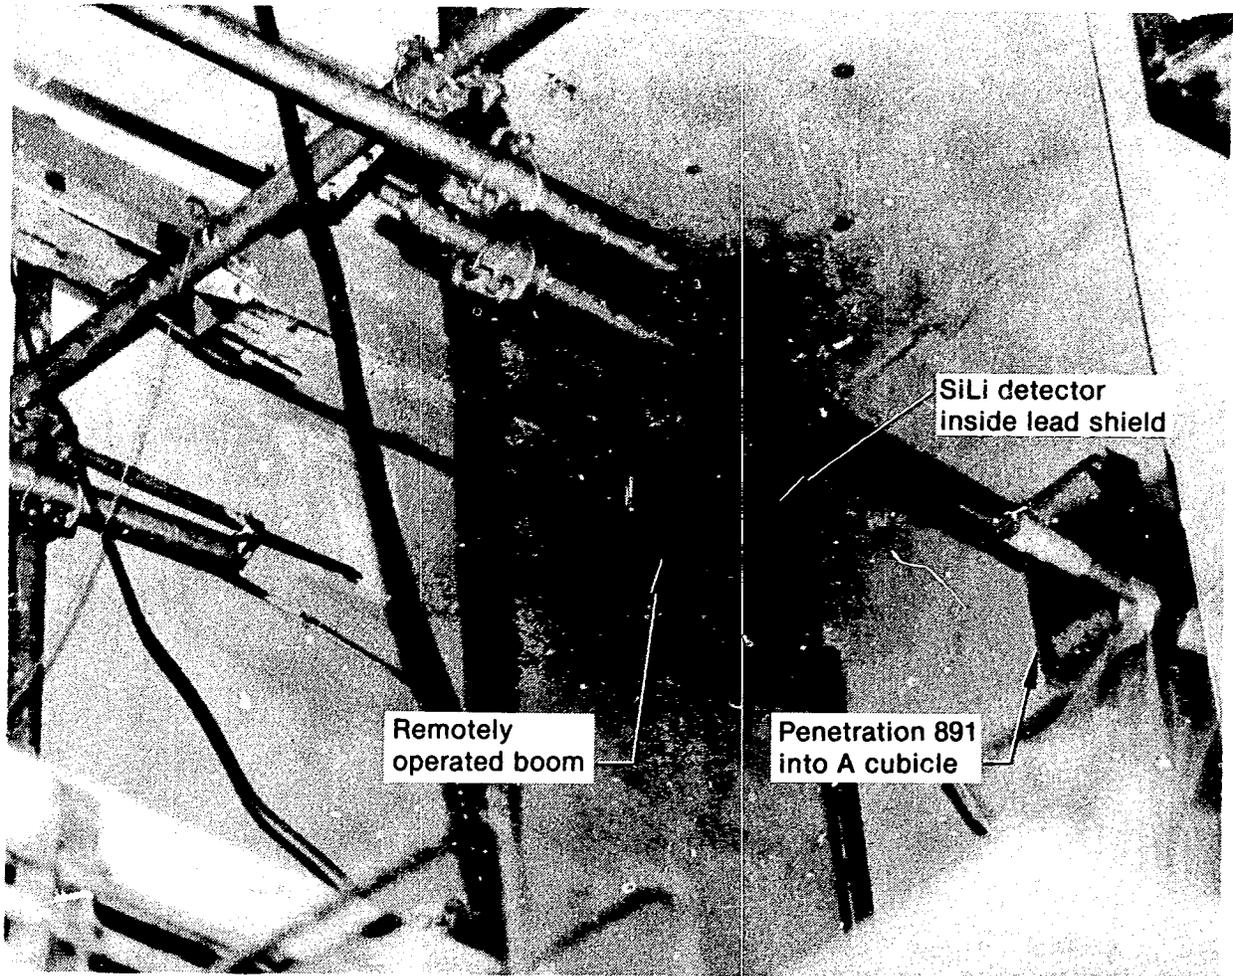
Figure 38. SiLi detector about to be lowered into demineralizer cubicle A to perform gamma spectroscopy.

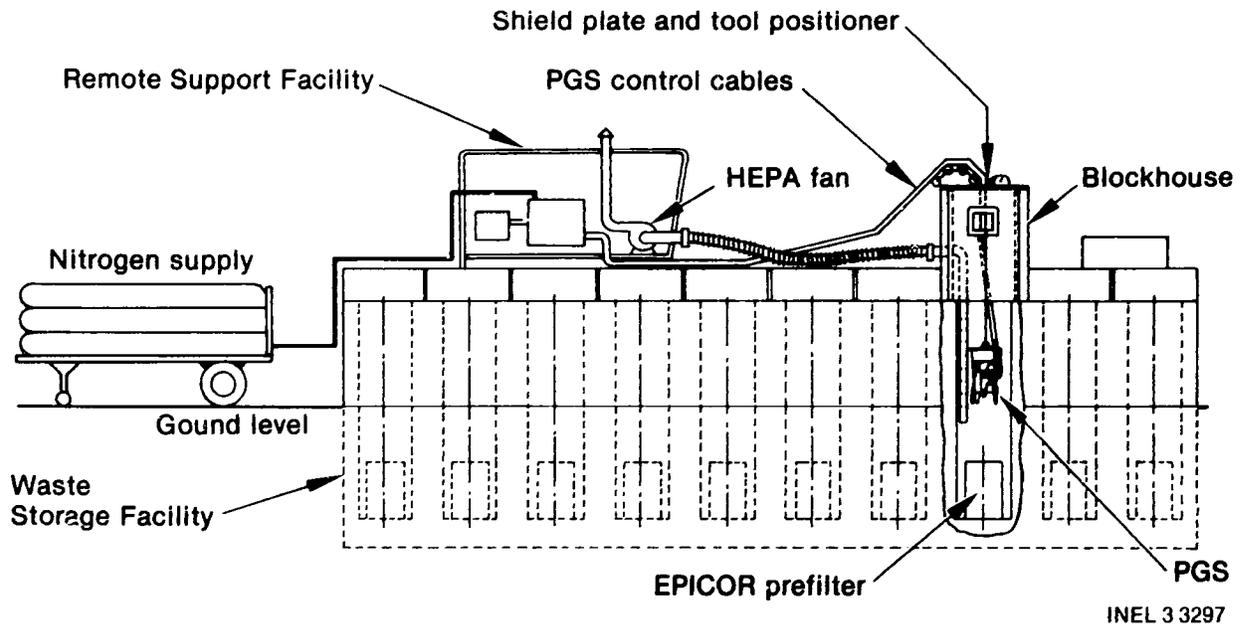
Figure 40. Arrangement of Prototype Gas Sampler system components at the TMI-2 solid waste staging facility.

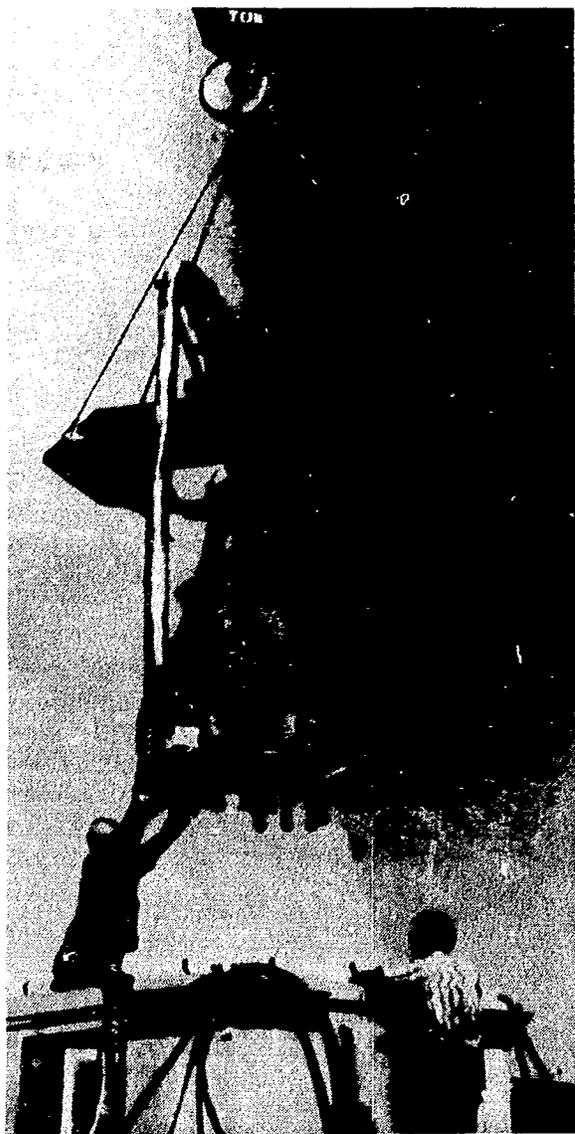
Figure 43. Prototype Gas Sampler being lowered into place onto a liner located in the storage module beneath the pictured blockhouse.
