GEND-032
Distribution Category: UC-78
TMI Supplement

TMI-2 TECHNICAL INFORMATION AND EXAMINATION PROGRAM 1982 ANNUAL REPORT

Published April 1983

EG&G Idaho, Inc.
Idaho Falls, Idaho 83415

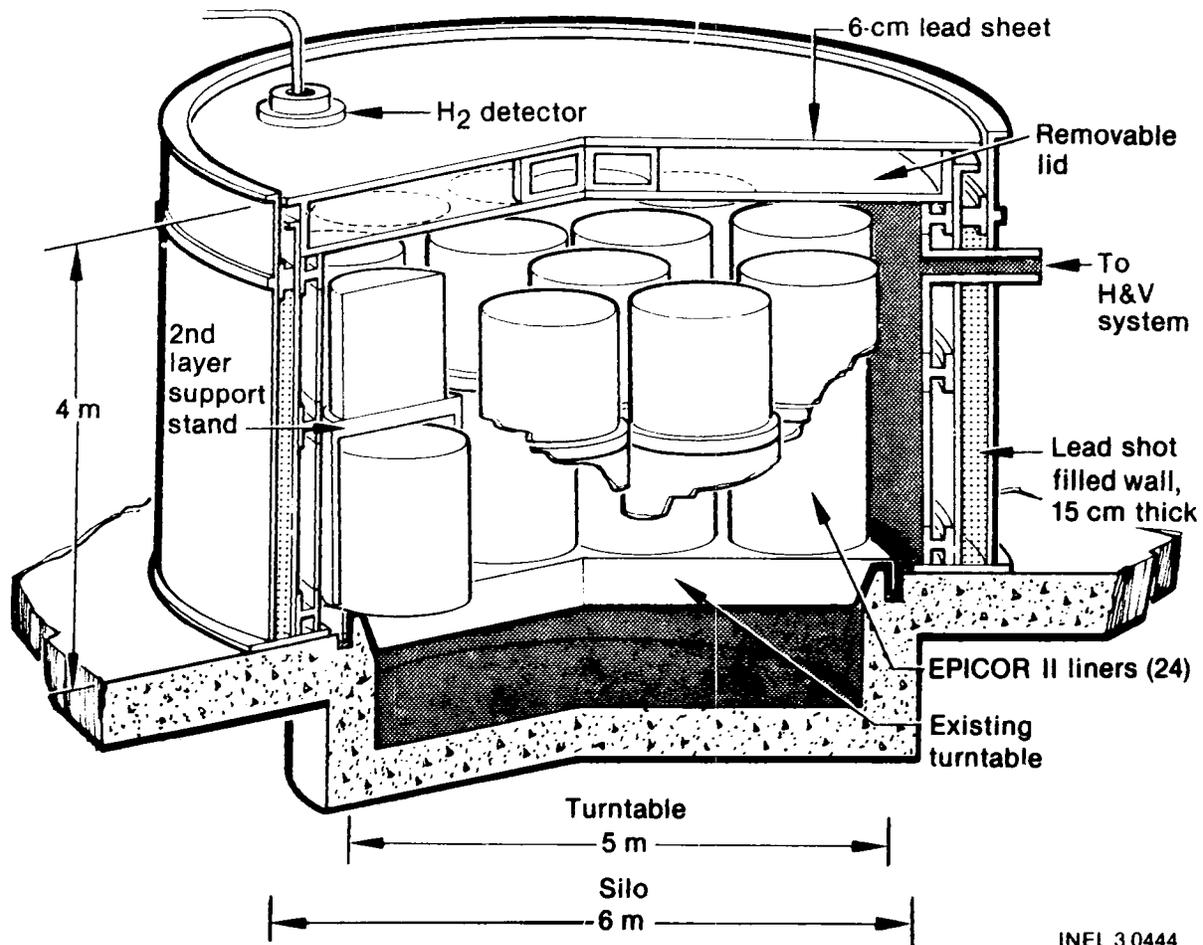
Figure 45. Cutaway view of an EPICOR storage silo in the INEL Hot Shop.

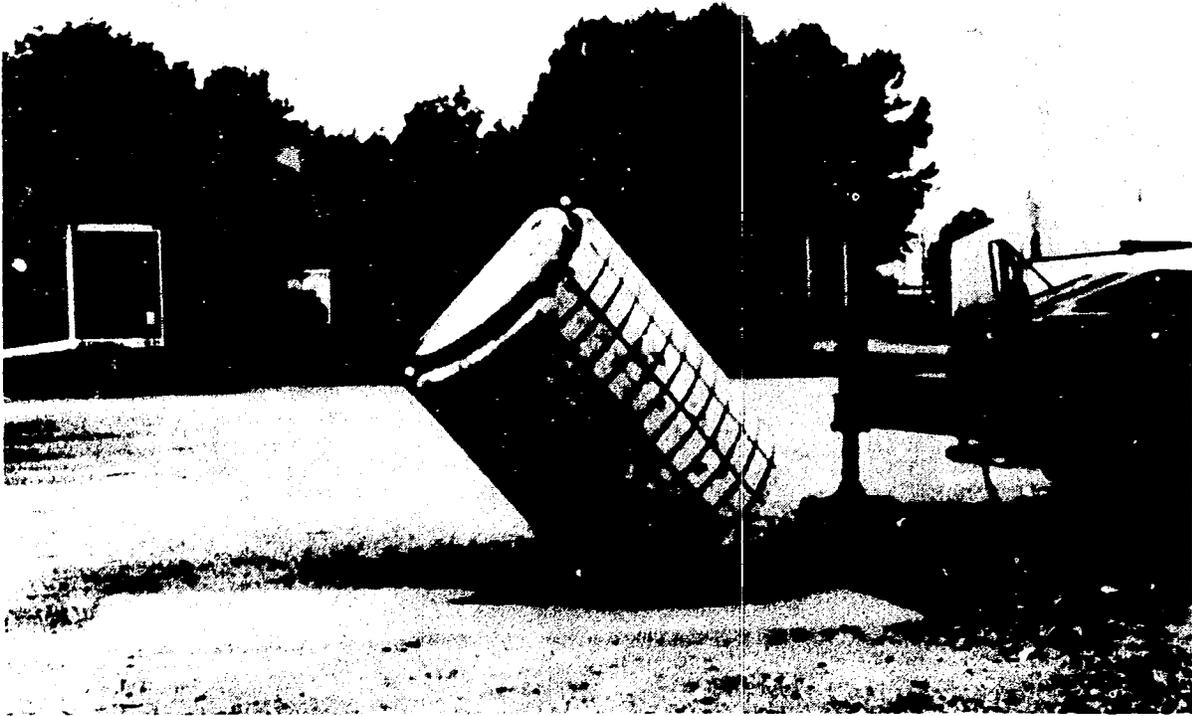
Figure 46. High Integrity Container undergoing impact testing shown here as it hits the concrete test pad.

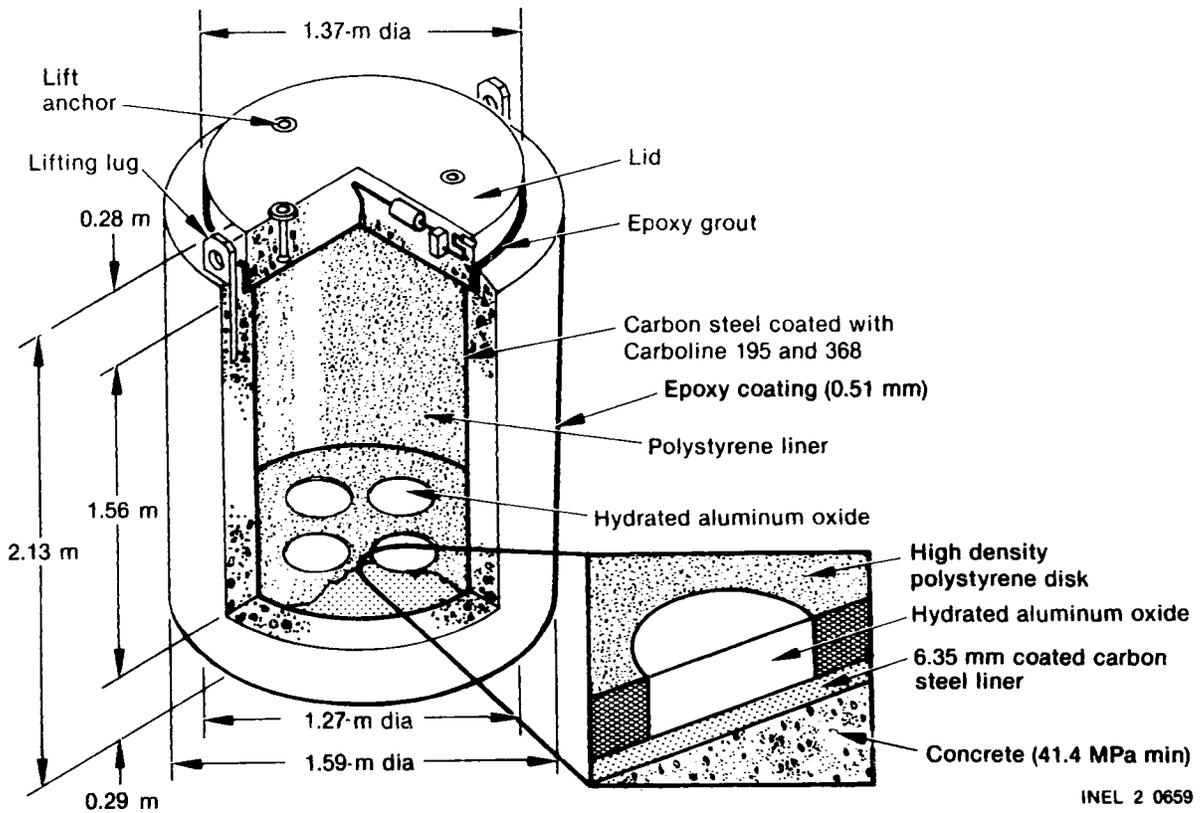
Figure 48. Cutaway view of a High Integrity Container.

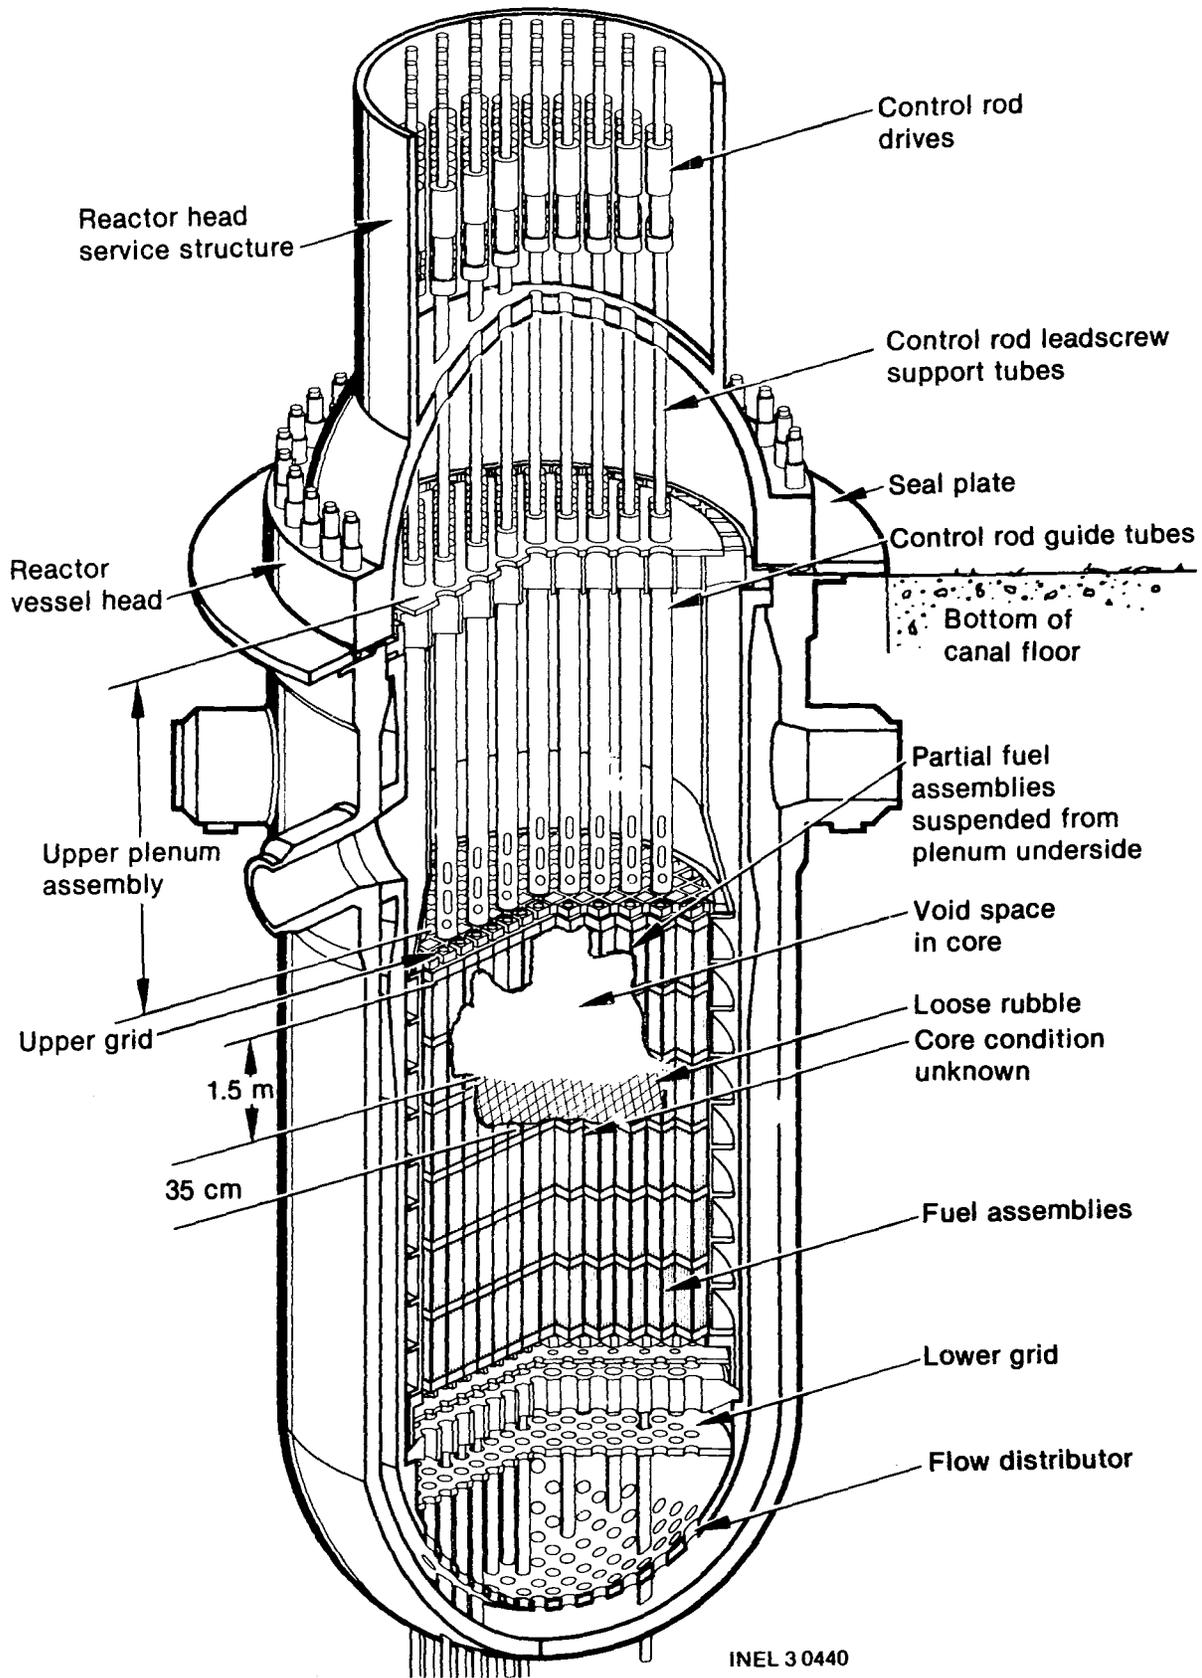
Figure 49. Structural components of TMI-2 core showing postulated damage area.

The camera inspection started in the reactor plenum (see Figure 49) in the general region of the

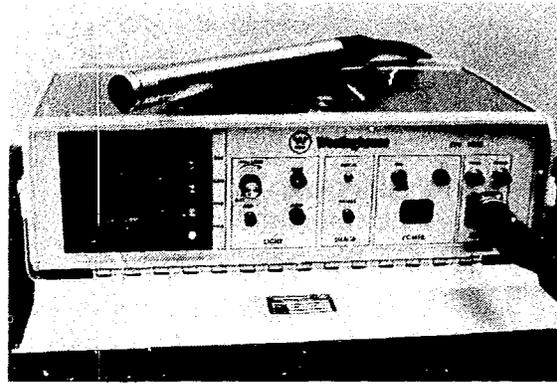
Figure 51. Quick Look inspection camera and control unit.

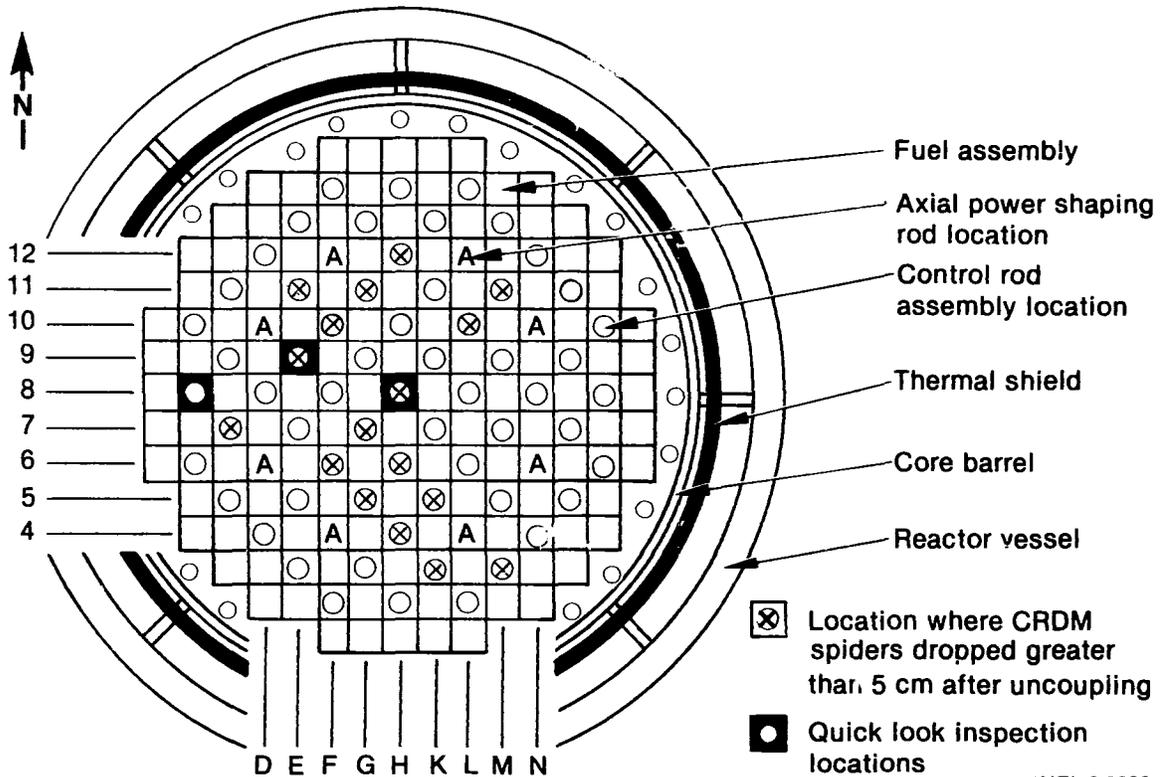
Figure 50. Unit 2 core cross section showing location of Quick Looks and CRDMs.

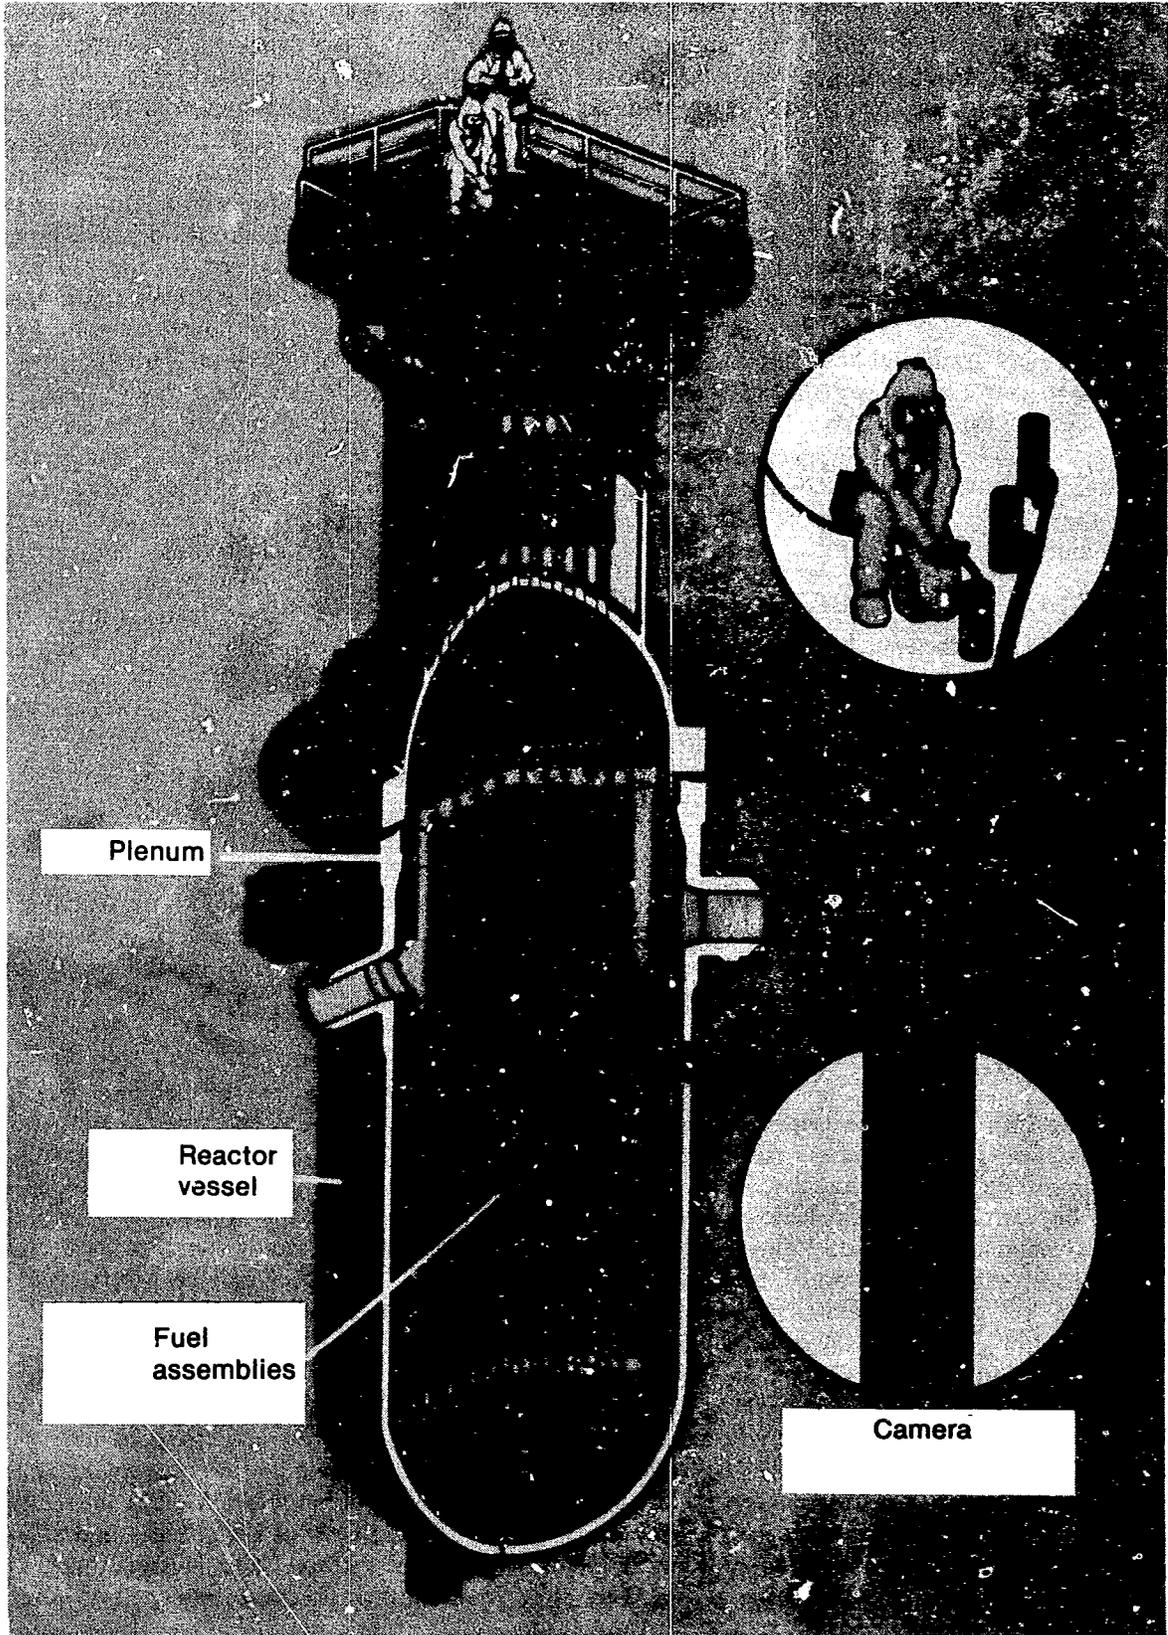
Figure 52. Quick Look camera access path into reactor internals and core.

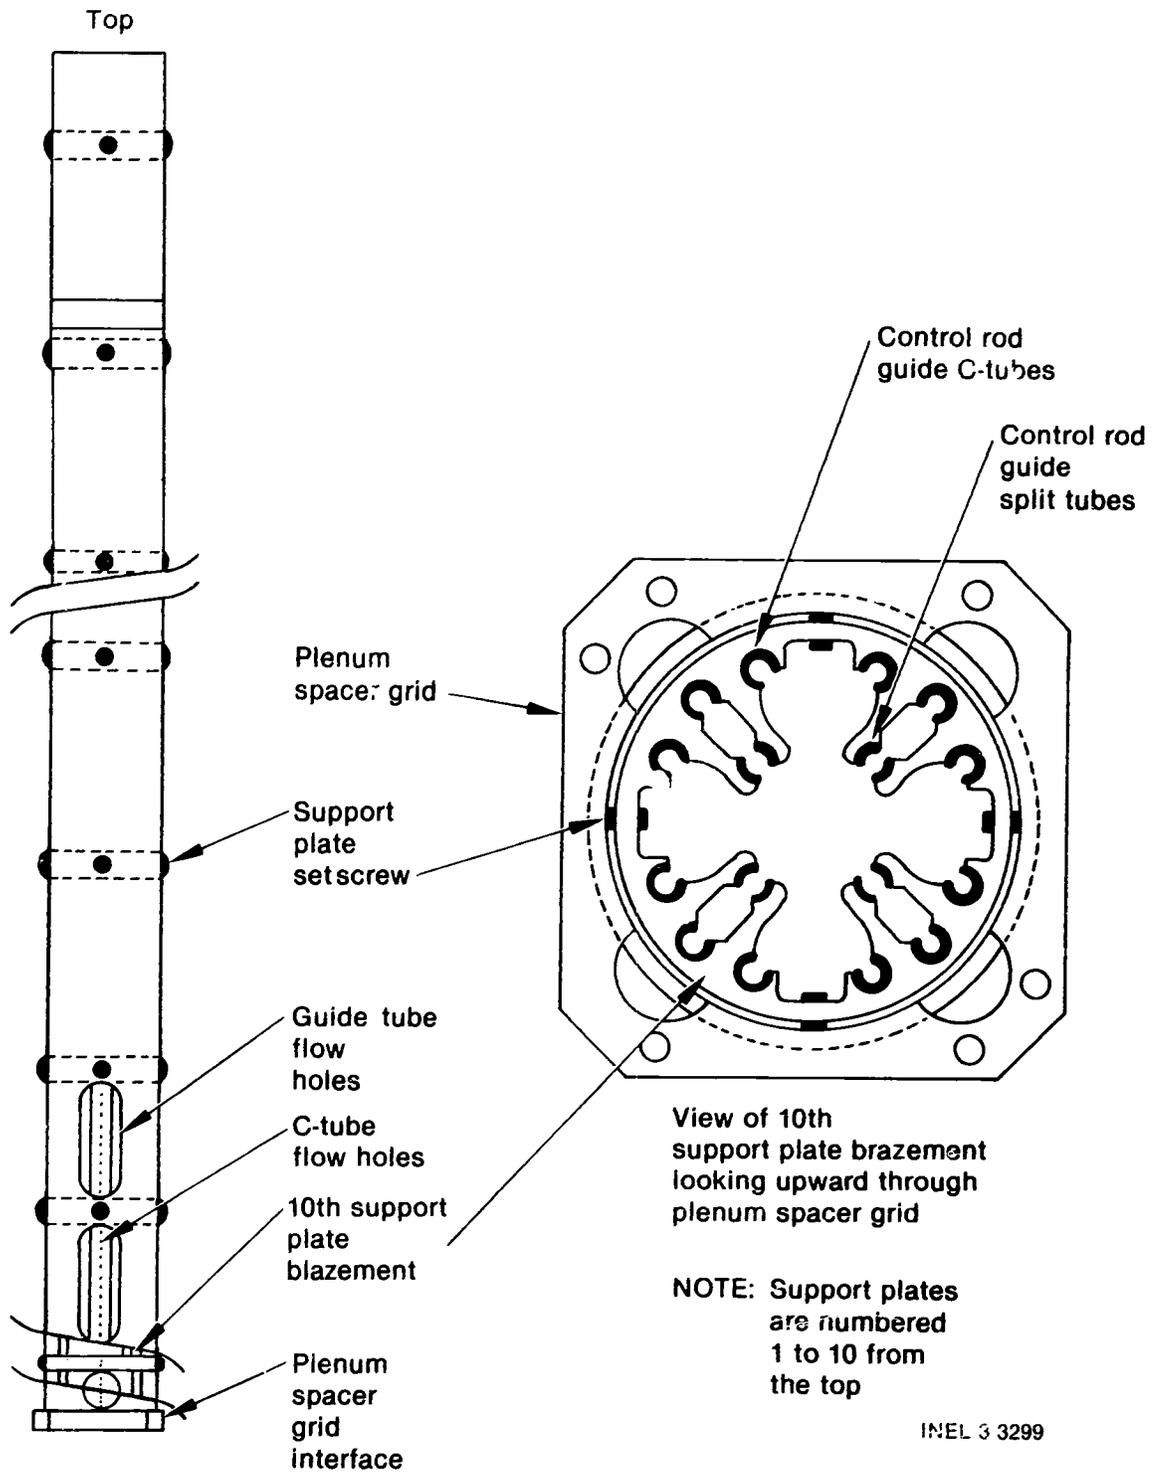
Figure 53. Control rod guide tube assembly with detail of tenth support plate.

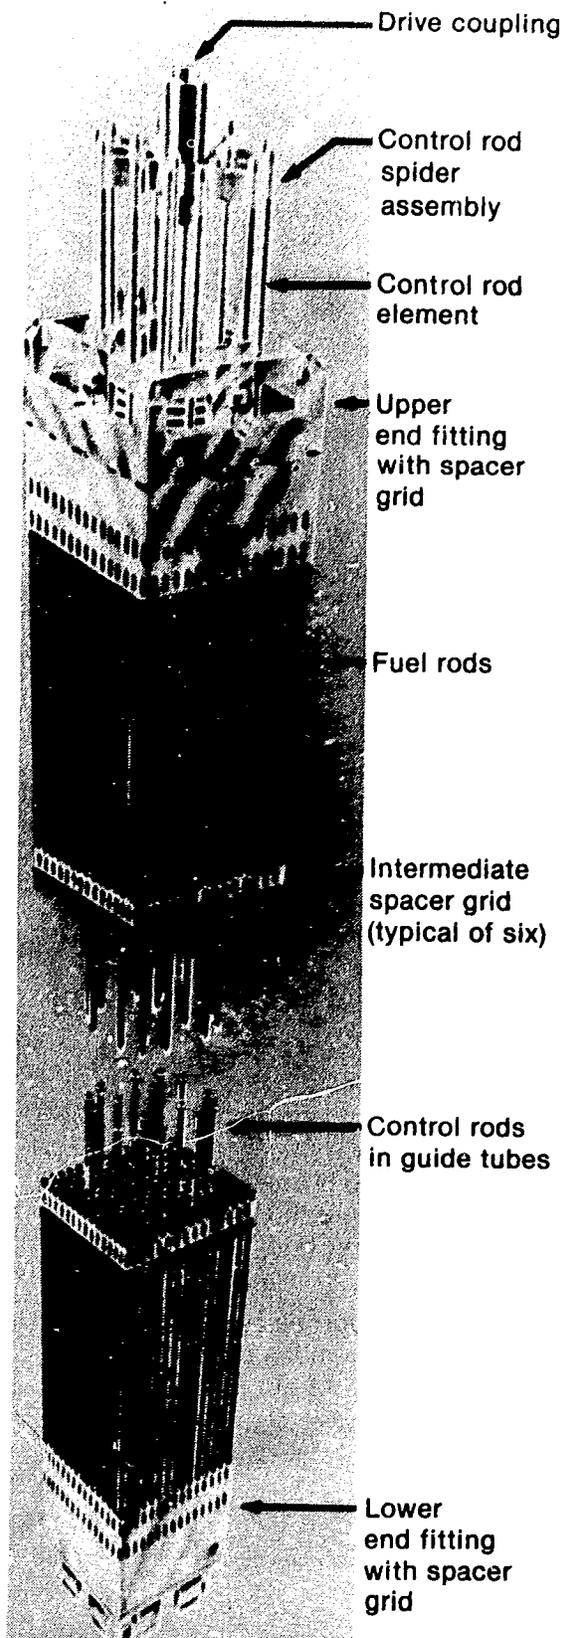
Figure 54. Components of typical fuel assembly.

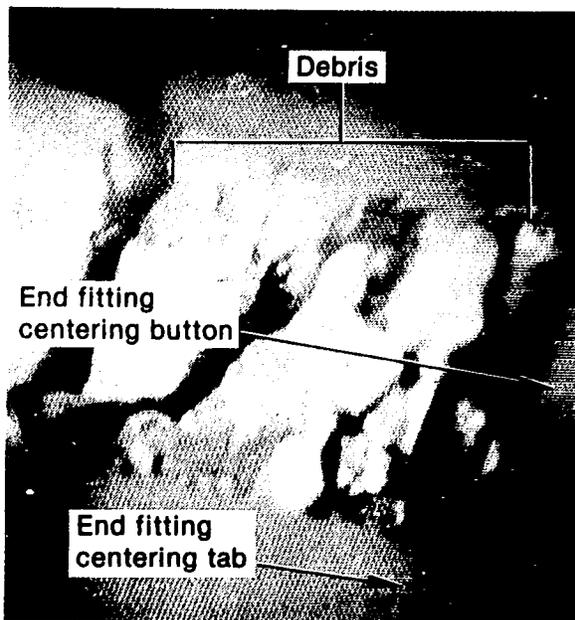
Figure 62. Metal chips and debris between centering tabs of an upper end fitting.

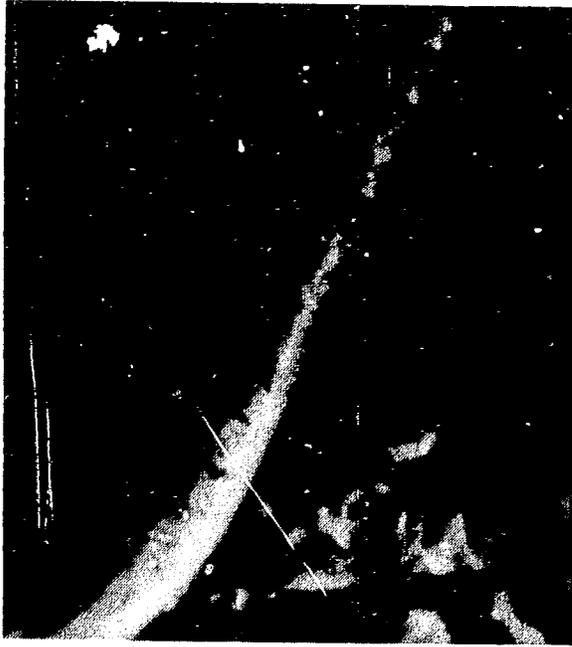
Figure 69. Unidentified rod on top of rubble bed at location E-9.
