EVALUATION OF SELECTED SAMPLES
FROM THE TMI-2 CORE

ABSTRACT

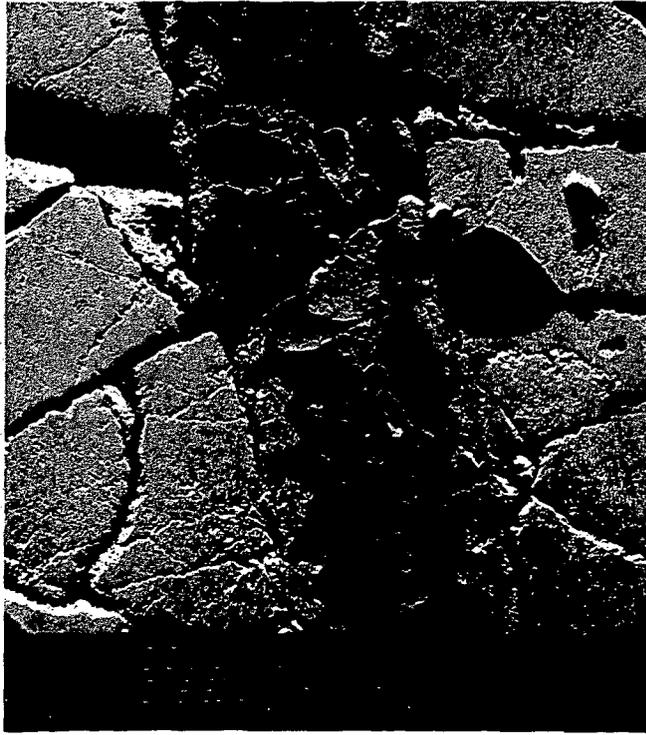
Figure 8. SEM secondary electron image of dike of matrix material in UO_2 pellet of transition region agglomerate, showing dissolution of UO_2 along interfaces.

"cladding," contained only Zr, Cd, and In as major constituents. This observation could suggest that molten Cd and In were the initiators in degrading the cladding. The cladding at "D" appears to have been breached, allowing the matrix materials to form dikes in the cracked fuel. The reason for the high U composition of the dike at "J" is apparent from Figure 8, which shows particles of fuel from the walls of the crack being absorbed into the matrix of the dike. In general, this specimen shows a multiphase matrix material, heterogeneous in its appearance of flow zones, but homogeneous in overall composition.
