SUMMARY OF TMI-2 CORE SAMPLE EXAMINATIONS^a

Idaho National Engineering Laboratory
EG&G Idaho, Inc.
Idaho Falls, ID 83415

ABSTRACT

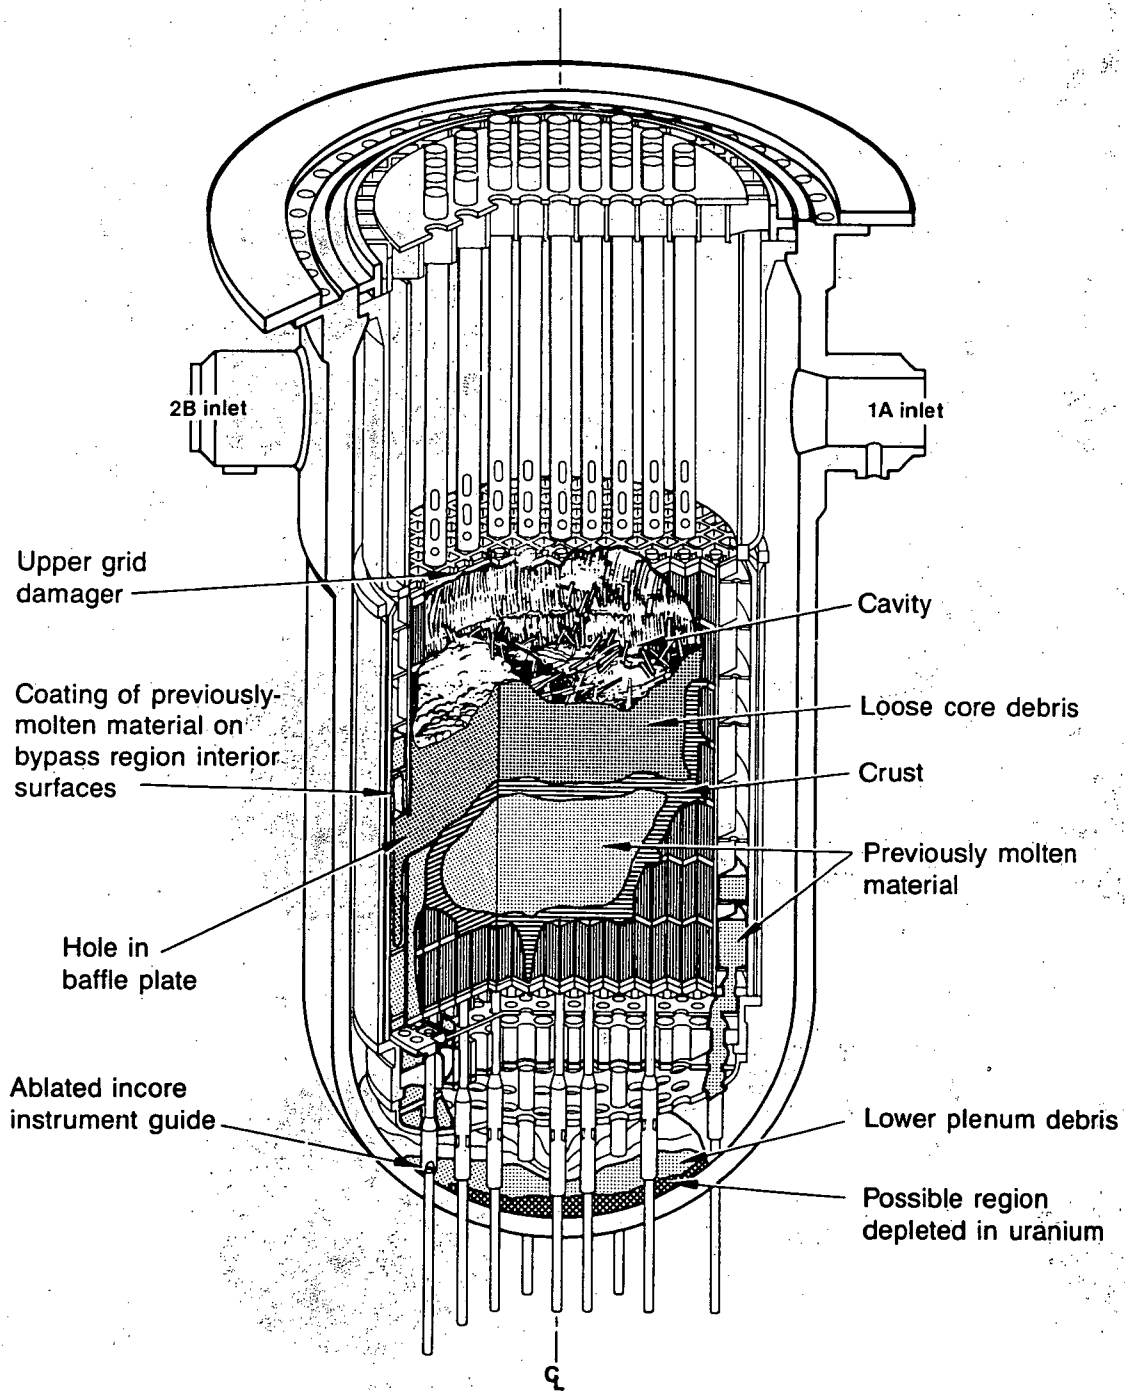
Figure 1. TMI-2 end state core condition.

The upper void region, illustrated in Figure 1, was approximately 1.5 m deep with an overall volume of 9.3 m³. Forty-two of the original 177 fuel assemblies were standing at the periphery of the core void. Only two of these fuel assemblies contained more than 90 percent of their full-length cross sections with the majority of the fuel rods intact. Non-destructive exams were performed for fuel assembly and control rod and burnable poison rod assembly upper end fittings from this region. Both non-destructive and destructive examinations were performed on fuel and control rod upper ends. The examinations that were performed are listed in Table 1. Results of the examinations of these components indicated large radial and axial temperature gradients, and differences in cooling behavior of control material existing over short distances. Peak temperatures of the upper spacer grids were 1500 to 1700 K. Previously molten control material had flowed upwards into the plenum spring region of control rods. Also, in the upper end of a fuel rod that had broken off, a previously molten mixture of fuel, cladding, and control and structural material had migrated upwards into the fuel cladding gap for several centimeters. This indicates that at some time during the accident the lower ends of the upper core region were immersed in liquid core materials.

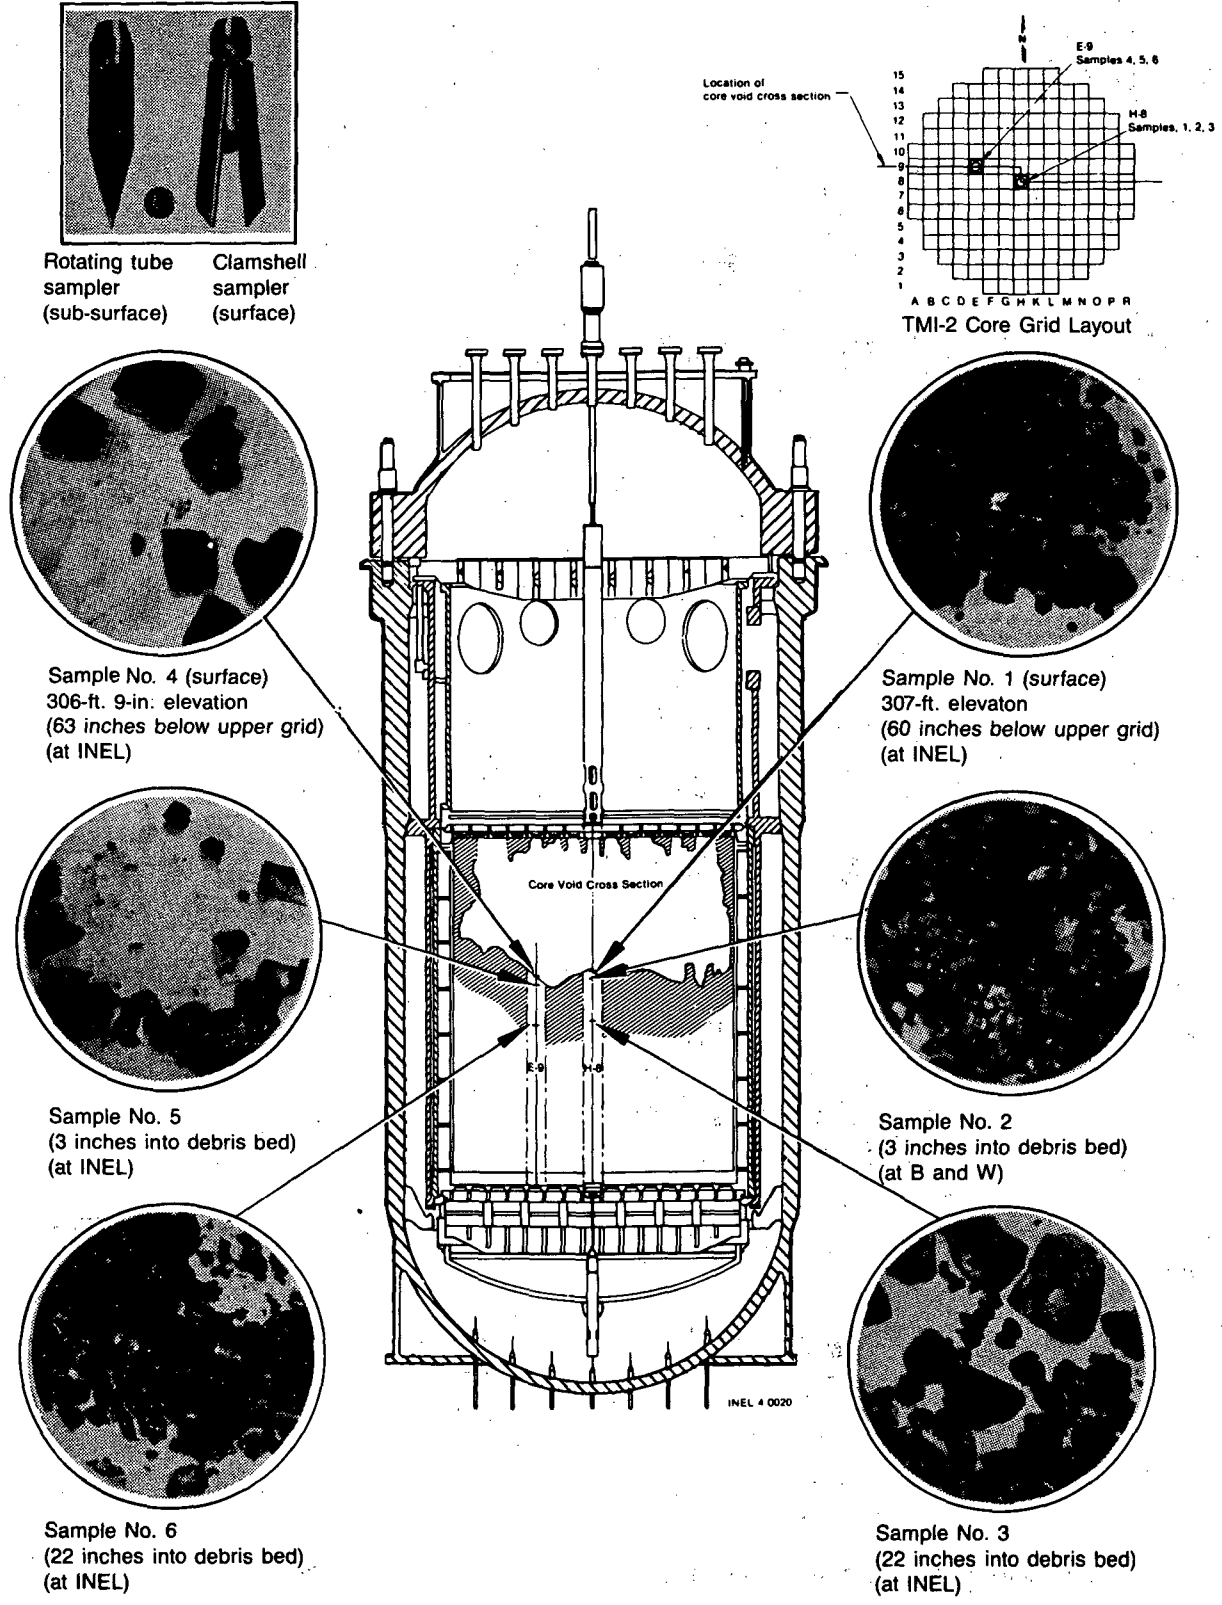
TMI-2 Core Debris Grab Samples

Figure 2. TMI-2 core debris grab samples.

The loose debris bed below the core void that was resting on a crust ranged in depth from 0.6 to 1 m, and consisted of whole and fractured fuel pellets, control rod spiders, end fittings and resolidified material² totaling about 26,600 kg. Samples obtained from the upper debris bed for examination are shown in Figure 2. The debris bed was heterogeneous, exhibiting a broad range of oxidation and material interactions, but was well mixed. Ninety percent of the sample particles were between 1 and 5 mm in their maximum dimension. Most of the debris bed consisted of shattered and resolidified material that contained regions of previously molten (U,Zr)O₂, indicating temperatures greater than 2700 K. There were also a few samples of previously molten material that were almost pure UO₂, indicating temperatures up to 3100 K. Metallographic examinations of individual particles indicated that most of the debris bed had remained at temperatures below 2000 K, or was exposed to high temperatures for only a short time. The bulk composition of the loose debris bed was primarily uranium, zirconium and oxygen with significant depletion of silver, indium, and cadmium control material, Zircaloy cladding, and structural material. Thus, the materials that are the first to melt and/or form eutectics and relocate are depleted from the upper debris bed. The upper debris bed consists of the remnants of highly oxidized fuel rods that shattered when they were cooled, and that were depleted of control, structural and cladding material before cooling.

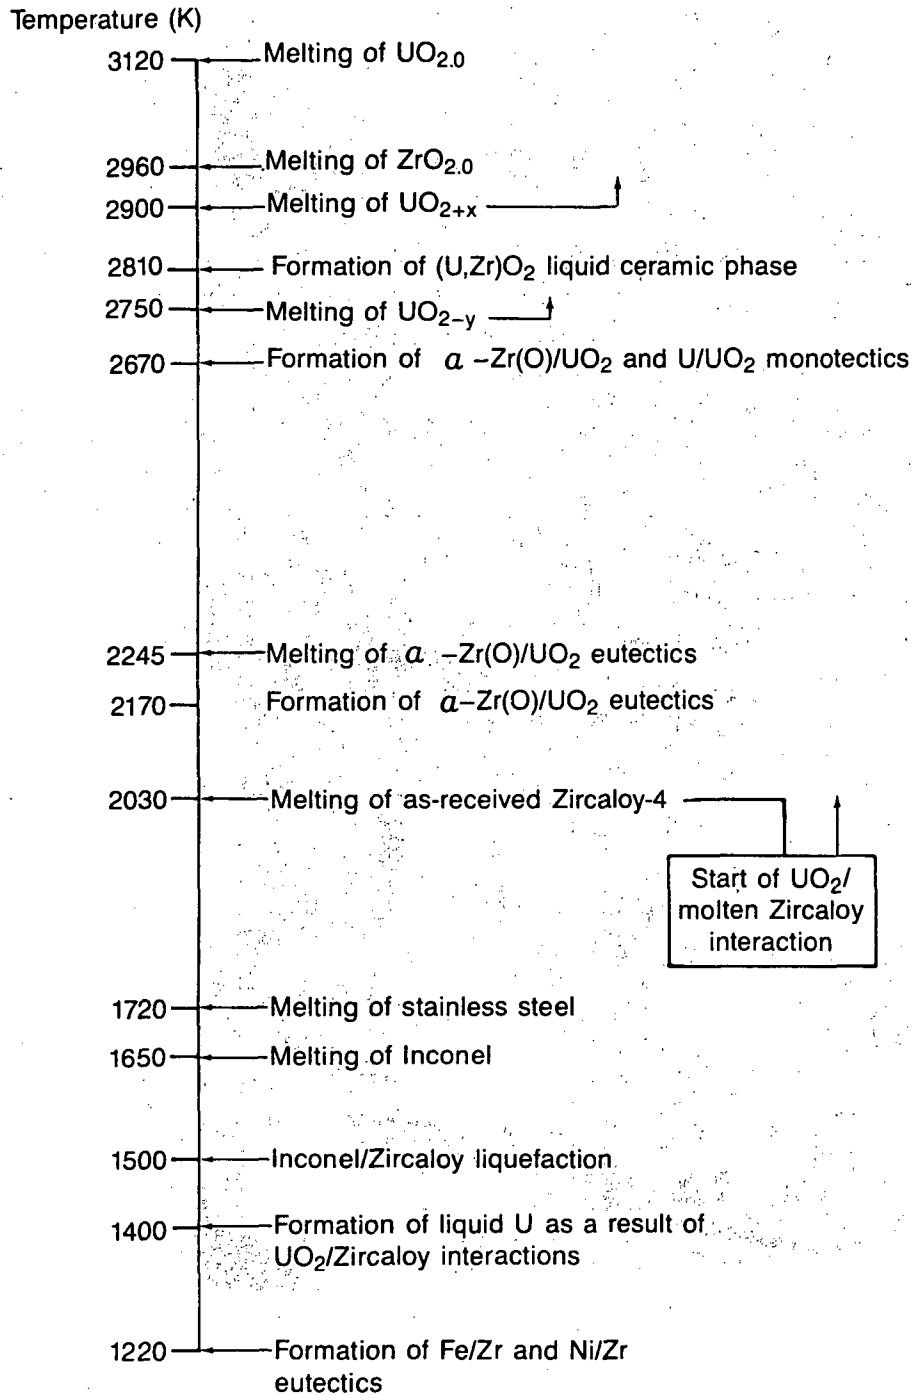
Figure 3. Temperature indicators for nuclear core materials.

Figure 3 displays the major melting and interaction points of core materials versus a temperature scale. The determination of whether these phenomena have occurred make it possible to bound peak temperatures. The silver, indium, cadmium control material melting range is between 1073 and 1100 K. Zircaloy transforms from the alpha to the beta phase between 1105 and 1245 K. Zirconium (from the cladding) forms eutectics with iron and nickel (from stainless steel control rod cladding or Inconel grid spacers) at 1200 K but the solid diffusion rate is too slow to be of concern until the temperature reaches 1500 K. Inconel, stainless steel and Zircaloy melt at 1660, 1720, and 2030 K, respectively. The dissolution of UO₂ by zirconium begins at 2030 K.

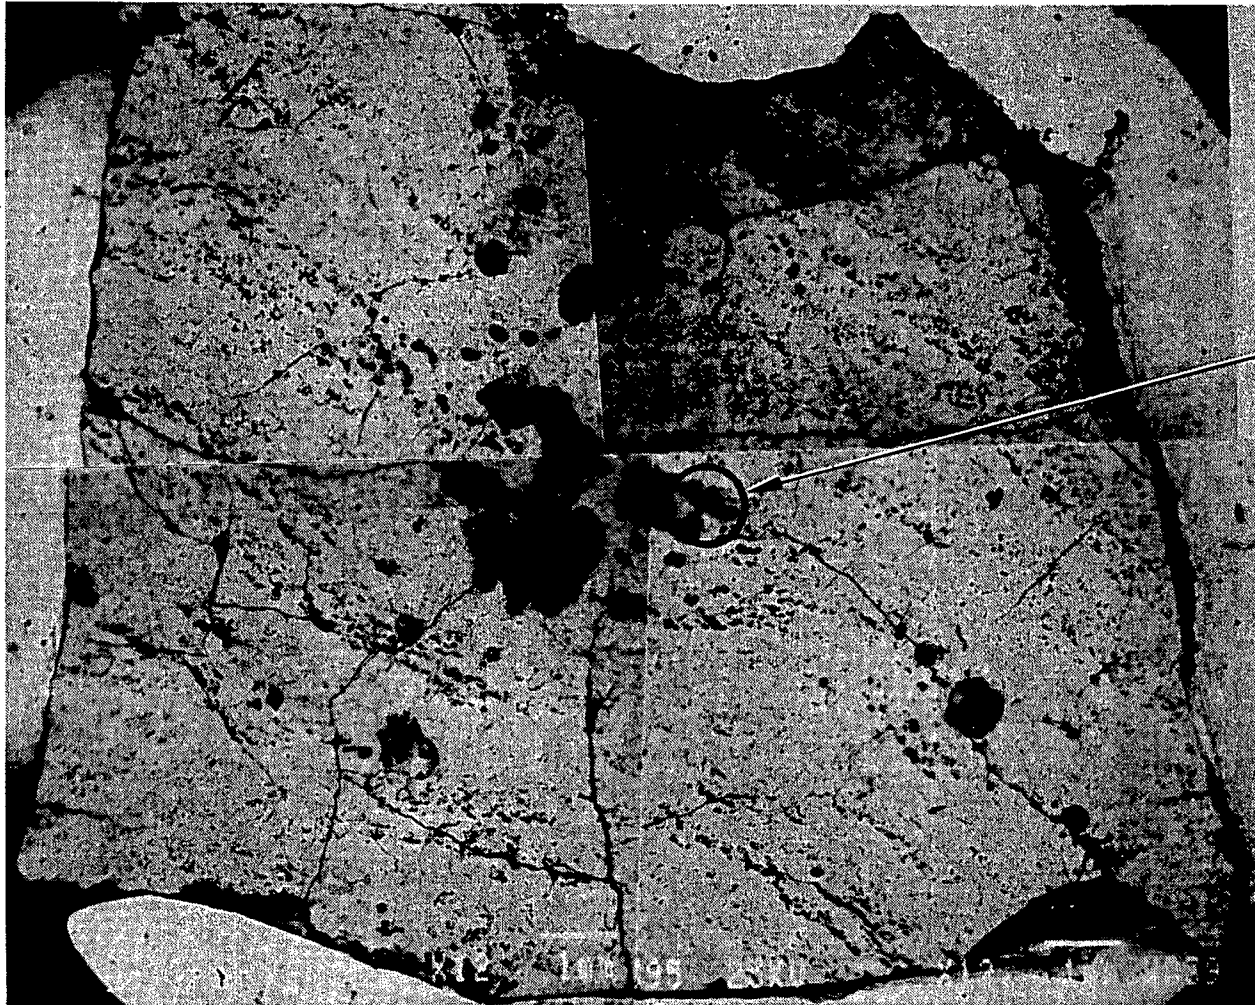
Examination
area

Figure 4. Core location K9 — ceramic particle (BSE image).

present. An example of an entirely ceramic particle from the central region is shown in Figure 4 which is a back scattered electron (BSE) image. The BSE image represents a composite average of the atomic number of the elements in a particular phase where the degree of brightness is proportional to the atomic number of the element (e.g., the high atomic number uranium is brighter than the lower atomic number iron). Examination of this ceramic particle indicated that the light regions were uranium and zirconium oxides, and the dark regions were mixtures of iron, chromium, and aluminum oxides. An entirely metallic particle from the central, previously molten region is shown in Figure 5. The metallic matrix of this sample consisted of a nearly dendritic structure of iron-nickel-chromium with circular inclusions containing silver-indium-tin. Although some of the Ag-In-Sn inclusions contained voids, many contained a spherical particle of chromium oxide (Cr_2O_3).

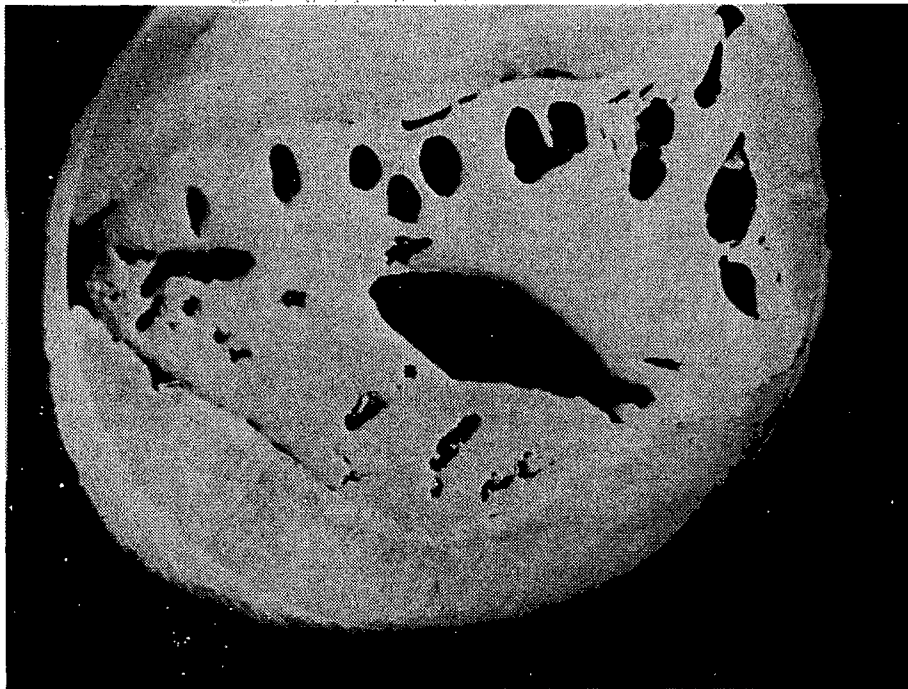
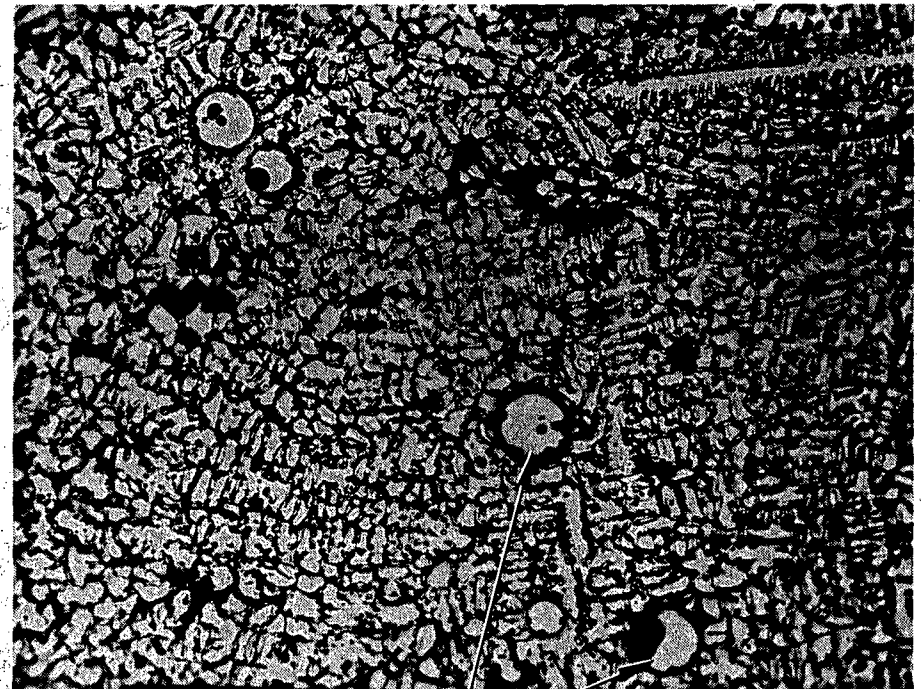
Silver inclusions

Figure 5. Core location 09 — metallic particle.

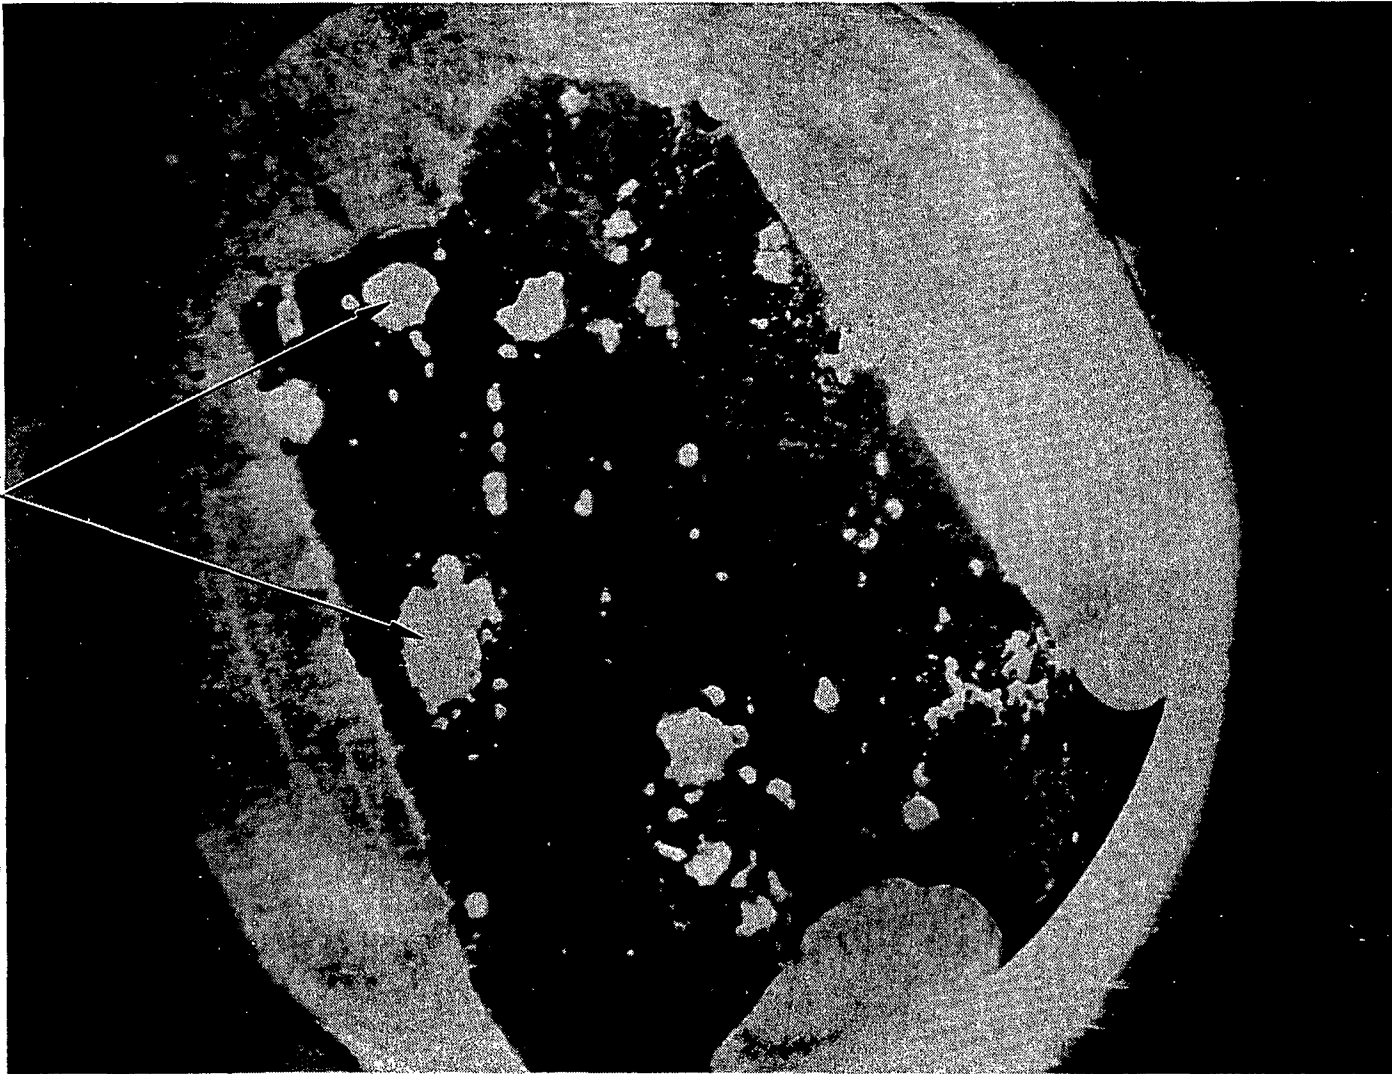
Metallic
inclusions

Figure 6. Ceramic particle with metallic inclusions (core location G12)

An example of a particle from the central, previously molten region that contained both metallic and ceramic phases is shown in Figure 6. The ceramic phase is primarily oxides of zirconium and uranium with small amounts of iron and nickel oxides, and is similar to the entirely ceramic particles found both in the central region and in the upper debris bed. The bulk composition of the metallic phases in the central region (which comprised about 15% of the central region) consisted principally of Fe-Ni and Ag-In phases. Thus, the central region contained much more metal than the upper debris bed where no pure metallics were found. Metals from the stainless steel cladding of the control rods, the silver, indium, cadmium control materials, and the Inconel spacer grids (only the Inconel contains molybdenum), existed in abundance in the central, previously molten region.

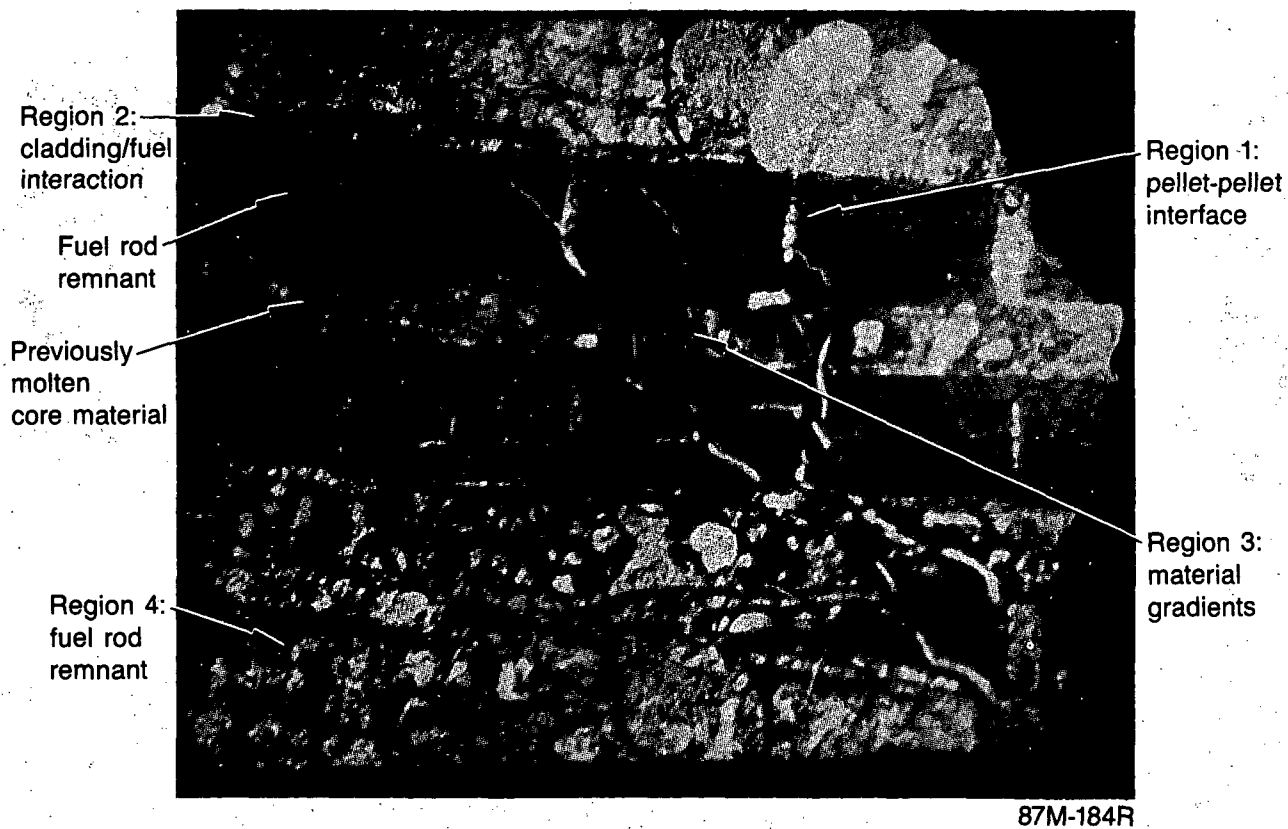
Core Material Interaction and Cladding Dissolution

Figure 8. Lower crust from core position K9 illustrating previously molten metallic material frozen around fuel rods.

The lower crust consisted of vertical fuel pellet stack columns surrounded by previously molten material as illustrated in Figure 8. Apparently during the early part of the accident, structural and control rod material flowed down the coolant channels, dissolved the Zircaloy cladding and flowed into the pellet/pellet interfaces and cracks in the pellets and froze forming the lower crust. The molten material was composed of a mixture of metallic structural and control rod components with relatively small (100 to 200 micron) UO_2 inclusions. It is clear that the eutectic between zirconium and iron and zirconium and nickel formed, and therefore, the previously molten metallic in the lower plenum reached at least 1400 K. Also, rounded edges of ceramic UO_2 particles that were carried downward in the melt indicate the onset of dissolution requiring that temperatures in the melt approach 2200 K. The metallic material in the lower crust contained an even higher percentage of zirconium than the peripheral crust. The composition of the three phases of the metallic material in the lower crust were Zr-Fe-Ni-Cr, Ag-In, and Zr-Ni-In.
