ASSESSMENT OF EXTENT AND DEGREE OF THERMAL DAMAGE TO POLYMERIC
MATERIALS IN THE THREE MILE ISLAND UNIT 2 REACTOR BUILDING

N. J. Alvares

This paper was prepared for submittal to
International Fire Safety Meeting,
Gaithersburg, MD
October 7, 1985

June 1985

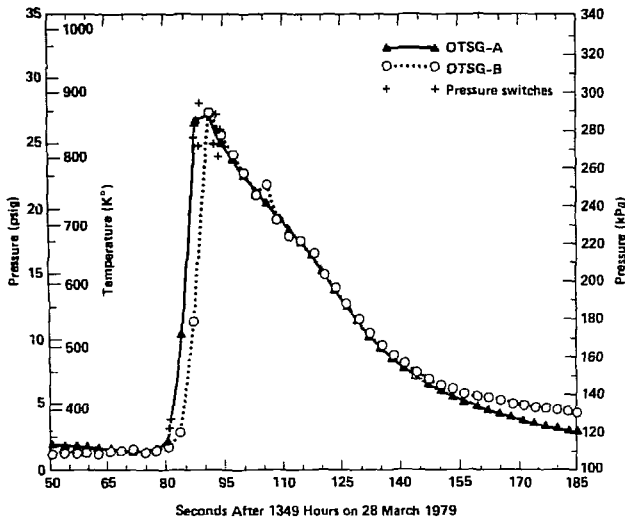
Fig. 1. Pressures recorded during the burn from OTSG (once-through steam generator) pressure transmitters and pressure switch actuation times. Corresponding average temperature via procedure described in Ref. 1 added to psig scale.

volume. Activation of the building spray system is defined by inflection and increase in the negative slope of interior-pressure-reduction curves (Fig. 1).¹

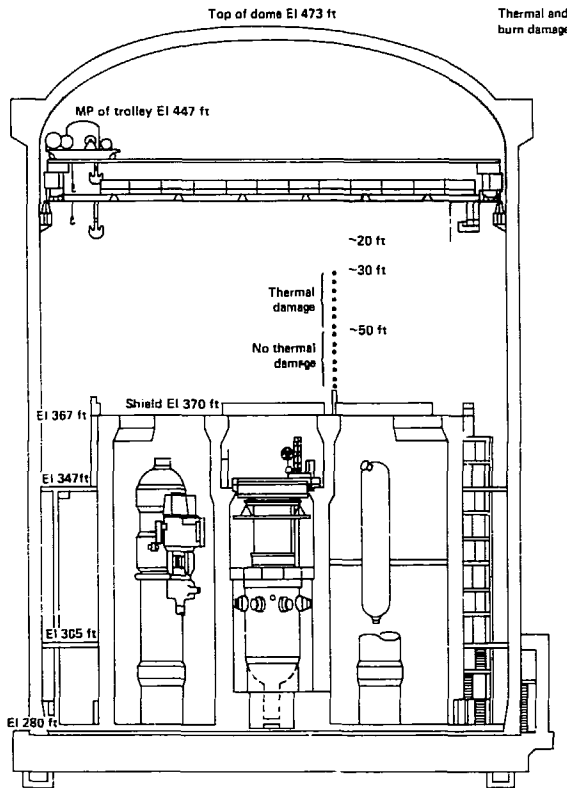
Fig. 2. Cross section of the TMI-2 reactor containment building.

A cross section of the reactor building (Fig. 2) and plan view of the main (347-ft) operations level (Fig. 3) show the regions of thermal and burn damage. Given that few operational ignition sources were available in the reactor building above the 305-ft level, the time delay to achieve peak overpressure is consistent with an ignition location in the basement. The potential electrical shorting of electrical control systems caused by basement water spillage and the frequency of steam release from the reactor coolant drain-tank pressure-release system supports this assumption.

Although photographic surveys of internal reactor building vistas, ensembles, items, and surfaces were abundant (approx 600 photos from 29 entries), clarity of burn detail in most photographs was not adequate for diagnostic purposes. However, the extent of thermal damage was defined (Figs. 2 and 3) as regions where thermally degraded materials were located, photographed, and, in some cases, extracted from the reactor building for further examination.
