TMI-2 REACTOR COOLANT SYSTEM
SURFACE DEPOSIT EXAMINATION
(DRAFT)

TMI-2 REACTOR COOLANT SYSTEM SURFACE DEPOSIT EXAMINATION

January 1988

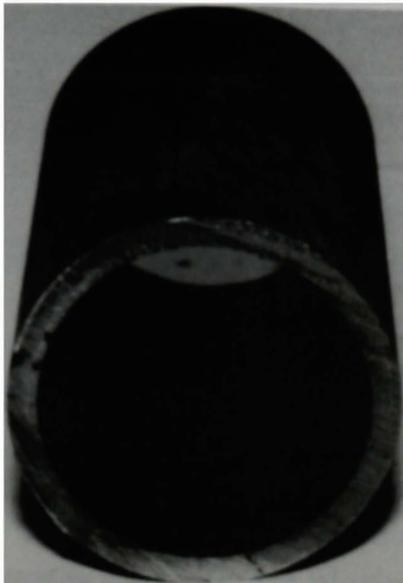
Figure 13. Photograph showing the LST section.

The entire outside surface of the LST section appeared solid black (Figure 13). The deposits were thin and largely uniform. Portions of the outer surface on one side were partially covered by a thin, yellow-orange deposit. The flat bottom of the section, which had been oriented toward the reactor core, showed adhesion of metallic particles ranging in size from barely visible to about 1 mm in diameter. The largest particles appeared spherical. The inside surface also appeared black with regions of yellow-orange surface material which covered less of an area.
