ANALYSIS OF THE TMI-2 DOME RADIATION MONITOR

Published August 1985

**Sandia National Laboratories
Albuquerque, New Mexico 87185**

Questions have been raised regarding the accuracy of the in-containment radiation readings from the LOCA qualified, dome radiation monitor, HP-R-214 during the March 28, 1979 accident at the Three Mile Island Unit 2 Reactor. This report discusses the accuracy of the readings, gives the results of examining the radiation monitor itself, and estimates the radiation environment inside containment during the accident.

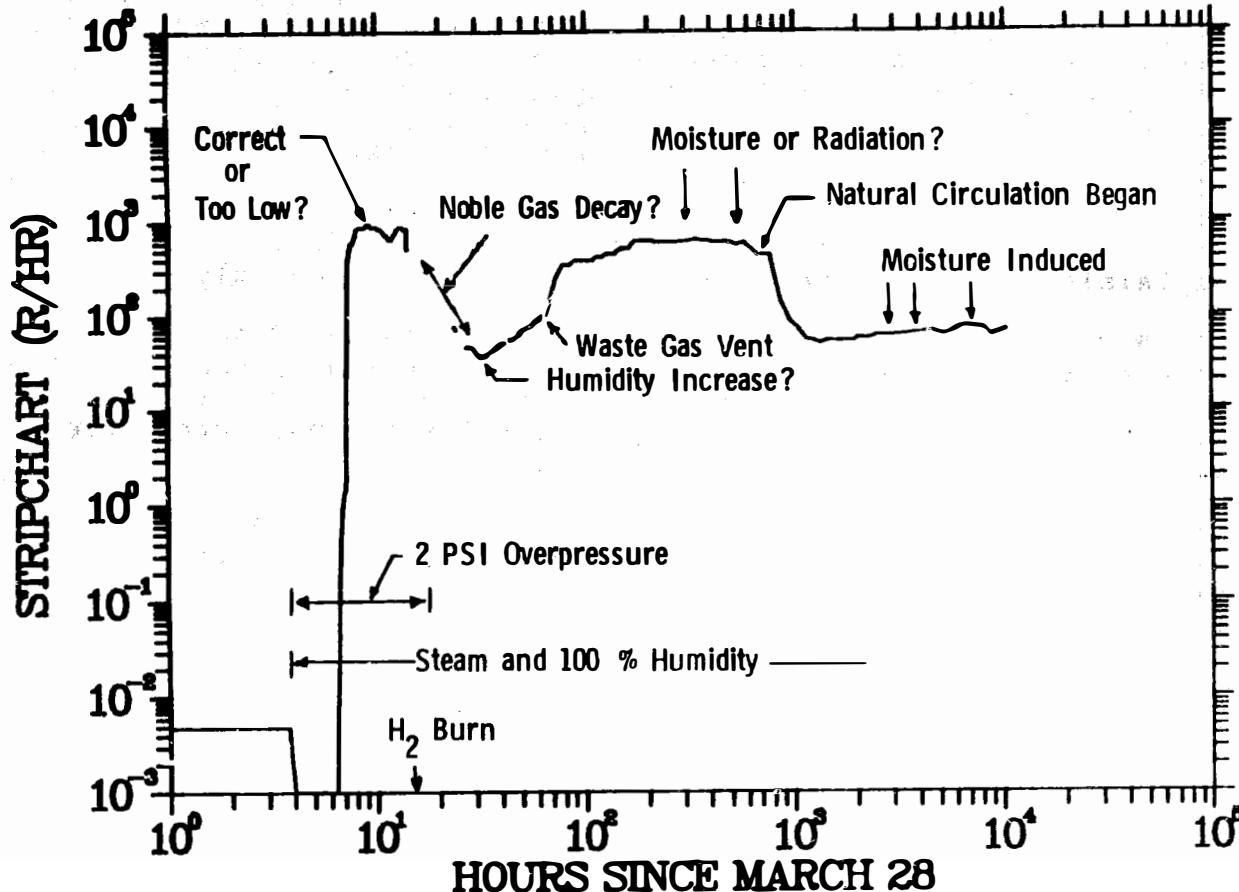
Figure 1. HP-R-214 Corrected Stripchart. The original HP-R-214 stripchart recording has been plotted on the proper log paper and corrected for recorder scaling errors.

The original Dome Monitor stripchart recording is erroneous because the output was plotted on five decade log paper rather than on eight decade paper and the recorder was improperly scaled. Figure 1 shows the Dome Monitor output as it should have been recorded, i.e. we have corrected the original stripchart to account for the log paper and scaling errors. This plot presumably gives the radiation levels inside the lead-lined stainless steel vessel. We have found, however, that some, if not all, of these radiation measurements are grossly inaccurate.

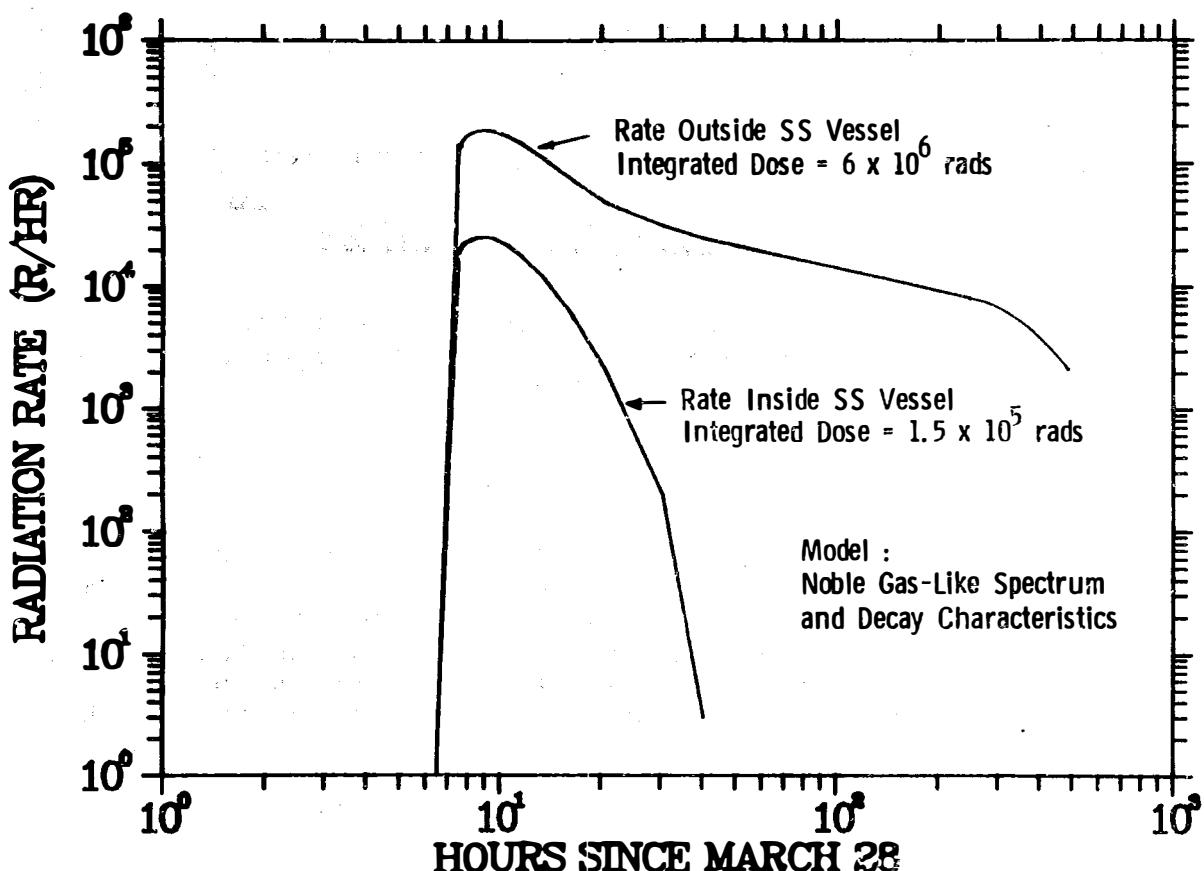
Figure 2. TMI-2 Gamma Radiation Time History. This is our best estimate of radiation history both inside and outside the stainless steel vessel (Hypothesis 2). We have assumed a noble gas spectrum and decay characteristics in order to calculate the level outside the vessel.

Gamma radiation rates as a function of time both inside the vessel shield and in the outside containment atmosphere are estimated in Figure 2. Here, we assume that Hypothesis 2 is

correct, and we calculate the time history based on total gamma dose measurements only. To do this, we have assumed the radio-nuclide energy spectrum and decay characteristics to be that of noble gases. Under these conditions the peak gamma rate in the upper part of containment was on the order of 200,000 R/hr. If we assume a 60% noble gas release, other radionuclides must account for about 85% of the level of activity. This seems high; therefore, it is our guess that 200,000 R/hr is an upper bound of the actual rate. We place no error bars on these estimates because of the numerous potential sources of error.

Notice that as time passes and the energy spectrum becomes softer, the rate inside the lead-shielded vessel drops dramatically with respect to that outside the vessel. This shows the importance of having a detector which does not require extensive shielding to survive. This detector is essentially useless after 20 hours, even though external radiation levels are still quite high.

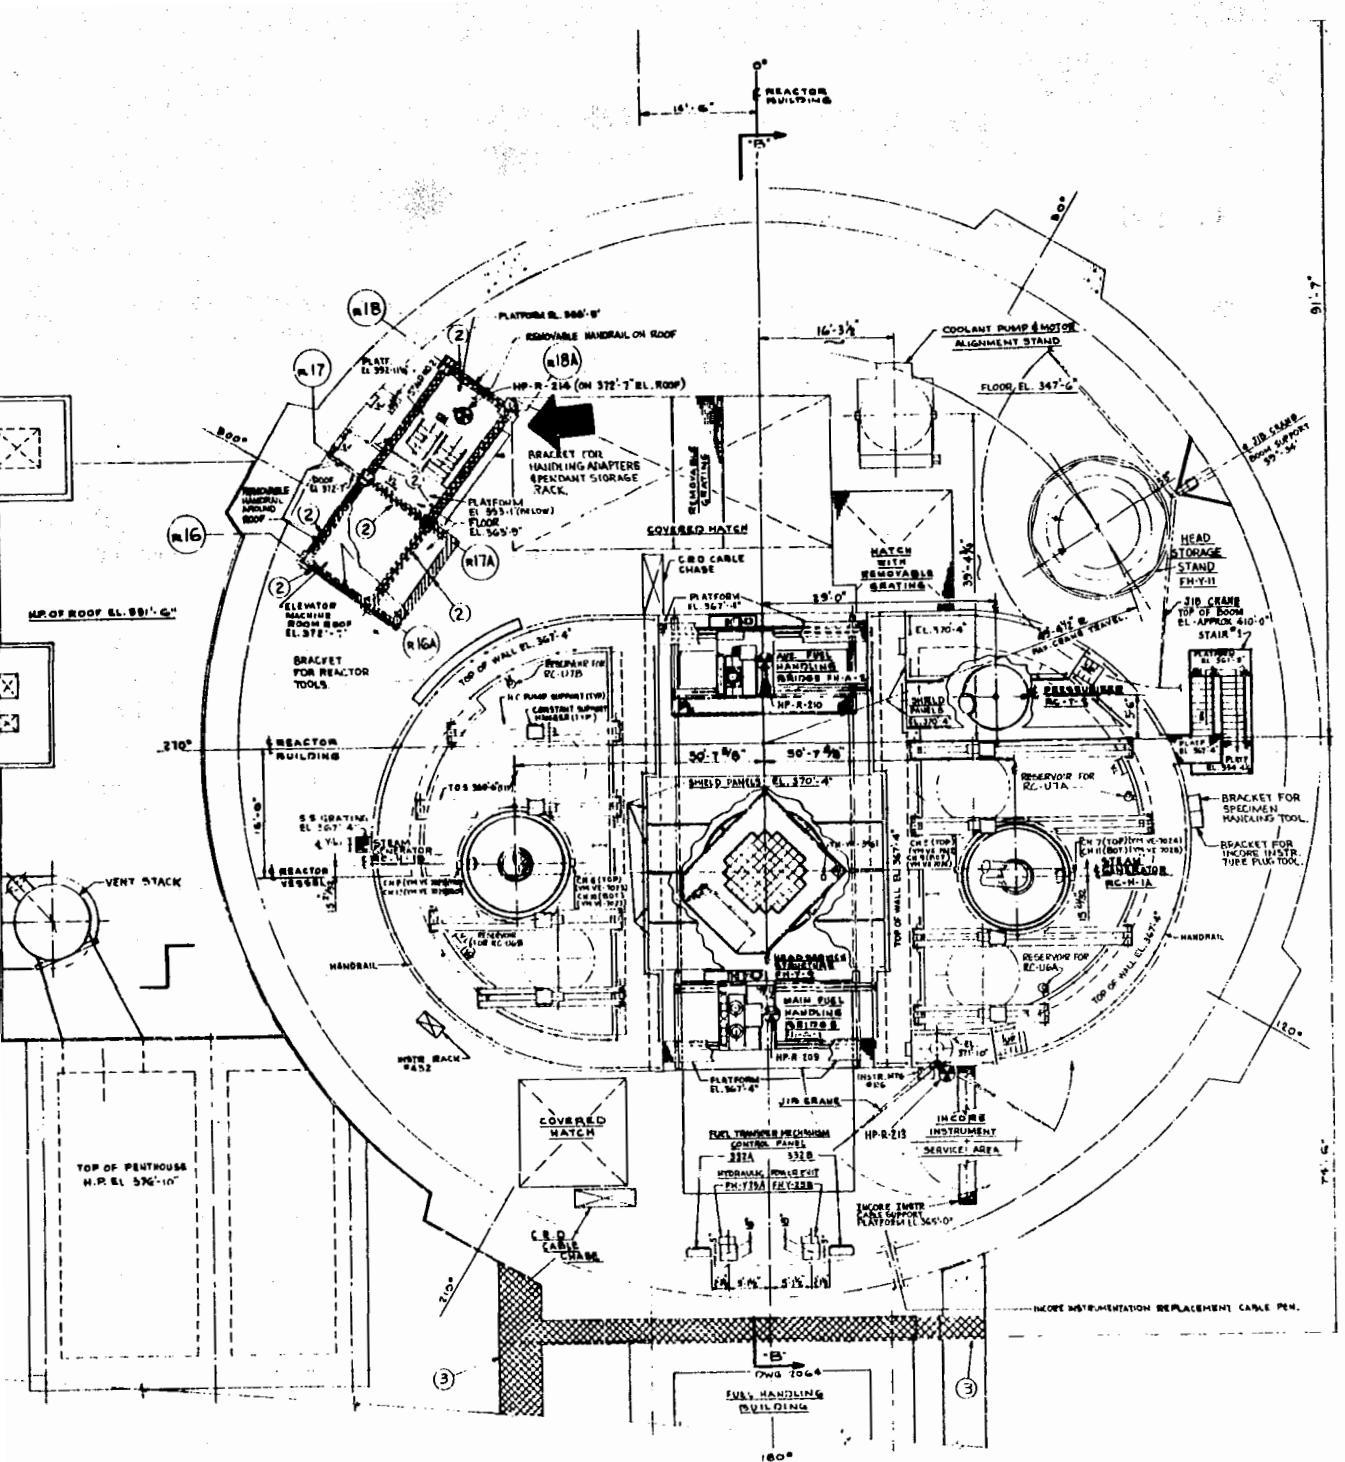
Figure 5. TMI Unit 2, 345-Foot Plan Layout. The Dome Monitor Detector HP-R-214 is located on top of elevator shaft as shown by the bold arrow.

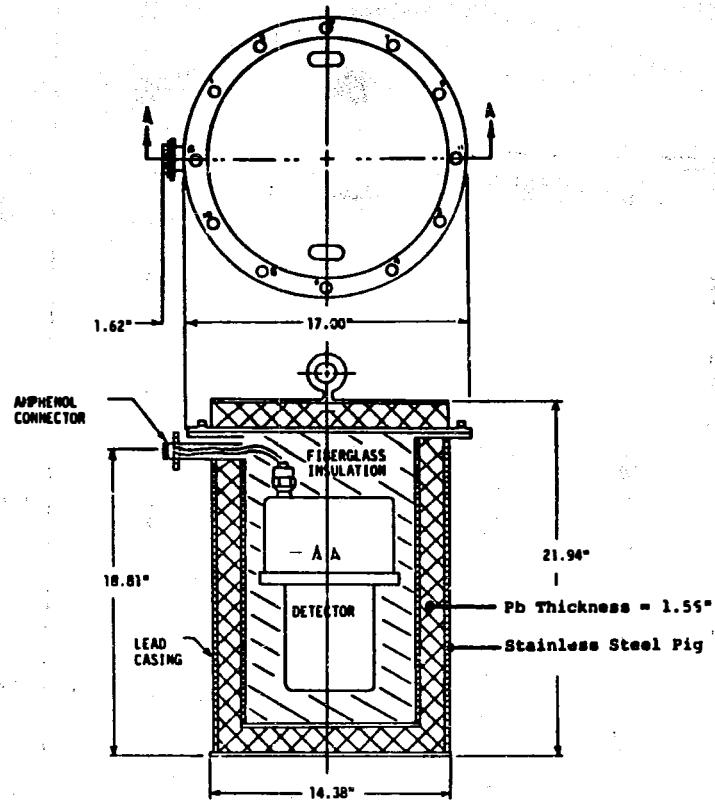
**Figure 8. Dome Monitor HP-R-214 Vessel.
Cross section of stainless steel container.**

The actual radiation detector is packed in fiberglass insulation and is housed inside the stainless-steel vessel. The vessel (sectional view, Figure 8) has lead between its double walls.

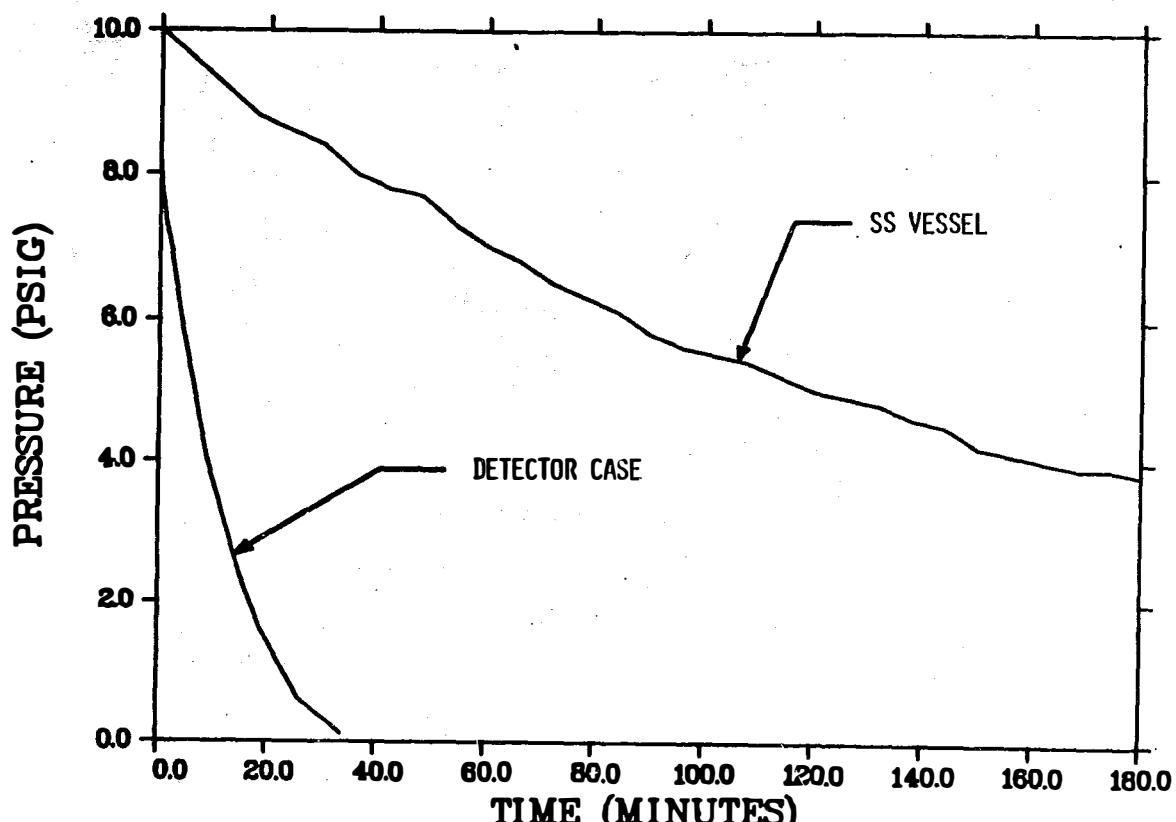
Figure 15. Leak Rates. The stainless steel vessel and detector container leak rates.

We mounted a specially designed fitting to the undamaged tube end which allowed us to leak-test the ss vessel. We then pressurized the container to 10 psig and observed the pressure as a function of time. Later in our examination, we injected air into the detector itself through the hermetic connector and measured the leak rate of the detector. We did this by inserting a hypodermic syringe needle through the rubber center portion of the connector and pumping air into it. The results of both these tests are shown in Figure 15.

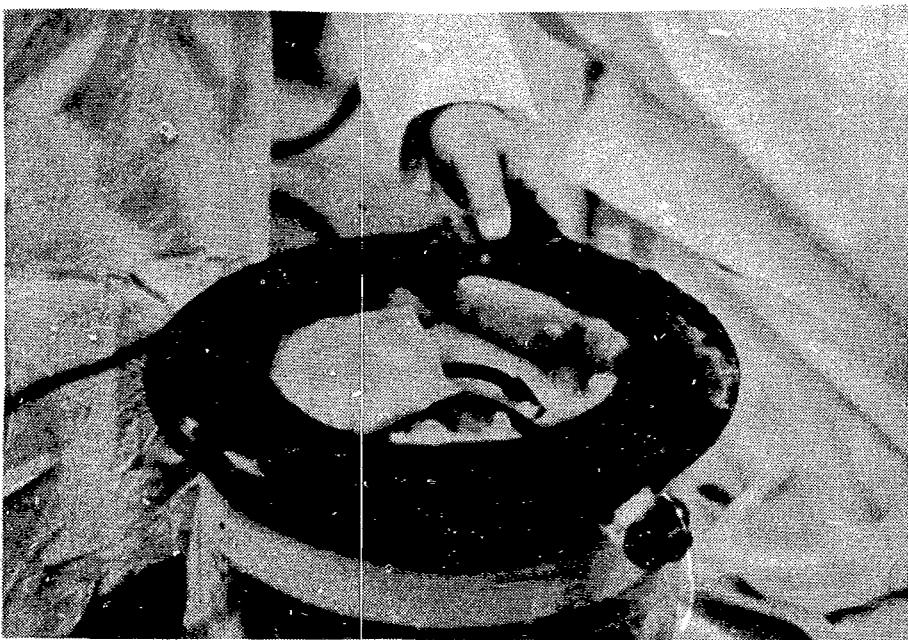
Figure 16. Stainless Steel Container Rim. The lid has just been removed. Notice how "dirty" the rim area which was under the gasket is. The radiation level measured 3 mR/hr in approximately the probe location shown in the photograph.

2. Stainless Steel Vessel Internal Contamination. As stated earlier, it was very important to determine whether significant radioactive contaminants were able to get inside the ss vessel. Because of this concern, we removed the vessel lid carefully to reduce the possibility that containment "dust" would fall into the vessel. All twelve top retaining bolts were tight, having a minimum of 60 inch-pounds breakaway torque. After the lid was removed, it was apparent from the spreading of the gasket that the top was indeed securely fastened. Figures 16 through 17 show the vessel and detector in various stages of disassembly.

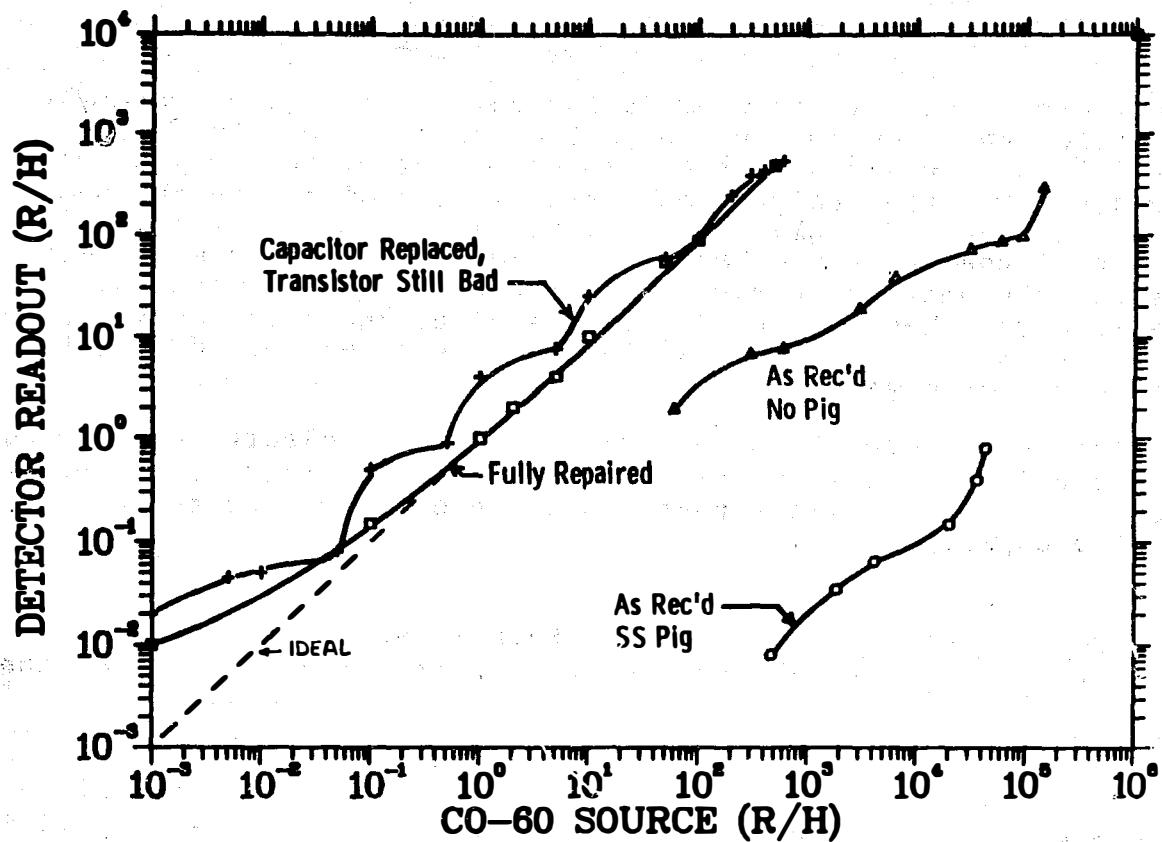
Figure 18. HP-R-214 Detector Readout Vs. Co 60 Source Strength. The curves show the response of the detector in the various stages of disassembly and repair when exposed to a Co 60 source. The curve in the lower right-hand corner is that measured upon receipt at Sandia National Laboratories after decontamination of the outside of the vessel. The curve directly above is the detector response outside the ss vessel but with no repair work done. The somewhat linear curves on the left are those of a partially and a fully repaired unit with low humidity.

The unopened ss vessel was exposed in the GIF facility; the results are given in Figure 18. The radiation levels measured inside the ss vessel by HP-R-214 are considerably below those of the new detector when it was later placed inside the vessel and similar data taken.

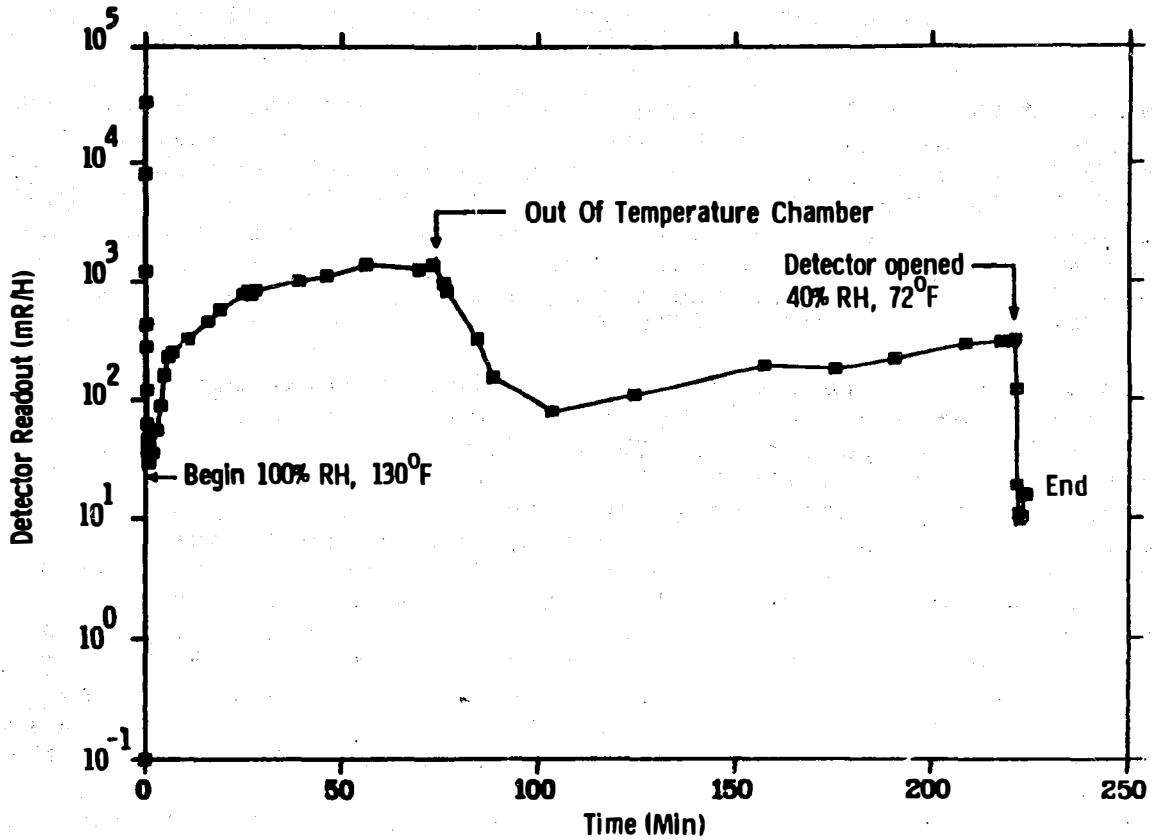
Figure 19. Humidity Effects. The detector was put in a 100% RH environment; it was heated up, allowed to cool, then opened up to room atmosphere. The unit was not exposed to any radiation source.

*The purpose of the wet sponge was to establish a known relative humidity (RH) of 100% inside the detector. Earlier, we had conducted tests in a standard humidity chamber but at humidities greater than 90% RH found that accurate control of the level could not be maintained.

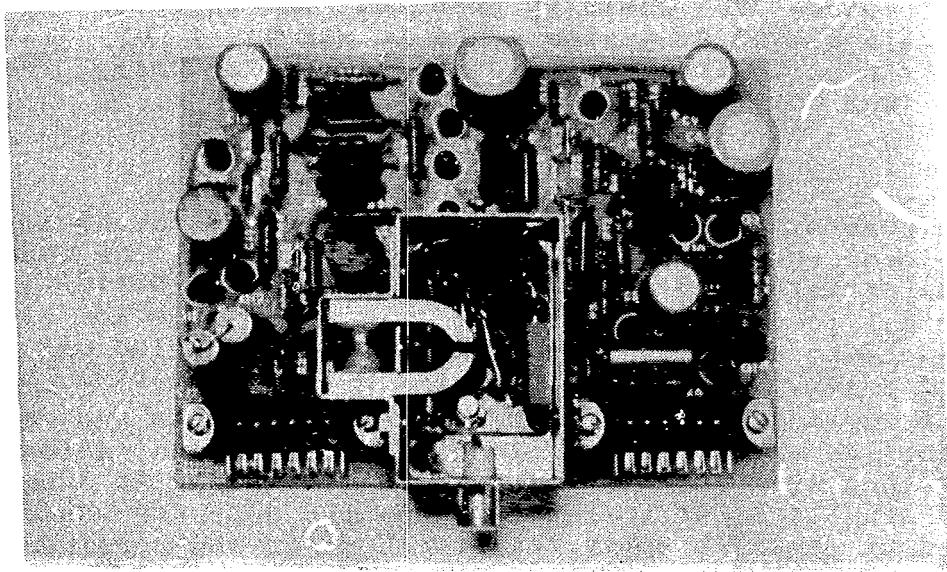
Figure 20. HP-R-214 Detector Lo Amp Board.
The cover has been removed from the preamplifier shield box. The ion chamber electrode enters the box on the down side of the photograph. The application of high humidity in this box or around the electrode plug caused the detector to read high with no radiation present.

Each of the Victoreen 847-1 detector ion chambers has a grounded guard ring around the chamber electrode to separate it from the -150 volt plate potential. This is typically done on extremely high impedance circuits to minimize any leakage from the high voltage plate to the output electrode. Surface conduction is a major problem, and it is enhanced by contaminants (notably sodium) and moisture. Resistance from the electrode to a voltage source as high as $10E10$ to $10E12$ ohms is still small enough to typically cause inaccurate readings. With reference to the guard ring, the design of HP-R-214 appears to be proper. We were not able to determine precisely which leakage paths were causing improper readouts from HP-R-214. However, we can state that they were either 1) inside the shielded preamplifier boxes in both the low and high preamplifiers, 2) on the ion chambers where the electrode exits, or 3) in both places. (See Figures 20 and 21.)

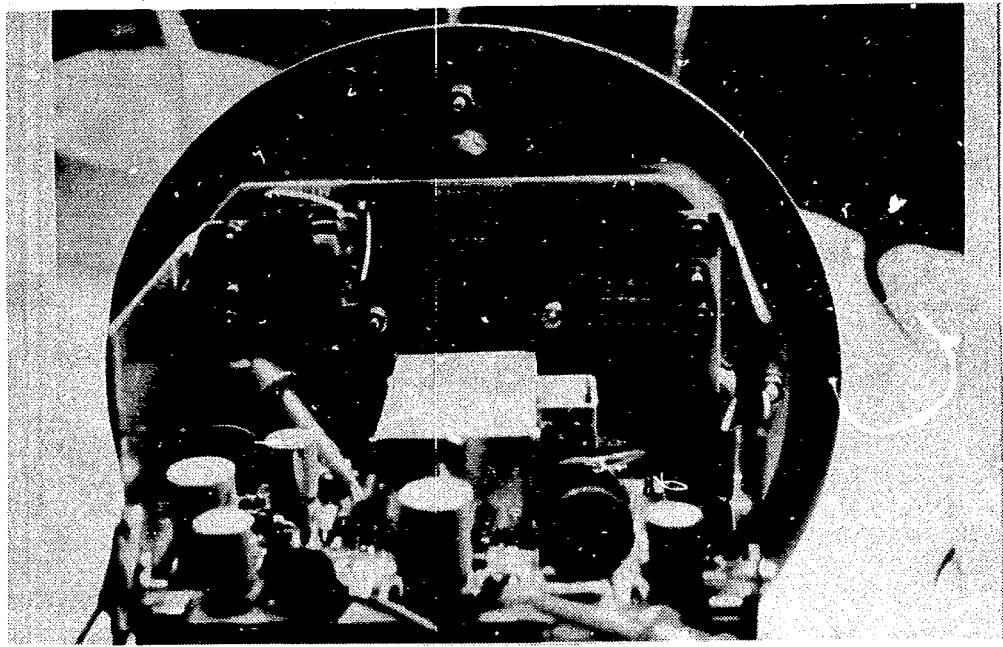
Figure 21. End View of Detector Electrode Pin. The pin exits the chamber assembly and plugs into a receptor jack in the end of the preamplifier shield box. The box is shown as it is mounted on the printed wiring assembly just prior to insertion into the chamber assembly connectors.

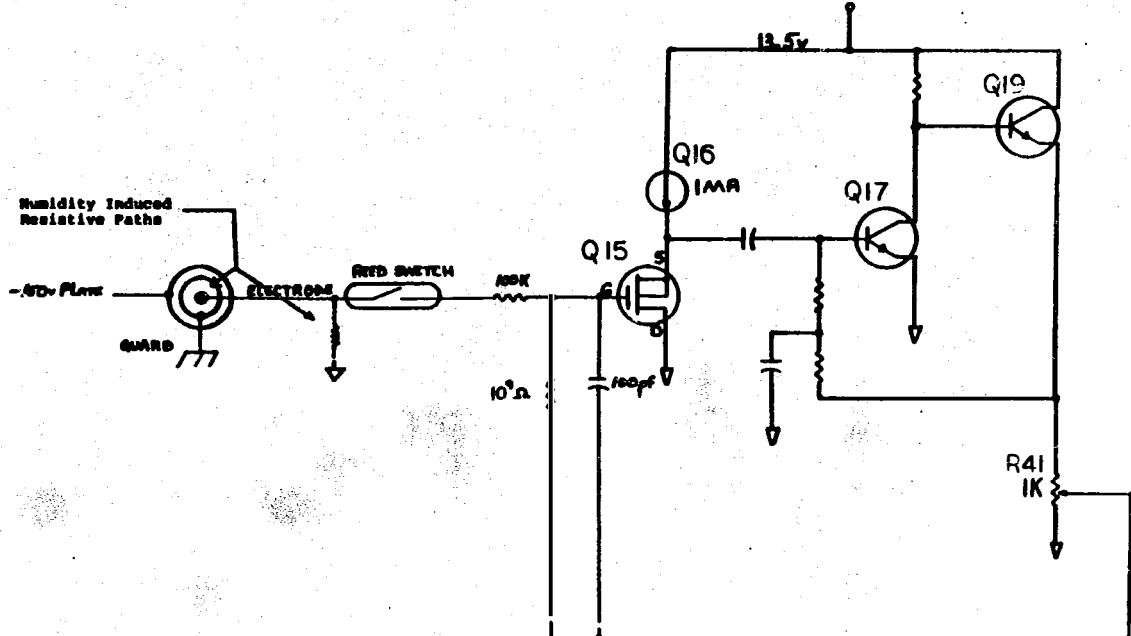
Figure 22. HP-R-214 Detector Pre-Amp Equivalent Circuit.
Feedback from R41 coupled with a humidity-induced resistive path on the ion chamber electrode and reed switch action can produce an AC signal out of the preamplifier. This signal is then amplified by 900. This erroneous signal causes the detector to indicate radiation where there is none.

Leakage Paths--The circuit diagram shown in Figure 22 is a simplified schematic of the high range preamplifier. Let us assume that a resistive path exists on the electrode side of the reed switch. The DC voltage on the emitter of Q19 is 0.7 volts. A part of this voltage is fed back to the gate of Q15. With the reed switch closed, the gate voltage would have a value set by the resistive divider action of the 10E9 ohm resistor and the moisture-induced resistance. When the reed switch is open, the potential would abruptly change since the moisture resistive path would no longer be there. This change, even though it is small, would appear as an AC signal out of the preamplifier and would be amplified by 900 by the time it reached the output of the last amplifier in the amplifier chain following the preamplifier. The signal could thus cause a significant deflection of the readout meter even in the absence of a radiation field.

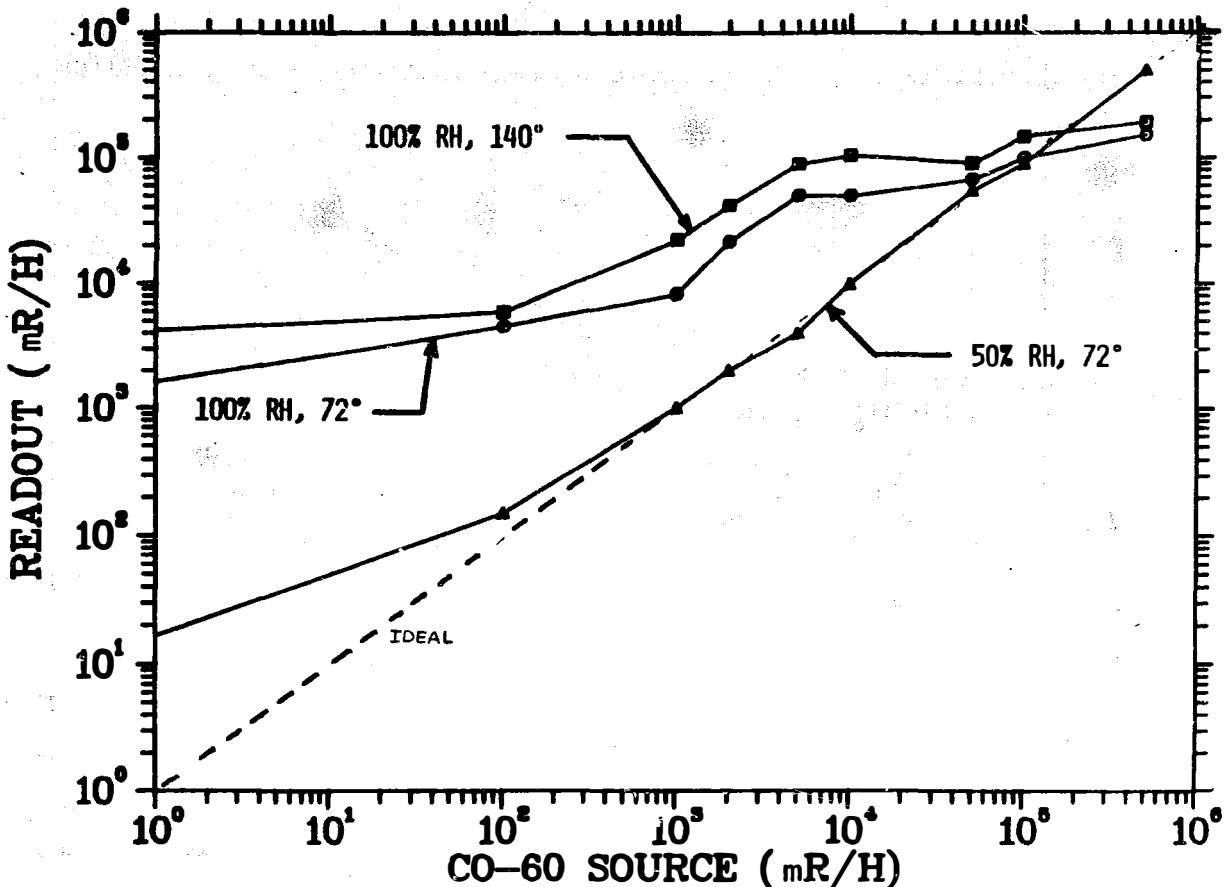
Figure 23. HP-R-214 Detector Readout on the Sandia Vertical Range. The effects of moisture and temperature on the detector accuracy are evident.

The data using the fully repaired unit was taken at the Vertical Range where 600 R/hr is the maximum achievable level. Figure 23 shows the data under different temperature and humidity conditions. Again, the room temperature, low humidity case is quite linear and accurate. The effect of 100% relative humidity is

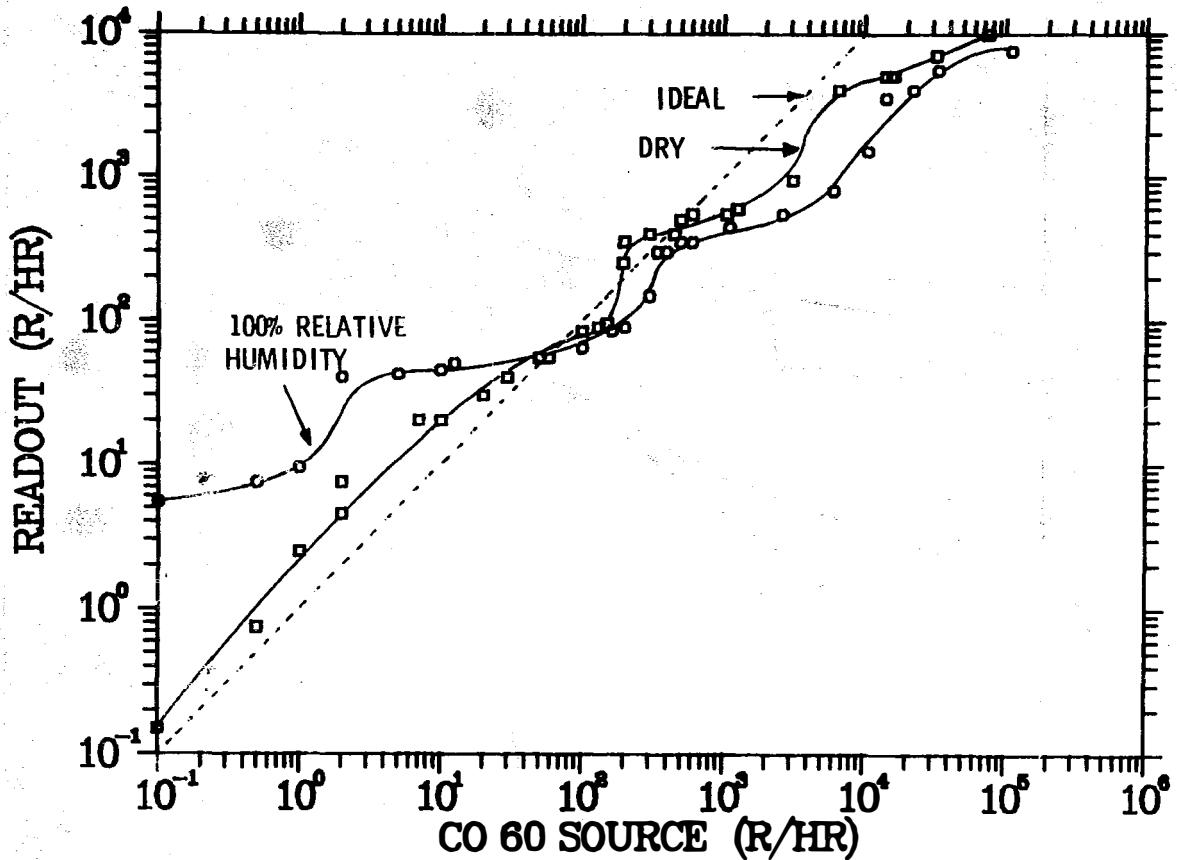
Figure 24. HP-R-214 Readout Vs. Source Level. Vertical range and HIACA data are shown for both dry and high humidity cases.

Figure 24 combines the relatively low level radiation data from the Vertical Range with the much higher levels attainable at HIACA. At low radiation levels the "dry" detector is significantly more accurate than when moisture is introduced. At radiation input levels above 100 R/hr, the readout response is substantially below what it should be for both dry and 100% RH cases.

The reasons for the higher readings at low radiation levels, as discussed earlier, is due in part to the erroneous high amplifier contribution to the output signal because of the particular DC feedback signal which results when humidity introduces a resistive path to ground. At very high radiation levels this effect is overshadowed by the radiation signal itself. The reason for the abnormally low readings at very high input levels appears to be the result of a reduction in low amplifier output. The photographs shown in Figure 25 of the high and low range preamplifier outputs demonstrate both the erroneous high range amplifier signal at low radiation levels (Figure 25 D, E, F and G) and the reduced low range amplifier signal (Figure 25 H) at high radiation levels. (The oscillation present on the high range preamplifier output was caused by the test setup.)

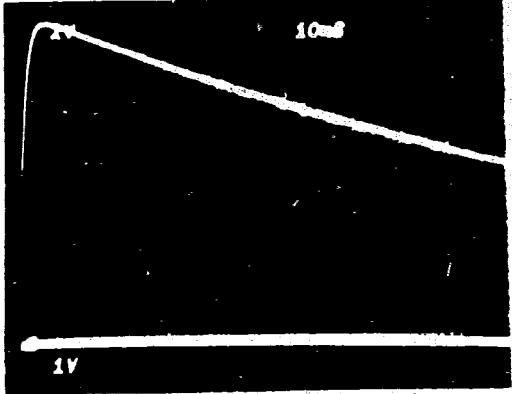
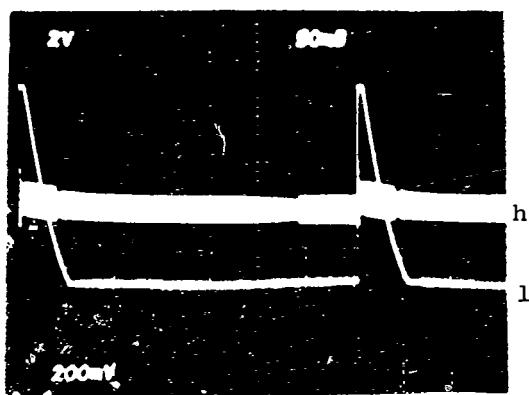
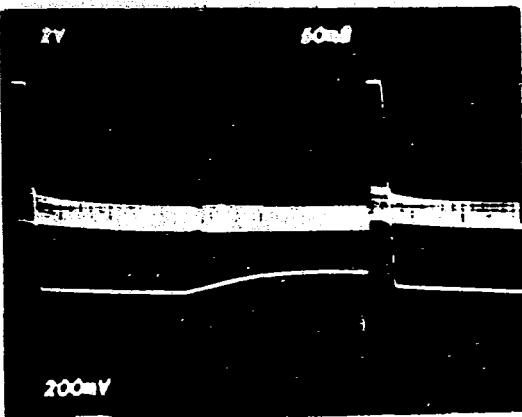
A. Dry, Source 1R/hr.
Meter .05R/hr.

C. Dry Source 500R/hr.
Meter 500R/hr.

F. Wet, Source 10R/hr.
Meter 40R/hr.

Figure 25. HP-R-214 Lo Amp and Hi Amp Outputs. The detector was exposed to radiation levels varying from background to 500 R/hr under both dry (low humidity) and wet (100% RH) conditions.

G. Wet, Source 50R/hr.
Meter 50R/hr.

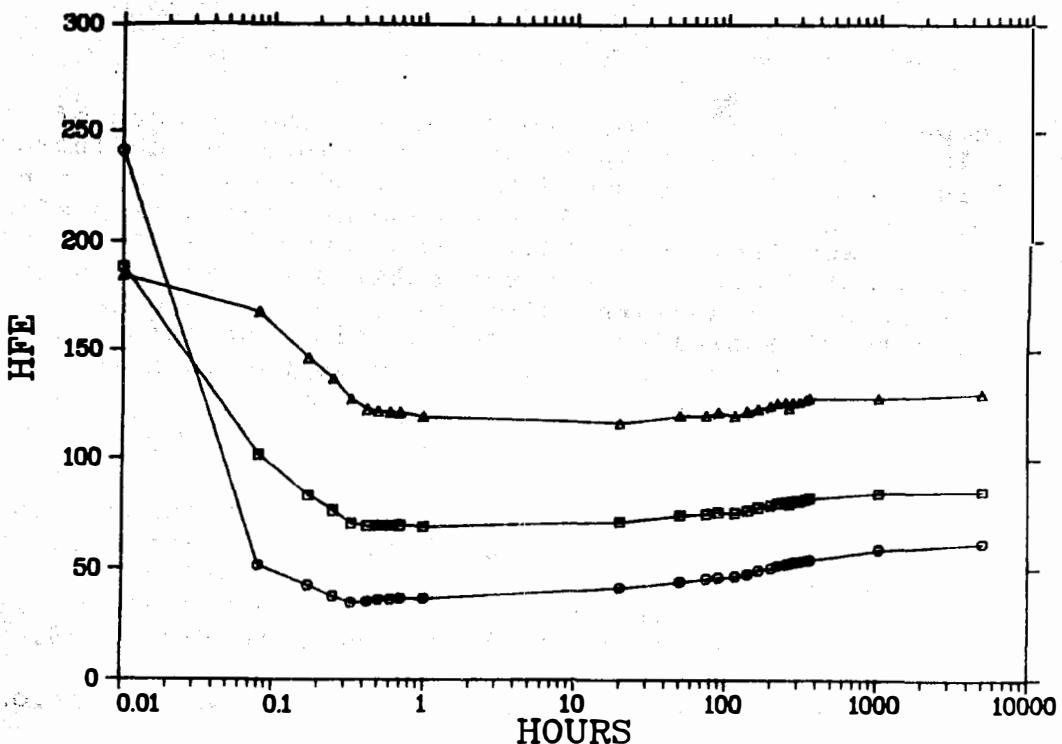
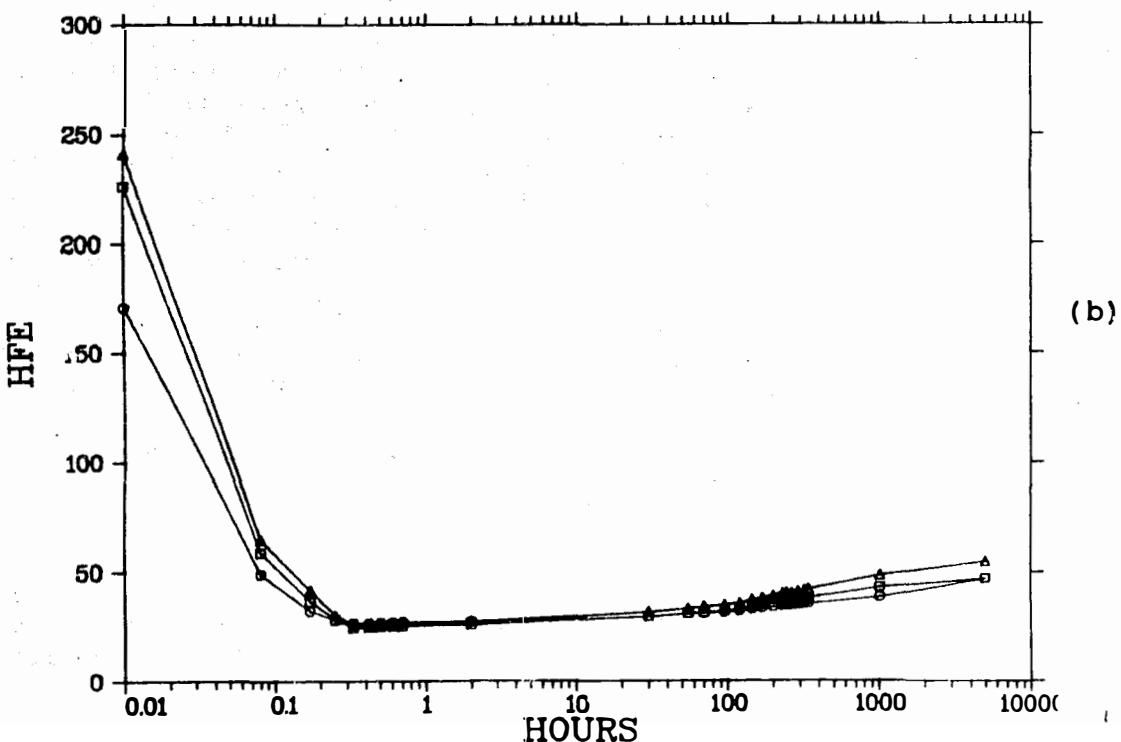
Figure 27. Transistor Annealing Characteristics. The top plot shows HFE annealing of three 2N3565 transistors which were exposed to an abrupt 5×10^5 rads. The lower plot shows a similar exposure of three 2N3904 transistors.

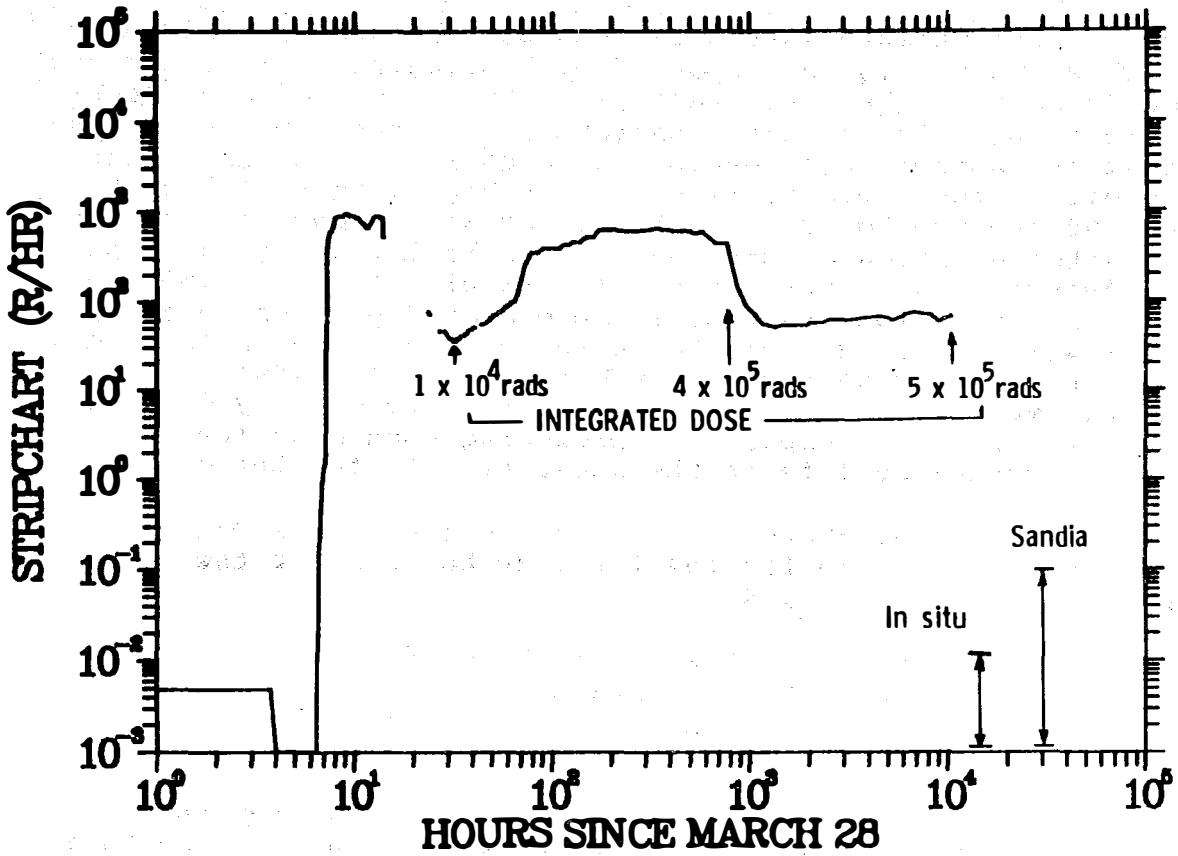
Figure 30. HP-R-214 Stripchart. The original stripchart has been corrected in this plot to account for the incorrect log paper and scaling. The "in situ" and "Sandia" notations refer to measurements made in place by TEC at TMI-2 and those made at Sandia. The vertical lines show the variability of level indications. This chart also shows the gamma integrated dose at three points in time. These doses were calculated by integrating the area under the stripchart curve.

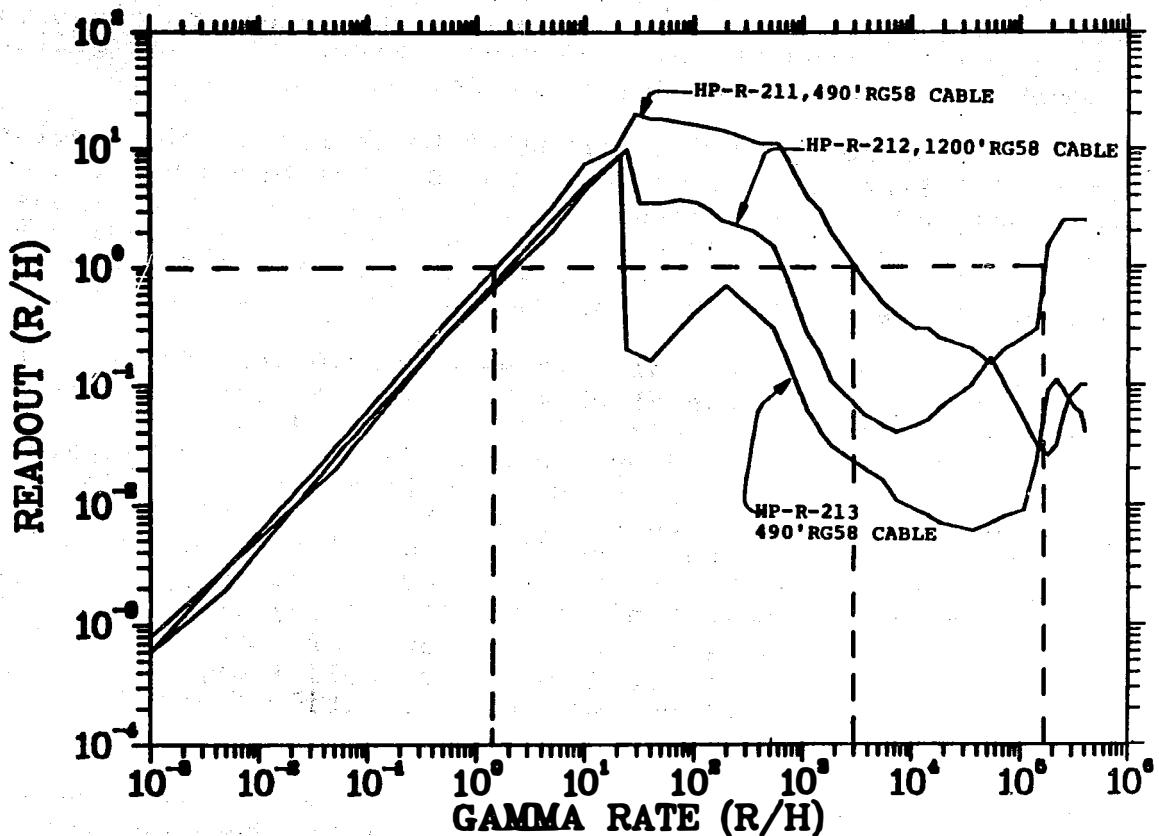
Figure 33. Multivalued Response. These curves demonstrate the multivalued response of HP-R-211, HP-R-212, and HP-R-213 when exposed to radiation levels far above 10R/hr which is the upper limit of these detectors.

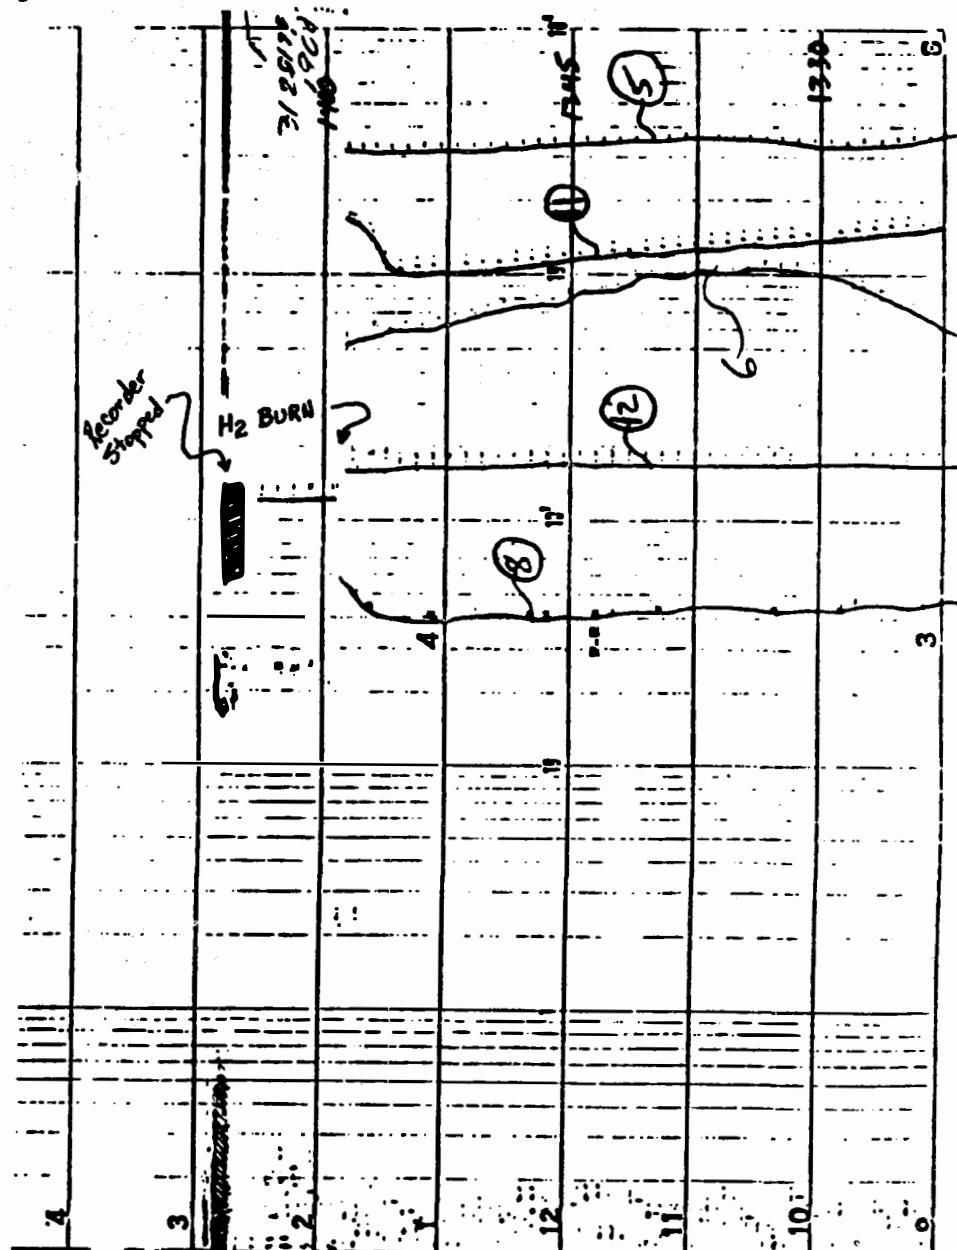
Figure 34. Actual HP-R-214 Stripchart Recording. The time axis is reversed and time increased toward the left. HP-R-214 is Channel 12 and HP-R-213 is Channel 11. The chart shows that HP-R-214 was functional after the hydrogen burn shock.

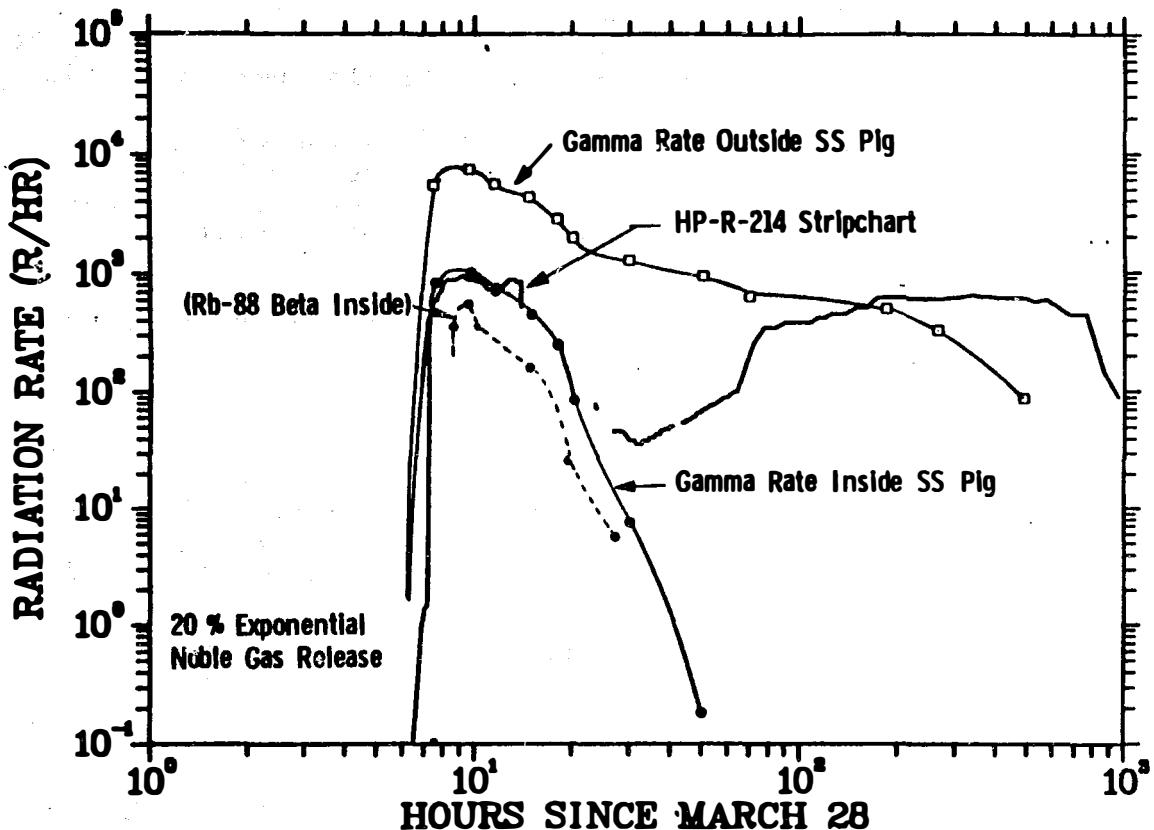
Figure 36. TMI-2 Gamma Rate History, Hypothesis 1. The first 20 hours of the stripchart recording is matched by assuming a 20% exponential noble gas release. This figure also shows what the level outside the vessel needed to be to produce the assumed level inside the vessel. If radioactive gas were present inside the vessel, Rb 88 high energy betas would have produced the response shown.

The major difficulty with Hypothesis 1 is that the indicated radiation levels in the 60 to 800 hour time frame are much higher than predicted based on the release of noble gas. No plausible radiation source has been found which would produce such high levels so late in the accident, including the shine from the steam generator candy canes.
