ANALYSIS OF THE TMI-2 DOME RADIATION MONITOR

Published August 1985

**Sandia National Laboratories
Albuquerque, New Mexico 87185**

Questions have been raised regarding the accuracy of the in-containment radiation readings from the LOCA qualified, dome radiation monitor, HP-R-214 during the March 28, 1979 accident at the Three Mile Island Unit 2 Reactor. This report discusses the accuracy of the readings, gives the results of examining the radiation monitor itself, and estimates the radiation environment inside containment during the accident.

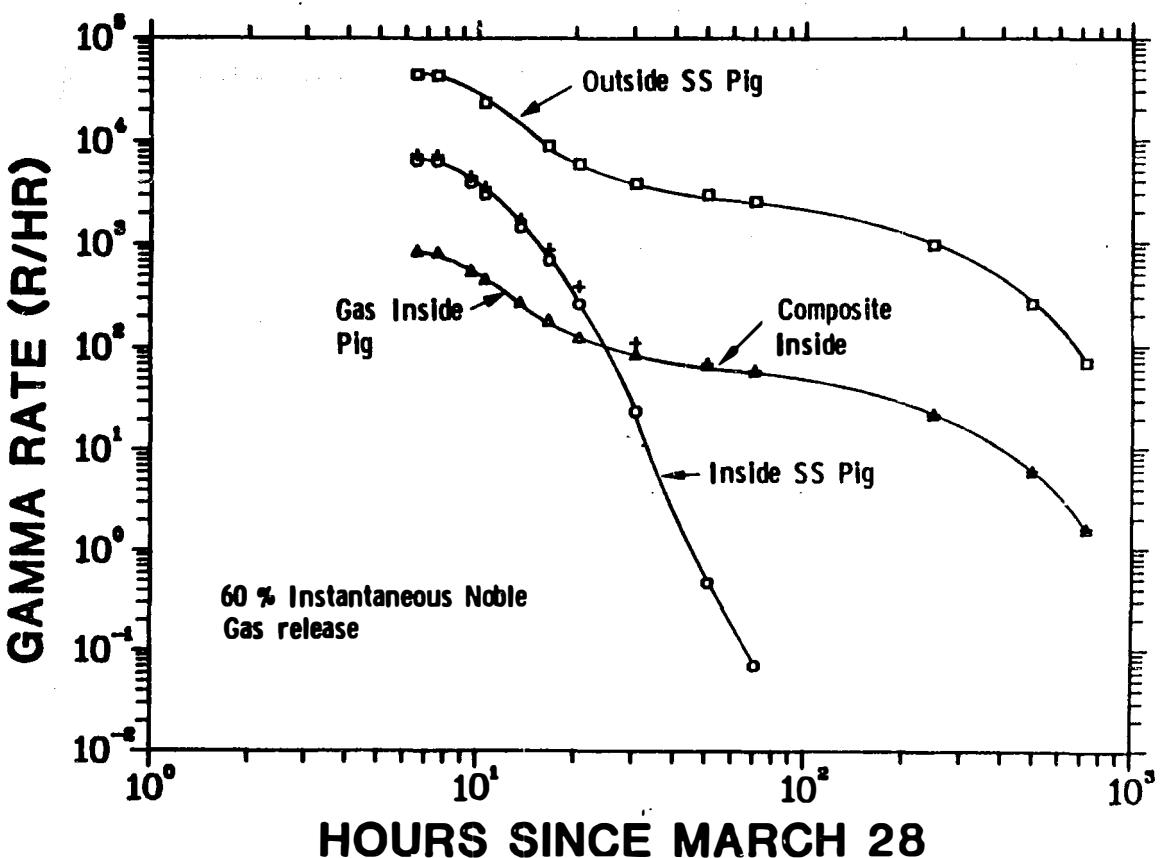
Figure 37. Effects of Radioactive Gas Inside the SS Vessel. If we assume that a 60% release of the core's inventory of noble gas occurred and that the containment atmosphere could somehow be present inside the ss vessel, radiation levels inside the vessel would be the "composite" curve. This curve and the contributions of gas inside the vessel and that due to the outer volume of containment atmosphere are shown in this figure.

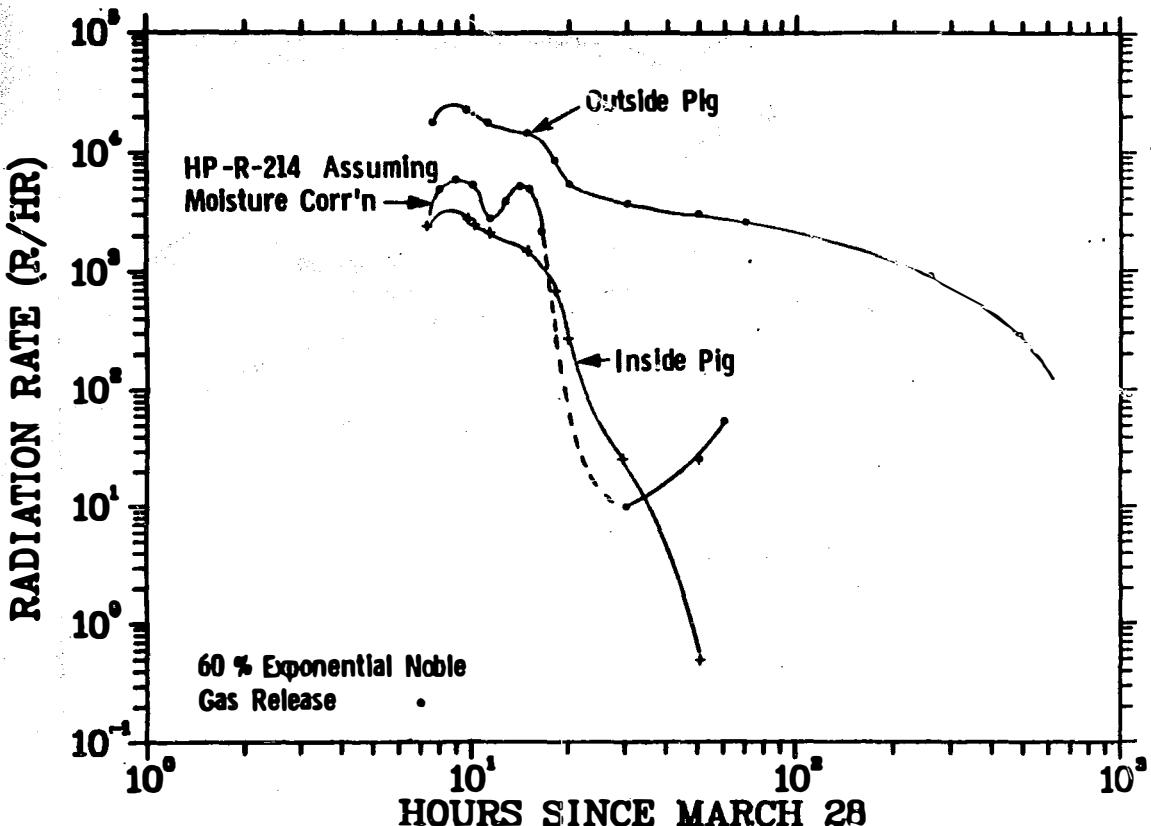
Figure 38. Moisture Correction. This set of curves shows the calculated rates inside and outside the ss vessel assuming a 60% noble gas release which is released exponentially with a two hour time constant. The additional curve shows what the detector would indicate if moisture were inside the vessel. This curve was derived by using Figure 24. Notice that the "Inside Pig" curves are both substantially higher than the actual stripchart recording, indicating that a 60% release is too high.

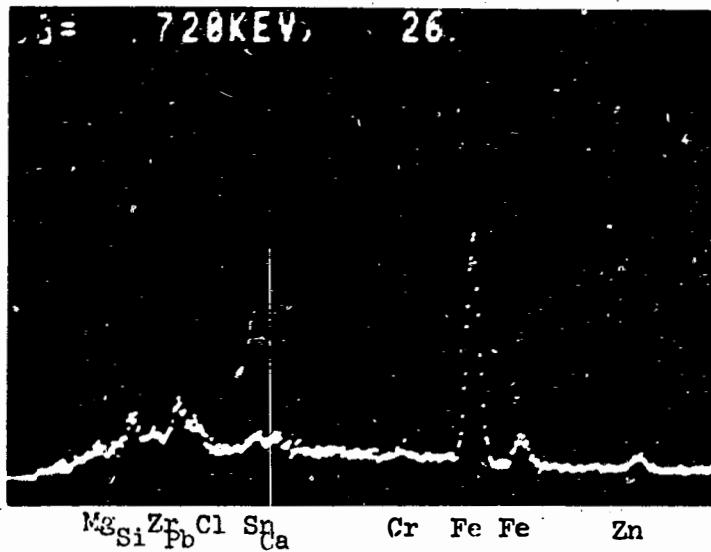
Figure 2
Elemental x-ray spectrum of particles in fig. 1

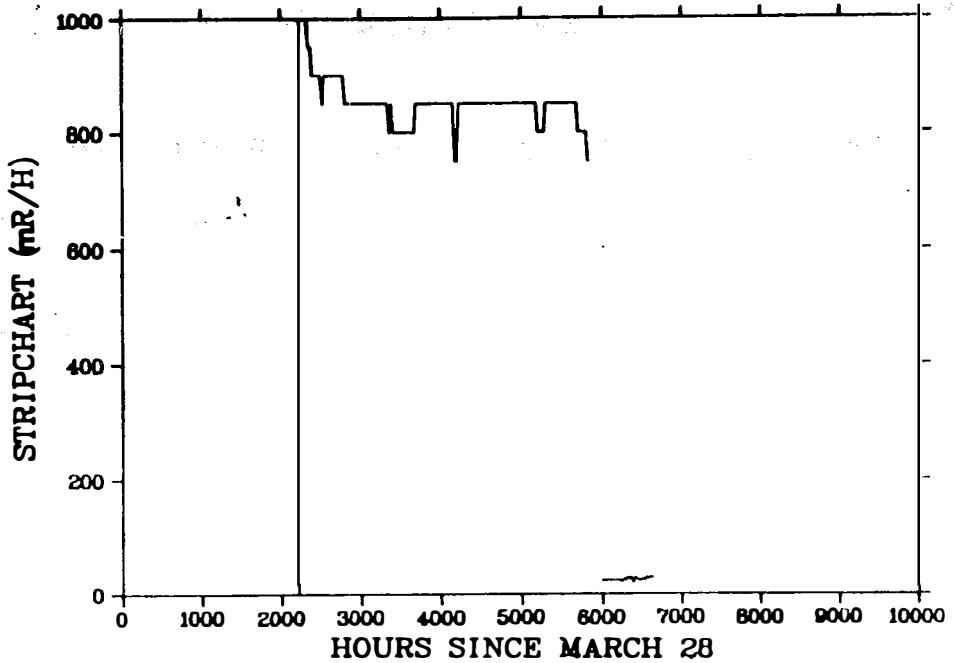
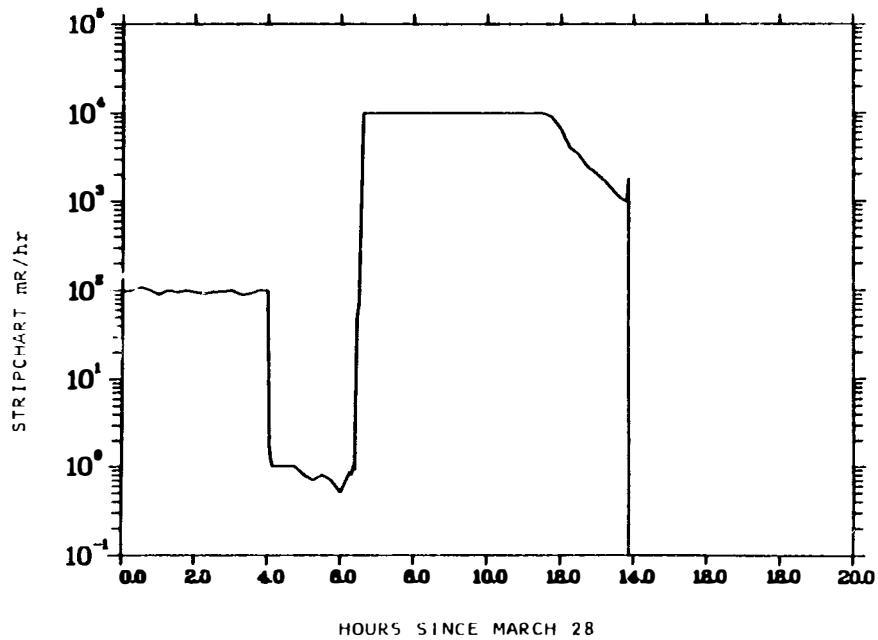
The top graph plots the stripchart from HP-R-212 as a function of hours since the beginning of March 28, 1979. The bottom shows similar information for HP-R-213. Note the difference in time scales. HP-R-213 failed early in the accident. HP-R-212 was not turned on until over 2000 hours after the accident began.
