FIELD MEASUREMENTS AND INTERPRETATION OF TMI-2 INSTRUMENTATION: CF-2-LT4

J. E. Jones
J. T. Smith
M. V. Mathis

Technology for Energy Corporation

January 1982

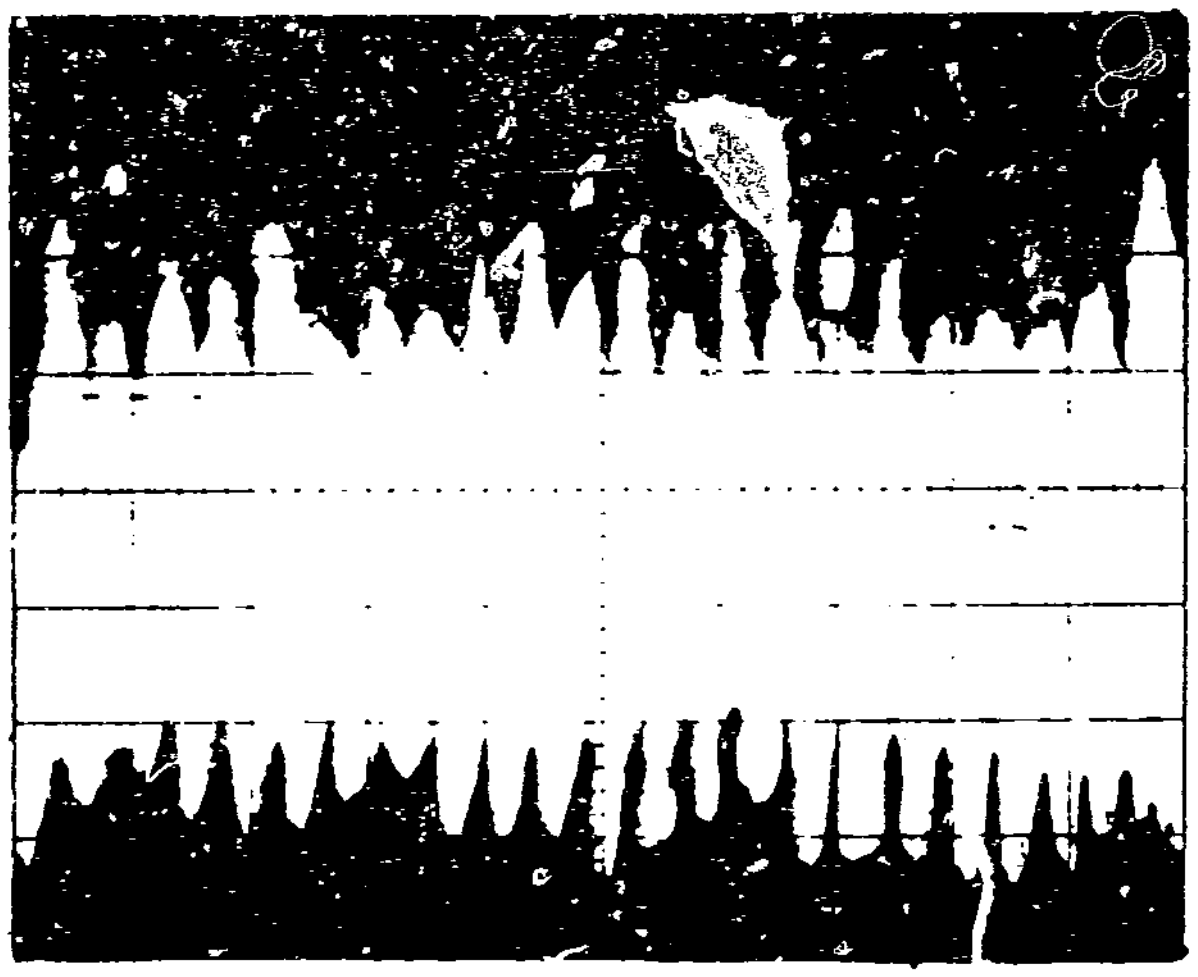
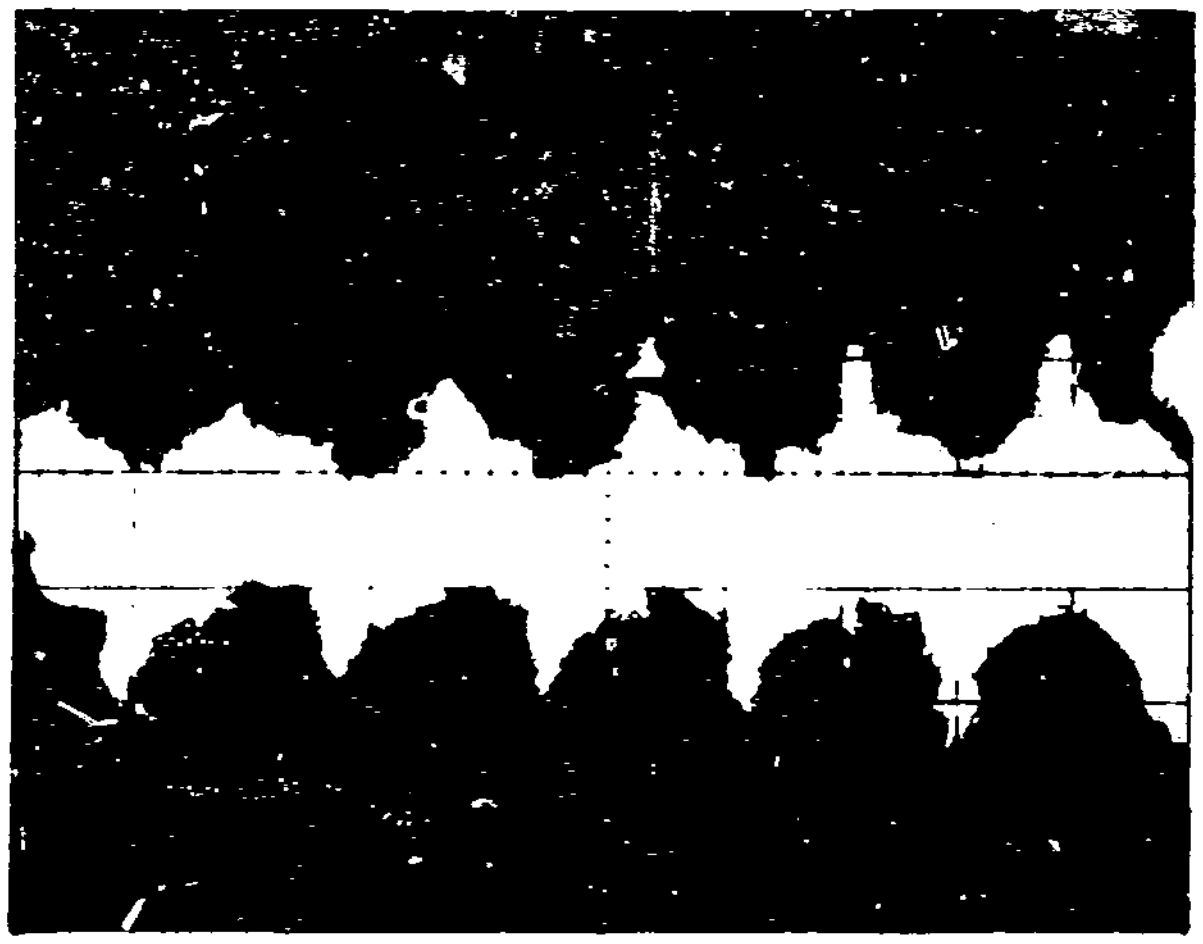
Figure 4-1. Oscilloscope Traces of Level Signal.

The time traces and frequency spectra do not indicate any serious contamination which would affect the DC readout. Table 5-1 lists the low level AC components present on the level signal. Note that even though up to 60 mV P-P fluctuations are present, readout devices normally respond at low frequencies. As a result, the worst-case effect of these AC variations is likely to be less than the 0.5 mV RMS value given for the 60 Hz components.

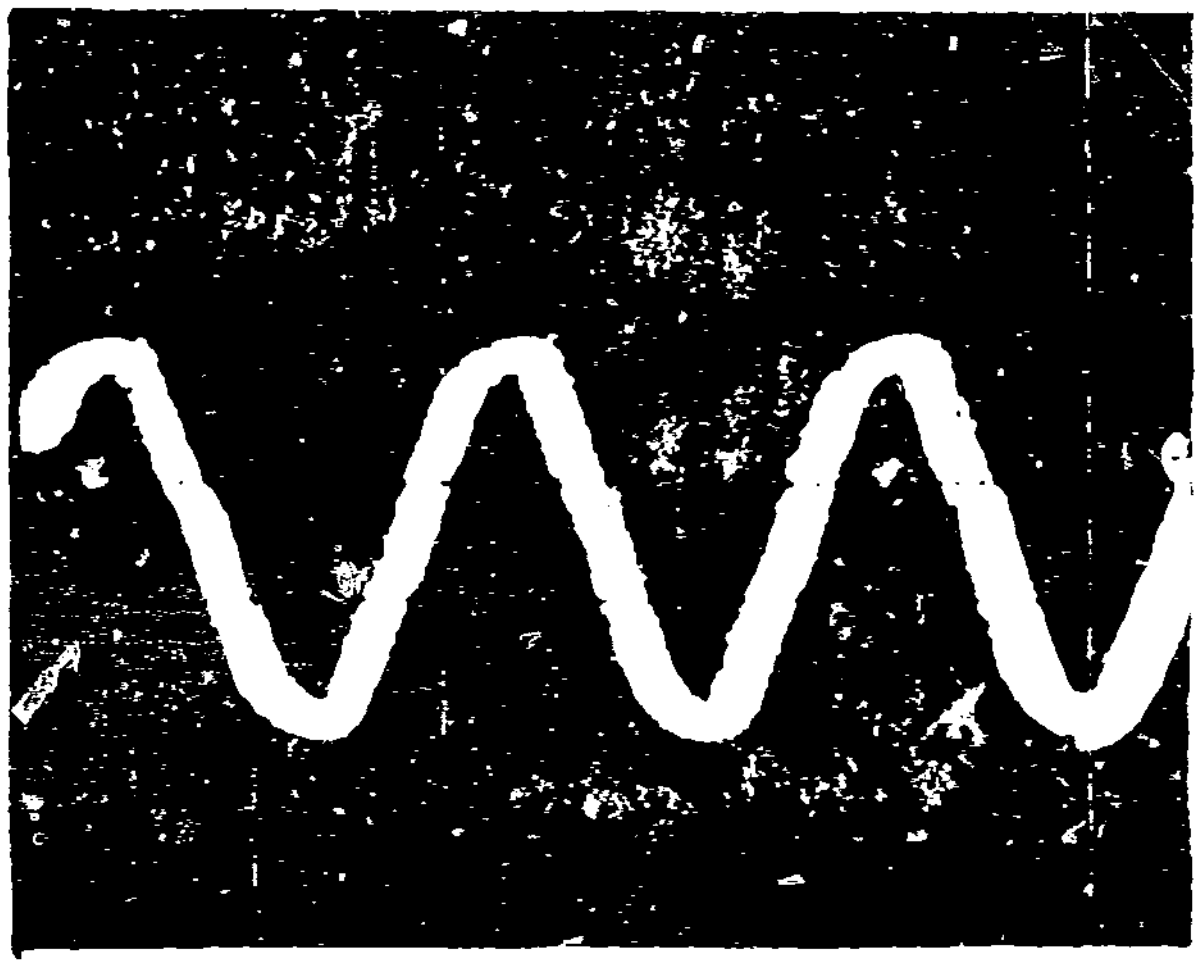
Figure 4-2. Oscilloscope Trace of 118 VAC Supply.

Since this device varies from -10 to +10 volts for a 0 to 14 foot level range, the observation of 11 foot level readout indicates that the voltage should be 5.71 volts. The measured value of 5.72 volts matches within 1% of this expected value, which indicates the readout meter is correctly calibrated. The 116 VAC value on the power supply line is also well within a normal operating range.

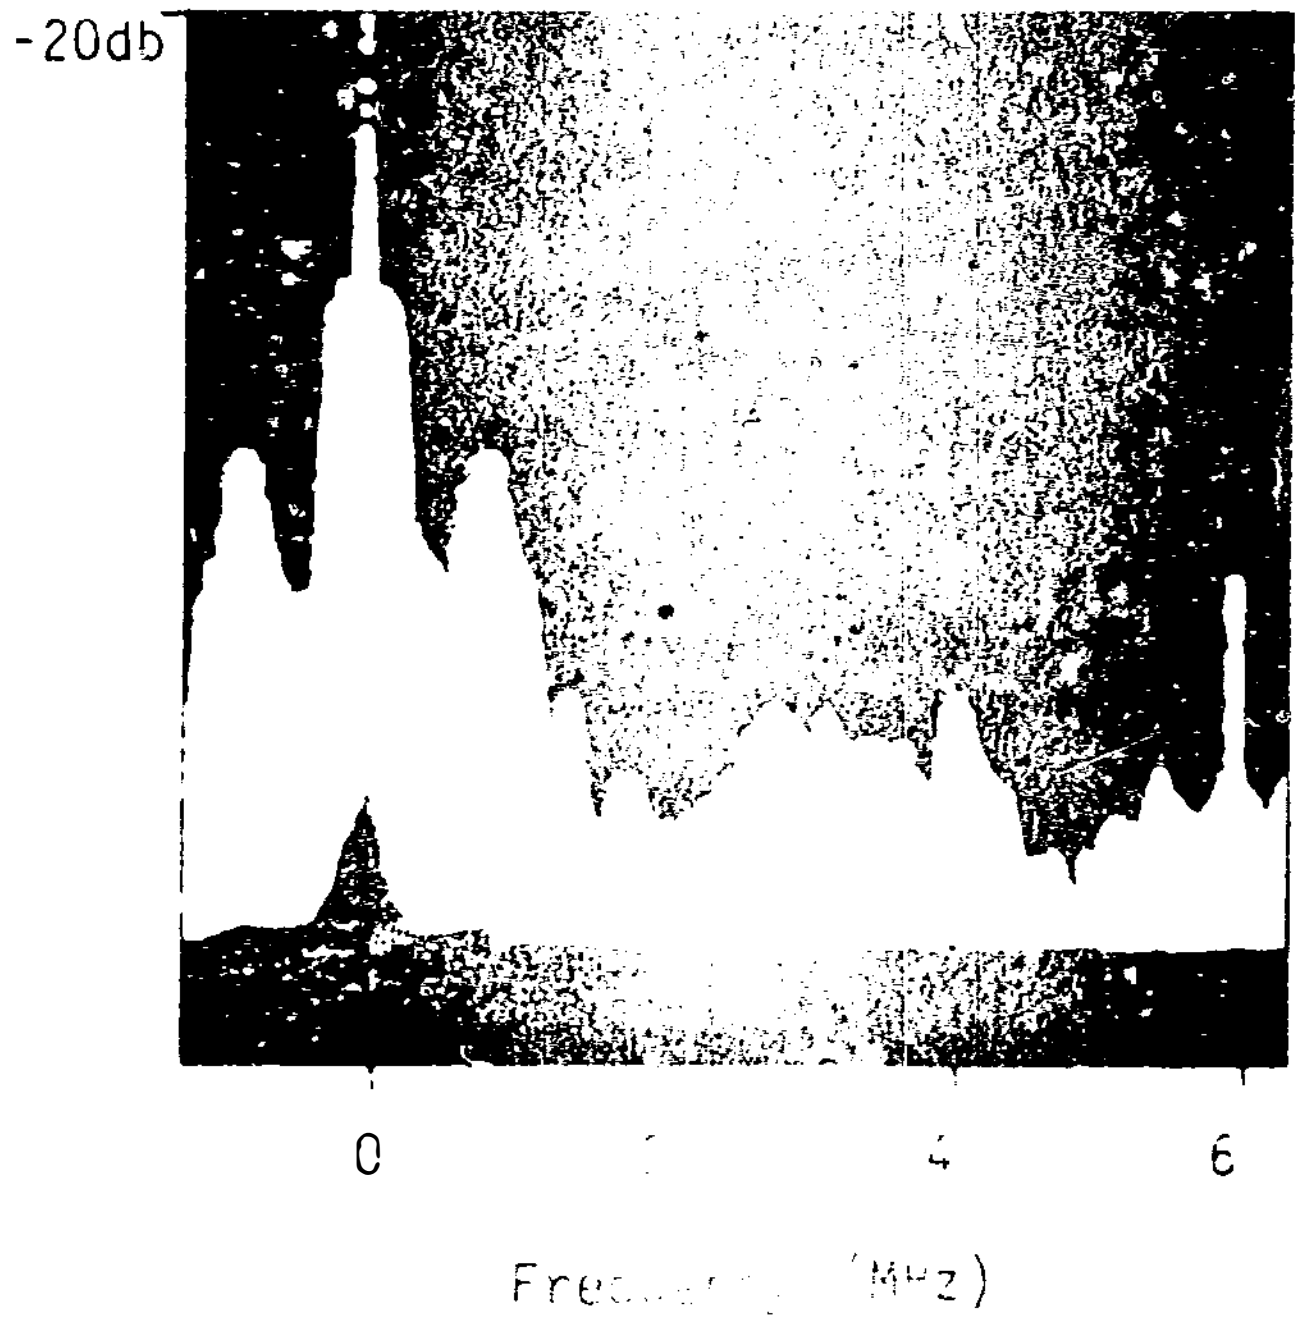
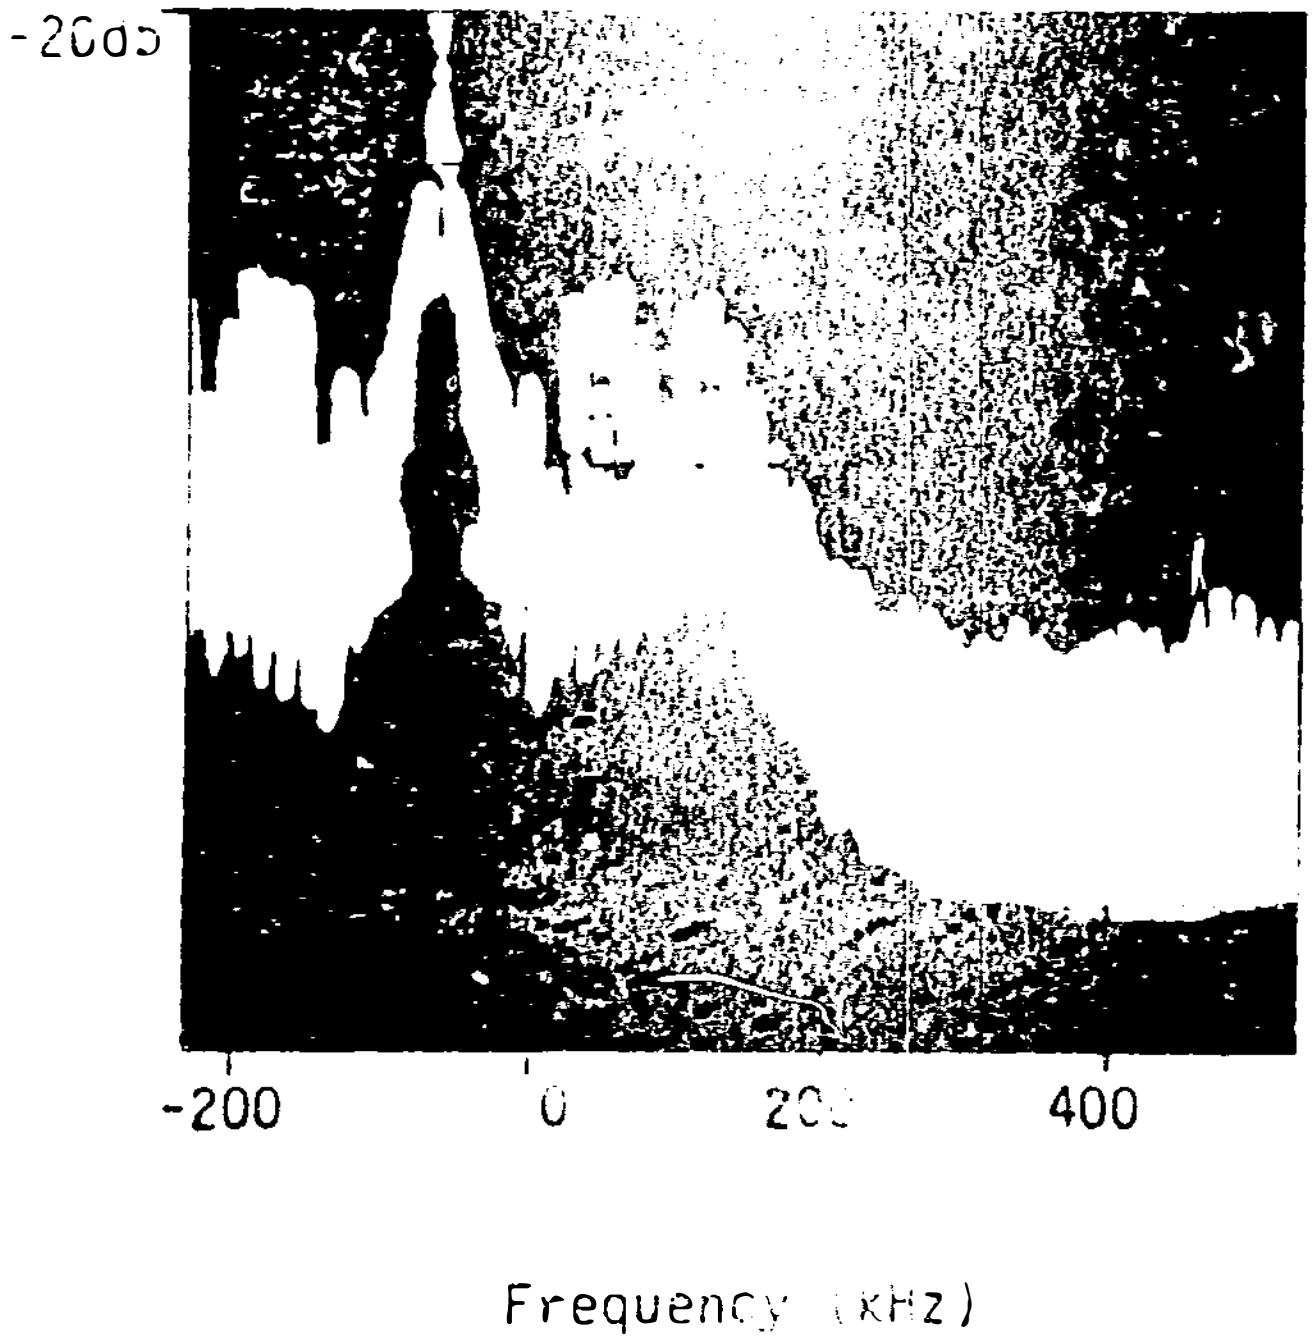
Figure 4-3. High Frequency Spectra of Level Signal.

One feature of the frequency spectrum of the level signal gives an indication that the differential pressure LVDT (see Figure 2-2) is operating. Since the LVDT AC output is "demodulated" by a full-wave rectifier and Resistance-Capacitance (RC) smoothing, a low level ripple must be present at the frequency of the internal oscillator. The oscillator for this type device operates at 1000 hertz and the component

Based on the measurements, data reduction, and circuit analysis of CF-2-LT4, there is no indication of degradation of the instrument. The only significant contamination present in the pressure signal that appeared to be abnormal was the 96 kHz component. However, the amplitude of this signal was relatively low and, from other measurements performed at TMI, this low-level 96 kHz component is probably due to a widespread 16 kHz (with harmonics) signal found in various circuits. In addition to the observation of no abnormal characteristics of the instrument, the low level oscillator ripple on the level signal indicates that the LVDT is working. Therefore, it appears that CF-2-LT4 is operating correctly, but these measurements could not determine if it is calibrated.

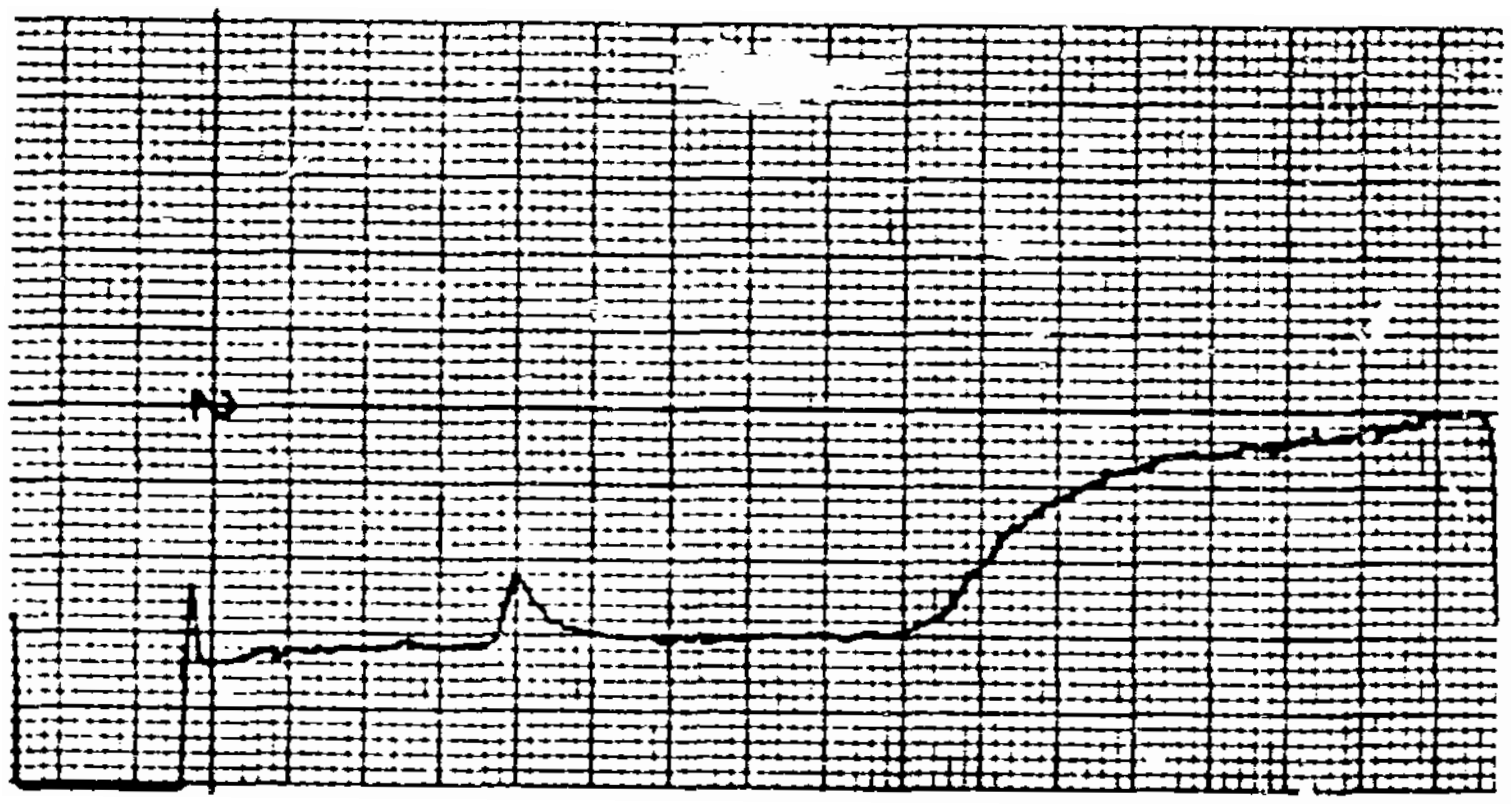
Figure 4-5. TDR Trace of Level Signal Lines

The results of TDR measurements performed on the cable (shown in Figures 4-5 to 4-7) are summarized in Table 5-2. Note that the lengths identified in the table are only approximate, since no calibration of the cable resistance and material composition was performed on the TDR instrument. Some junction points were not identified by these measurements, but no indication of cabling problems is present in this data.

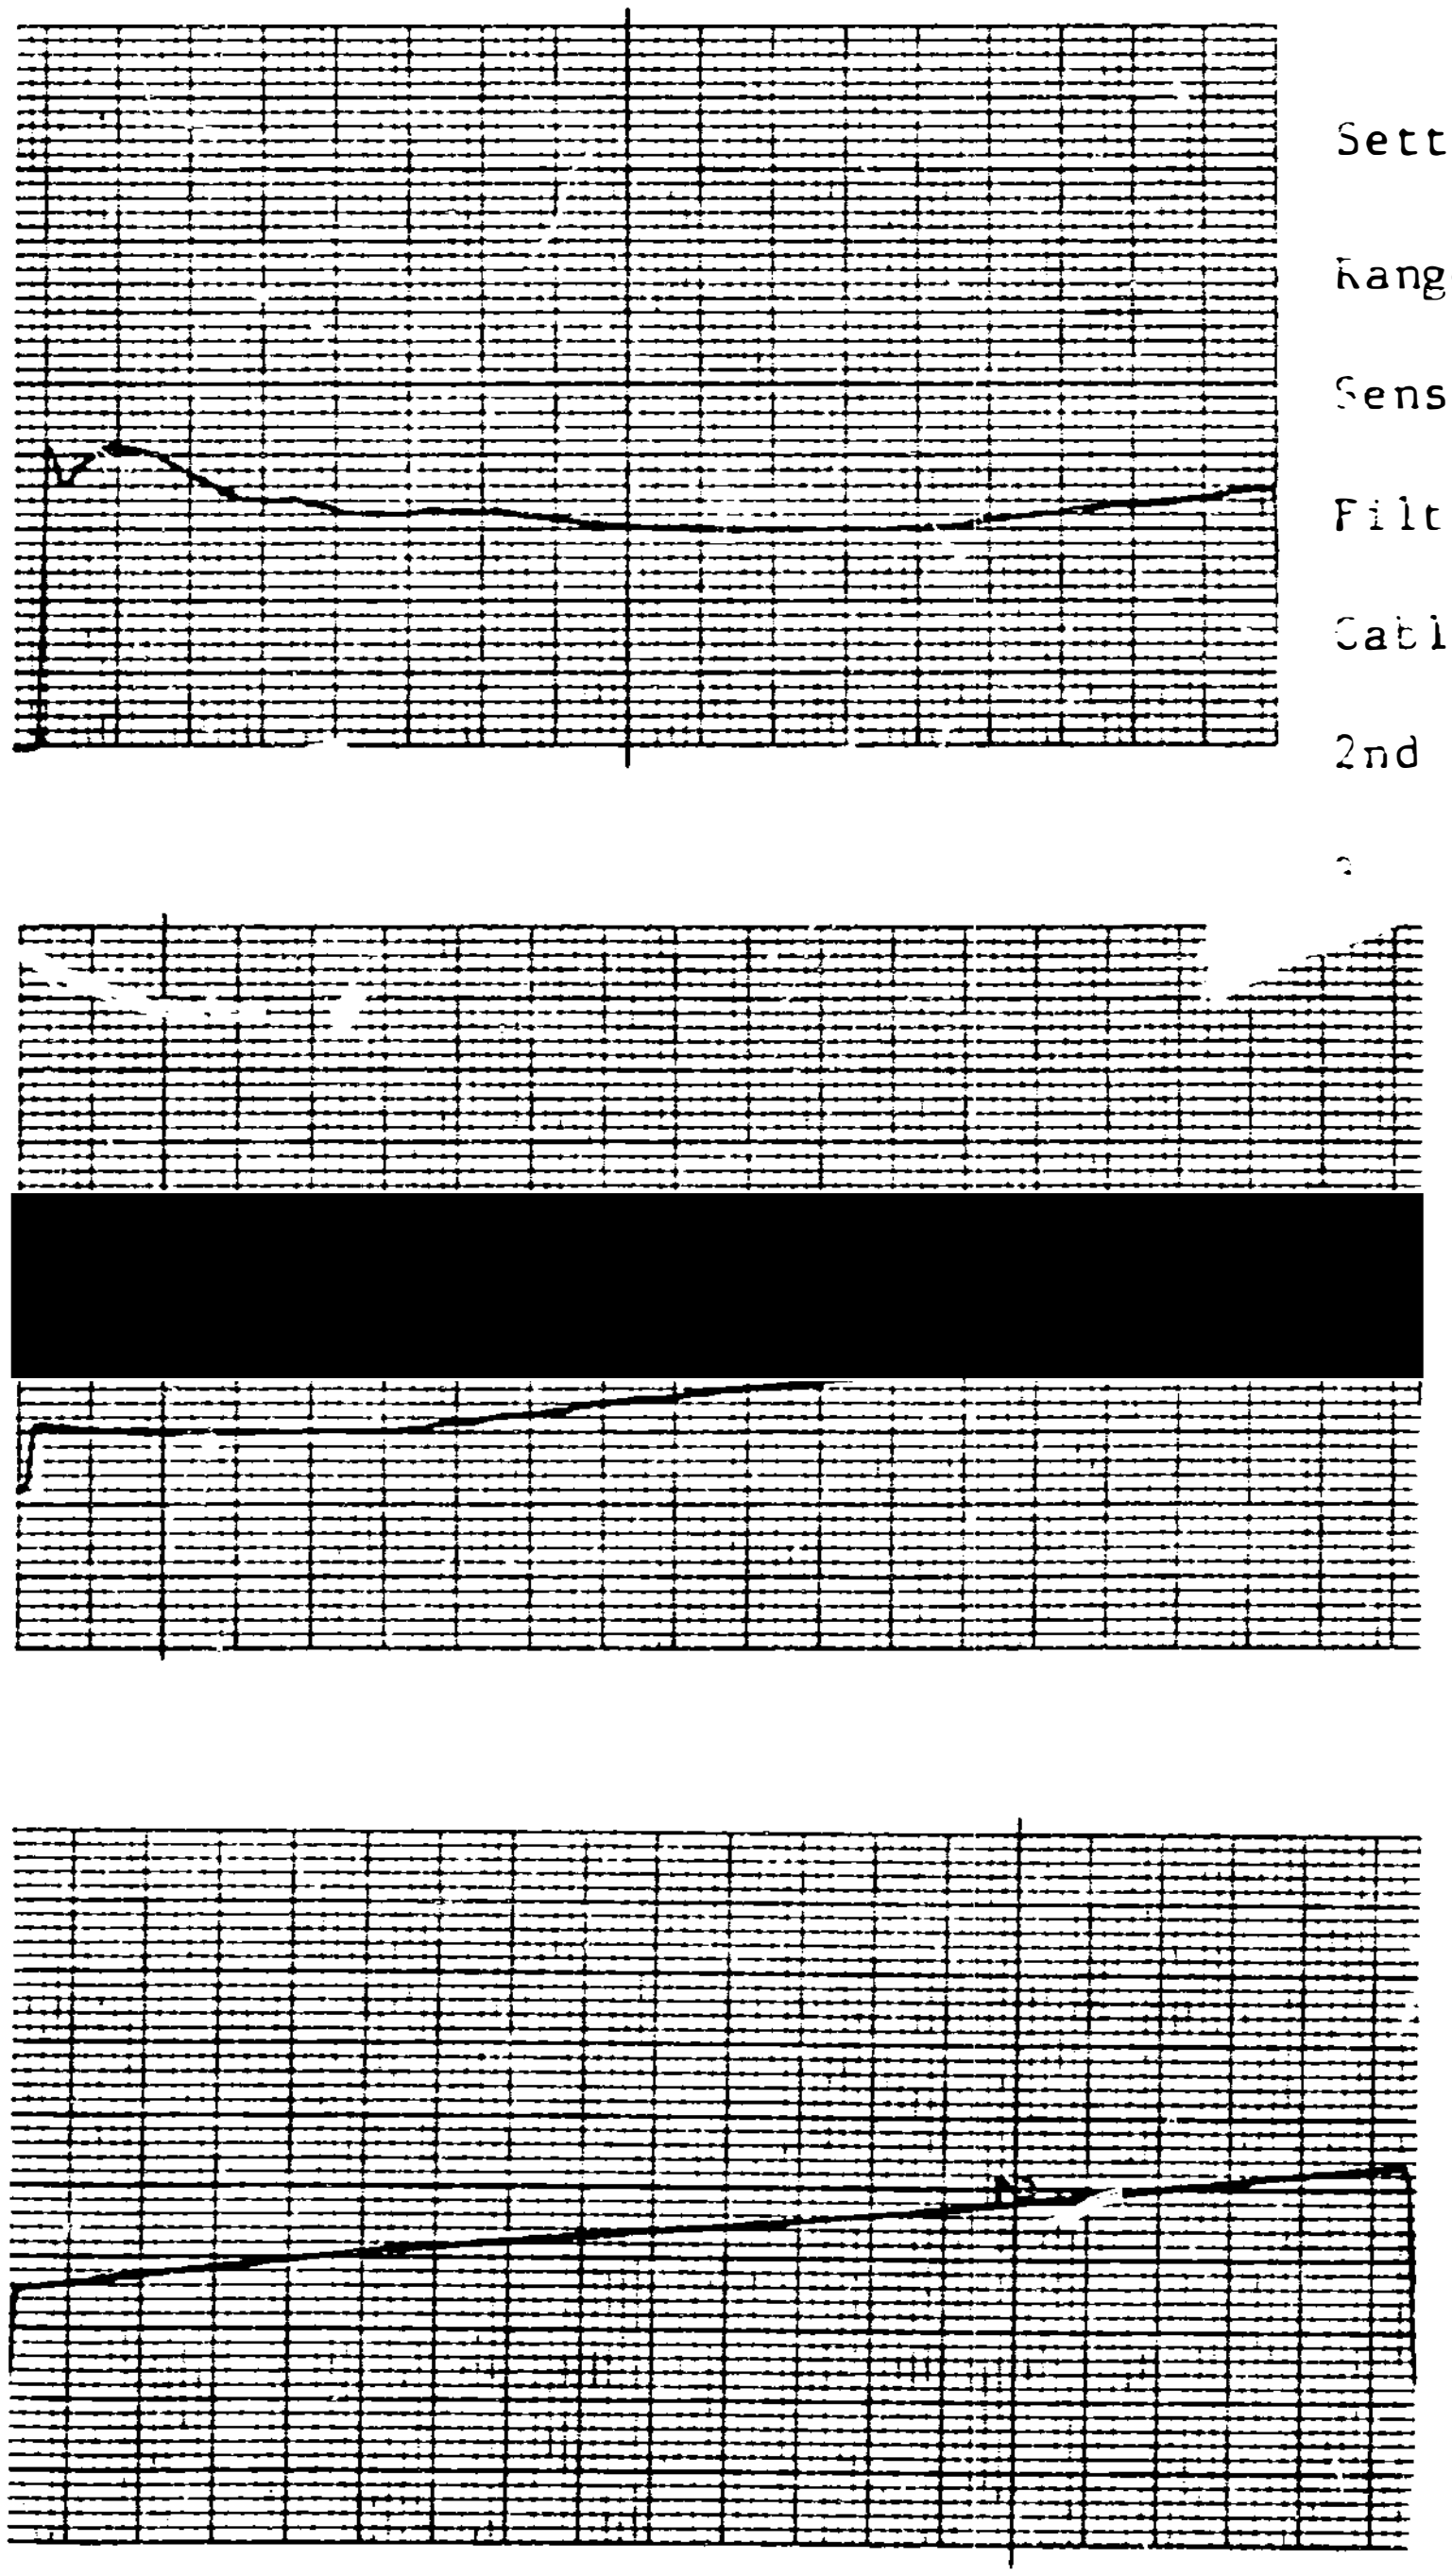
Figure 4-8. TDR Trace of 118 VAC (H) to Shield

Signal Lines	Distance* (ft)	Description**	Probable Cause
+Signal	211	Point R increase	Penetration R607
-Signal	489	Large R increase	Electronics
+Signal	200	Point R increase	Penetration R607
Shield	416	Point R small increase	Terminal block
	464	Large R increase	Electronics
118 VAC (H)	263	Point R increase	Penetration R607
118 VAC (L)	716	Large R increase	Electronics
