GEND-INF- 017
Volume VIII
January 1982

FIELD MEASUREMENTS AND INTERPRETATION OF TMI-2 INSTRUMENTATION: HP-R-212

Technology for Energy Corporation

January 1982

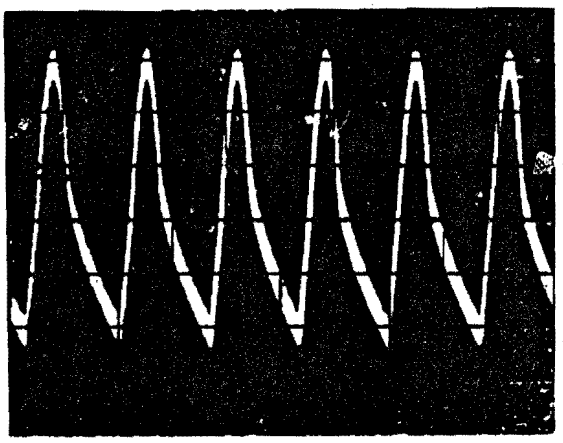
Photo # 102-1

Figure 4-1. Typical Fluctuations Present on Checksource Line 1.

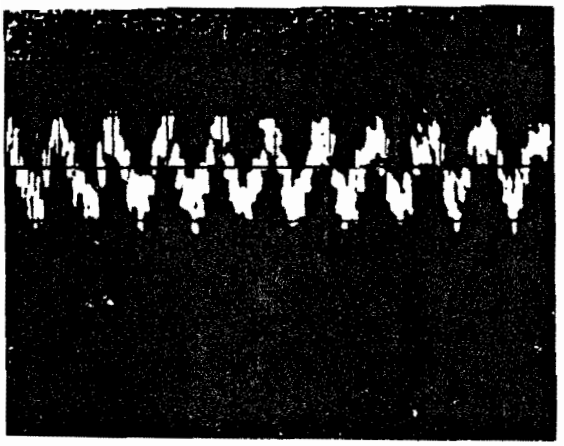
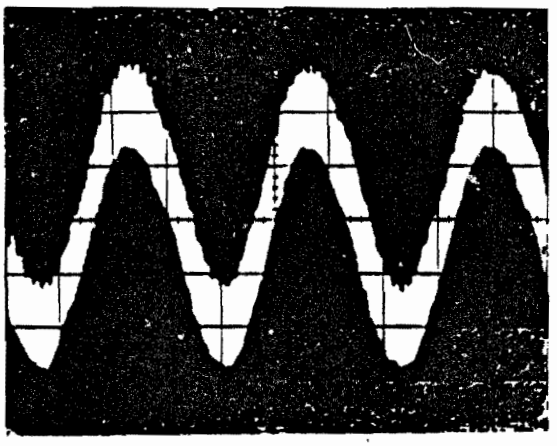
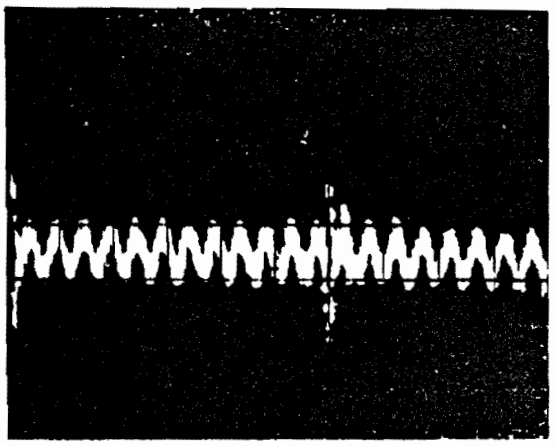
Figure 4-3. AC Variations on the 600V Power Supply.

The 10 V power supply measurements indicated a 10.1 VDC output value, which is within the expected range. The 600 V power supply was measured at 469 VDC when connected to the detector assembly, but 599 VDC when the connecting cable to the assembly was removed. This indicates an excessive load on the high voltage due to some problem in the detector or cable, or a defective power supply. The Signal In measurement produced a 4.3 VDC reading, which is lower than the expected value of 5.0 VDC for a 0-10 V pulsing output. Measurements on the checksource produced a 13.8 ma current load, which indicates the electrical path through the checksource coil is intact.

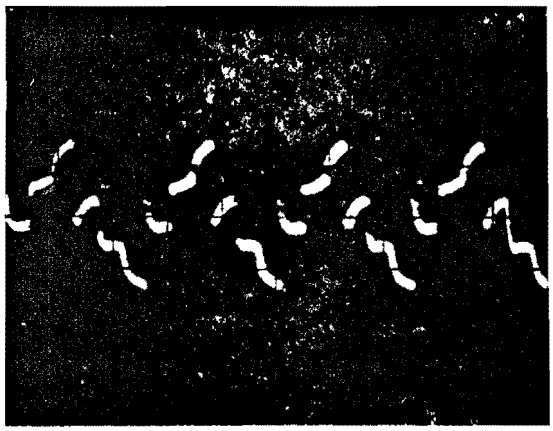
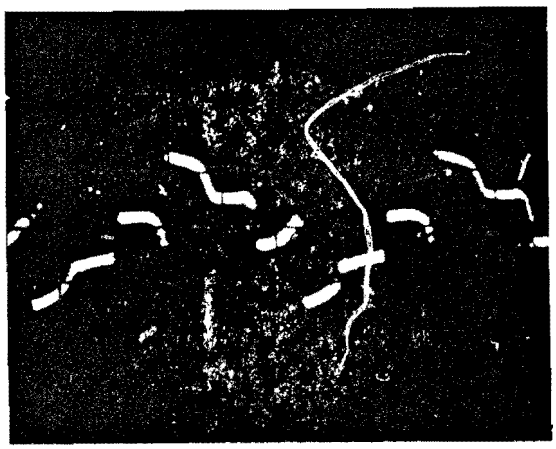
Figure 4-4. AC Variations on the Signal Output.

The Signal In waveform would normally be 0-10 V pulses with a frequency proportional to the radiation present. The oscilloscope photograph of the Signal Out line (Figure 4-4) shows that the output is a periodic waveform of approximately 6 volt peak-peak variation (and a 4.3 volt offset). Frequency spectra show the frequency of the signal to be 40 kHz and nearly sinusoidal. Resistance data (Table 4-1) similarly indicate a problem among the Signal In, +10V, and Shield lines. Table 5-2 gives a comparison of resistance data from a new detector assembly to that from HP-R-212. All resistances are higher than for the new assembly, but only the Signal In-Shield (+) and the Shield-10 V (-) show a significant increase.

In addition, the output of the detector should consist of 0-10 V pulses even if the "anti-jam" circuit is active. The observed output was nearly sinusoidal, ranging from approximately 1.3 V to 7.3 V, and resistance measurements indicated an increase in the expected values. A review of the detector circuit shows that this behavior could be explained by a failure of transistor Q7. The measurements indicate that

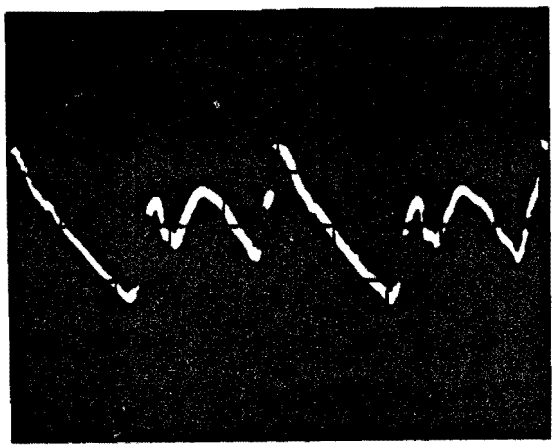
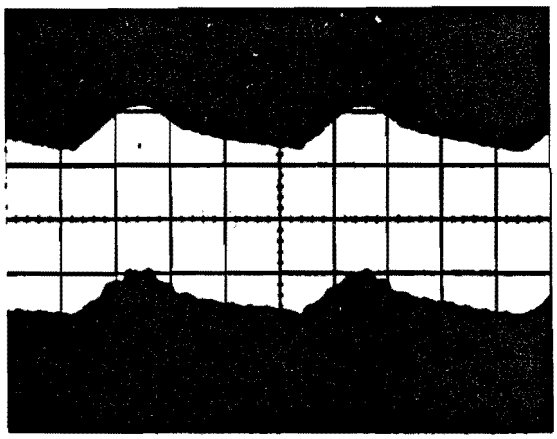
Photo #102-8

Figure 4-5. AC Variations on the 10V Power Supply.

The time traces and frequency spectra were used to summarize the major characteristics of the measured waveforms. Results of this summary are presented in Table 5-1. Both the power supplies exhibit normal characteristics when compared to other TMI-2 measurements. The only indication of a possible problem is from the relatively large 100 mV P-P 120 hertz ripple in the 10 V supply; however, this is not believed to be large enough to cause failure of the instrument.

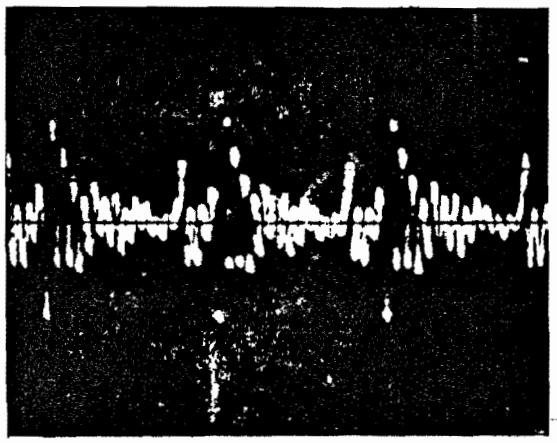
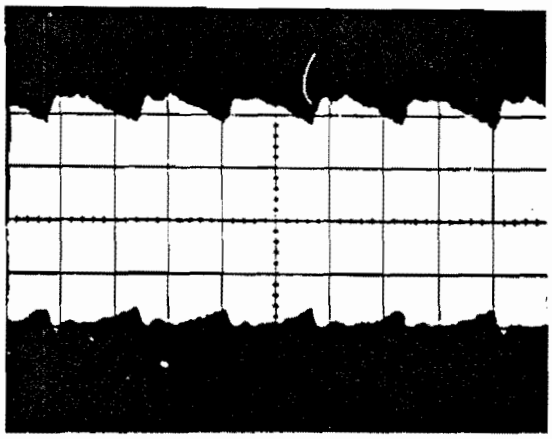
Photo #102-10

Figure 4-6. Typical Fluctuations Present Between Ground-AC Ground.

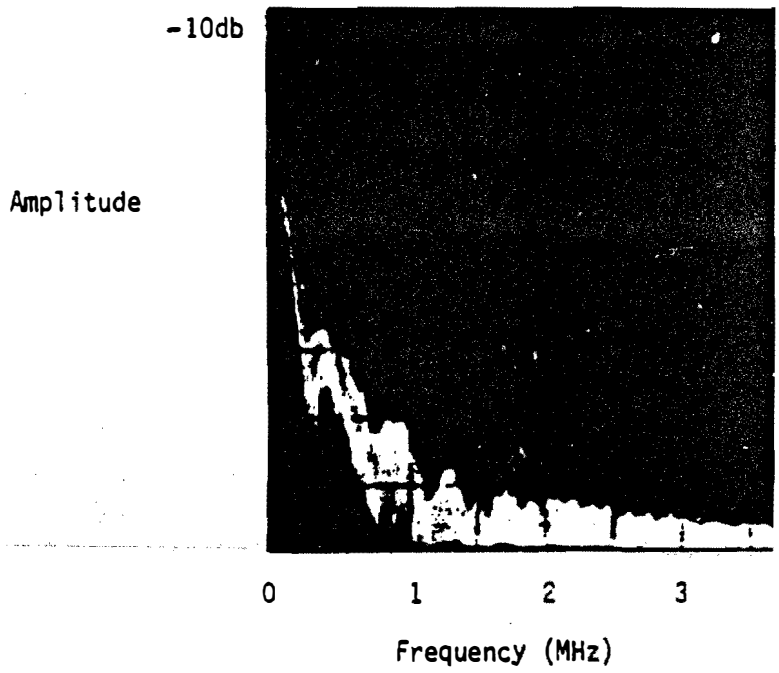
Photo #102-12

Figure 4-7. High Frequency Spectrum of 10V Power Supply.

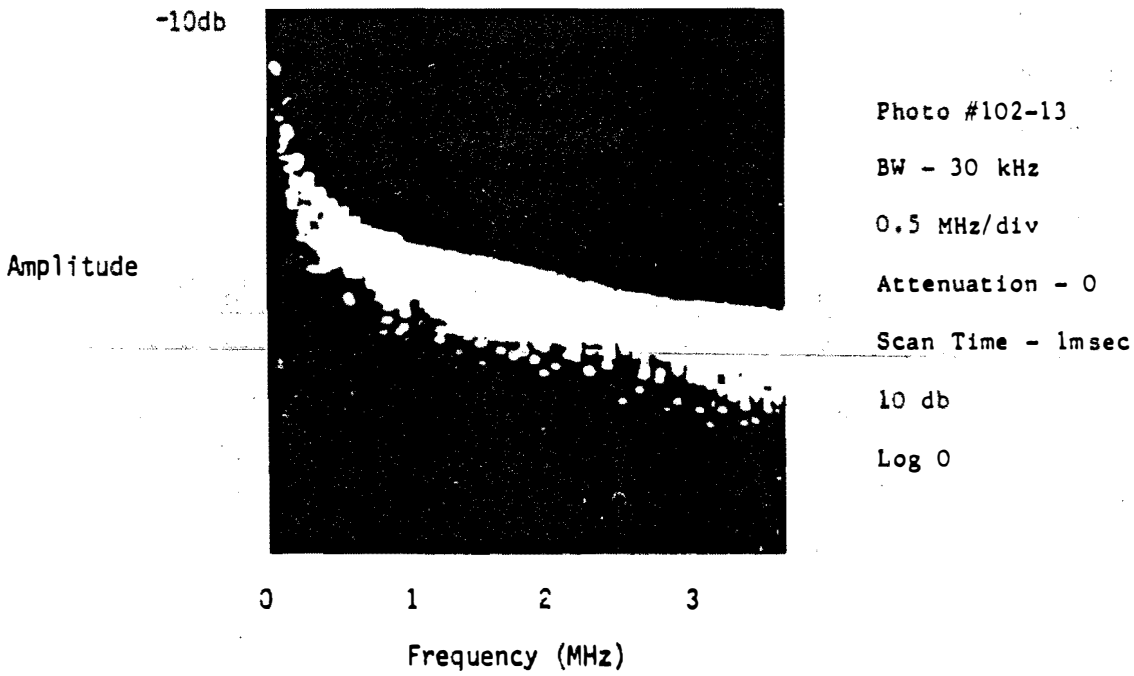
Figure 4-8. High Frequency Spectrum of Signal Output.

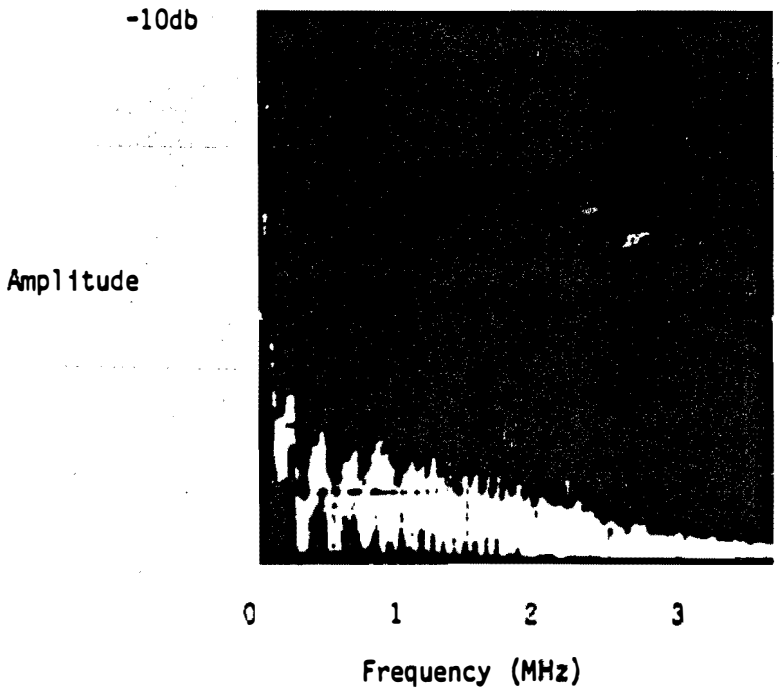
Photo #102-14

Figure 4-9. High Frequency Spectrum of 600V Power Supply.

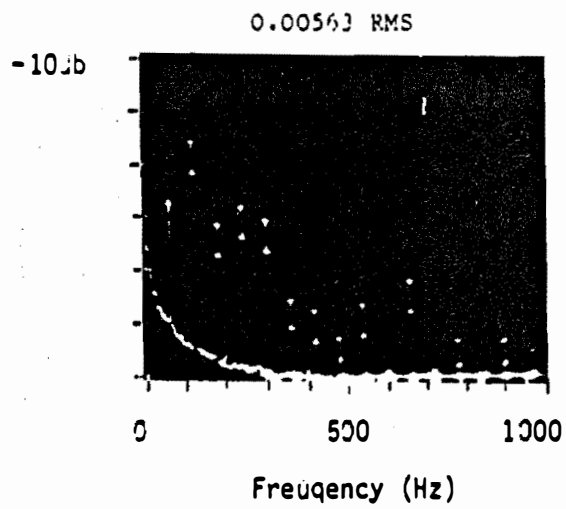
Figure 4-11. Low Frequency Sprectra of Signal Output.

40 kHz harmonics illuminated

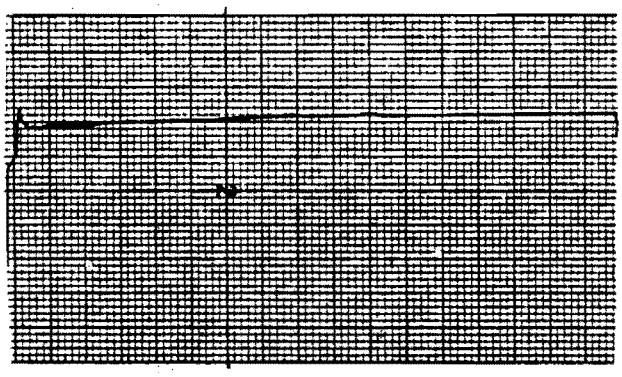
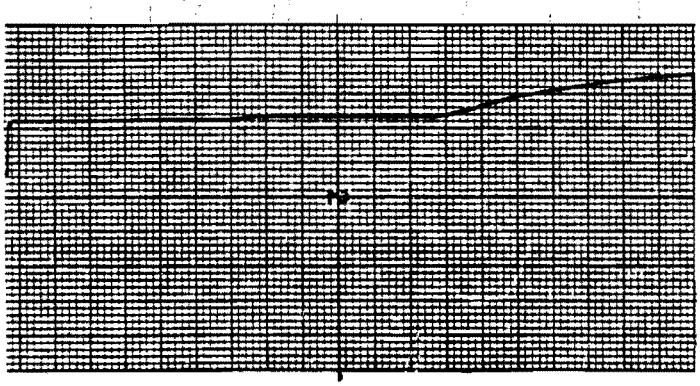
Figure 4-13. TDR Traces from the Checksource Lines.

The results of TDR measurements performed on the cable (shown in Figures 4-13 to 4-16 are summarized in Table 5-3. Note that the lengths identified in the table are only approximate, since no calibration of the cable resistance and material composition was performed on the TDR instrument. Some junction points were not identified by these

Signal Lines	Distance (ft)*	Description**	Probable Cause
Checksource (+)	505	Point R Increase	Remote Meter
Checksource (-)	996	Point R Increase	Penetration R507
	1285	Continuous R Increase	HP-R-212 Detector
600 V Supply	515	Point R Increase	Remote Meter
Ground	1246	Continuous R Increase	HP-R-212 Detector
Signal	505	Point R Increase	Remote Meter
Shield	1320	Continuous R Increase	HP-R-212 Detector
10 V Supply	289	Point R Increase	(?)
Ground	474	Point R Increase	Remote Meter
	975	Point R Increase	Penetration R507
	1274	Continuous R Decrease	HP-R-212 Detector

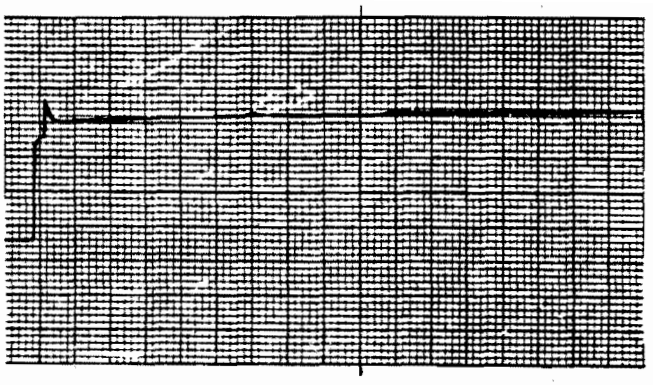
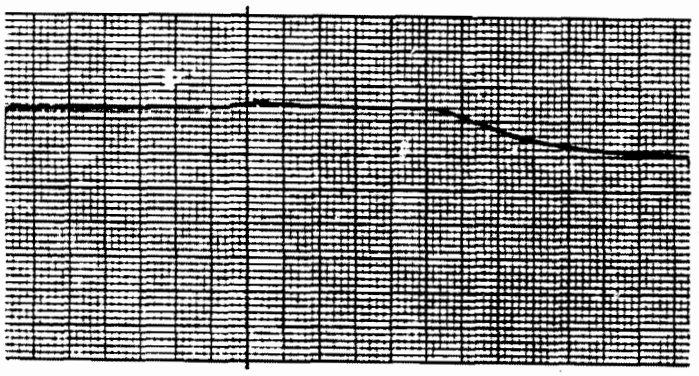
Figure 4-16. TDR Traces from the 10V Power Supply Lines.

measurements, but this is not unusual due to the cable lengths involved and the small resistance changes that would occur at terminal block junctions. The only unusual inflection occurred on the 10 V power supply line which indicated an interface resistance at approximately 289 feet from the control room. However, measurements did not indicate a resistance change on the 10 V line, and this was not considered to be a problem.
