PRELIMINARY REPORT OF TMI-2 IN-CORE INSTRUMENT DAMAGE

Merlin E. Yancey
Ned Wilde

January 1983

Technically Edited and Published
on Behalf of the GEND Group
By
EG&G Idaho, Inc.
Idaho Falls, Idaho 83415

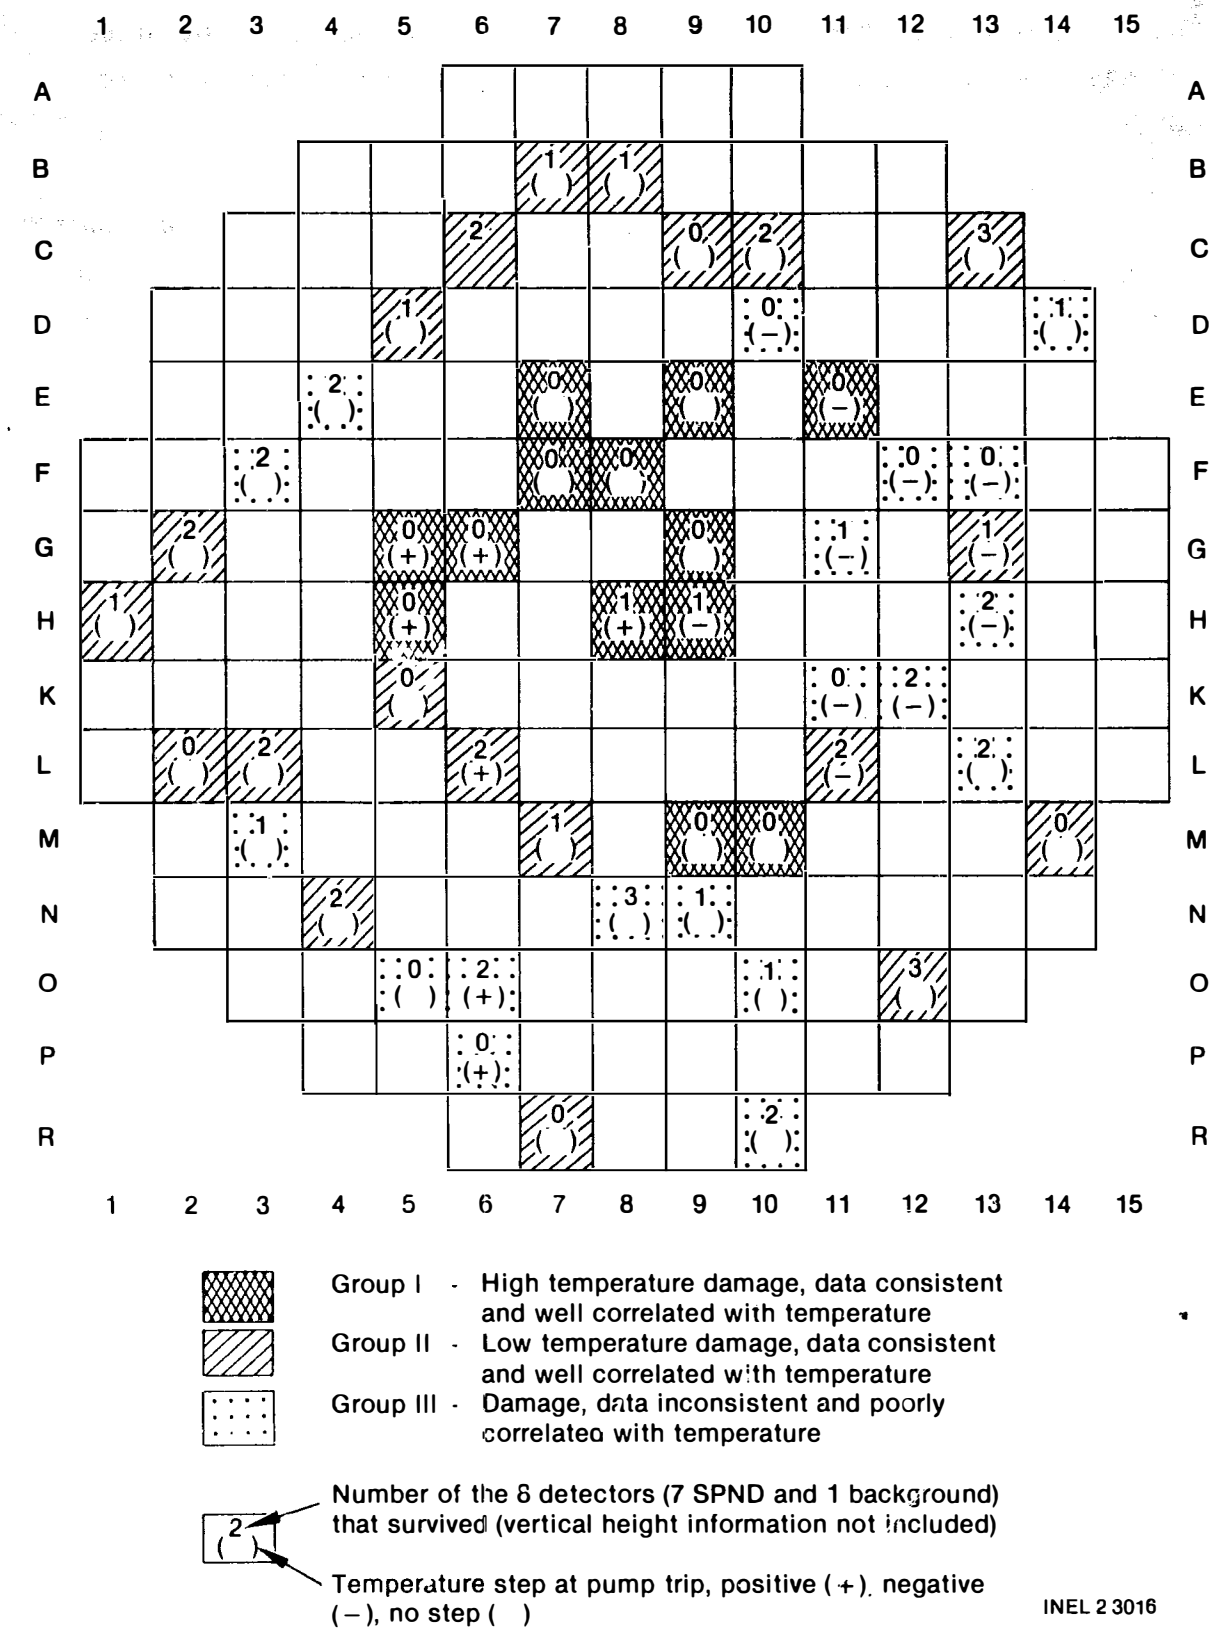
Three statistical groups of damage are identified in Figure 1. Group I consists of locations having experienced highest temperatures and apparently greatest damage. As expected, these locations are in the center of the core. Group II consists of locations having experienced lower temperature and apparently least damage. They are nearer the perimeter of the core. Within these first two groups, measured data and, presumably, damage to the instruments are very consistent and correlate well with temperature. Group III locations present inconsistent data and are poorly correlated with temperature. They seem to be geometrically grouped in two regions of the core, as shown in Figure 1.

The loss of all seven SPNDs and the background detector was mostly in Group I, while being inconsistent in Group III. For the most part, one or

Figure 1. In-core instrument damage map.

more survived in Group II. Also, most of the survivors, 40 out of 50, were at the lower two core levels. None of the other data seems to correlate with vertical height.

The statistical analysis characterizes instrument damage into three types, which, as shown in Figure 1, tend to group. Group I is primarily in the center of the core where higher temperatures existed. Instrument damage appeared greatest in this region. Statistically, the data, and presumably the damage, were consistent. That is, the data had small variance from location to location, as opposed to random and large variance. Group II is primarily the perimeter of the core, where lower temperatures prevailed. Instrument damage appeared less in this region but was still statistically consistent. Group III is the interesting group, since the data are inconsistent and do not seem to make sense. The group is concentrated in two areas. In Figure 1, these areas are bottom and right. The right area contains most of the negative temperature steps that occurred during the pump trip.

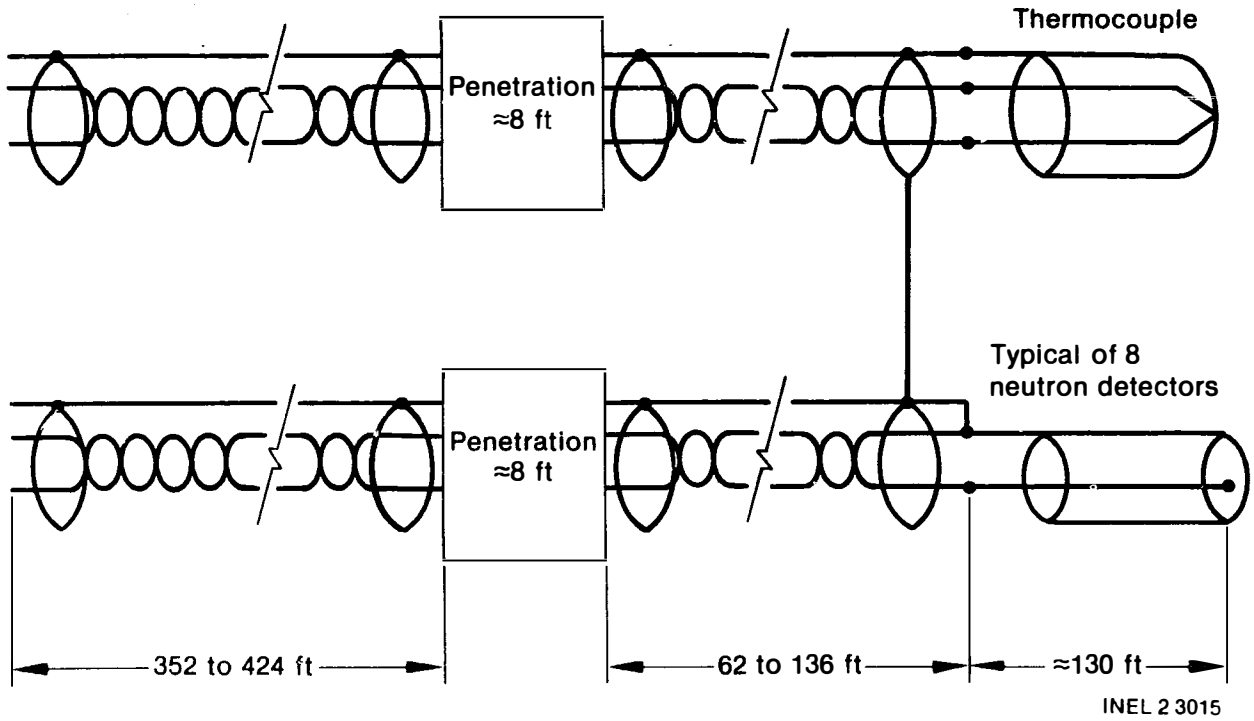
Figure 2. In-core instruments and range of cable lengths.

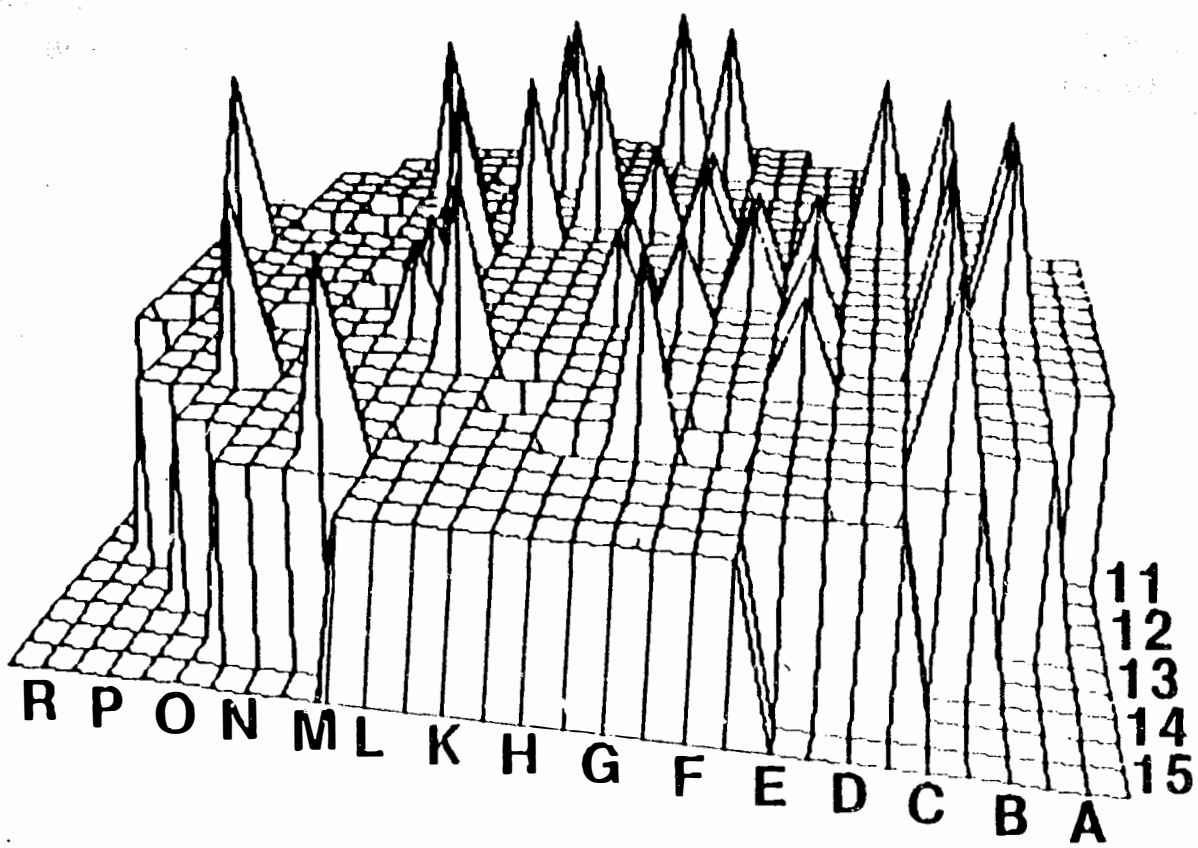
The delta change in the normalized resistance for each of the TCs was plotted three-dimensionally. The plot of the logarithm of the normalized resistance is shown in Figure 3 (compare Figure 1). The longest vertical height on the lot corresponds to the TC experiencing the minimum reduction in normalized resistance, thus, the base represents a TC 25 ft shorter than installed length. Grid locations where the vertical height drops below zero represent TCs having open junctions, and no resistance data were available.

A review of the TC data indicate that the center area of the core experienced the major change during the accident. The in-core SPND data also indicate that the majority of the shorted SPNDs were located in the center area of the core.

Figure 3. Three-dimensional plot of normalized resistance for each thermocouple.

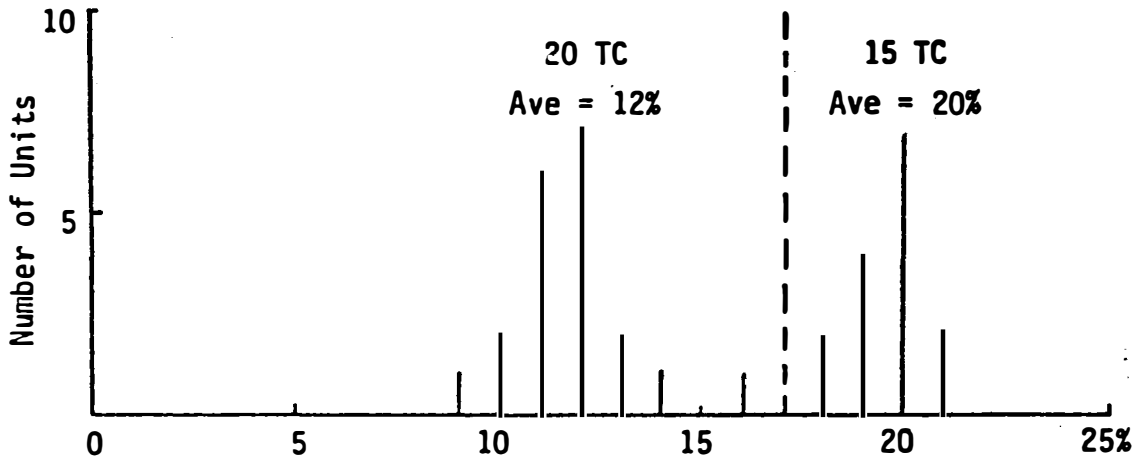
Figure 4. Distribution of thermocouple resistance decrease.
