# **CHARACTERIZATION OF EPICOR II PREFILTER LINER 3**

**Nancy L. Wynhoff**  
**V. Pasupathi**

**Published April 1983**

**Battelle Columbus Laboratories**  
**505 King Avenue**  
**Columbus, Ohio 43201**

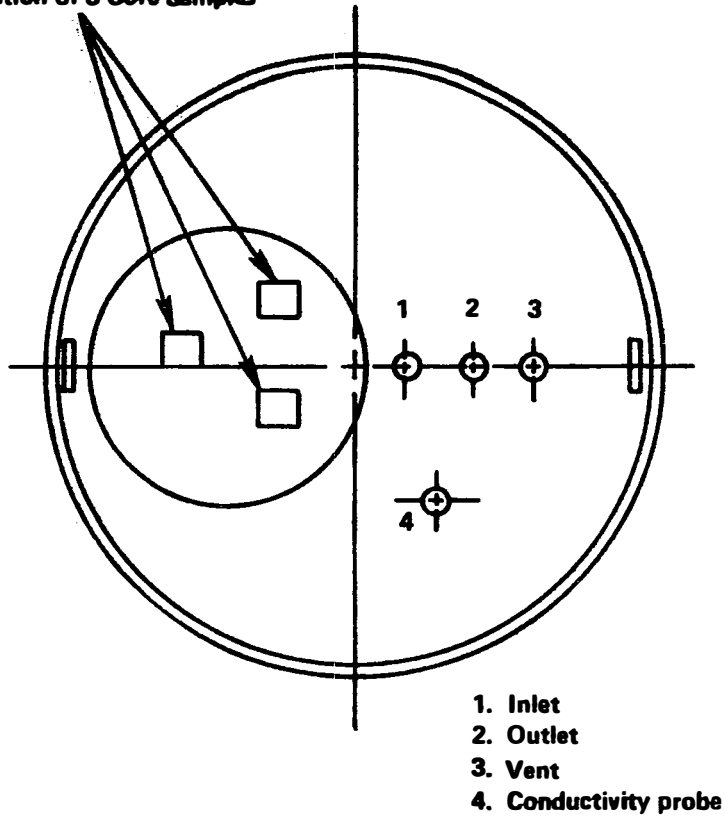
**Location of 3 Core Samples**

During the first core sampling operation, the core sampler apparently struck the underdrain system after being inserted 26 inches into the approximately 30-inch resin bed. Removal of the shutter exposed a 24-inch core sample. After thoroughly probing the bed to determine the location of the underdrain system, a second core sample was taken. The sampler was 28 inches into the bed and an approximately 24 1/2-inch core sample was obtained. A third core sample, approximately 29 inches in length, was taken and shipped to Brookhaven National Laboratories. Figure 12 shows the relative locations of the three core samples obtained.

**FIGURE 12. SCHEMATIC OF TOP OF LINER PF-3 SHOWING RELATIVE LOCATION OF 3 CORE SAMPLES TAKEN.**

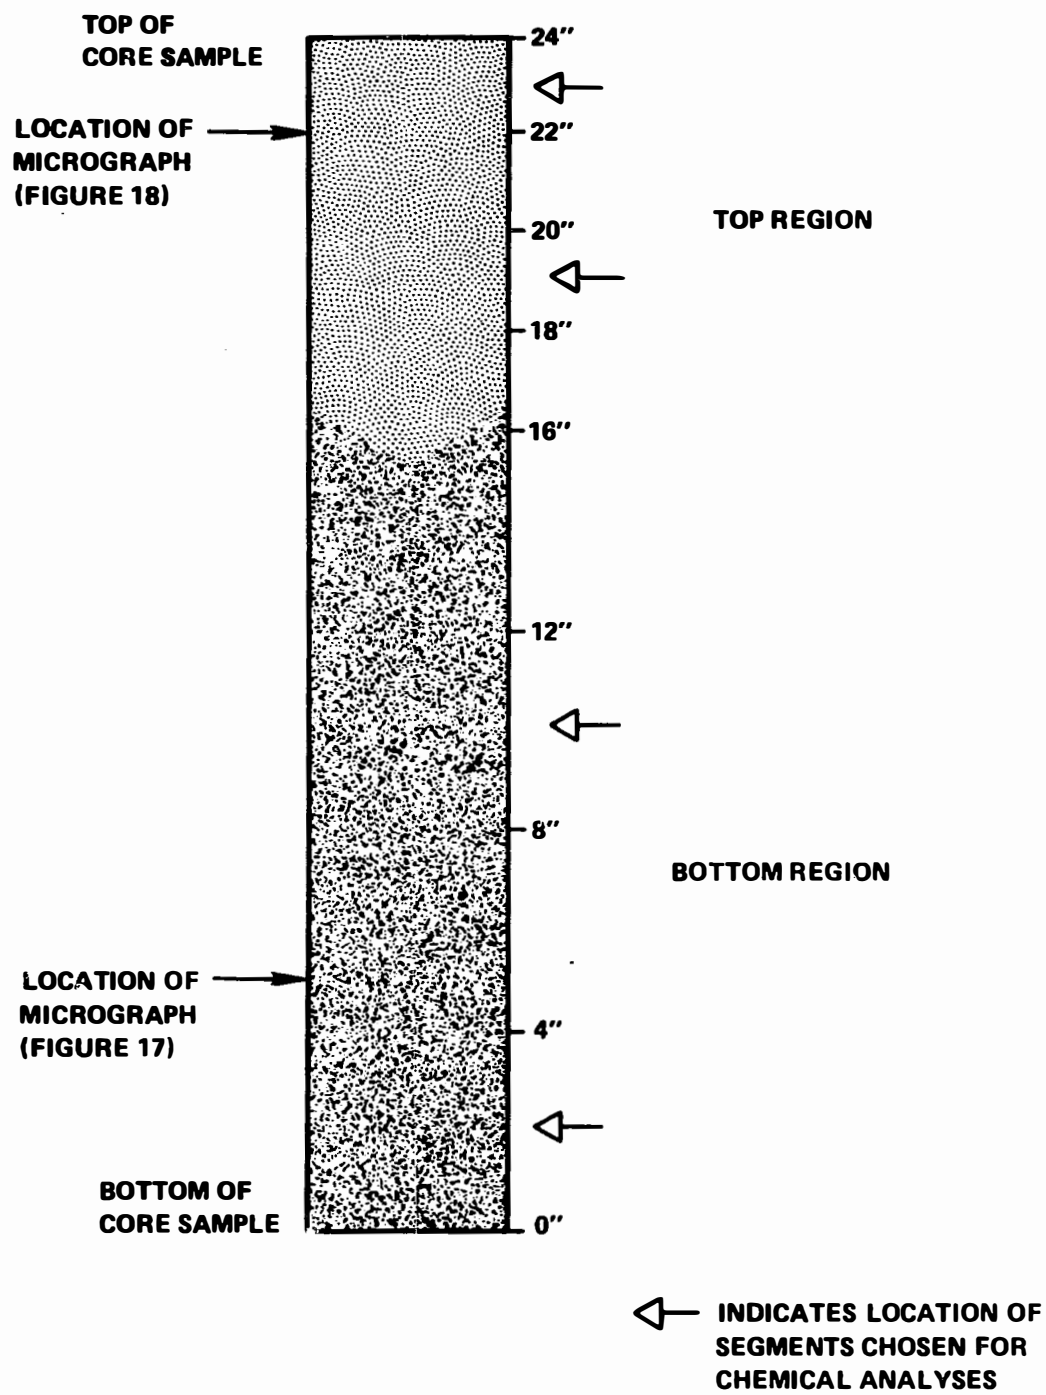
Using the hot cell stereomicroscope at ~30X magnification, a preliminary visual examination of core sample #2 was made with ion-exchange media exposed by removing the shutter from the core sampler. A schematic of the core sample is given in Figure 16. Two distinct regions were observed. The bottom region, approximately 16 inches in length, consisted of regular-shaped, light-colored, spherical particles that appeared translucent. These particles were yellow or orange in color. Figure 17 is a photomicrograph of this region. The top 8 inches of the core sample appeared darker than the bottom region. This region consisted of translucent, spherical particles in varying shades of dark and light and irregular shaped particles which were dark brown or black and looked like charcoal. Because the identity of the material used in liner PF-3 is considered proprietary and is not available for use in this project, it is not possible to determine the reason why some of the spherical particles are darker in color than others. A photomicrograph of this region is shown in Figure 18. Figure 19 is a micrograph of the light, powdery material at the top of the media bed.

FIGURE 16. SCHEMATIC OF CORE SAMPLE NO. 2.
