Docket No. 50-320

Mr. S. K. Kanga, Director  
Three Mile Island Unit 2  
GPU Nuclear Corporation  
P.O. Box 480  
Middletown, PA 17057

Subject: Reactor Building Polar Crane Load Test

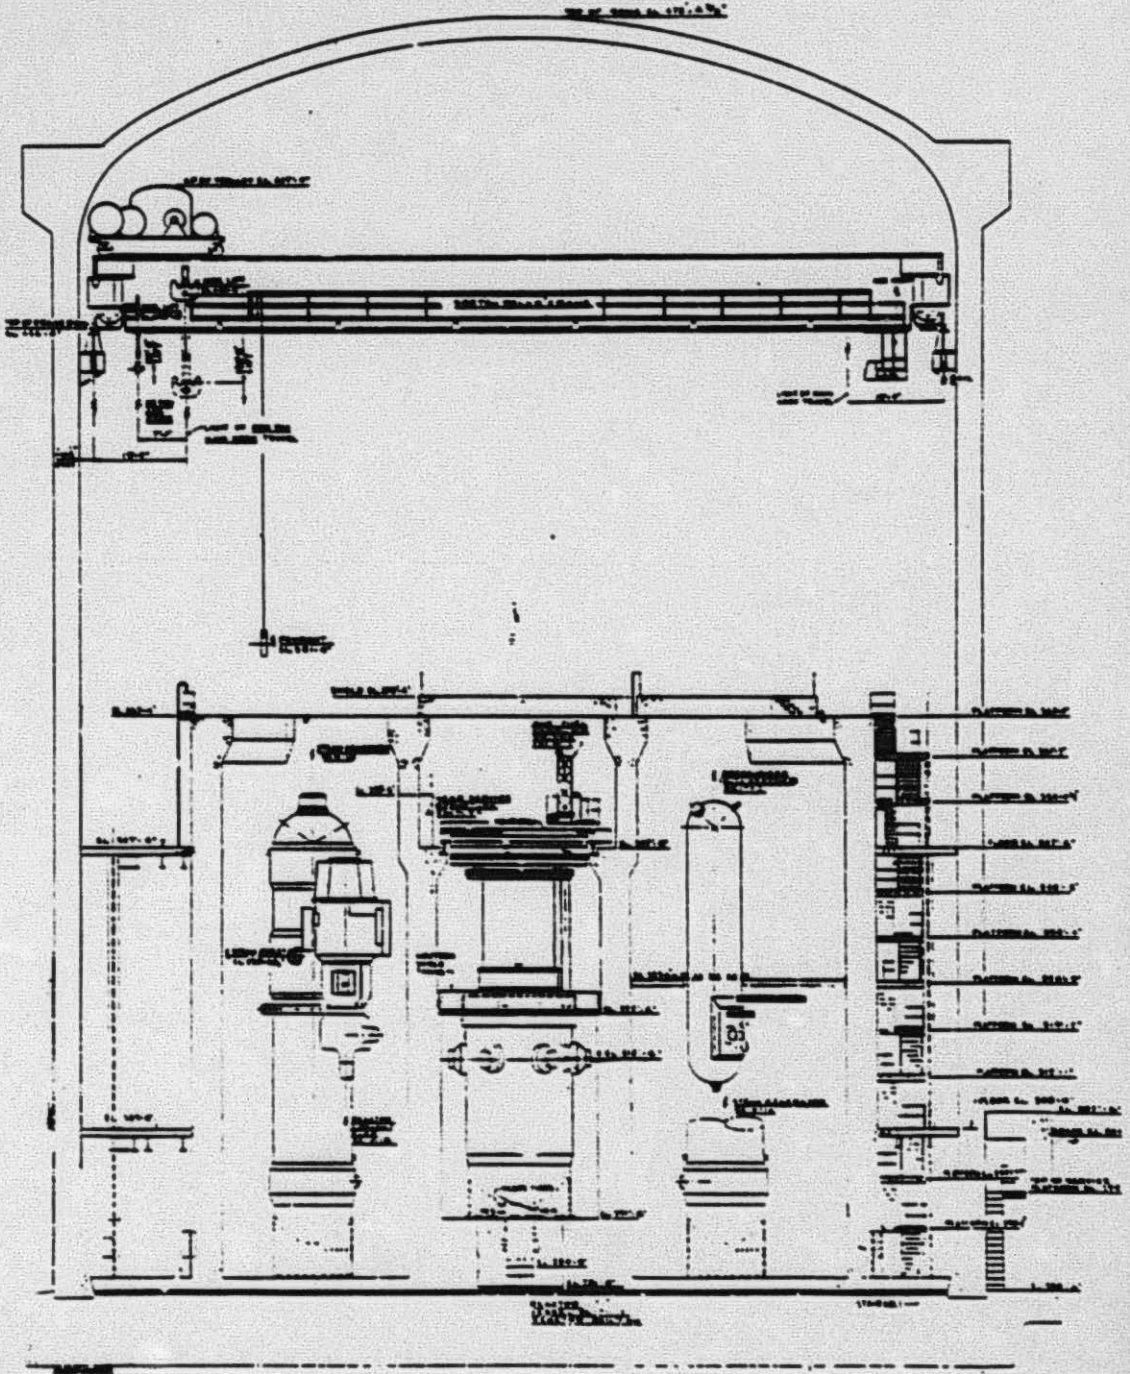
FIGURE 2.1

POLAR CRANE SIDE VIEW

The TMI-2 accident exposed the polar crane to temperature and environmental conditions that resulted in damage to its electrical and mechanical components. Structural components were not damaged as was confirmed by GPU's inspection reports (Appendix C) and the inspection by our crane consultant. As previously stated, the refurbishment process was only intended to restore the crane components that were considered necessary for head lift and subsequent cleanup activities. The components were to be restored to pre-accident conditions and capabilities. In their letter dated January 4, 1982 (Reference 20), GPU requested guidance on the requirements for crane refurbishment. We responded on April 1, 1982, with the following guidance:

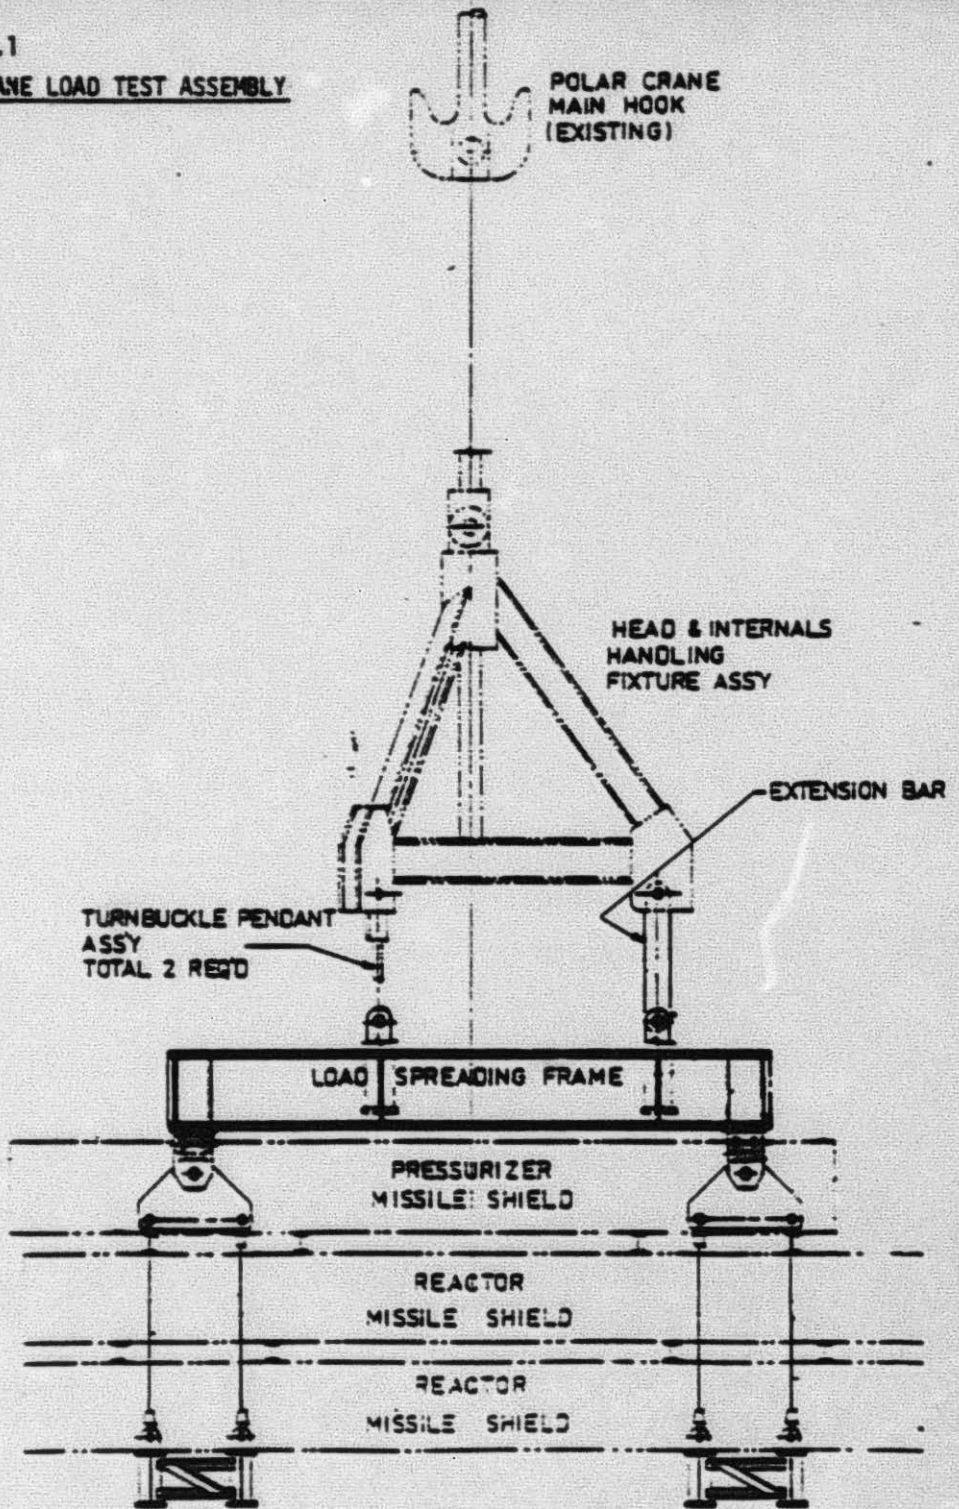
**FIGURE 8.1**  
**POLAR CRANE LOAD TEST ASSEMBLY**

The load test assembly is comprised of a lower support structure, missile shields stacked on the lower structure, the load spreader frame which rests on top of the uppermost missile shield, and rigging that connects the lower frame and upper load spreading frame (see Figure 8.1). The load test frame will be load tested at the same time it is used. The test/use of the frame is for the combined weight of the missile shields which is approximately 192 tons. ANSI N14.6 requires a 150% test whereas the actual test/use is at 100%. We concur with the 100% since the only use of the assembly is for the test. At the rigging connecting point on the load spreader

Four wire rope slings are required for each missile shield, each being attached at the lifting lugs of the shield at one end and attached to and a single plate at the other (see Figure 8.1). Because the missile shield structure is a rigid body and the possibility does exist that the slings will not be exactly the same length, the missile shield lift is categorized as indeterminant from the standpoint of stress analysis. Therefore, in our evaluation of the potential load on each sling, only two of the four

The load cell was also calibrated by the manufacturer up to 220 tons, thereby giving added assurance that the stress limits of the cell will not be exceeded. In summary, we conclude that the load test frame, cell rigging and the load cell are acceptable for the polar crane load test.

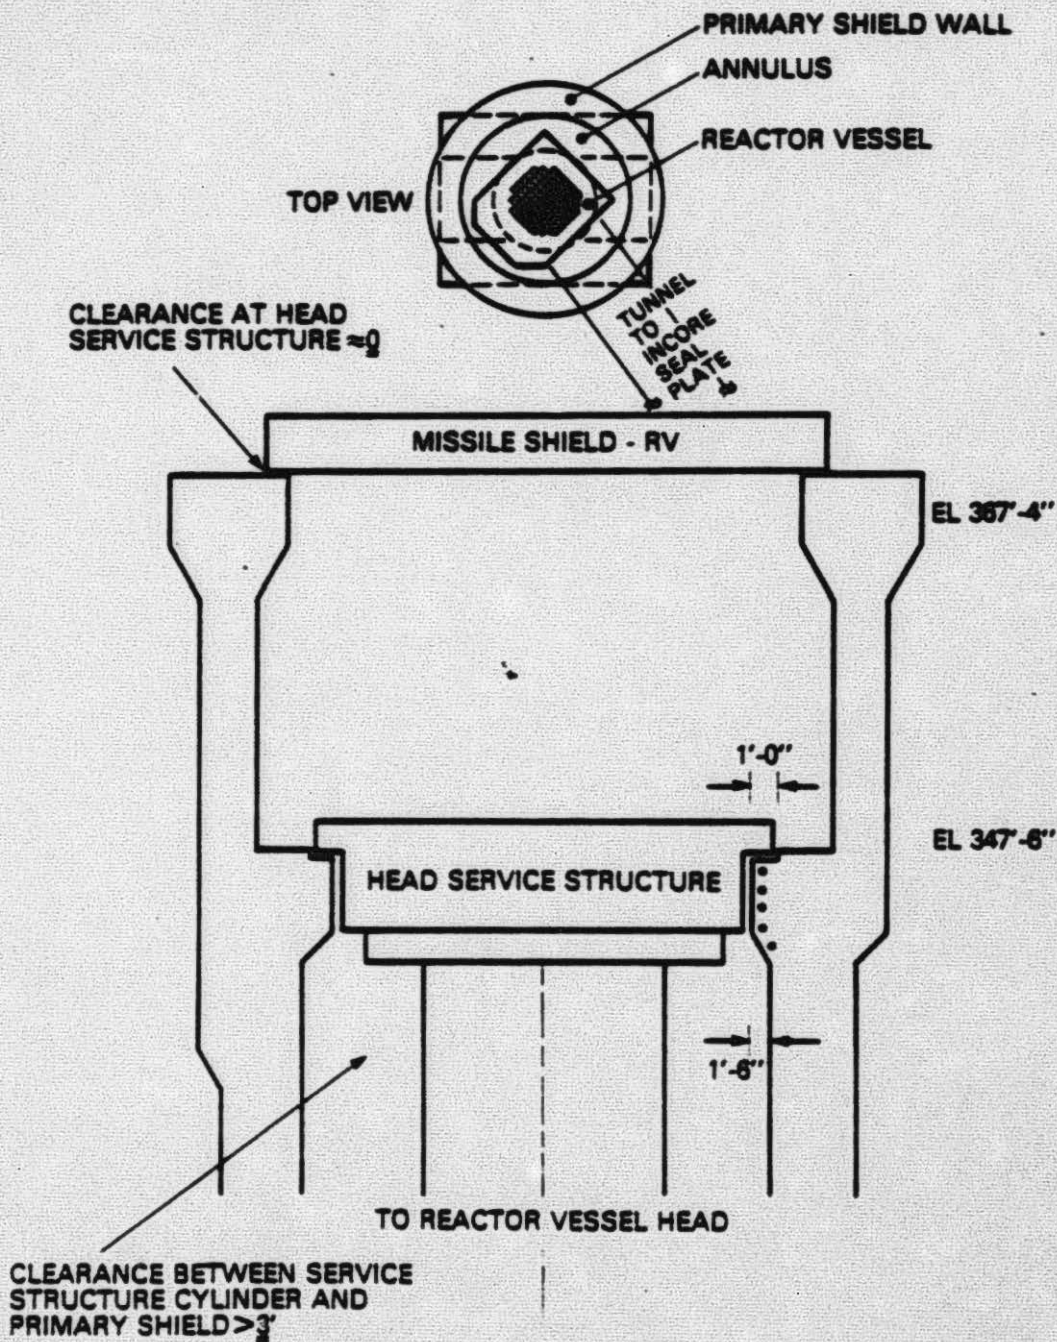
FIGURE 10.1

We do not consider the severing of the in-core instrument tubes which penetrate the lower reactor vessel head to be a credible event for a number of reasons. First, a significant amount of the kinetic energy in the missile shield would be dissipated in the deformation of the service structure (see Figure 10.1). Second, the missile shield would have to fragment into pieces which would fit within the physical constraints of the reactor vessel and surrounding concrete structure, an annulus of slightly less than 2 feet of maximum clearance (see Figure 10.2). The fragmented pieces would have to clear the four 28 inch diameter inlet pipes, two 36 inch diameter outlet pipes, and two 14 inch core flood tank pipes which penetrate the reactor vessel (see Figure 10.3). Having cleared the vessel piping, a piece of missile shield no larger than about 9 inches in maximum dimension would have to strike the concrete pad supporting the reactor vessel, bounce at a 90° angle and pass through one of the 9-1/4 inch diameter holes in the reactor vessel support skirt, and strike an in-core instrument tube with enough energy to fail 0.22 inch thick tubing (see Figure 10.4). We consider such an event to be incredible.

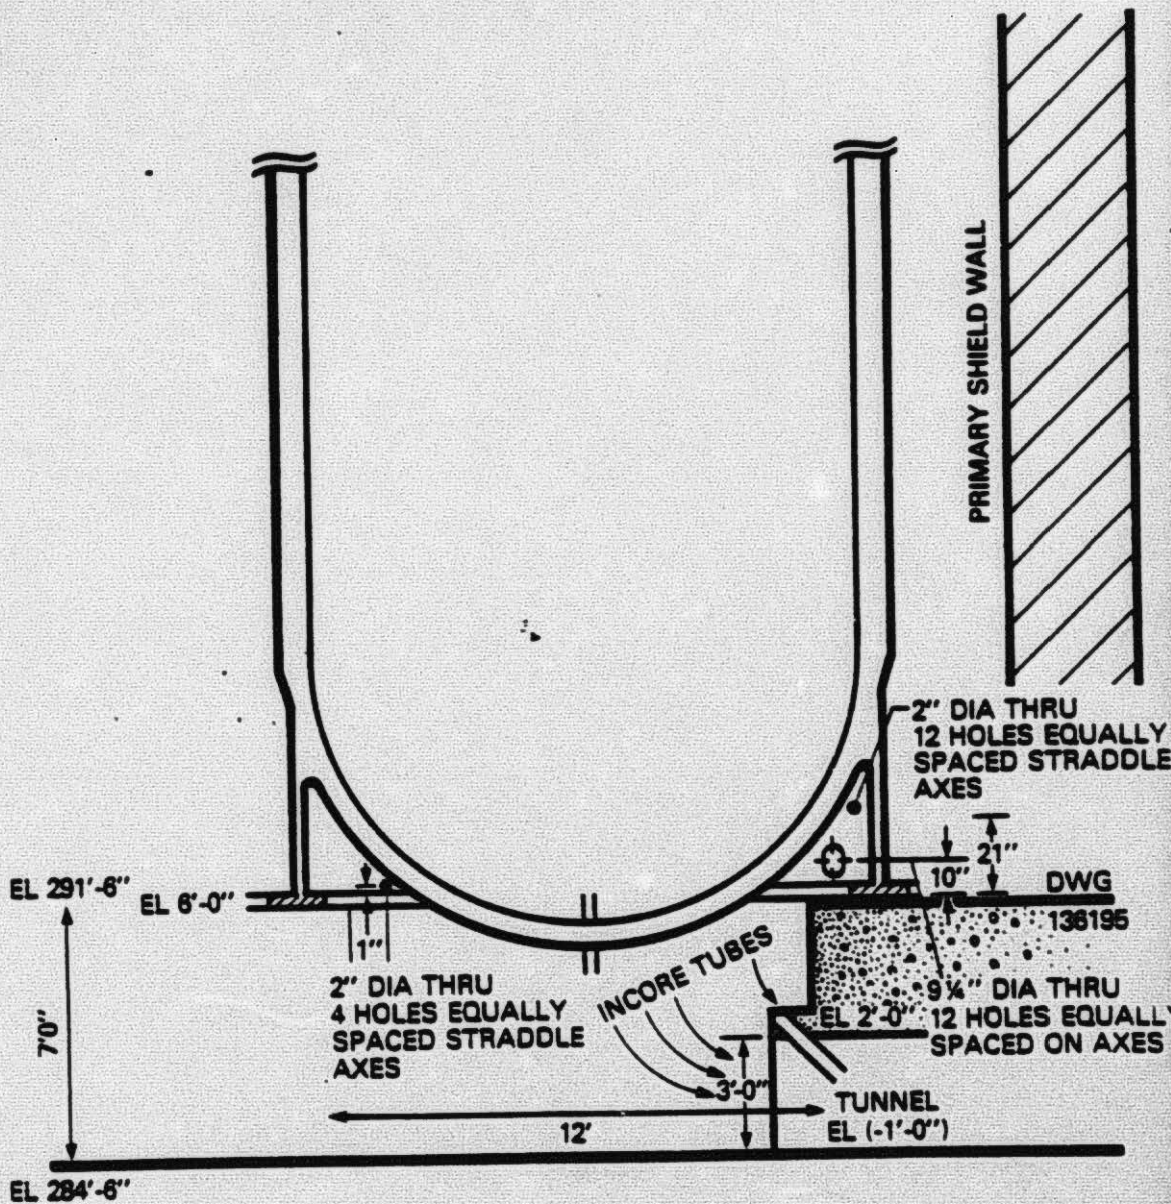
FIGURE 10.4

LOWER REACTOR VESSEL/SKIRT AREA
