**THE
ACCIDENT AT
THREE MILE
ISLAND**

*Reports Of The Technical
Assessment Task Force, Vol. IV*

REPORTS OF THE
TECHNICAL ASSESSMENT TASK FORCE

VOLUME IV

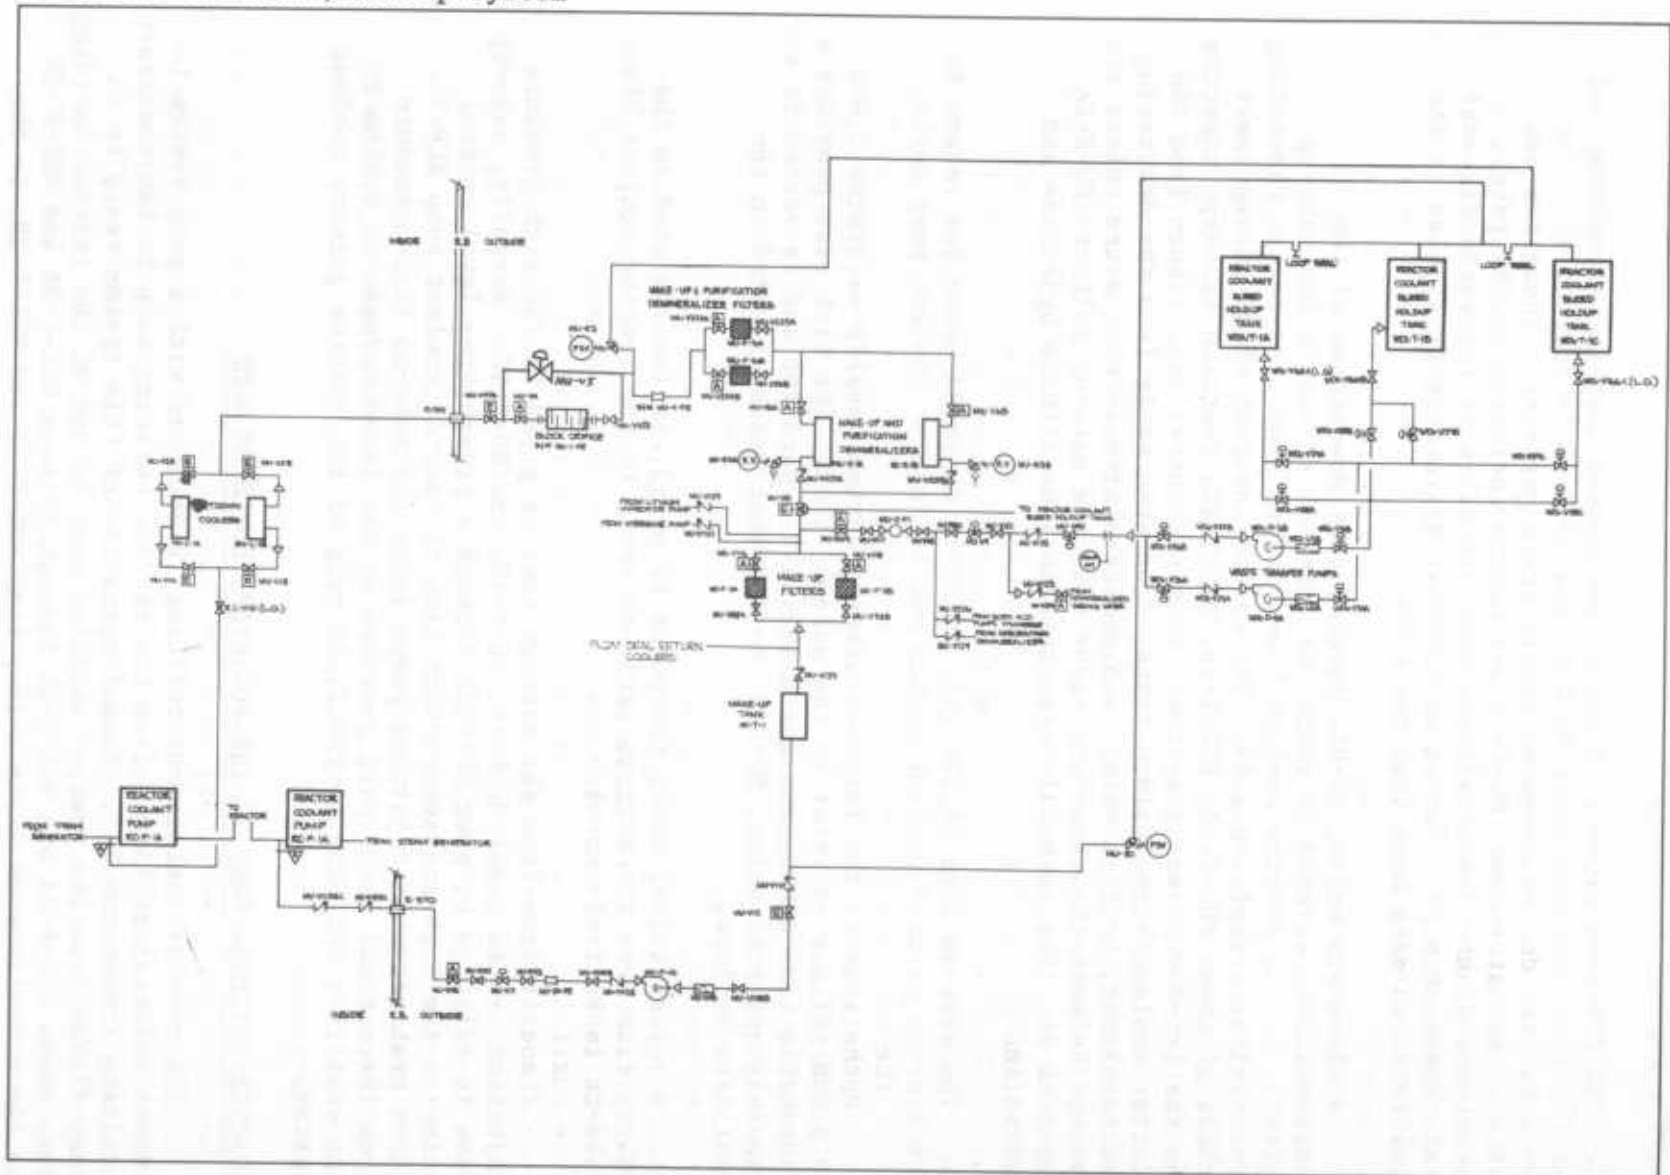
FIGURE 1: Let-Down/Make-up System

It is important to note that if the let-down/make-up system is in operation with the valves open upstream of the block orifice valve and a block or obstruction is effected downstream, this pressure relief valve MU-R3 relieves pressure by venting to the reactor coolant bleed holdup tanks (reference 6). The same relief is provided if the overpressure is caused by dissolved gases.

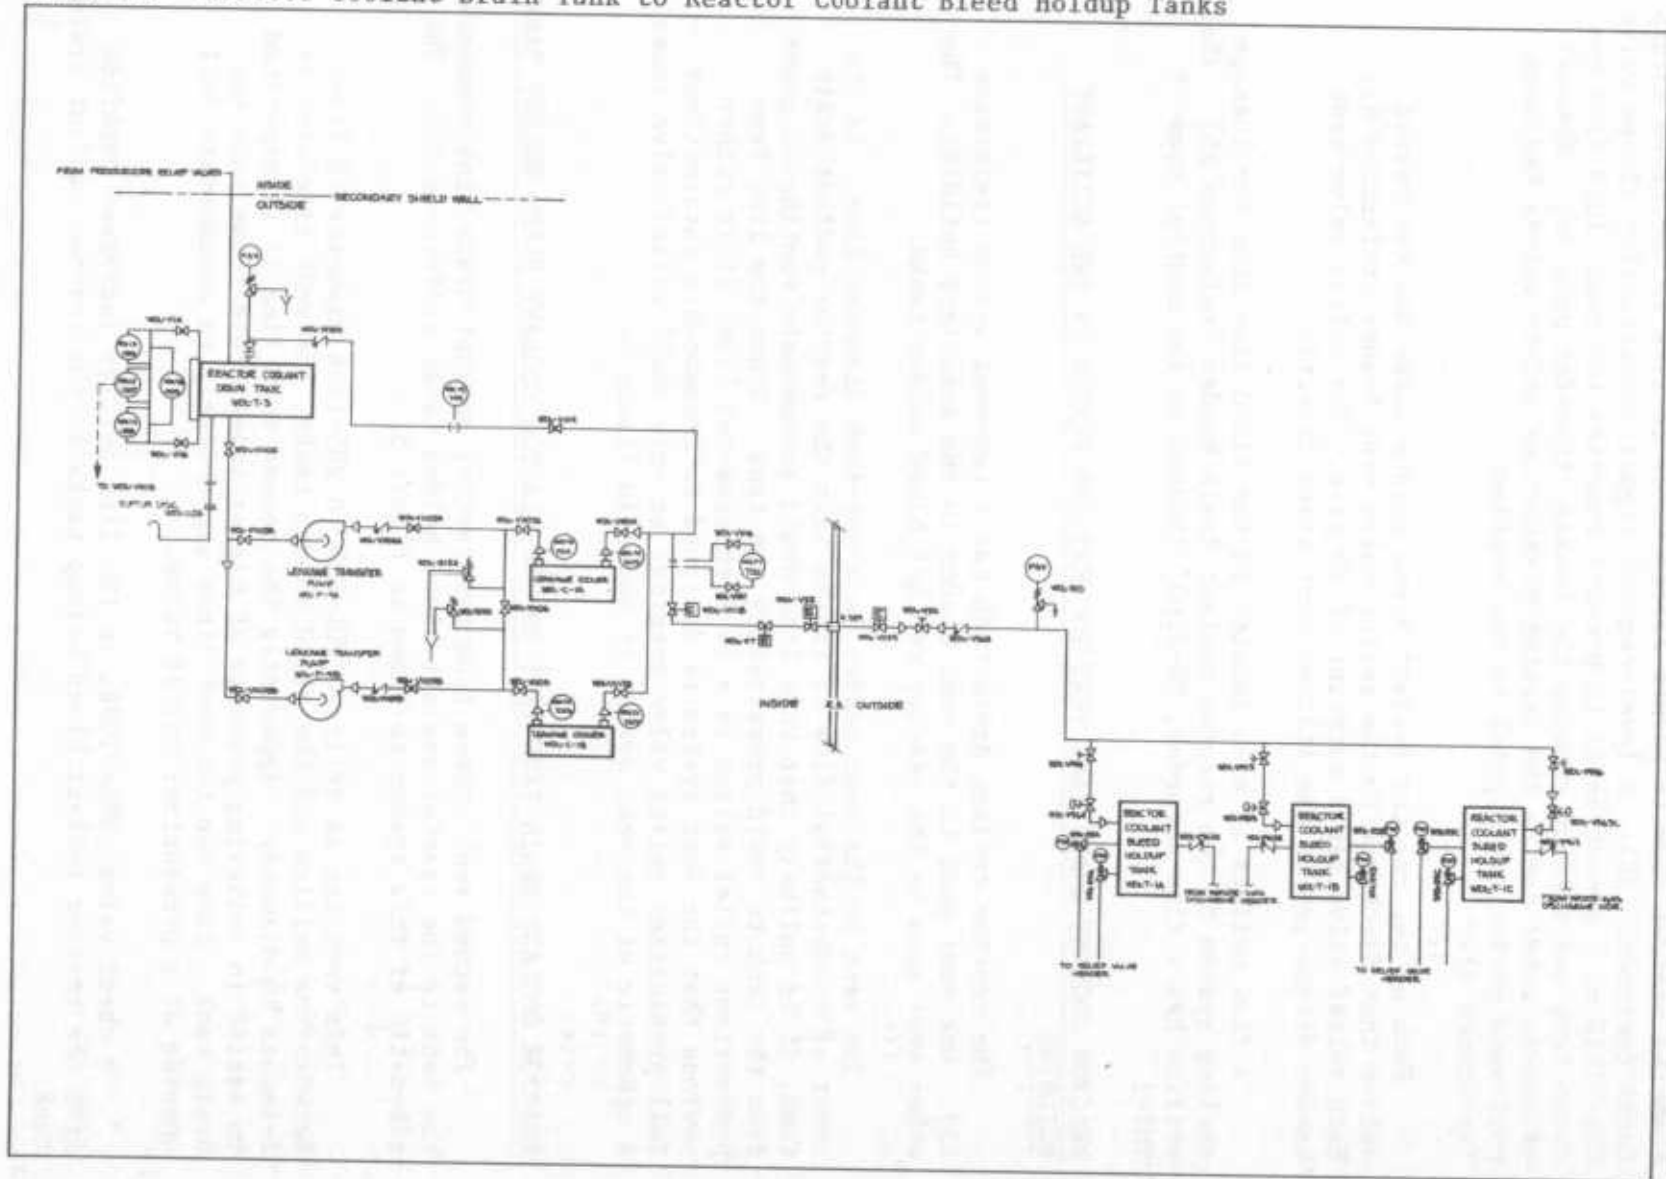
FIGURE 3: Reactor Coolant Drain Tank to Reactor Coolant Bleed Holdup Tanks

The reactor coolant drain tank receives the fluids released from the pressurizer relief valves through a 14-inch diameter line (reference 25). The tank is located in a cubicle at the bottom level of the reactor containment building at a center-line level of 289 feet outside the secondary shield wall (references 20, 26). A schematic of the connections and pumps of the reactor coolant drain tank is shown in Figure 3.

to the reactor coolant bleed holdup tanks. To remove fluids from the reactor coolant drain tank, normally a valve, WDL-V1118, is open remotely from the control room to permit excess water to flow to the bleed holdup tanks (reference 28). A level-control signal automatically closes valve WDL-V1118 at a preset level to prevent removing too much fluid from the drain tank and thereby running the leakage transfer pump dry. Removal of excess water due to the leaking pressurizer safety valves had been performed periodically prior to the accident (reference 4).

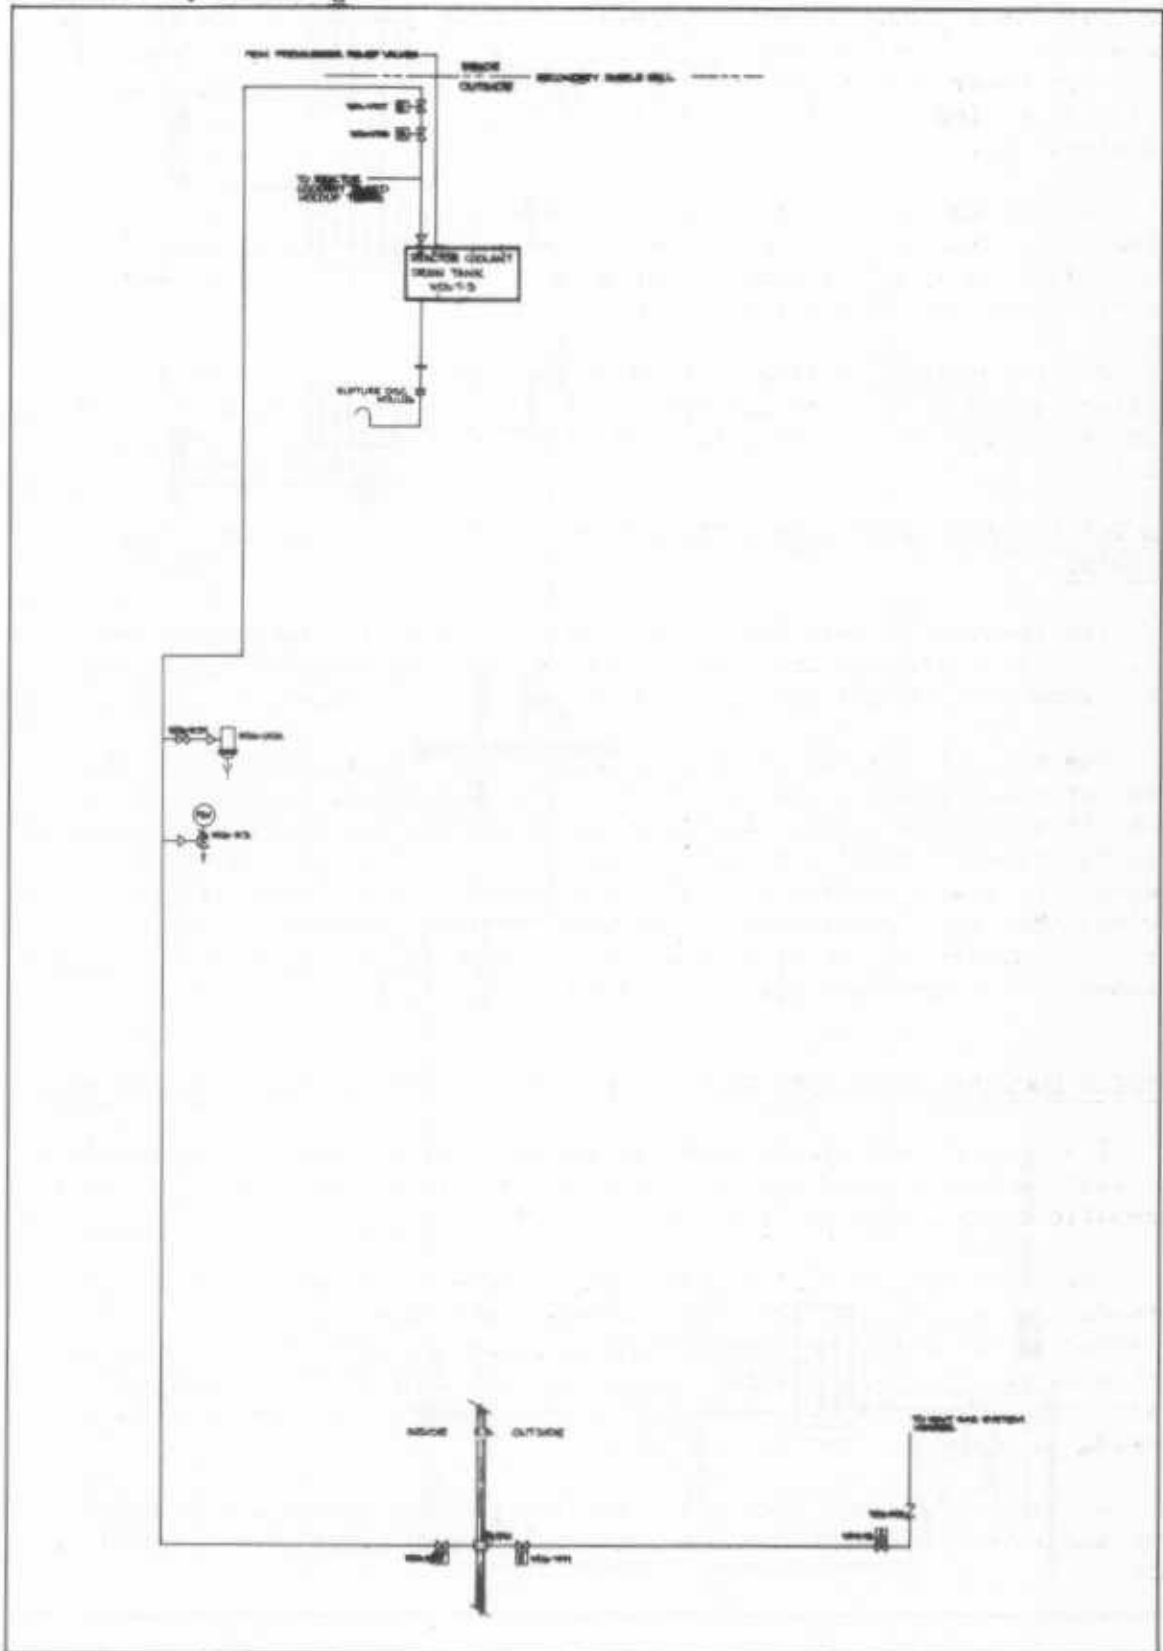
FIGURE 4: Reactor Coolant Drain Tank Vent to Vent Header
In Auxiliary Building

The vent to the vent header is a one-inch diameter line. In the event of a substantial flow of fluids into the reactor coolant drain tank, it is unlikely that this line would accommodate venting of gases from the tank to avoid pressurizing the tank. Since the line from pressurizer relief valves is a 14-inch diameter line, it is rather obvious that the vent system is designed to accommodate intermittent full pressurizer relief valve openings or only small relief valve leaks. A schematic of the vent system is shown in Figure 4.

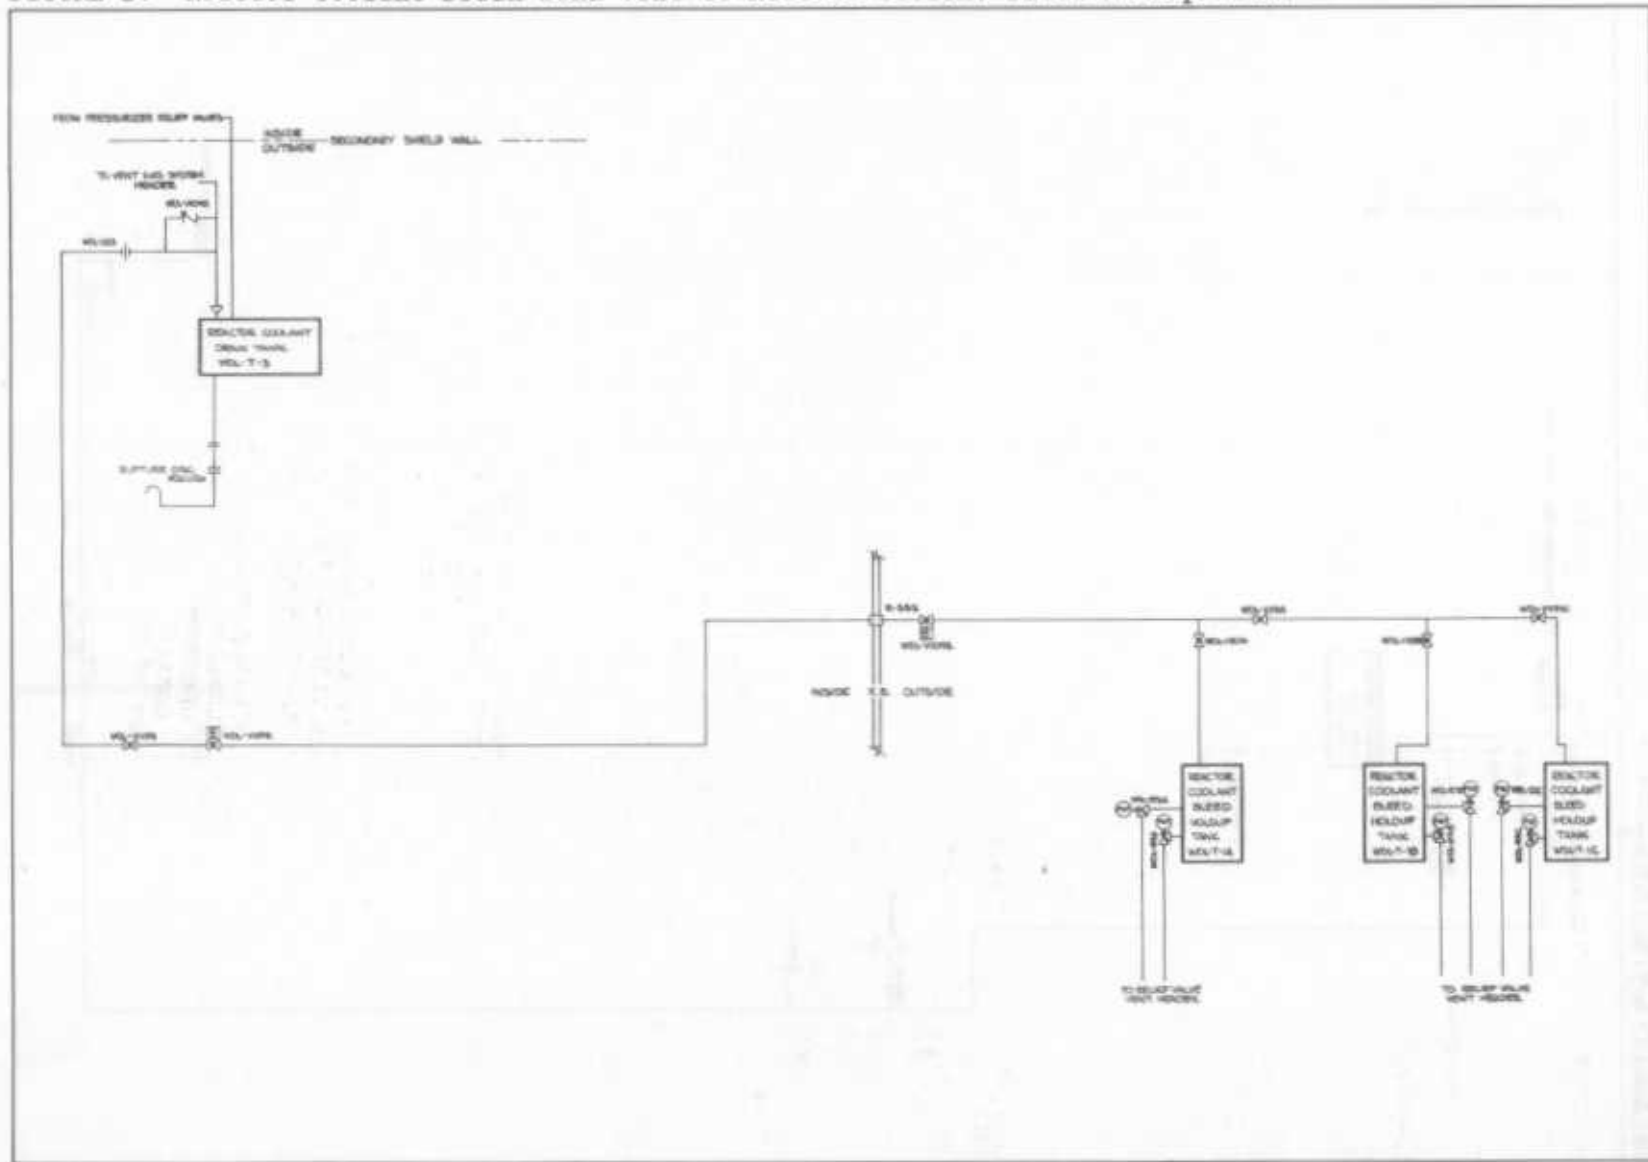
FIGURE 5: Reactor Coolant Drain Tank Vent to Reactor Coolant Bleed Holdup Tanks

The second vent system from the reactor coolant drain tank connects the tank to the reactor coolant bleed holdup tanks (reference 25). The schematic of this system is shown in Figure 5.

A check valve, WDL-V1098, in the line permits increased backflow from the reactor coolant bleed holdup tanks to the reactor coolant drain tank.

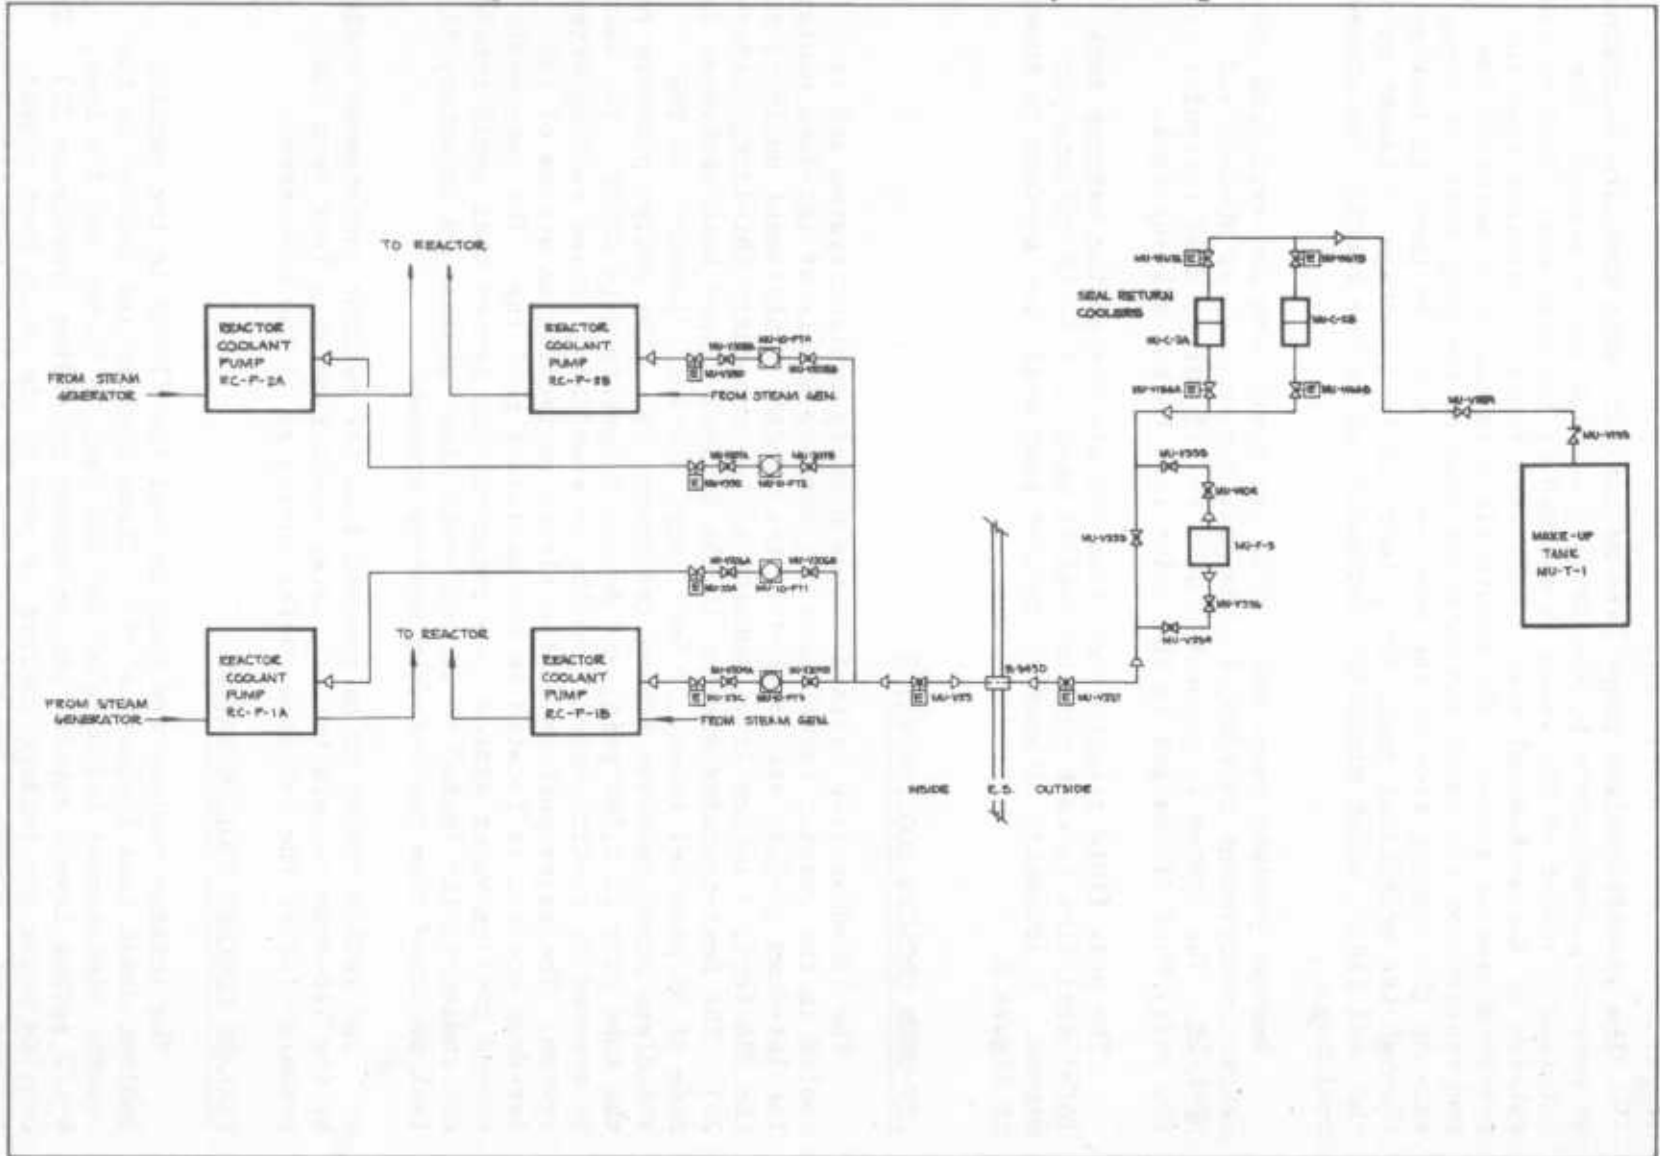
FIGURE 6: Reactor Coolant Pump Seals to Seal Coolers in Auxiliary Building

The seal fluid return comes from the mixture in the make-up tank. Total seal flow to each reactor coolant pump is 8 to 10 gallons per minute. A schematic of reactor coolant pump seal flow systems is shown in Figure 6.

water is in the auxiliary building. Both the tube sides and the shell sides of the leakage coolers operate at approximately 5 to 10 psig. Therefore, there is no strong driving force to transmit radioactivity to the auxiliary building. via the leakage coolers cooling water.
