NUREG-0600

INVESTIGATION INTO THE MARCH 28, 1979
THREE MILE ISLAND ACCIDENT
BY
OFFICE OF INSPECTION AND ENFORCEMENT

Investigative Report No. 50-320/79-10

Office of Inspection and Enforcement
U. S. Nuclear Regulatory Commission

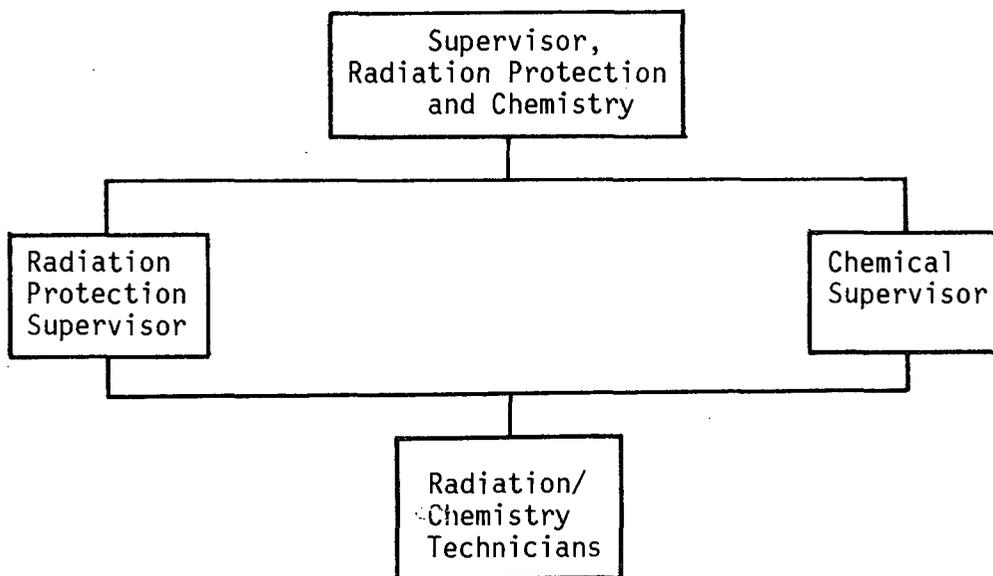
The organization of the radiation protection and chemistry staff as shown in Figure 6.2-1 of the Technical Specifications is shown as follows:

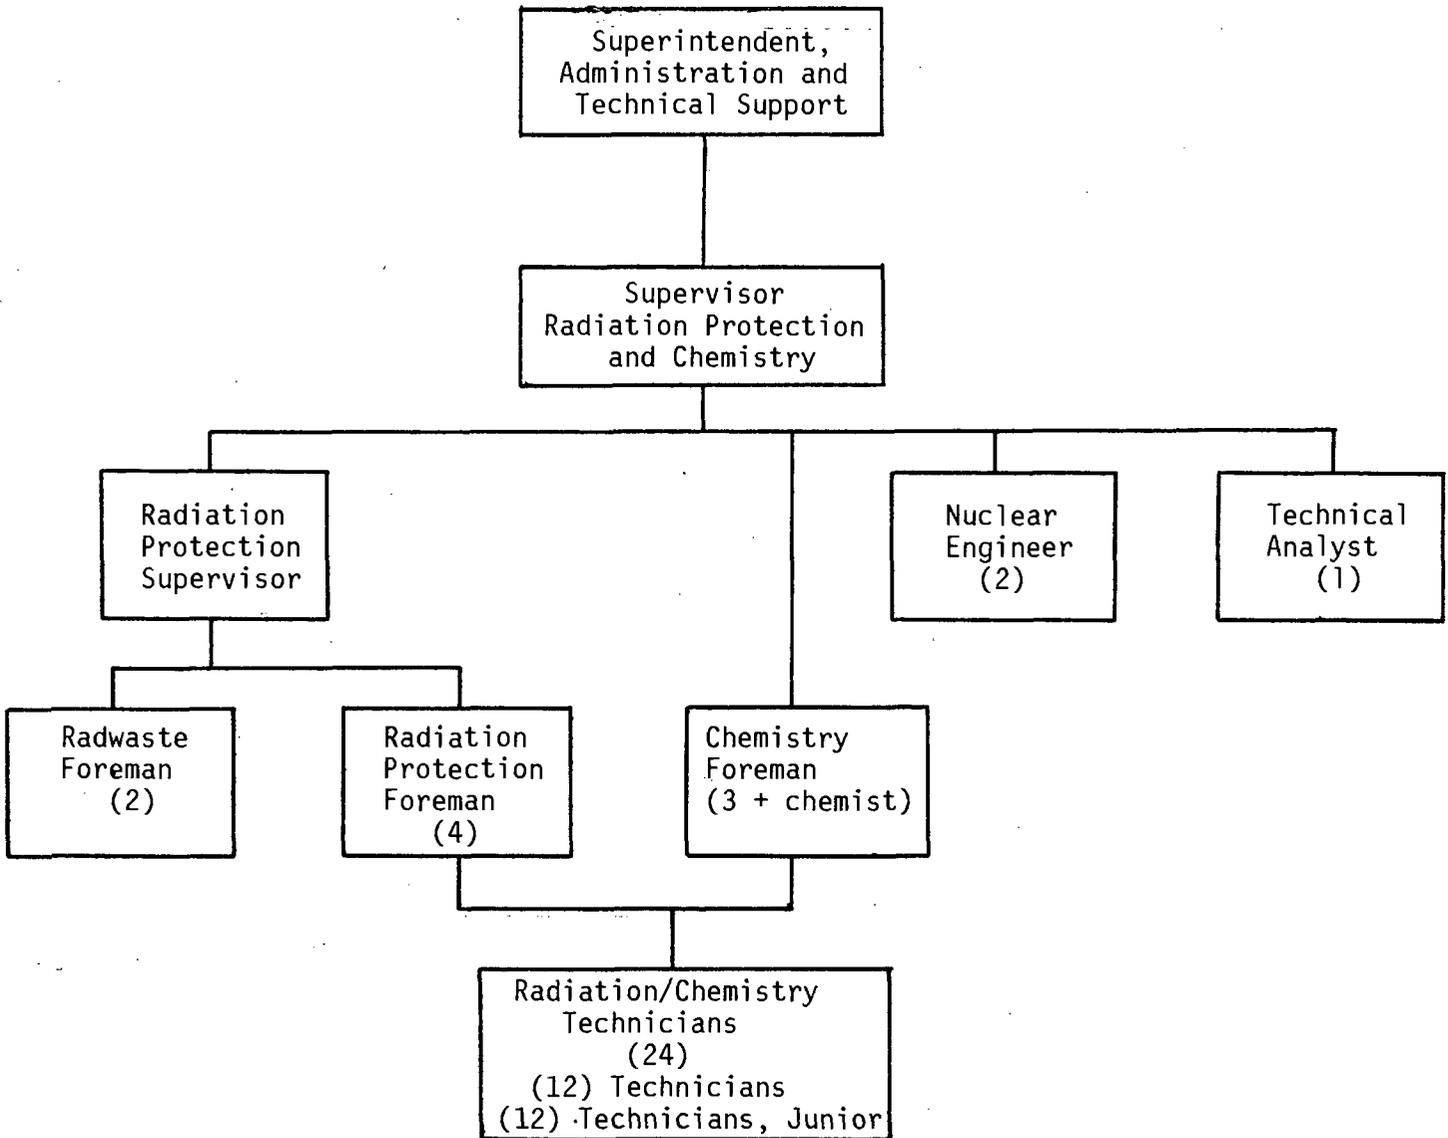
The actual organization of the radiation protection and chemistry staff prior to March 28, 1979 is shown as follows (Int. 94, 124, 133):

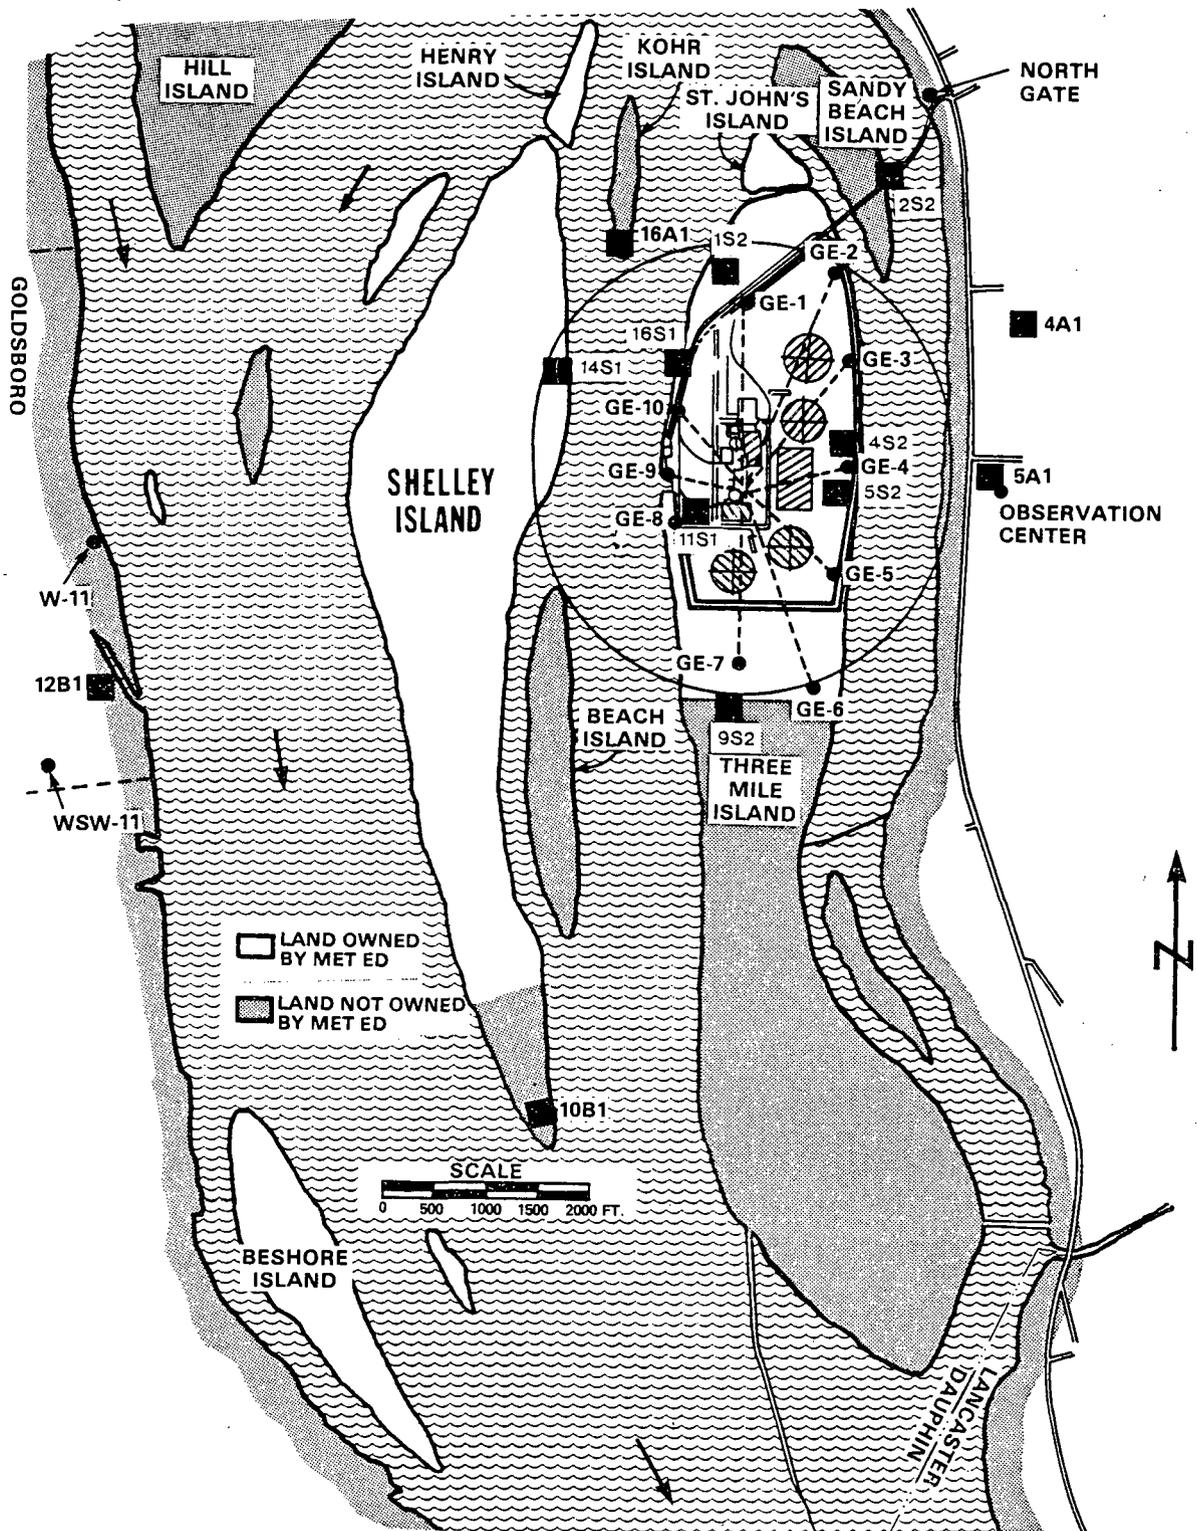
Figure II-3-2

ON ISLAND (GE SERIES) SURVEY POINTS
AND NEAR-FIELD TLD LOCATIONS

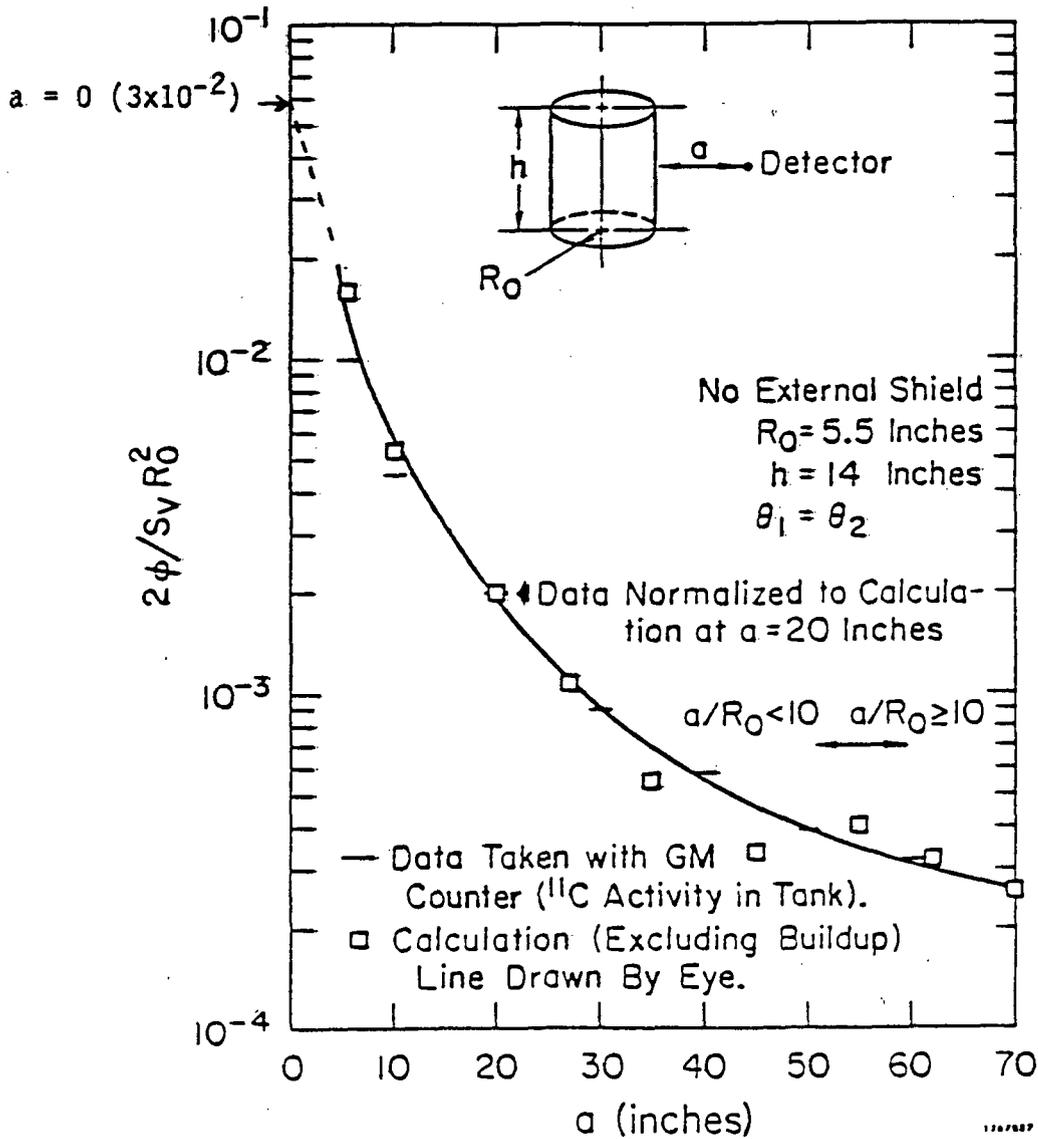
EVALUATION OF PHOTON FLUX (ϕ) AT THE SURFACE OF A RIGHT CIRCULAR CYLINDER

For $R/R_0 = 0.32$, $\phi = \frac{2.6 \times 10^{-2}}{2} = 1.3 \times 10^{-2}$ photons/second

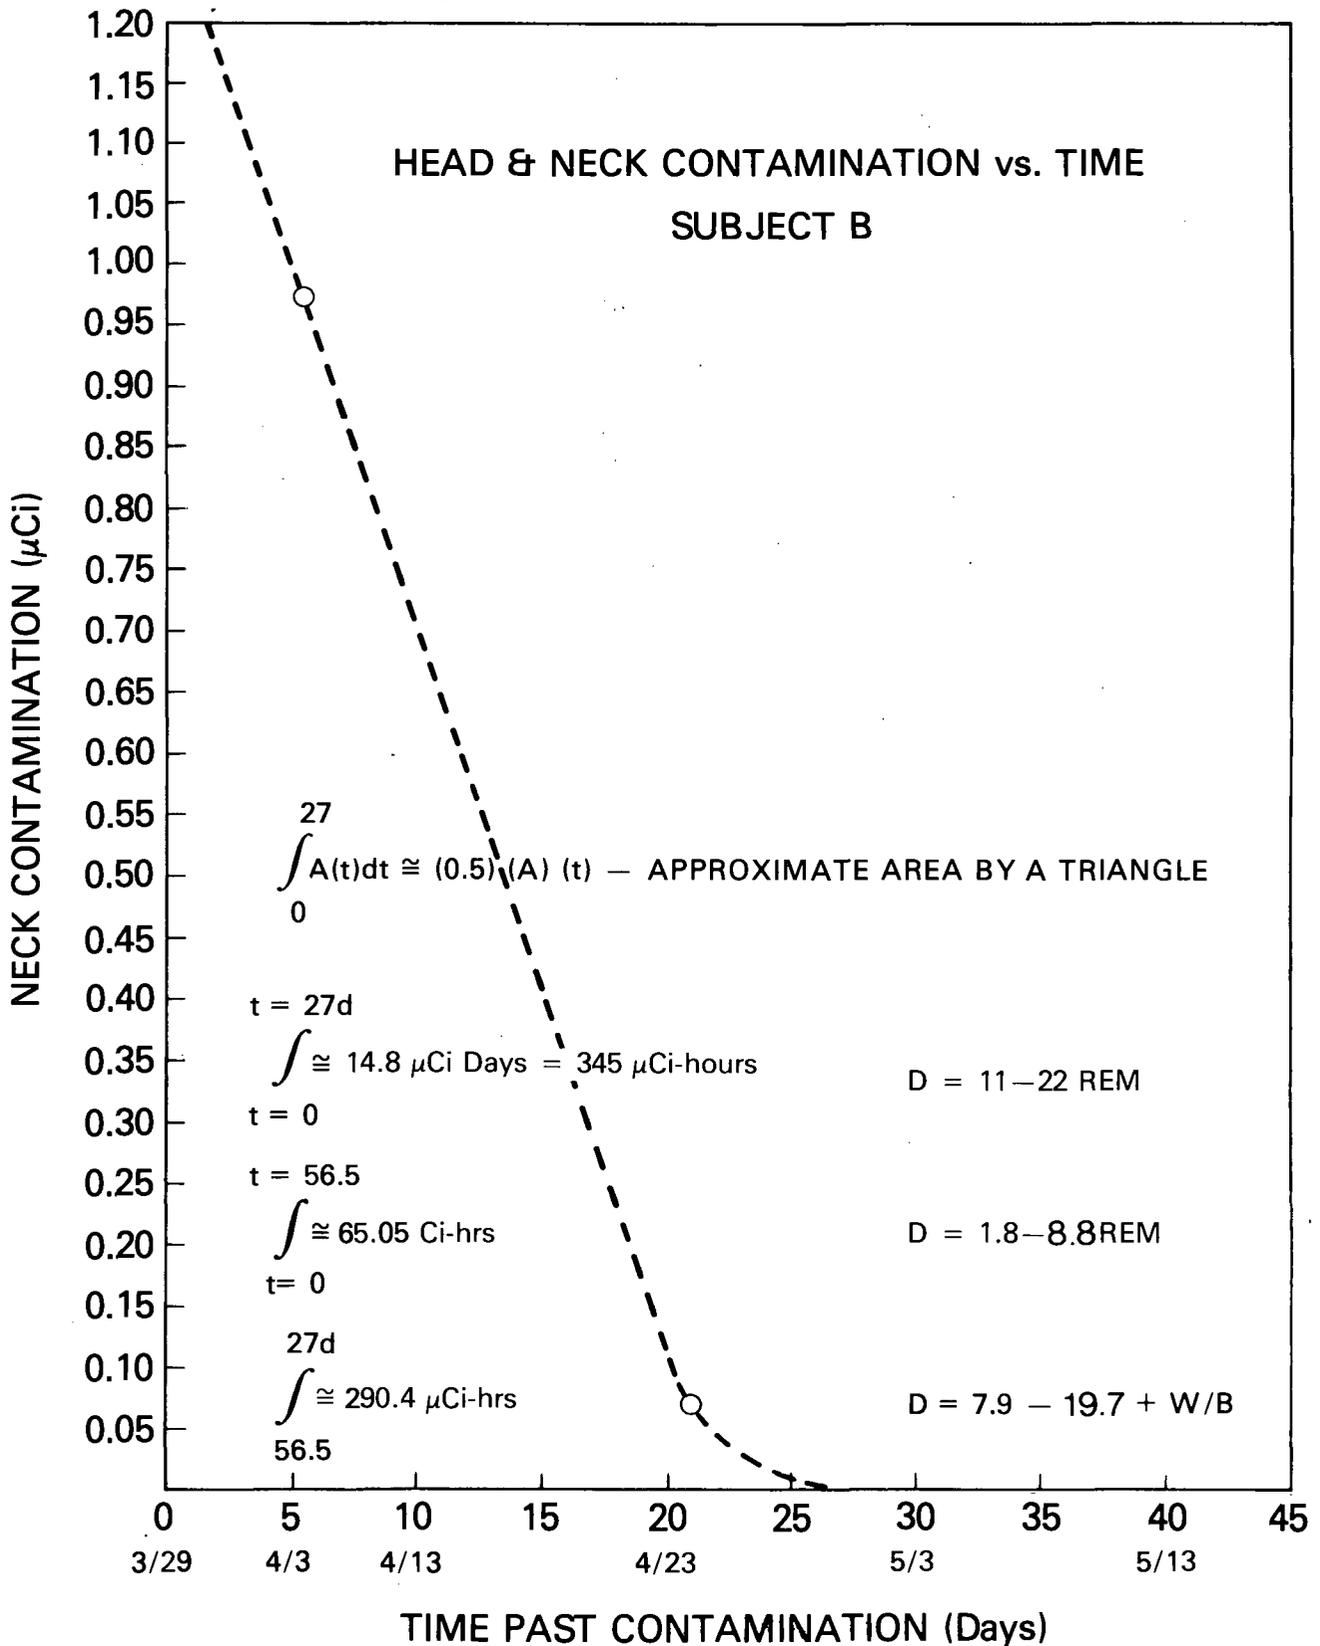
Figure II-B-2

EVALUATION OF SKIN DOSE DUE TO CONTAMINATION AND DIRECT RADIATION
