Supplement to Reportable Occurrence NF-32-77-16  
Davis-Besse Nuclear Power Station Unit 1  
Date of Occurrence: September 24, 1977

## SUMMARY

## 2. EVENT DESCRIPTION

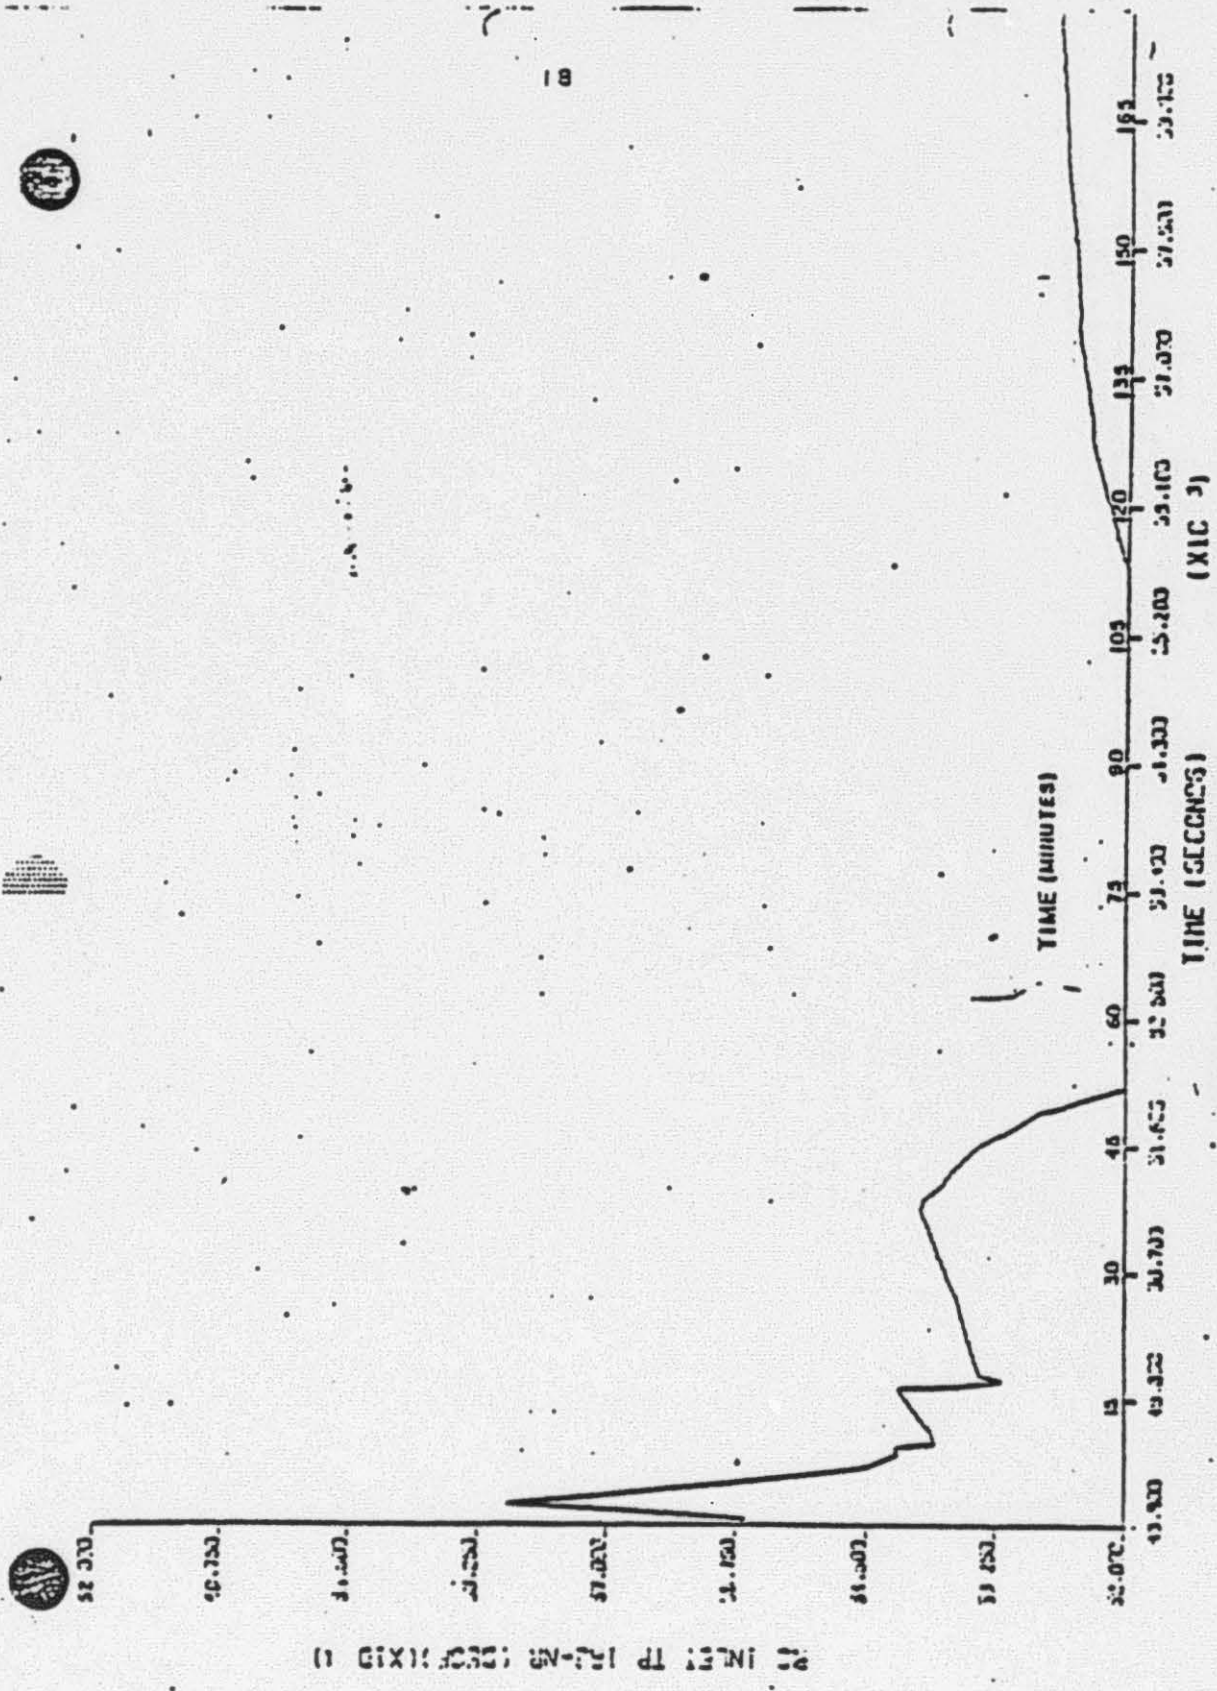
FIGURE 4-1

During this rapid depressurization event (see section 2 above and Exhibit 3, Figures 7-1 through 7-4), the reactor coolant system pressure dropped from about 2300 psig to about 930 psig in 7½ minutes and gradually recovered to 1800 psig in two hours (see Figure 4-1). During this 7½ minutes the reactor coolant outlet temperature dropped at varying rates from about 580 F to about 533 F. Approximately 30 minutes after this initial temperature change, a second slower and smaller temperature change from 540 F to 505 F occurred over a 21-minute period. Following this second temperature decrease, the temperature gradually increased over a 2-hour period to 528 F. The reactor coolant inlet temperature changes and durations were similar to those of the reactor coolant outlet temperature (see Figure 4-2).

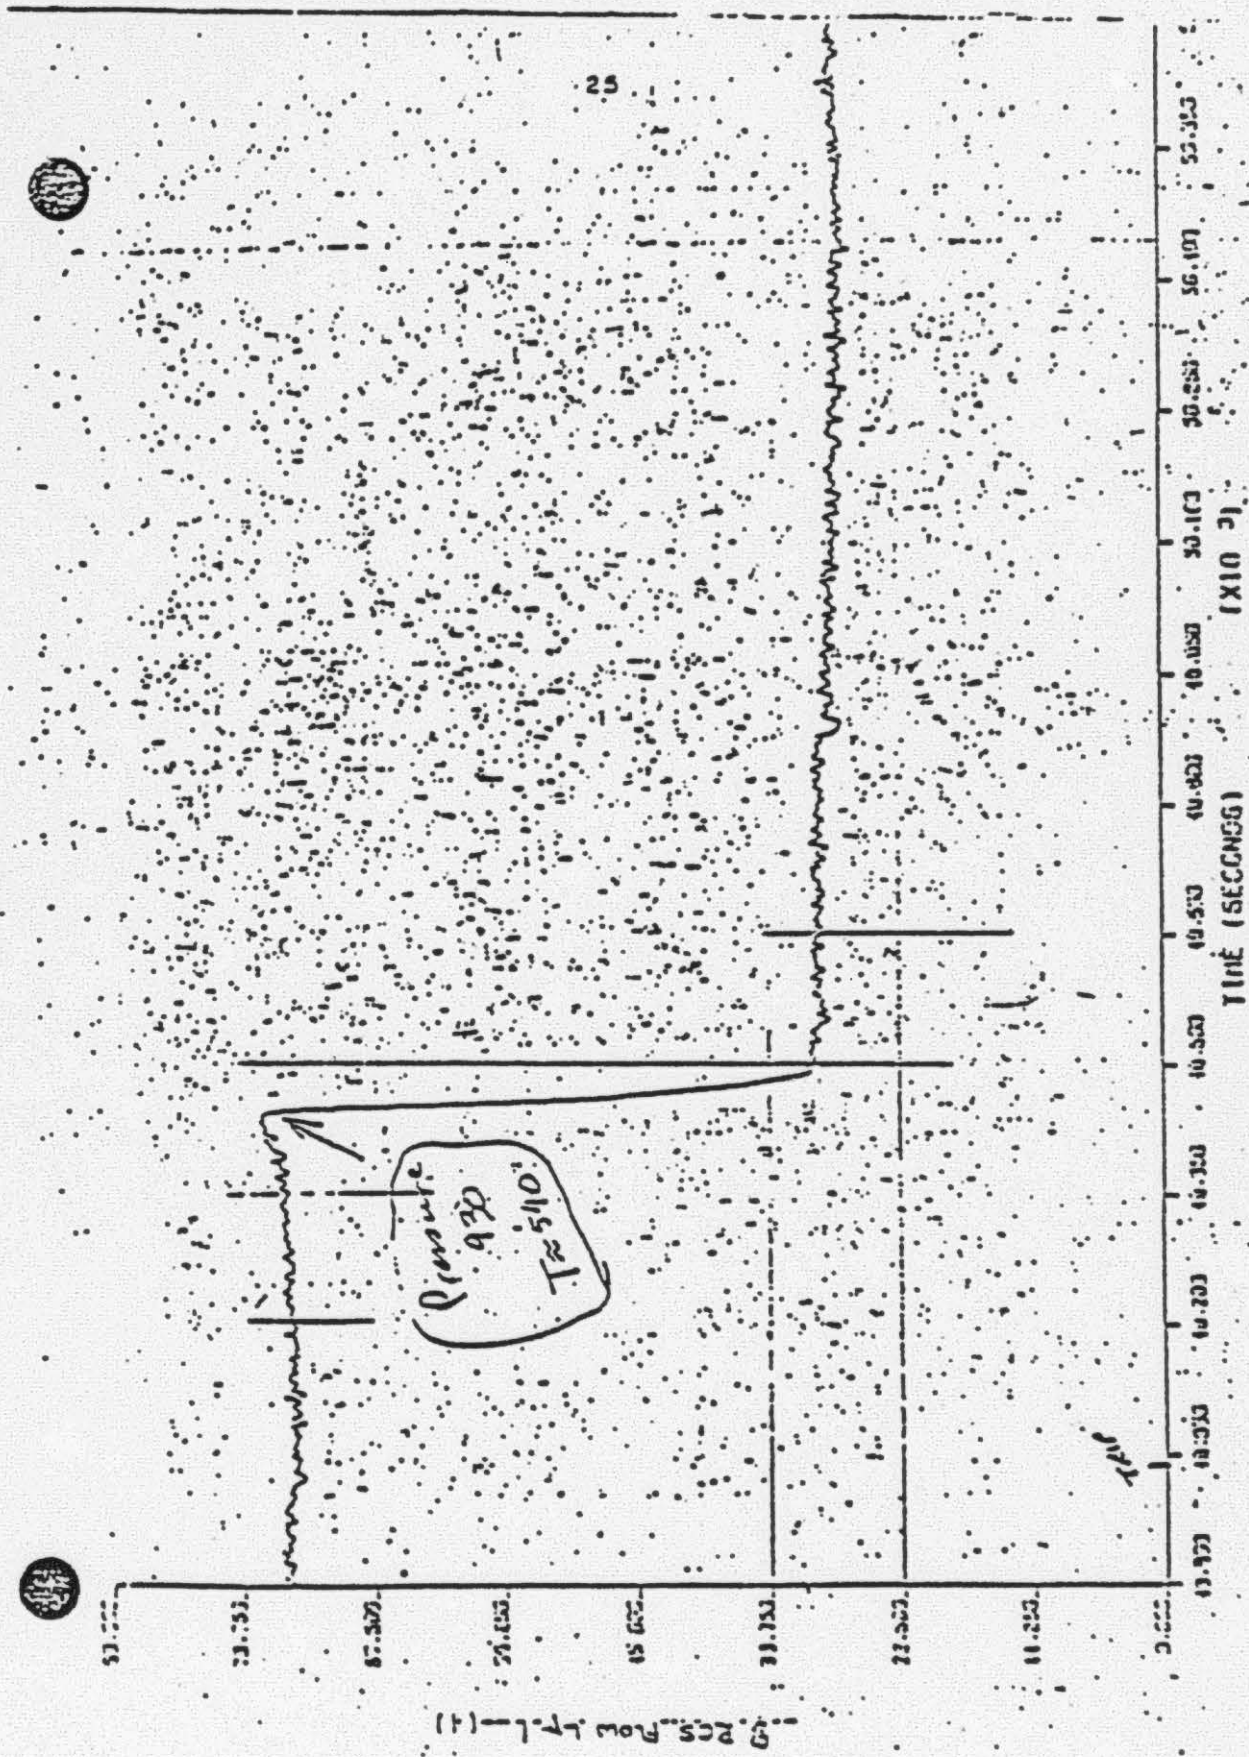
FIGURE 4-8

Assuming a coolant temperature of 337 F and  $150 \times 10^6$  lb/min system flow (per Figures 4-8 and 4-9), the net lift force will be less than 375 lb. The maximum allowable lift force is 472 lb. Therefore, we conclude that fuel assembly lift-off did not occur.
