STAFF REPORT
ON THE GENERIC ASSESSMENT
OF FEEDWATER TRANSIENTS
IN PRESSURIZED WATER REACTORS
DESIGNED BY THE
BABCOCK & WILCOX COMPANY

Office of Nuclear Reactor Regulation
U. S. Nuclear Regulatory Commission

**Manuscript Completed: May 1979
Date Published: May 1979**

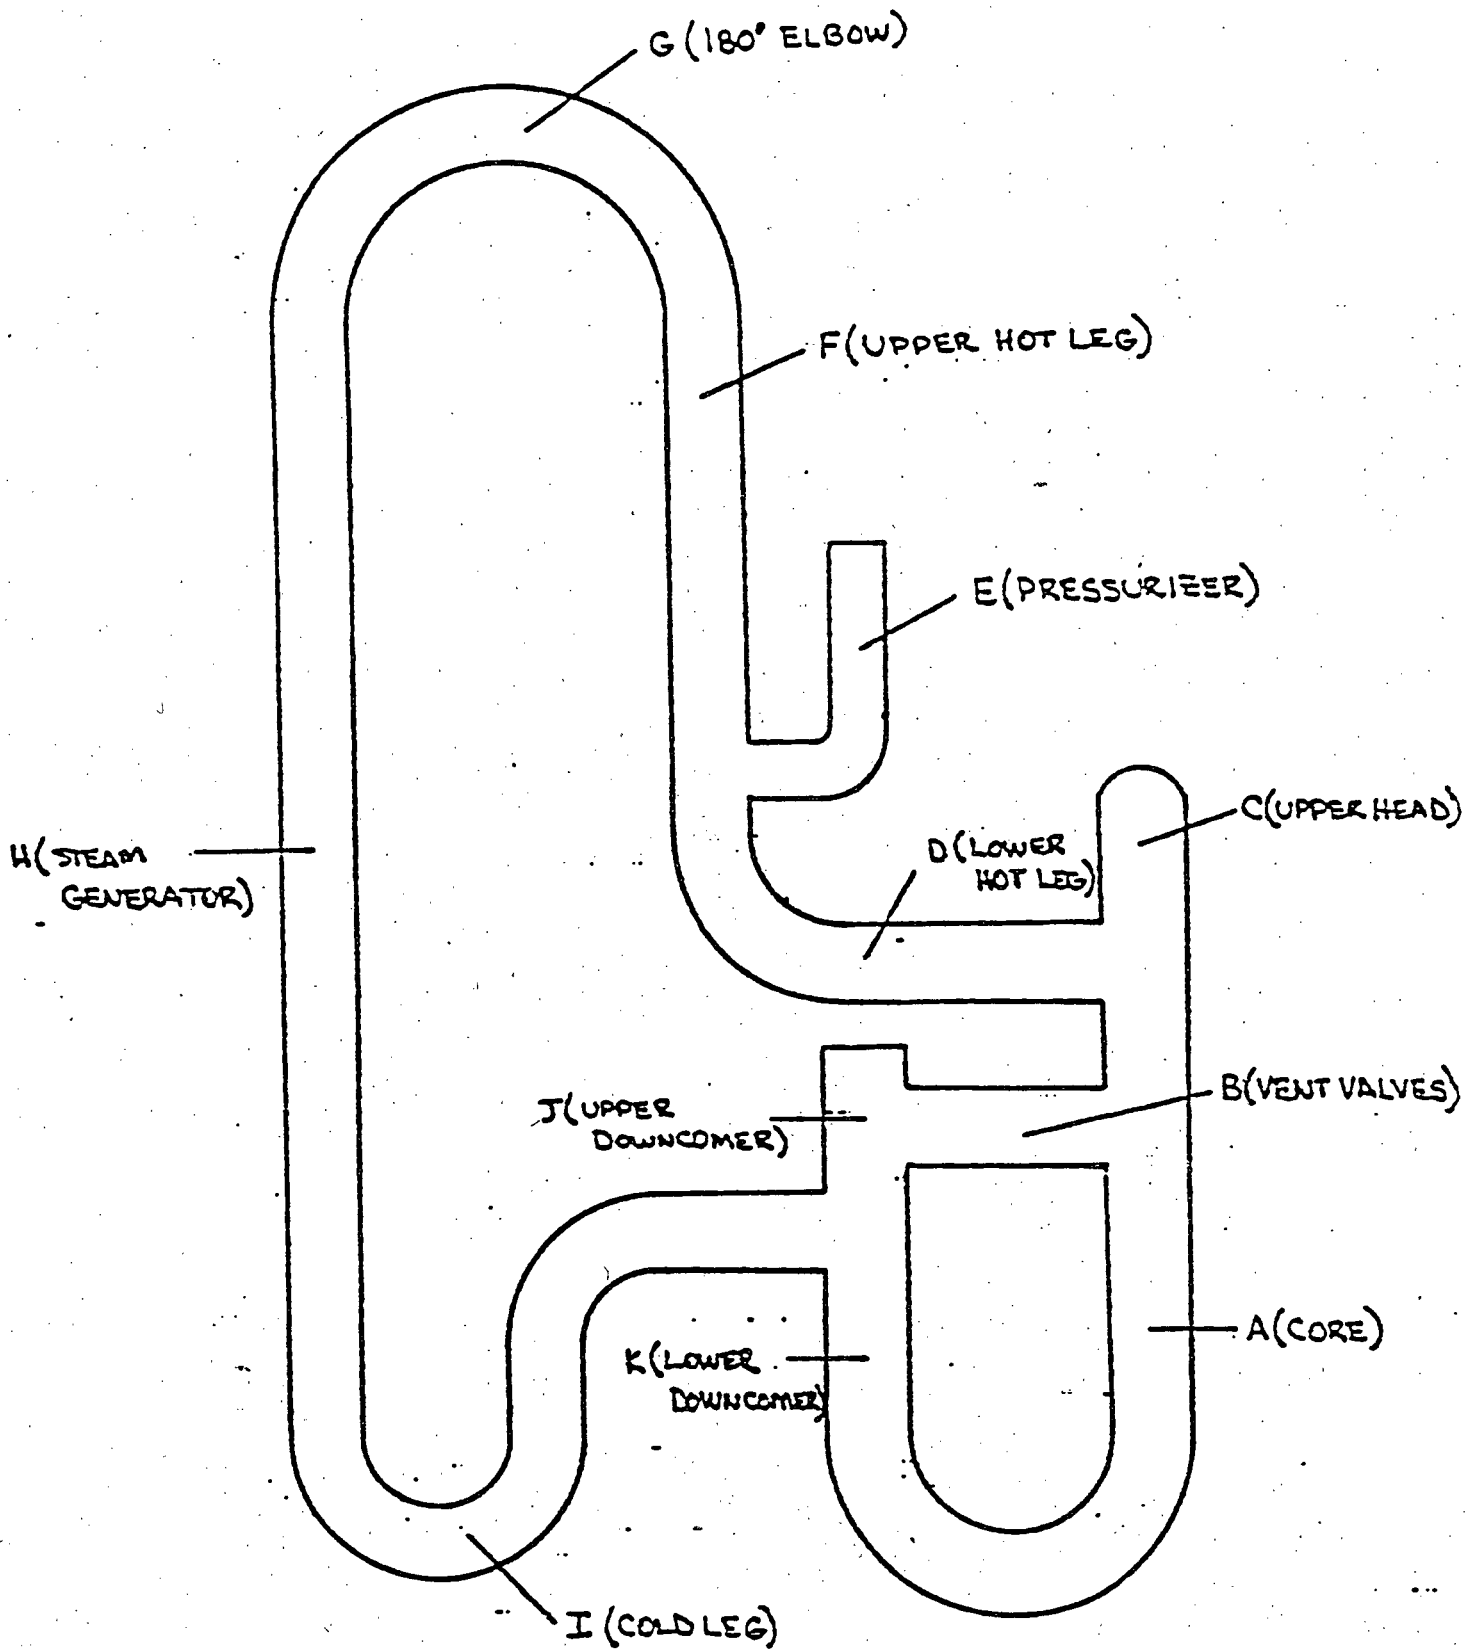
Figure 6-1 B&W System as a Sealed Manometer for a Relatively Small LOCA

This is substantiated by a more detailed examination of the fluid conditions during a relatively small LOCA. Such an accident can be viewed as a very slow transient during which, at any particular time, the system is not meaningfully different from steady-state conditions. The RCS can then be properly described as a sealed manometer. For the B&W system, because of the vent valves, this manometer is double looped as illustrated in Figure 6-1 with important volumes identified by letters.

- (1) Insufficient noncondensibles are available in the initial RCS fluid to block the flow of steam at G (this is a 3-ft diameter pipe).
- (2) Heat transfer coefficients with noncondensibles present are sufficiently large to condense steam in the lower regions of H. Even if the heat transfer were momentarily inadequate, this would merely cause a pressure increase and resultant temperature increase until the temperature difference compensated for the lower heat transfer coefficient.

- (3) The open manometer paths D, F, G, H, and B assure that hydrostatic balances exist between regions H and A, and between regions K and A. If these balances do not exist, fluid movement will occur to produce them.

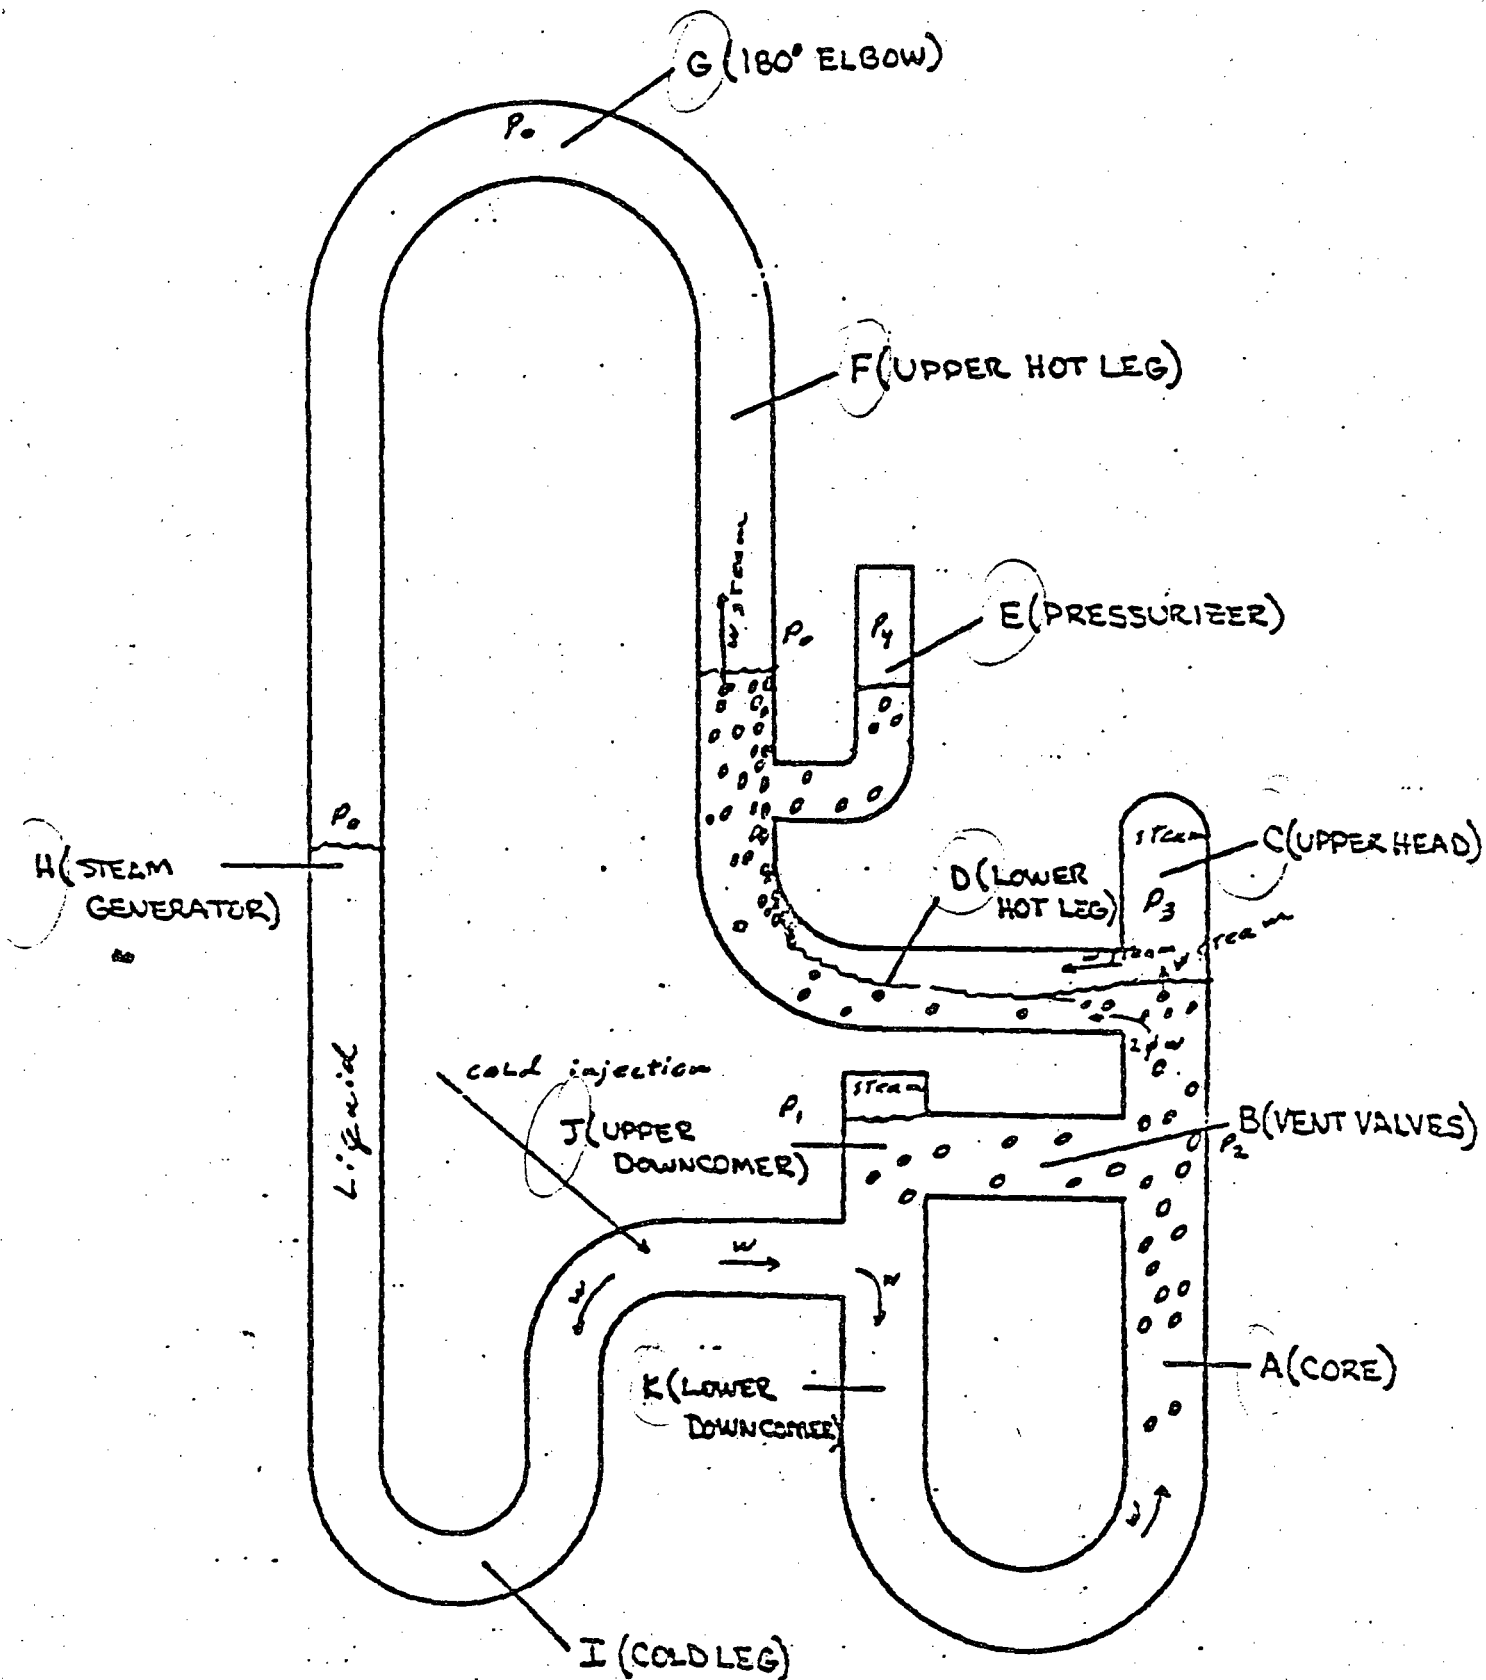
Figure 6-2 Flow Pattern During RCS Repressurization Following a Relatively Small LOCA

Most likely, mechanism (1) will repeat for several cycles prior to mechanism (2) occurring. In any case, uncovering of the core cannot take place. Again, if the core fluid level is lowered, then the fluid level in H must be low and condensation is a credible phenomenon. The flow pattern in D, the horizontal section of the hot leg, is of interest during repressurization. This is illustrated in Figure 6-2 along with the pressures within the system. The following hierarchy of pressures exists:

$$P_0 < P_3 < P_1 < P_2$$

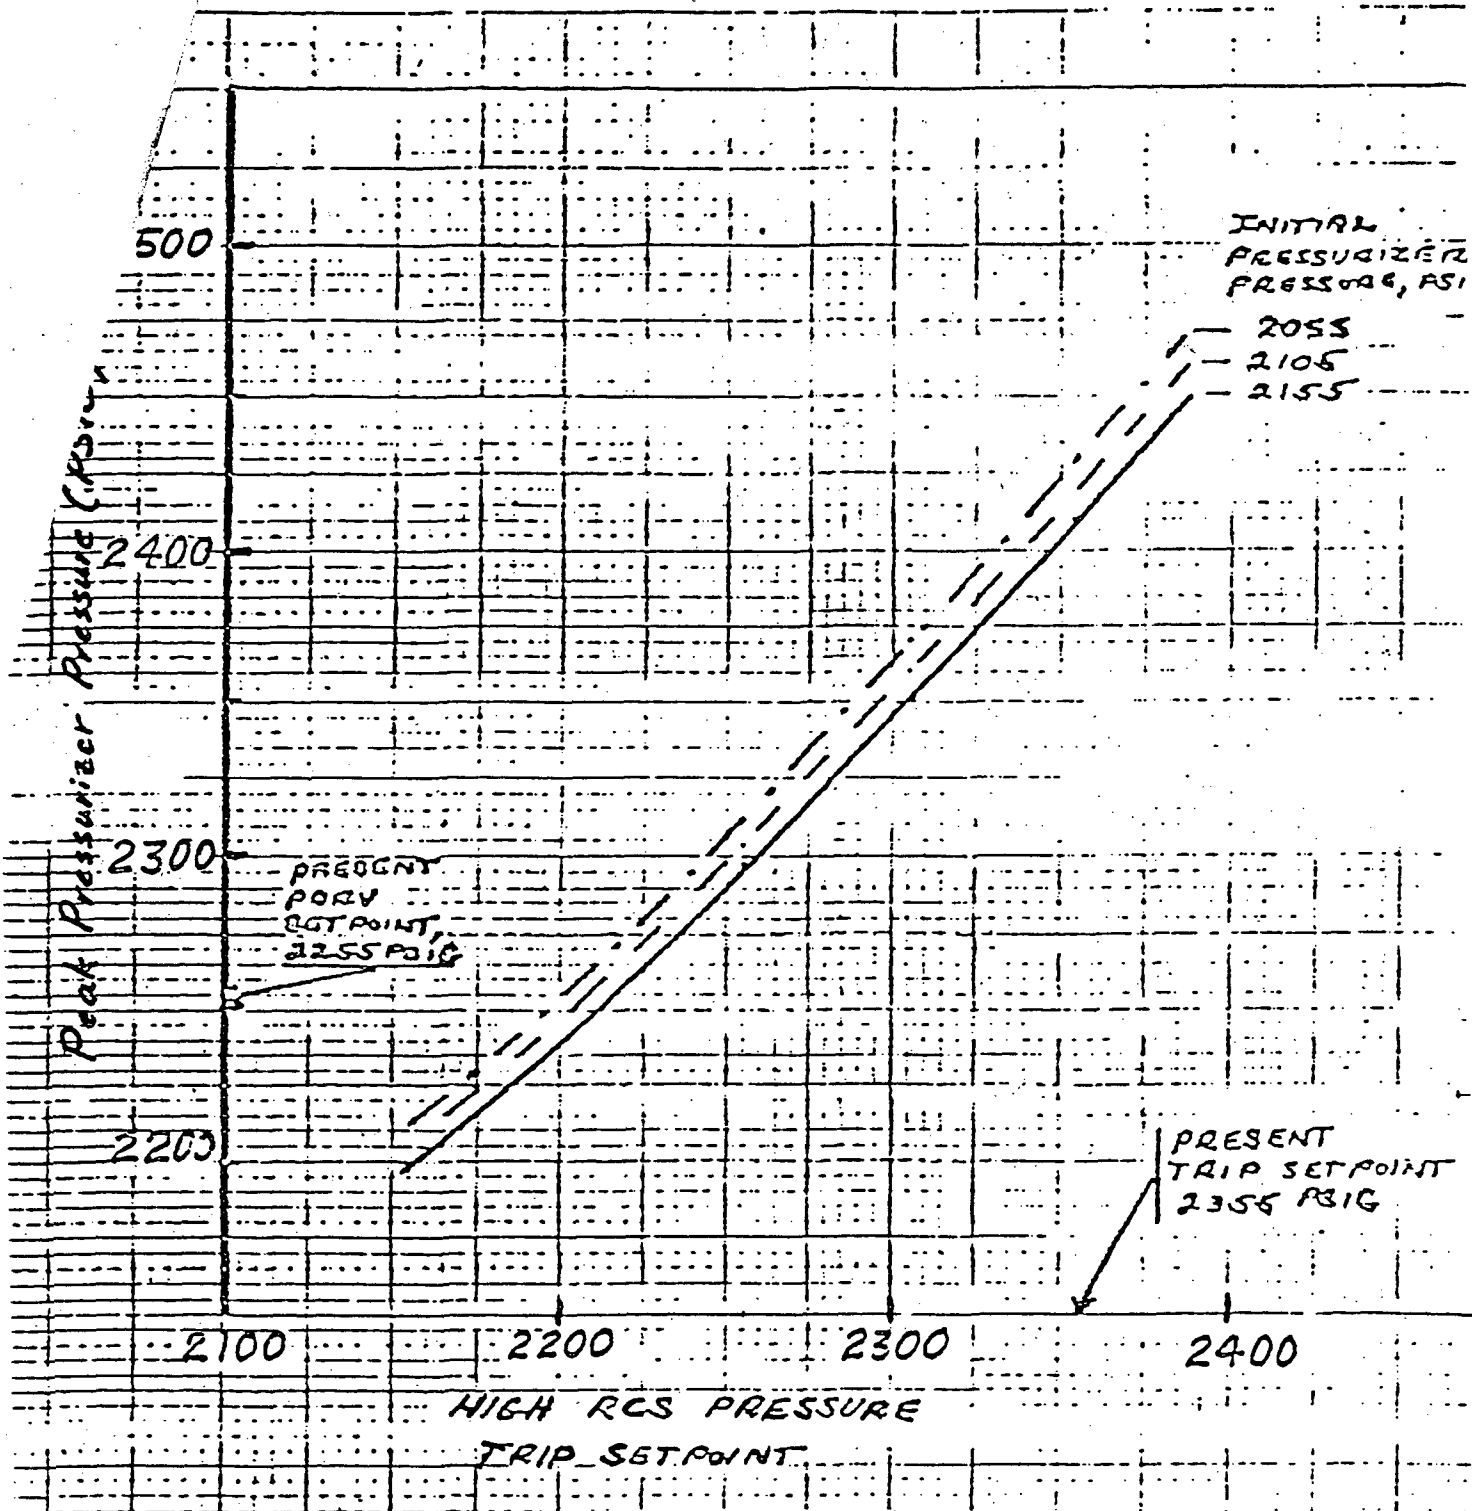
Figure 1

The effect of changing the reactor coolant system pressure trip setpoint upon peak pressurizer pressure is typified by the attached figure 1. which was developed by B&W for a loss of feedwater transient.

Peak pressurizer pressure as a function of RCS pressure trip setpoint for a loss of feedwater transient for expected conditions and various initial pressures.
