TMI-2 Instrument Nozzle Examinations at Argonne National Laboratory*

To be submitted for publication in the Proceedings of the Symposium on Achievements of the OECD Three Mile Island Vessel Investigation Project, Boston, MA, October 20-22, 1993.

Abstract

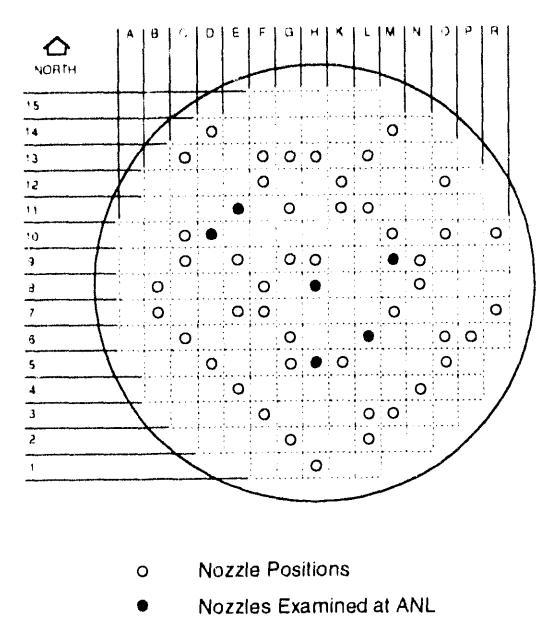
Fig. 1. Grid Map of TMI Core Showing Locations of Nozzles Examined at ANL

The nozzle segments received at ANL were from locations D10, E11, H5, H8, L6, and M9. Figure 1 shows the location of these nozzles in the reactor grid plan. These nozzle segments represented a range of thermal damage, i.e., melt-off and surface degradation, found in the fourteen nozzles during the removal operations. Nozzles in the area of E-F/7-9 were significantly more damaged than the peripheral nozzles. The degree of damage to individual nozzles would be indicative of the possible damage, or change in metallurgical condition, of the vessel in proximity to the nozzle. The H8 nozzle was the most heavily damaged of those examined at ANL, having a length of only 70 mm atop a residual stub left on the vessel of only 51 mm. The L6 nozzle, on the other hand, was 241 mm long and showed no outward appearance of any damage. The other four nozzles had either melt-off damage at different elevations (M9 and H5) or different degrees of surface damage (D10 and E11). Thus, the examination of these six nozzles would provide information and insight to satisfy all of the objectives of the examinations.

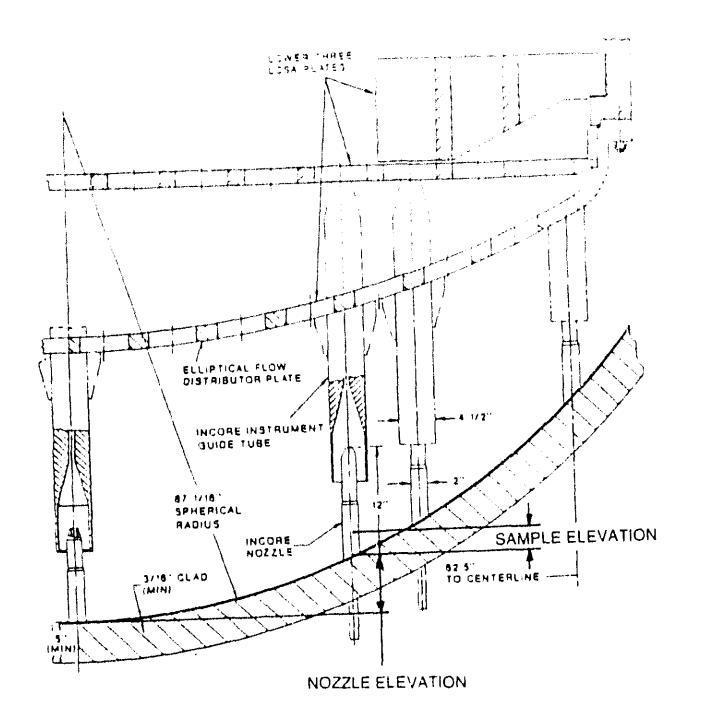
Fig. 2. Lower-head Area and In-core Instrument Guide Tubes. (MPR No. F-73-30-311)

Pattern of Nozzle Damage - To appreciate the significance of the damage findings, the elevation of the damage to a particular nozzle above the bottom of the vessel must be considered. Figure 2 shows the relationships between the elevations of nozzle locations referenced to the lowest nozzle location at H8, while Table 1 provides the actual elevations and segment lengths for the six ANL nozzles. These elevations are important to the understanding of the man-
