**Results of Examinations of Pressure Vessel Samples
and Instrument Nozzles from the TMI-2 Lower Head***

G. E. Korth
Idaho National Engineering Laboratory
EG&G Idaho, Inc.
Idaho Falls, ID 83415

D. R. Diercks and L. A. Neimark
Energy Technology Division
Argonne National Laboratory
Argonne, IL 60439

October 1993

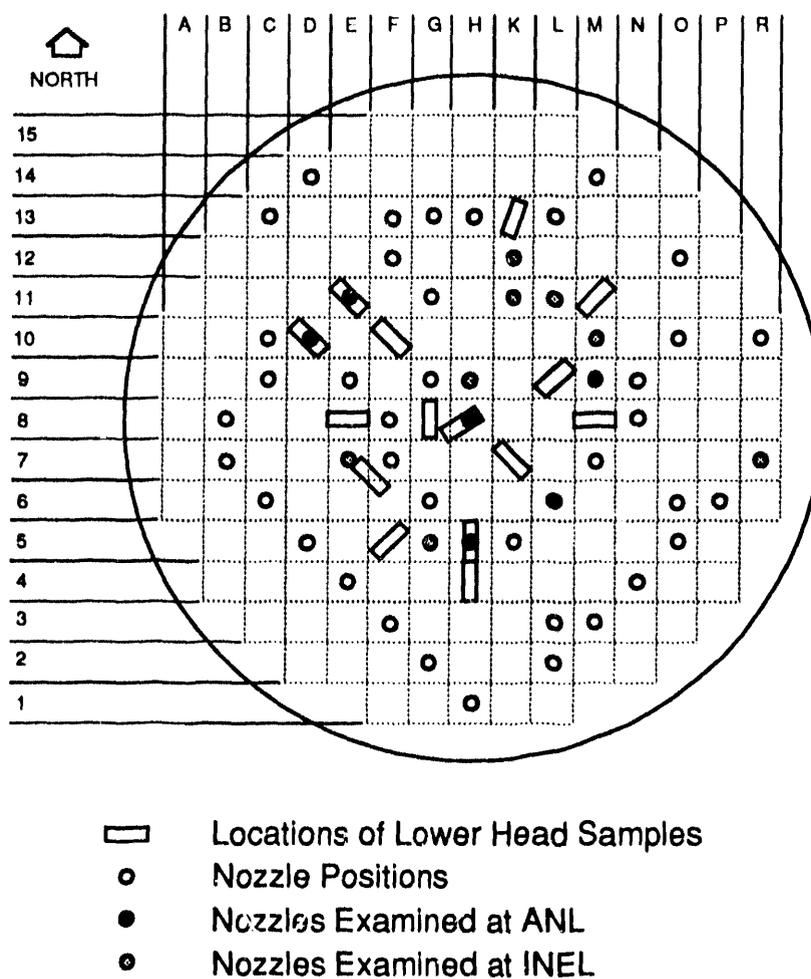
Fig. 1. Grid map of TMI core showing locations of lower head samples and nozzles.

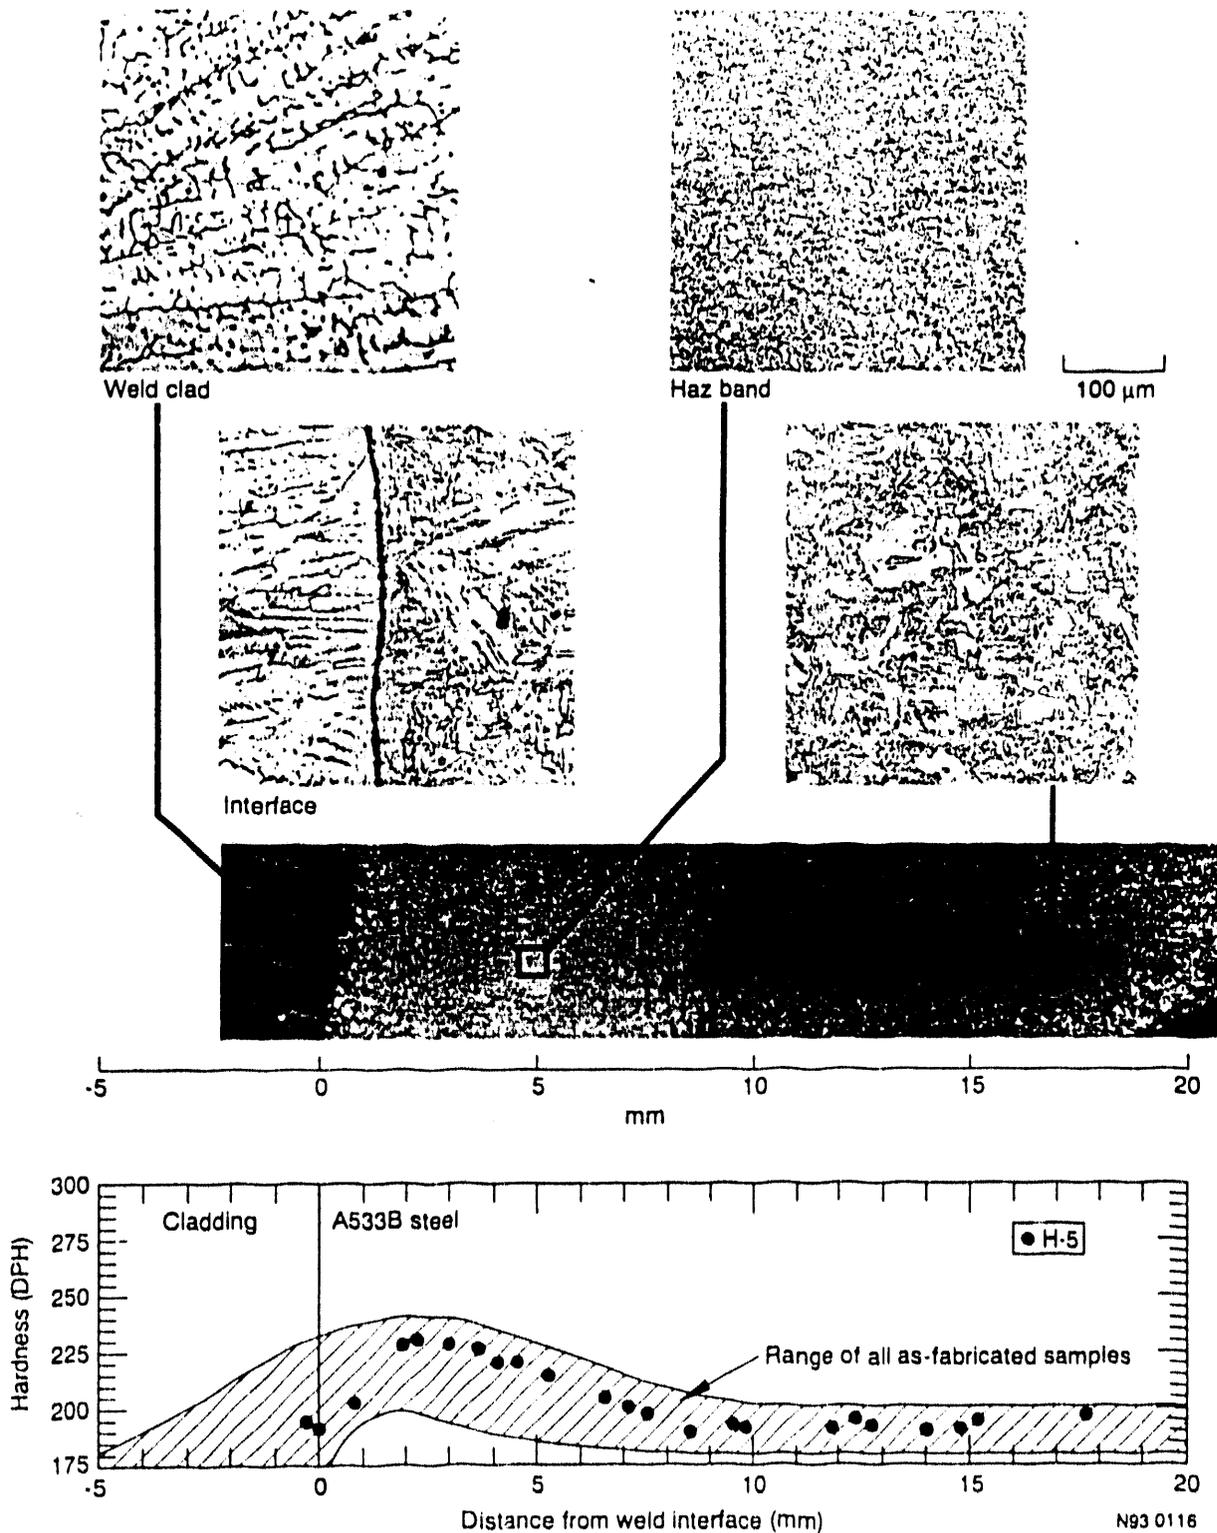
Hardness Measurements. The hardness profiles of most of the TMI-2 samples had the typical characteristic profile of as-fabricated material as shown in Fig. 4, but the hardness profiles from Samples E-6, E-8, F-10, and G-8 were markedly different than all other samples, as shown in Fig. 5. The characteristic hardness profile through the HAZ band had risen sharply in these four samples to much higher levels and was then sustained throughout the full sample depth. Heat-affected bands from the weld cladding were not evident in these four samples, but were completely eliminated by the thermal effects of the accident.

Fig. 4. Typical as-fabricated microstructure and hardness of TMI 2 lower head material (from Sample H-5).

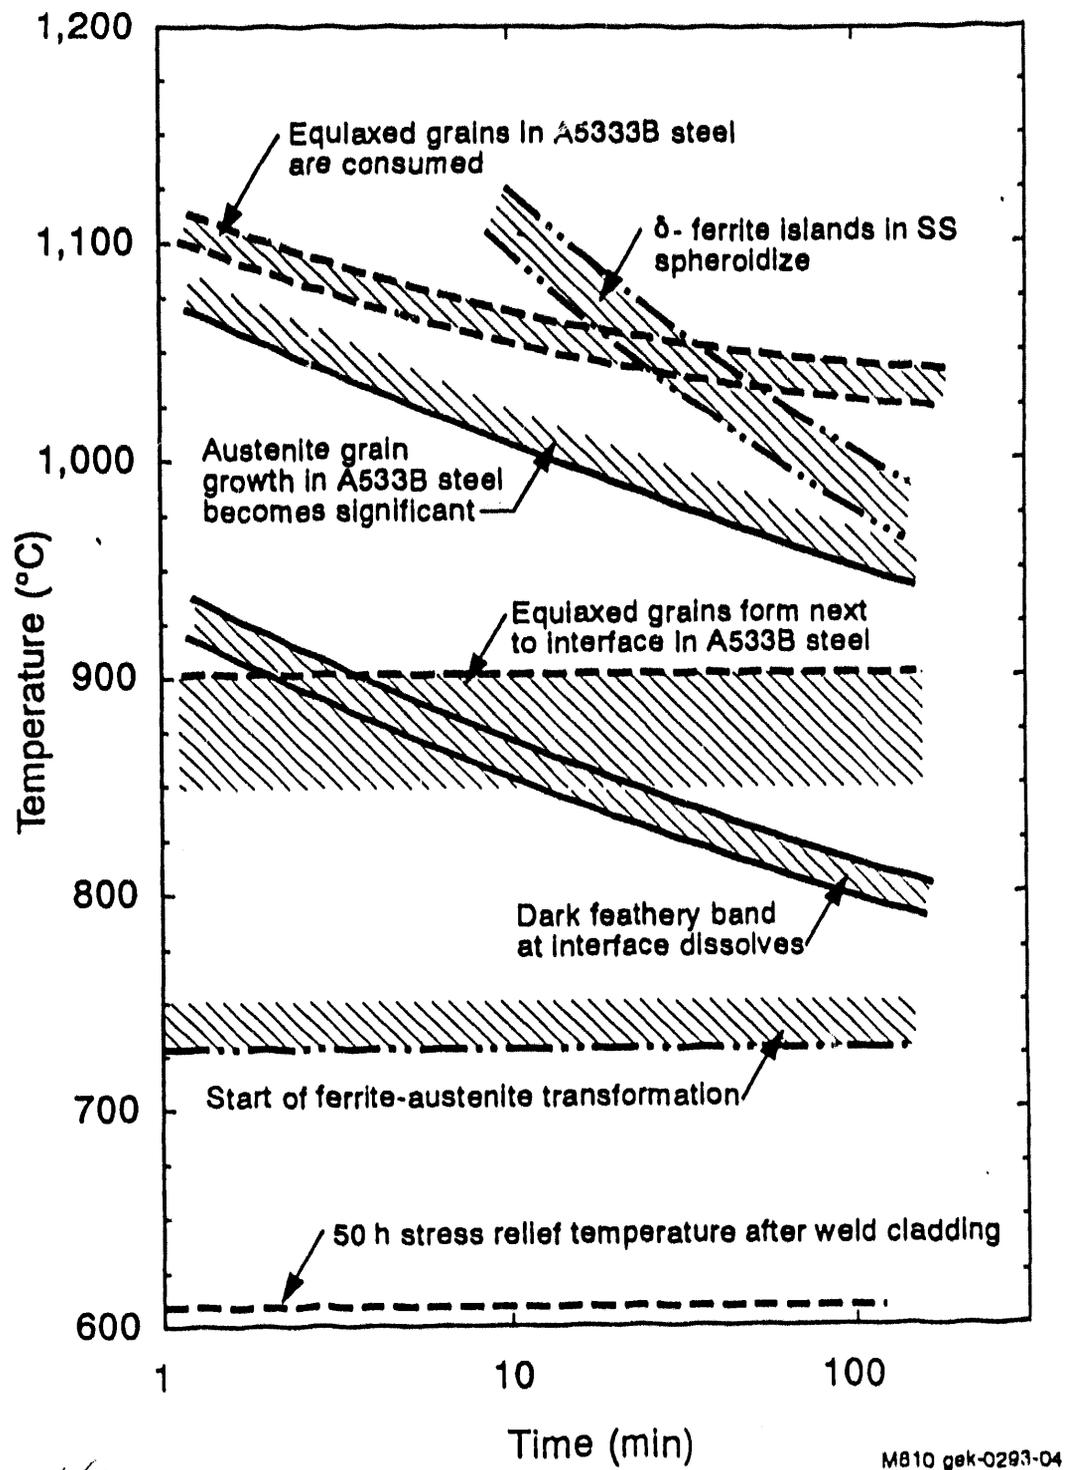
As the standards were prepared and examined, various metallurgical observations revealed a step-wise process that could be used in determining the thermal histories of the TMI-2 samples. A diagram (shown in Fig. 6) was constructed, which illustrates the metallurgical changes with time and temperature of the Midland and TMI-2 lower head A533B steel with a 308L stainless weld clad. Since the vessel was stress relieved at 607°C after the weld cladding, no thermal effects from the accident could be detected at or below this temperature and, therefore, the diagram shows only metallurgical observations for temperatures above this point. The lowest temperature indicator, above the stress relief temperature, was the ferrite-austenite transformation, which starts at 727°C and is complete by ≈830°C. Variations in the typical as-fabricated hardness profile will be evident when this threshold is exceeded. The next indicator is the dissolution or dissipation of a dark feathery band at the interface; this occurs between 800 and 925°C, depending on the time. The next indicator of increasing temperature is the appearance of small equiaxed grains, which formed in the A533B steel adjacent to the interface at temperatures between 850 and 900°C and disappeared between 1025 and 1100°C as they were consumed by grain growth in the low alloy steel. The equiaxed grains, which are not typical for a low alloy steel, appear to be devoid of cementite, probably due to a loss of carbon into the stainless steel. Grain growth in the A533B steel becomes significant above approximately 950 to 1075°C, depending on the time involved. The highest temperature indicator shown on the diagram is the change in morphology of the δ-ferrite islands in the stainless steel cladding. In the approximate range of 975 to 1000°C at 100 minutes or 1100 to 1125°C at 10 minutes, the δ-ferrite islands begin to lose their slender branch-like morphology and become spherical in shape. This spheroidizing of the δ-ferrite islands is believed to be associated with the dissolution of $M_{23}C_6$ carbides, which decorate the ferrite-austenite boundaries and stabilize their shape. When the carbides dissolve, the δ-ferrite becomes more spherical to minimize surface energy. There was also evidence that some of the δ-ferrite was consumed into the austenitic matrix after exposures above 1000°C since there was a net loss of δ-ferrite after cooling. Researchers in the Federal Republic of Germany⁷ and Spain⁹ observed that δ-ferrite in the cladding of non-affected samples was 4-5%, but only 1.4% in E-8.

Fig. 6. Diagram of time-temperature observations of A533, Gr. B pressure vessel steel clad with Type 308L stainless steel.

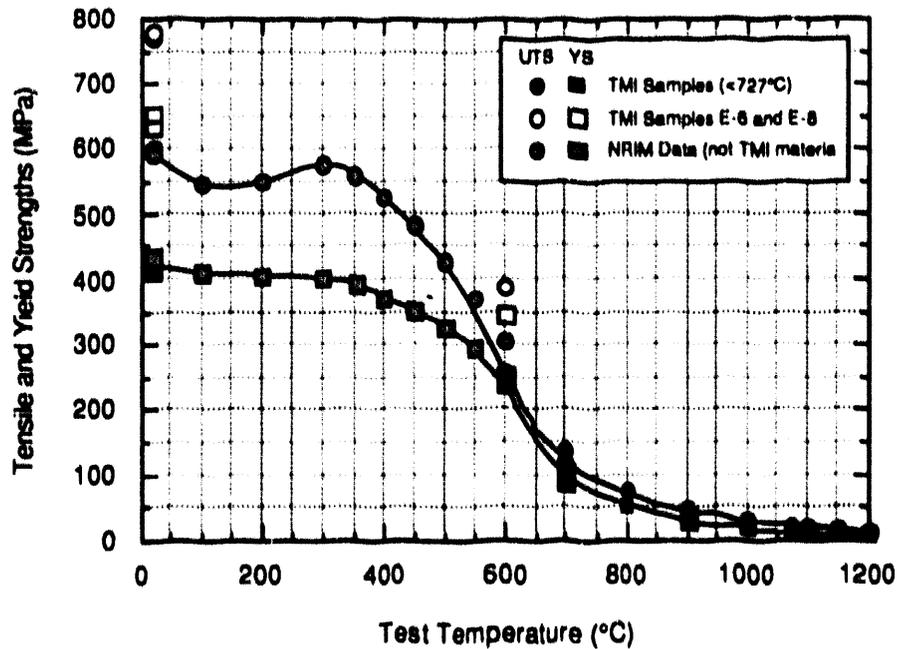
The results of the tensile tests conducted on the lower head base-metal specimens are presented in Fig. 14. These tests were carried out at ANL as well as in Belgium, France, and Spain. Also plotted in Fig. 14 are average values reported by the Japanese National Research Institute for Metals (NRI) for five other heats of A533, Grade B steel.¹⁵ The NRI data were obtained at a strain rate of $5 \times 10^{-5} \text{ s}^{-1}$ up to yield and $1.25 \times 10^{-3} \text{ s}^{-1}$ for the remainder of the test. The NRI tensile strength data suggest a strain-aging effect between 100 and 300°C, resulting in a local tensile strength minimum at ~150°C. Both the tensile and yield strengths of this alloy are strongly temperature dependent; the room-temperature values are reduced by more than a factor of 2 at 600°C and by more than a factor of 10 at 900°C.

The data for specimens taken from lower head samples E-6 and E-8 are plotted separately in Fig. 14, and these data lie significantly above the best-fit curve to the remaining data. It has been determined that both of these samples were heated to maximum temperatures of ~1000-1100°C during the accident, followed by a relatively rapid cooling.² The resulting hardening has produced significant increases in strength at both room temperature and 600°C.

Fig. 14. Tensile and yield strengths of TMI-2 lower head material

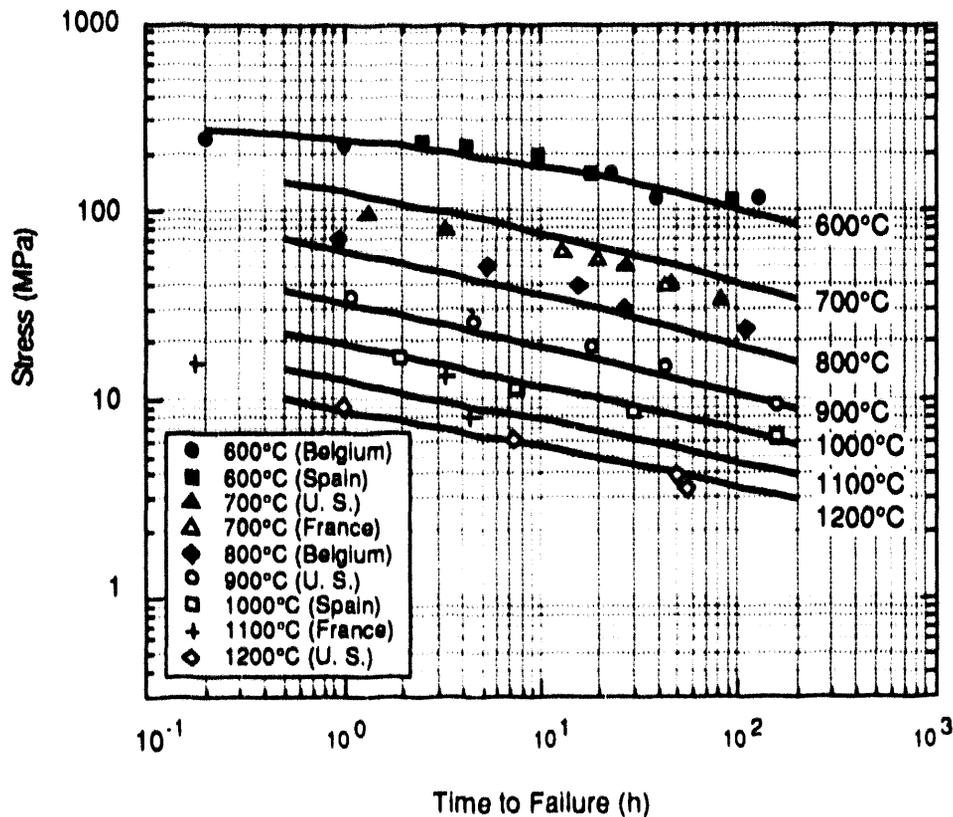
These tests were carried out at ANL and in Belgium, France, and Spain, and the resulting stress-vs.-time-to-failure data are plotted in Fig. 15. The tests were conducted in an Ar or He environment except those conducted by the SCK/CEN in Belgium. All but one of the Belgian tests was conducted in vacuum: a single test at 800°C and 30 MPa was conducted in an Ar environment.

Materials with slightly different thermal histories were tested at both 600 and 700°C. At 600°C, tests were conducted on specimens from Sample K-13, for which the maximum temperature during the accident did not exceed 727°C, as well as on specimens from Sample F-5, for which the maximum temperature was apparently somewhat >727°C over a portion of the sample. No significant difference in time to failure is observed in Fig. 15. This lack of an effect may be attributed to the fact that the maximum temperature probably did not significantly exceed the transformation temperature of 727°C in F-5, particularly in the bottom half of the sample from which the creep test specimens were taken. Similarly at 700°C, specimens from Sample M-11, for which the maximum temperature may have approached or slightly exceeded 727°C, show no difference in behavior when compared with specimens from Sample H-8, for which the maximum temperature remained below 727°C.

Fig. 15. Stress-rupture data with Manson-Haferd best fit

A comparison of the resulting best fit curves with the actual s vs. t_f data in Fig. 15 shows a reasonably good fit to the data. However, systematic departures from the actual data are noted in the 700-900°C region. This problem may be associated, in part, with the ferrite-to-austenite phase transformation that occurs over the temperature regime from 727 to \approx 850°C.

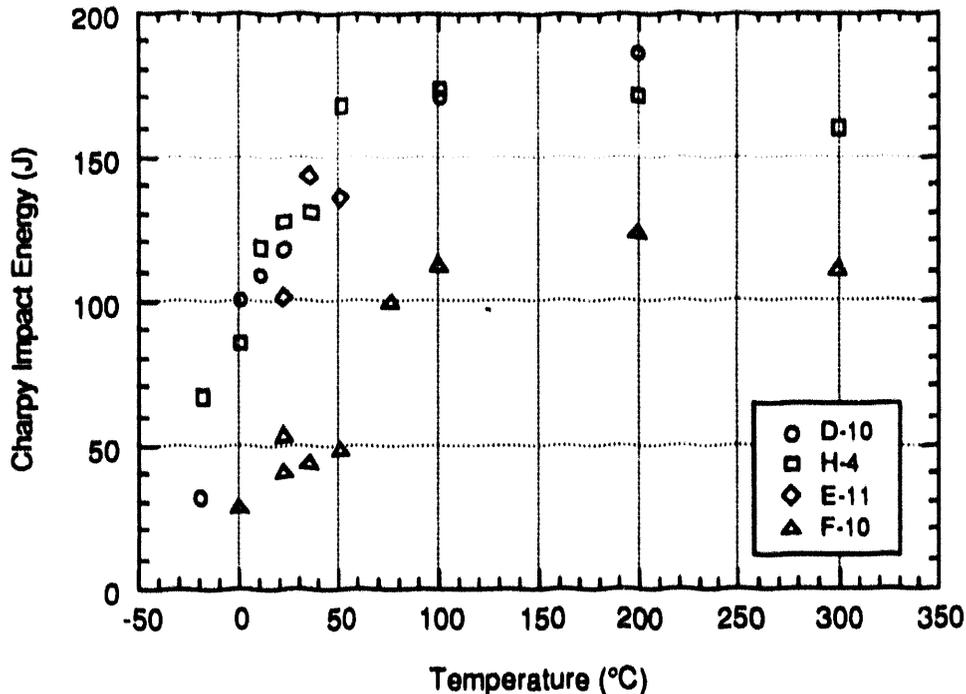
Fig. 16. Absorbed impact energy vs. test temperature

Impact Tests. The impact tests on the lower-head material were conducted in Italy⁸ using the procedure and conventional Charpy V-notch test specimen described in ASTM E23, and the data are summarized in Fig. 16. The three groups of test specimens for which the maximum temperature did not exceed 727°C show similar behavior, with an upper shelf energy of ~170 J and a transition temperature of the order of 20°C. However, the data from specimens of Sample F-10, for which the maximum temperature was as high as ~1050°C, stand in marked contrast. The F-10 material shows a significantly higher ductile-to-brittle transition temperature of ~70°C, as well as a lower upper-shelf energy of ~120 J. These differences reflect the reduced ductility and impact resistance that is produced in this material by the high temperatures and relatively rapid cooling associated with the accident.
