**Results of Examinations of Pressure Vessel Samples
and Instrument Nozzles from the TMI-2 Lower Head***

October 1993

**Results of Examinations of Pressure Vessel Samples
and Instrument Tube Nozzles from the TMI-2 Lower Head**

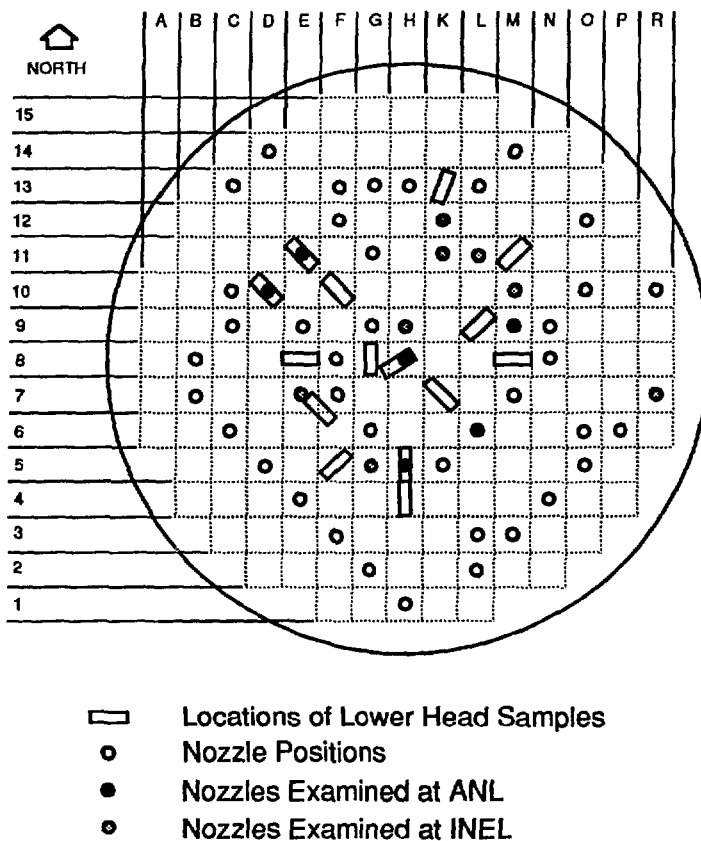
Fifteen prism-shaped samples, each ≈ 152 - 178 mm (6-7 in.) long, 64-89 mm (2.5-3.5 in.) wide, and 64-76 mm (2-1/2-3 in.) deep, were recovered from the TMI-2 lower head during the first phase of the program (Fig. 1). The samples were cut from the inner surface of the lower head and typically extend through approximately half the lower head thickness. These 15 samples were subjected to detailed initial examinations and were then sectioned into metallographic and mechanical test specimens for further characterization (Fig. 2). The results of the initial sample examinations, metallographic studies, and mechanical tests are reported here.

Fig. 1. Grid map of TMI core showing locations of lower head samples and nozzles.

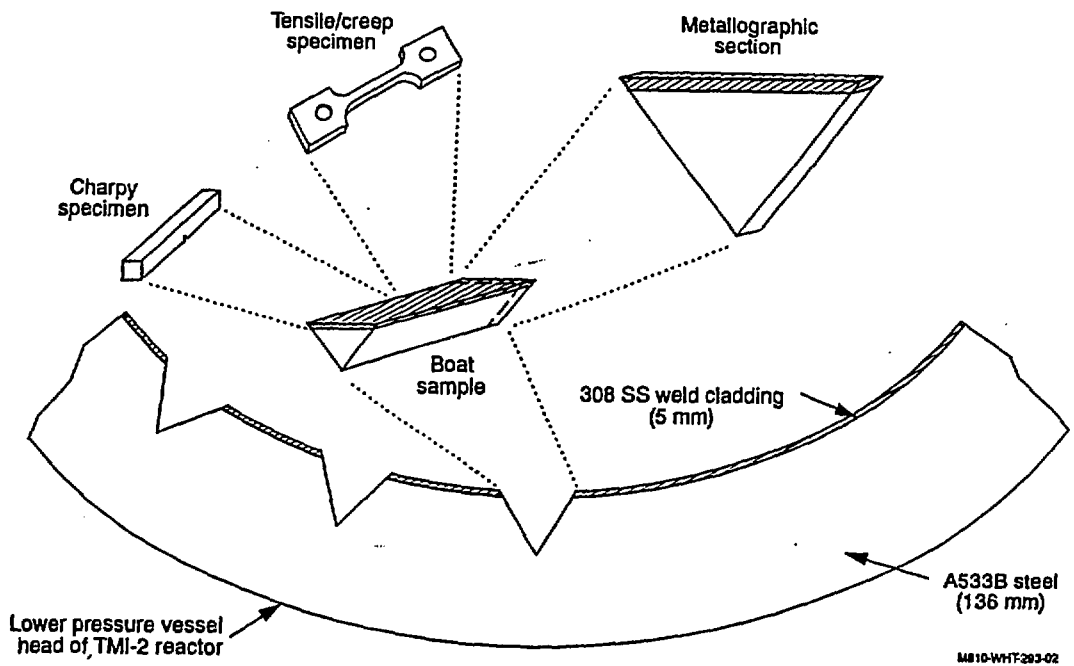
Fig. 2. Schematic of the source of the TMI-2 metallographic and mechanical property samples.

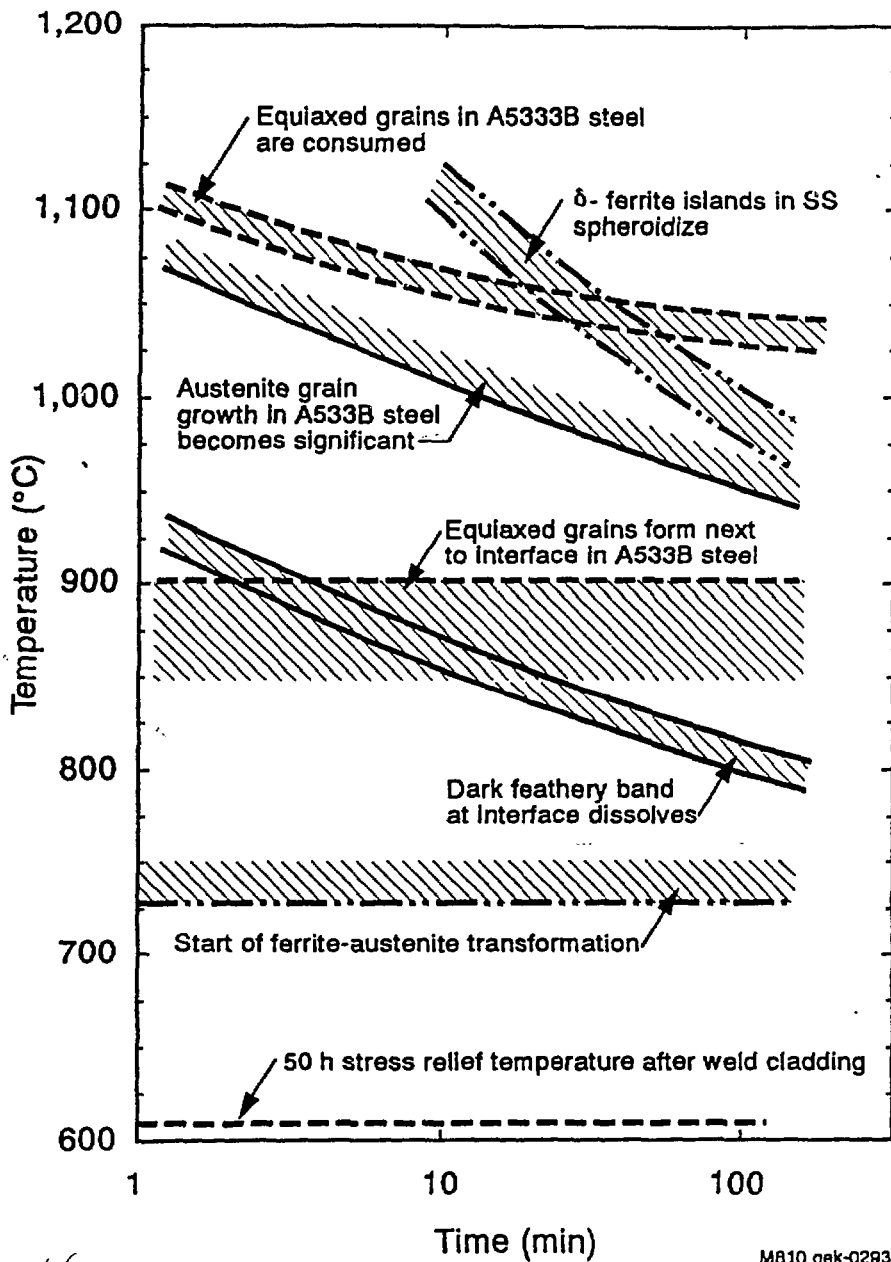
As the standards were prepared and examined, various metallurgical observations revealed a step-wise process that could be used in determining the thermal histories of the TMI-2 samples. A diagram (shown in Fig. 6) was constructed, which illustrates the metallurgical changes with time and temperature of the Midland and TMI-2 lower head A533B steel with a 308L stainless weld clad. Since the vessel was stress relieved at 607°C after the weld cladding, no thermal effects from the accident could be detected at or below this temperature and, therefore, the diagram shows only metallurgical observations for temperatures above this point. The lowest temperature indicator, above the stress relief temperature, was the ferrite-austenite transformation, which starts at 727°C and is complete by ≈830°C. Variations in the typical as-fabricated hardness profile will be evident when this threshold is exceeded. The next indicator is the dissolution or dissipation of a dark feathery band at the interface; this occurs between 800 and 925°C, depending on the time. The next indicator of increasing temperature is the appearance of small equiaxed grains, which formed in the A533B steel adjacent to the interface at temperatures between 850 and 900°C and disappeared between 1025 and 1100°C as they were consumed by grain growth in the low alloy steel. The equiaxed grains, which are not typical for a low alloy steel, appear to be devoid of cementite, probably due to a loss of carbon into the stainless steel. Grain growth in the A533B steel becomes significant above approximately 950 to 1075°C, depending on the time involved. The highest temperature indicator shown on the diagram is the change in morphology of the δ-ferrite islands in the stainless steel cladding. In the approximate range of 975 to 1000°C at 100 minutes or 1100 to 1125°C at 10 minutes, the δ-ferrite islands begin to lose their slender branch-like morphology and become spherical in shape. This spheroidizing of the δ-ferrite islands is believed to be associated with the dissolution of $M_{23}C_6$ carbides, which decorate the ferrite-austenite boundaries and stabilize their shape. When the carbides dissolve, the δ-ferrite becomes more spherical to minimize surface energy. There was also evidence that some of the δ-ferrite was consumed into the austenitic matrix after exposures above 1000°C since there was a net loss of δ-ferrite after cooling. Researchers in the Federal Republic of Germany⁷ and Spain⁹ observed that δ-ferrite in the cladding of non-affected samples was 4-5%, but only 1.4% in E-8.

Fig. 6. Diagram of time-temperature observations of A533, Gr. B pressure vessel steel clad with Type 308L stainless steel.
