## PRELIMINARY RESULTS OF THE TMI-2 CORE BORES<sup>a</sup>

Idaho National Engineering Laboratory  
Idaho Falls, Idaho 83415

### ABSTRACT

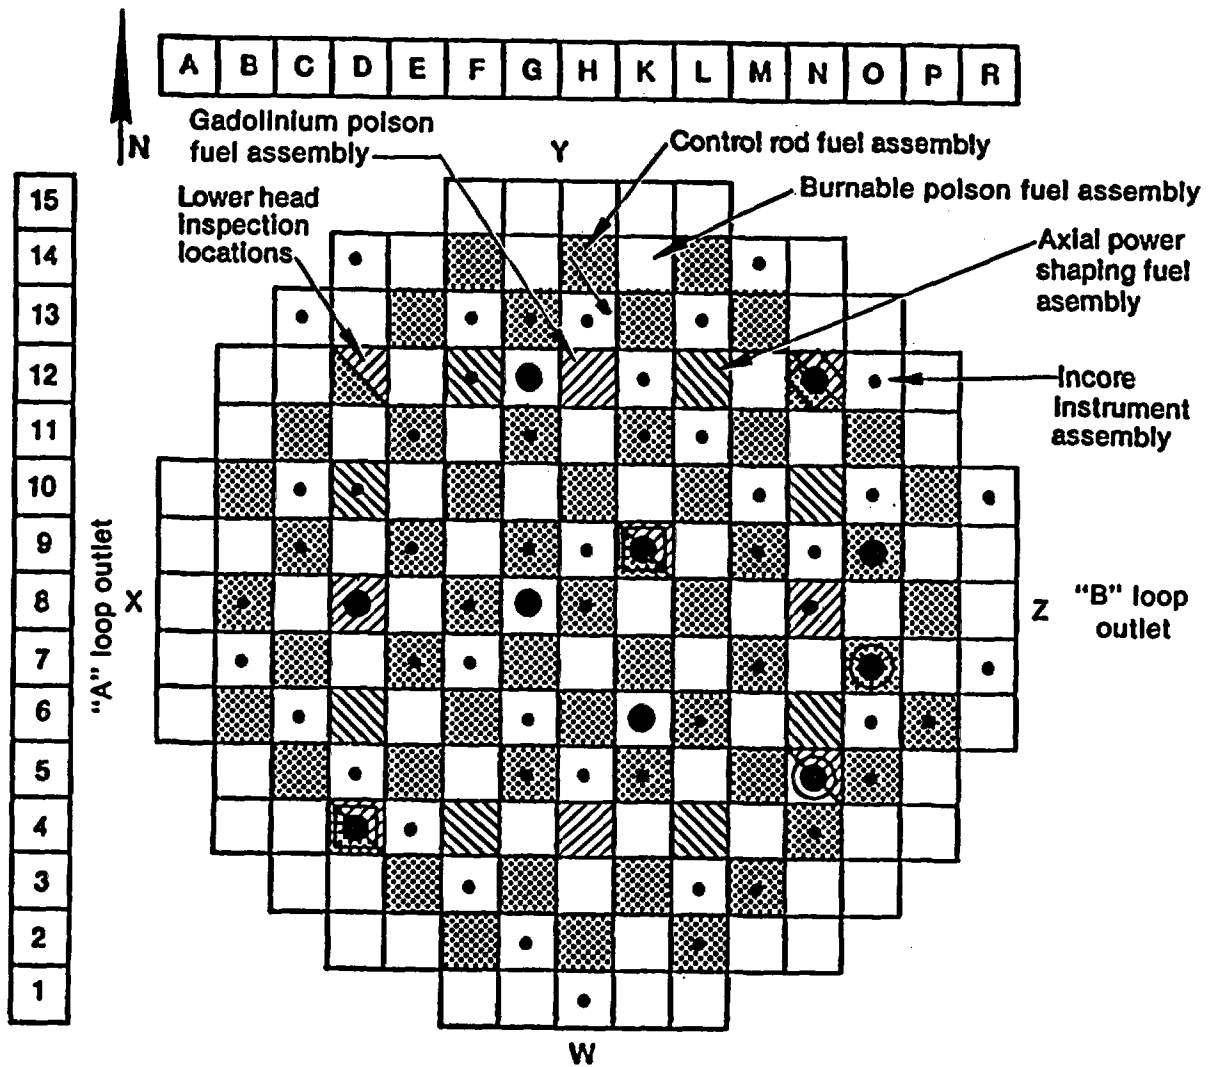
Figure 2. The ten core bore drilling locations.

The assemblies from which the ten core bores were drilled are identified and their locations shown in Figure 2. The pattern provides east-west and southwest-northeast diametral cross-sectional samples, as well as two radial sample cross sections from core center to the north and one to the southeast. A north-south sample line was also established on the eastern side of the core. The ten core bores provide two samples from the center of the core, two samples from near mid-radius, and six samples from around the core periphery. Access into the lower plenum for video inspection was obtained at three inspection locations, N12, D4, and K9, and two samples may have been obtained from the lower plenum at assemblies K9 and D4.
