Instrumentation Performance During the TMI-2 Accident

ANIMMA 2013

Instrumentation Performance during the TMI-2 Accident

Joy L. Rempe, *Senior Member, IEEE*, and Darrell L. Knudson

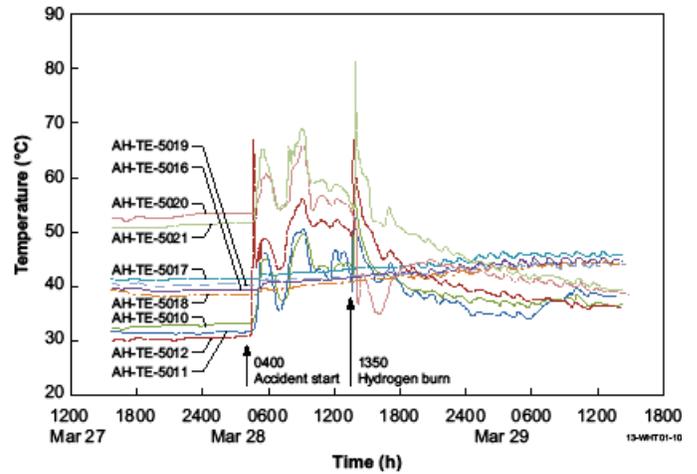
Fig. 9. Reactor building temperatures at selected locations.

- Peak values for containment building temperature would not have been obtained without considering data from other sensors such as the containment building pressure transmitters. Calculations assuming peak containment pressures (see Fig. 8) yielded peak containment temperatures of 650 °C, which are much higher than the measured 93 °C peak temperature data (Fig. 9). Recognizing that the TMI-2 containment temperature data had a limited sampling rate, experts qualified the containment pressure and a modified set of containment temperature data.
