Assessment of Thermal Damage to Polymeric Materials by Hydrogen
Deflagration in the Three Mile Island Unit 2 Reactor Building*

N. J. Alvares**
Lawrence Livermore National Laboratory

UCRL--92721

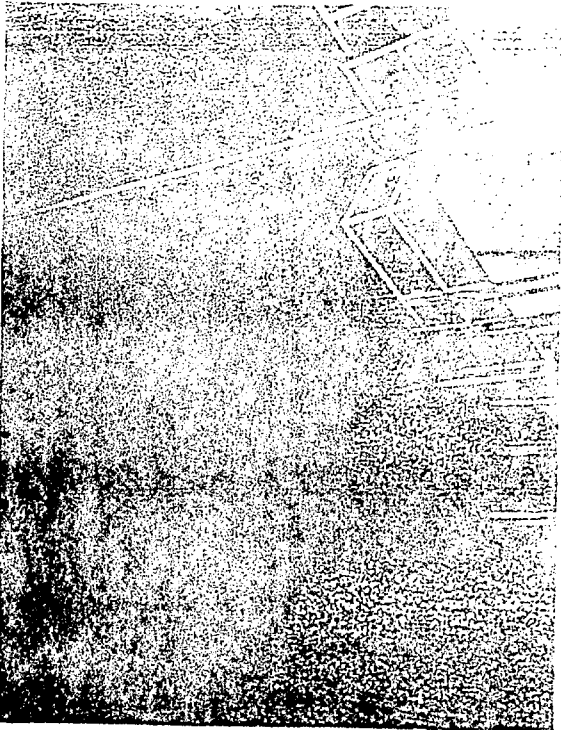
Fig. 16

Figure 16. Thermal damage pattern and β/γ activity along the Du Pont Hypalon and ethylene propylene covered polar crane pendant.
