ADDITIONAL ADDENDA TO THIRD REPORT OF TAAG - Hmb-581-82

TO: File FILE NO. TMI  
FOR: Information DATE July 16, 1982  
FROM: G. W. Tucker and C. M. Ball  
SUBJECT: Three Mile Island Unit No. 2 500-Ton Polar Crane - NNS Comments and Recommendations for Reactivation

**TO** E. J. Wagner  
**FROM** *R. Oakes / H. Young*  
 R. Oakes/H. Young  
**SUBJECT** W.O. 3680-01  
 Technical Assistance & Advisory Group  
 TMI-2 Recovery  
 Closure Head and Fuel Removal Containment

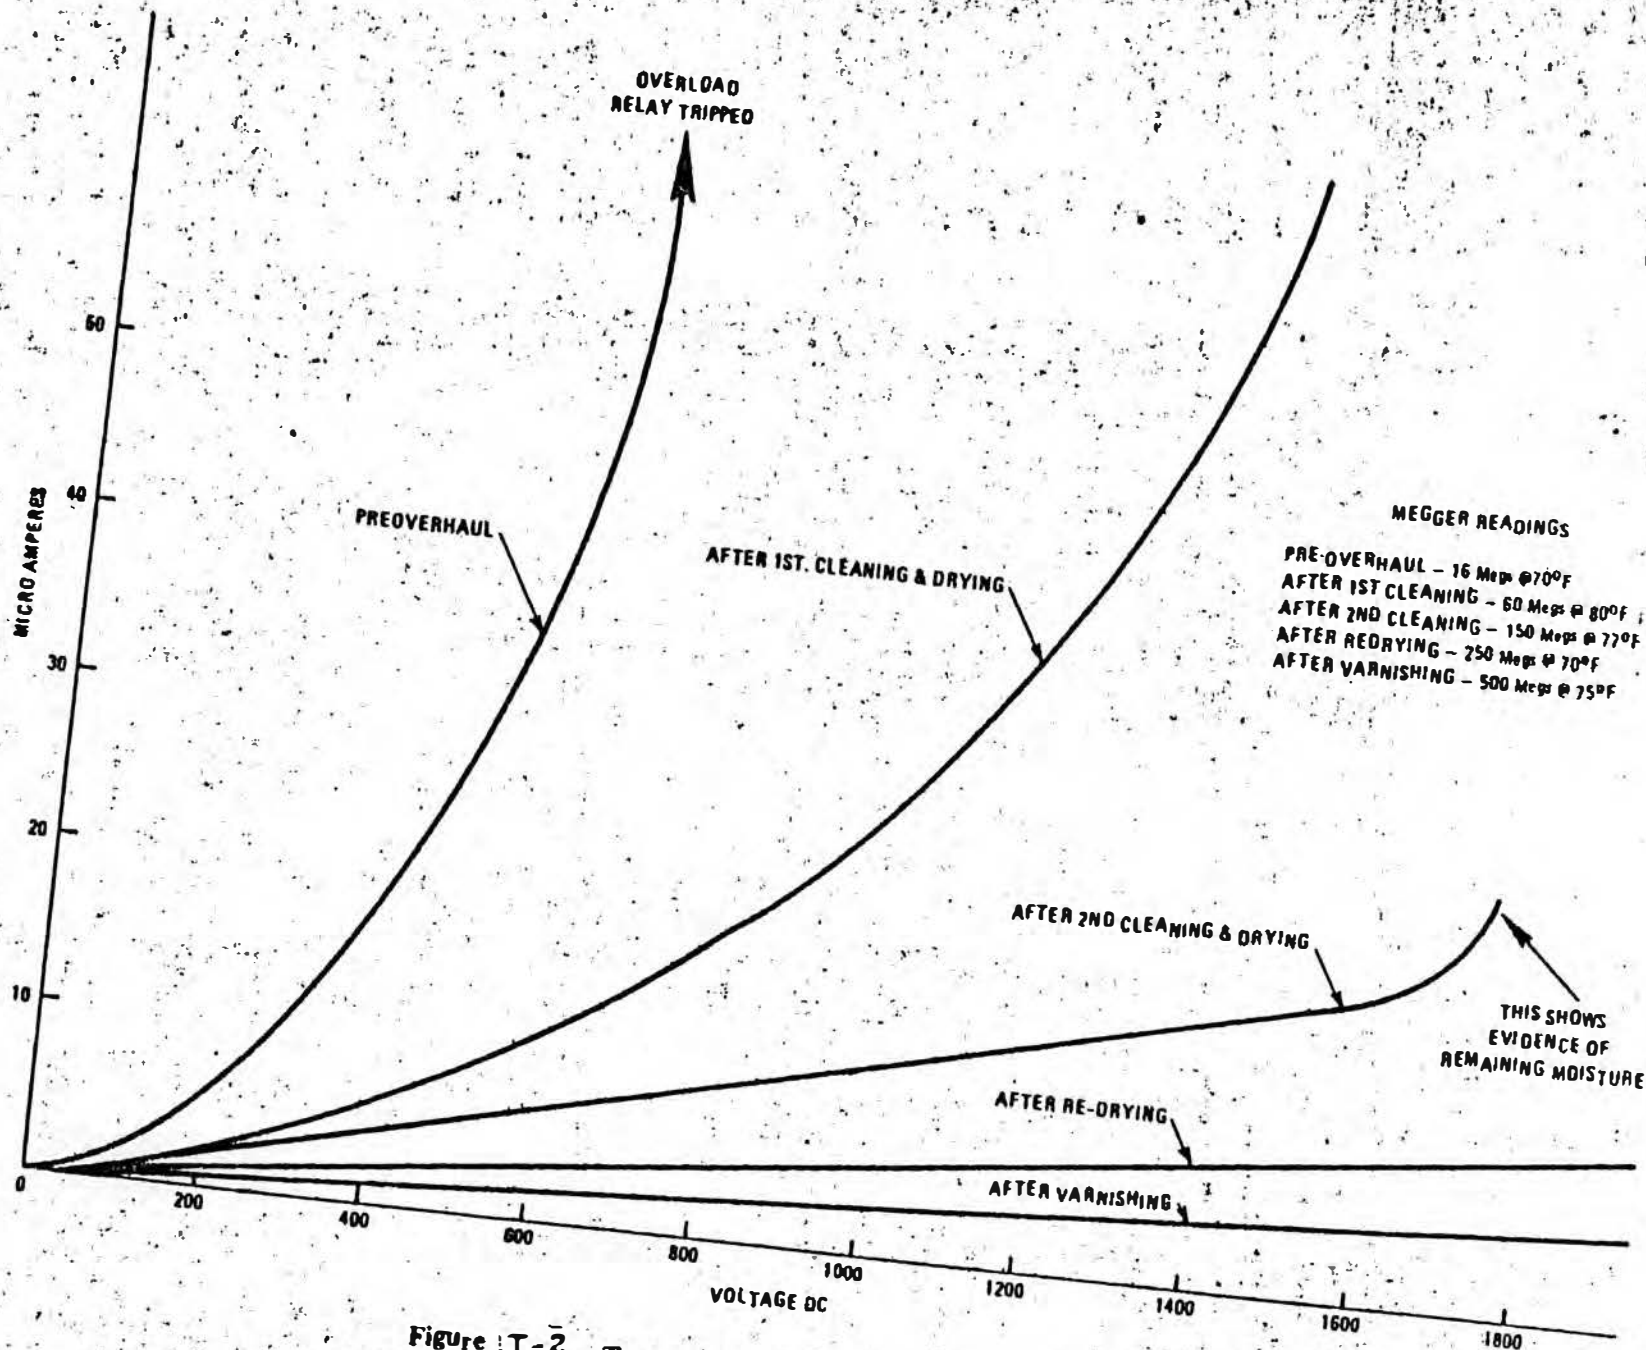
Figure I-2. Typical DC High Potential Test Curves  
NOTE: Curves plotted are for a 1000-KW 415-VDC Generator

6. Dc high potential curves should be obtained prior to starting overhaul and after each major step in the overhaul procedure. In this manner improvements can be noted as the work progresses.
7. A typical set of curves for a large 1000-KW 415-VDC diesel-driven generator is shown in figure-I-2. On large rotating equipment such as submarine and surface ship propulsion motors and generators, a flat low leakage line as illustrated should be obtained before reinstallation in the ship. For example, even though a generator showed 150 megohms after a second cleaning and drying, an additional period in the drying oven removed the hook and lowered the whole curve. For smaller and less important units the cleaning and drying work may be stopped after the second cleaning and drying step.
8. When dc high potential tests are made, ac high potential tests are to be omitted.
