**Color Photographs
Of The Three Mile Island Unit 2
Reactor Containment Building:
Volume 1—Entries 1, 2, 4, 5, 6**

October 1981

**EG&G Idaho, Inc.
Idaho Falls, Idaho 83415**

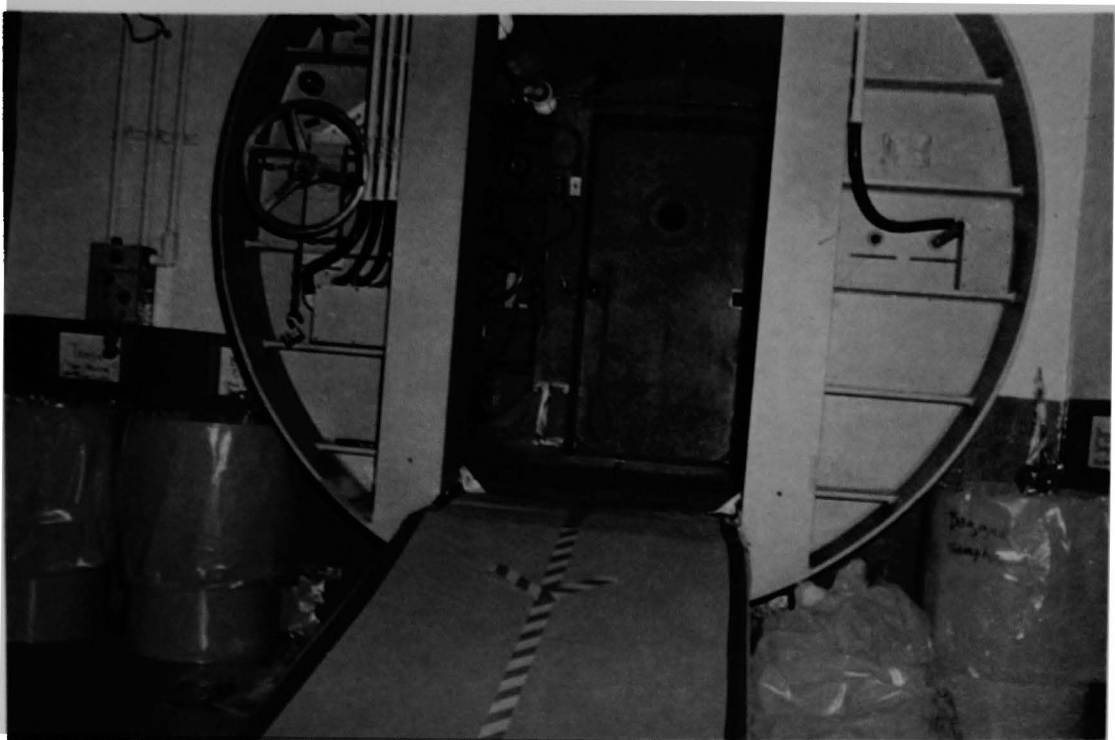
Figure 1 (4A). Anteroom entry ramp into personnel air lock 2.

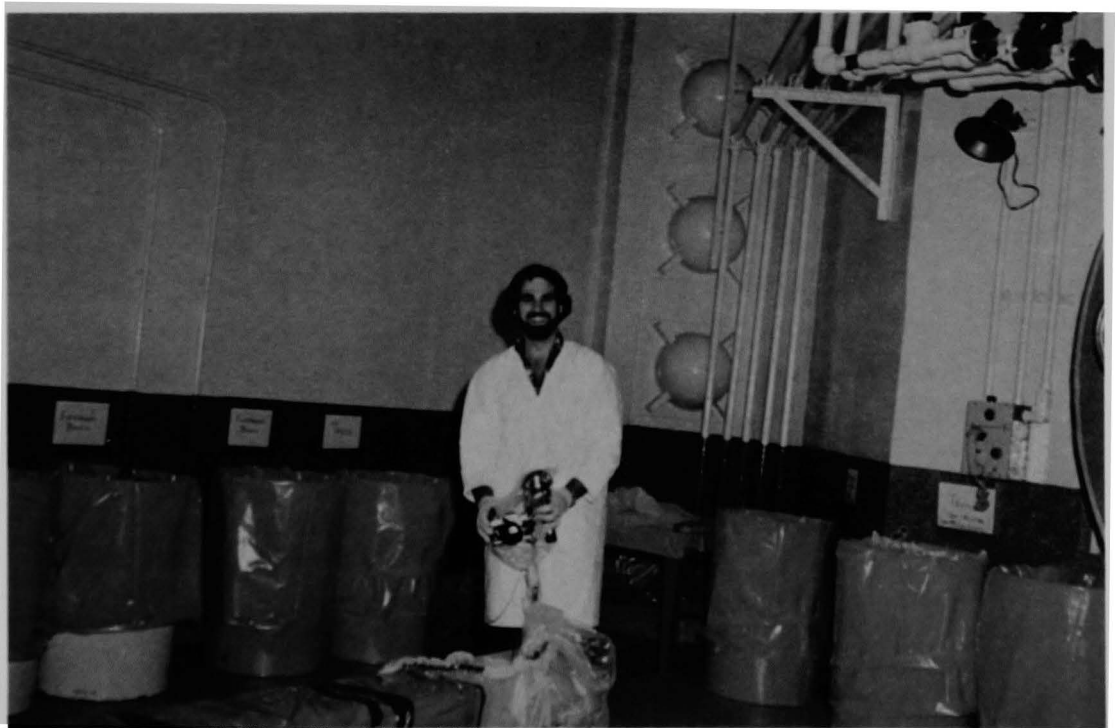
Figure 2 (4A). Anteroom; personnel air lock 2 at right.

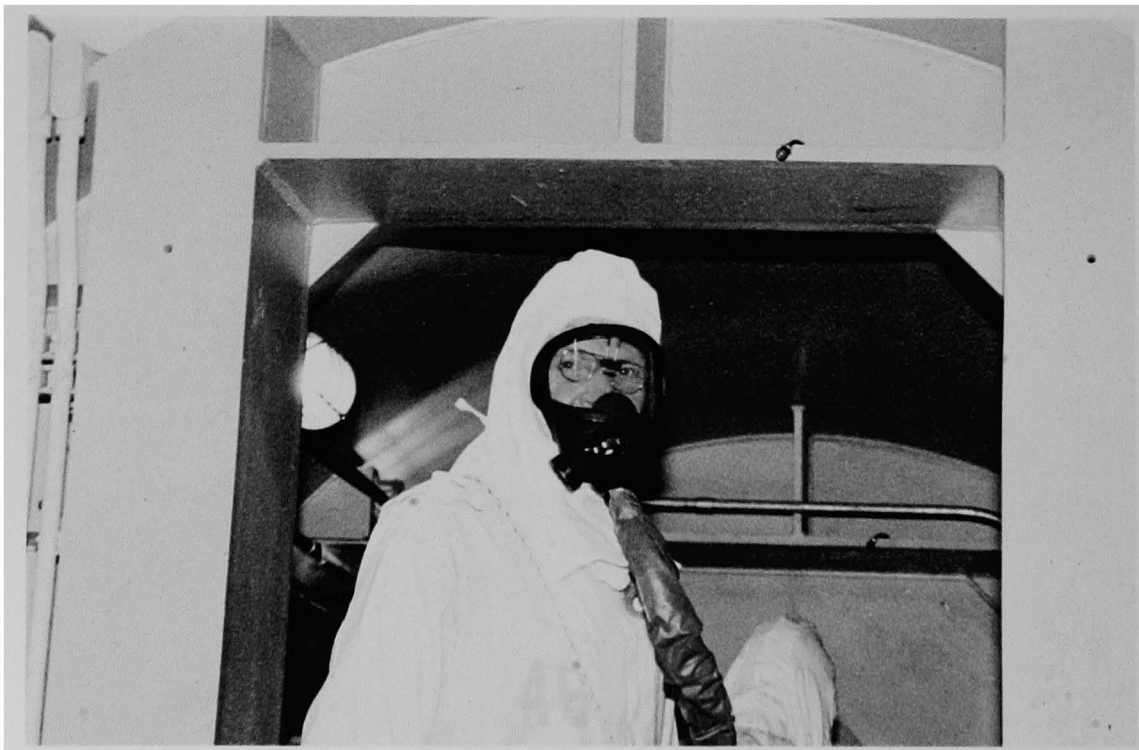
Figure 4 (5B). Technician standing within doorway of personnel air lock 2.

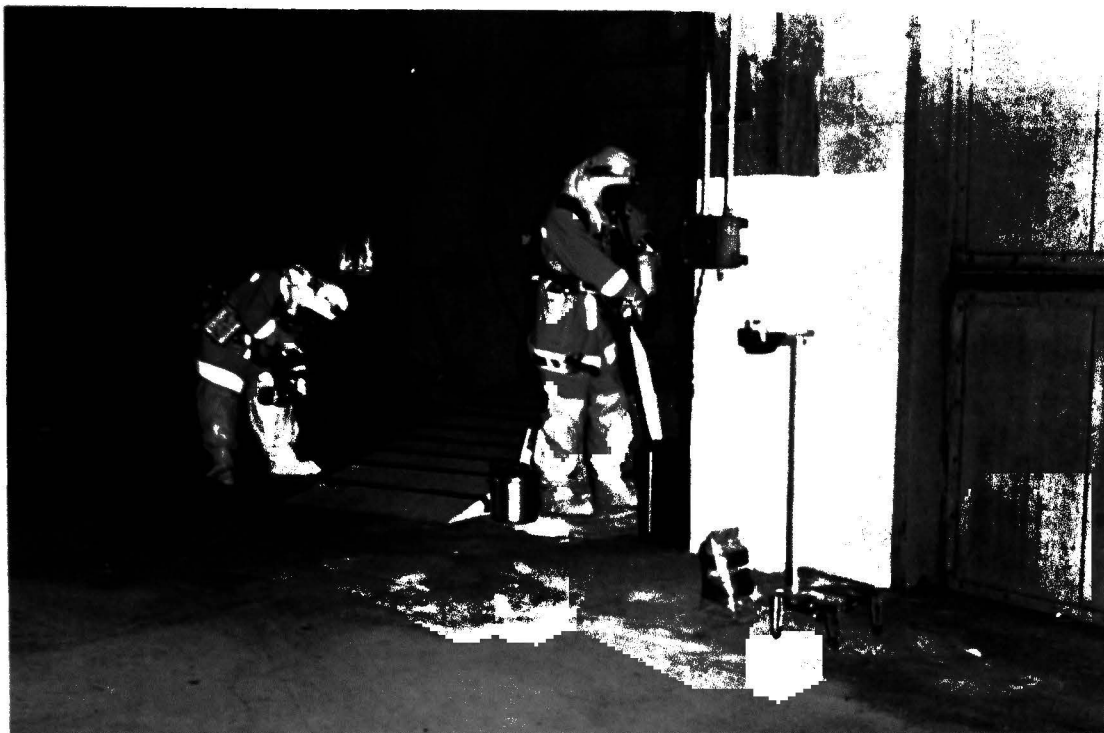
Figure 5 (2A). Technicians setting up decontamination test equipment inside of containment; air lock 2 in background, elevator door right.

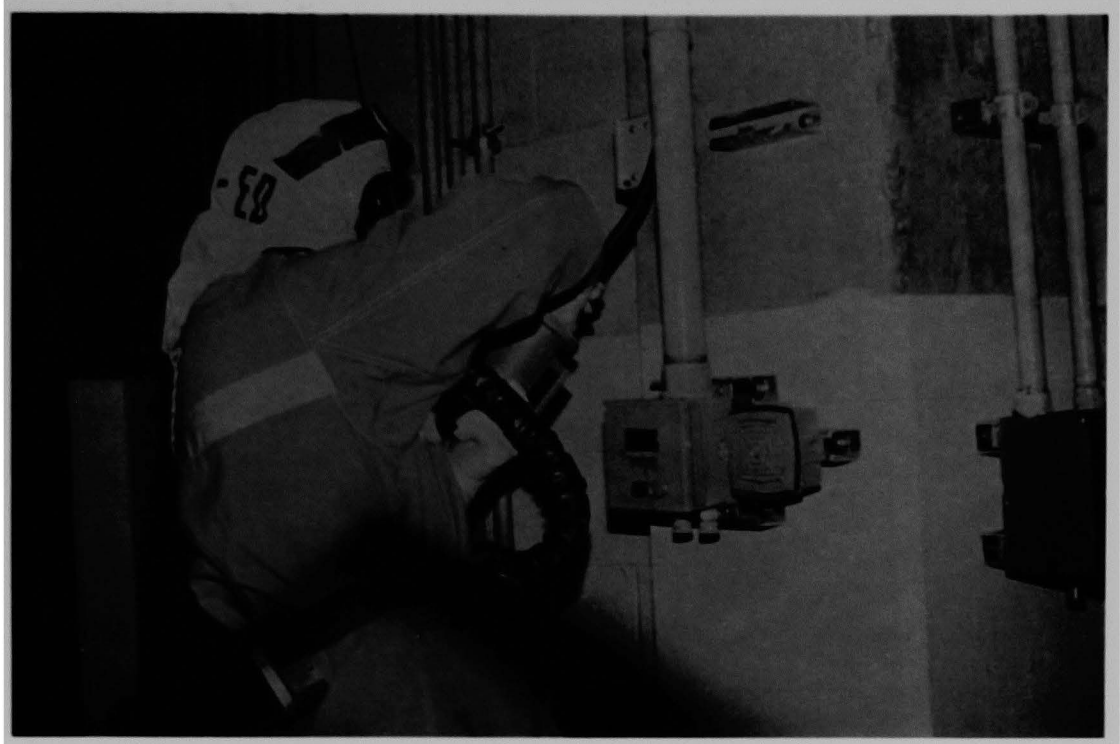
Figure 9 (2B). Technician removing HP-R-211 radiation monitor from northeast elevator wall.

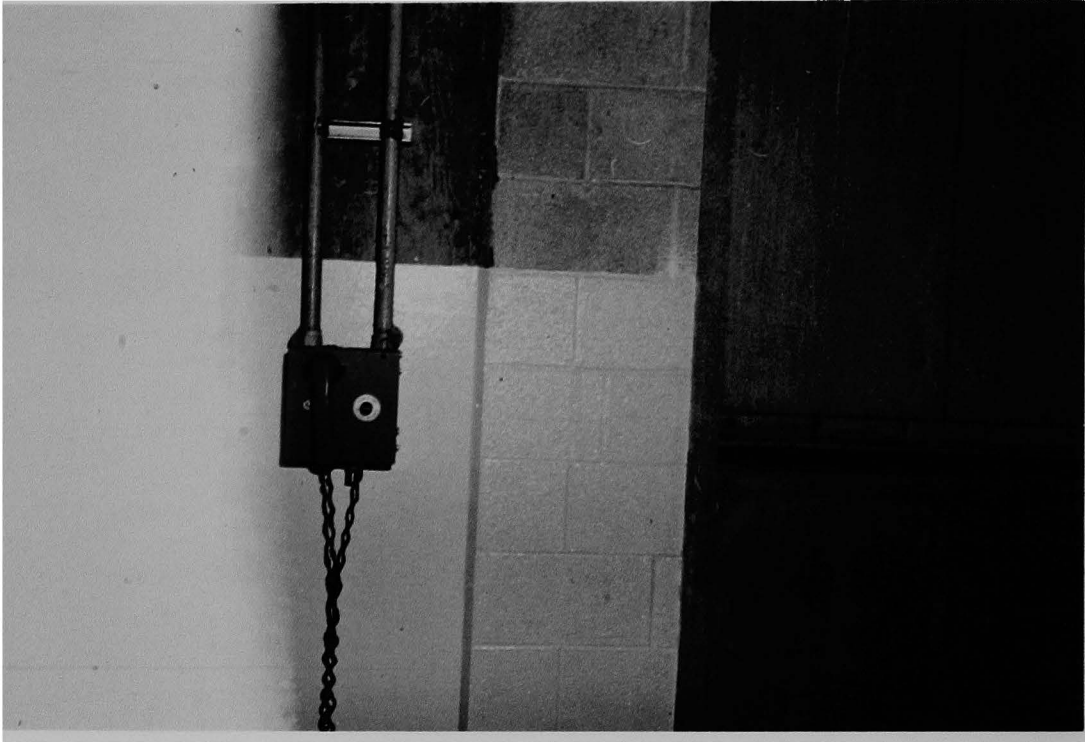
Figure 11 (4A). Surface detail of Gai-tronic phone and elevator door.

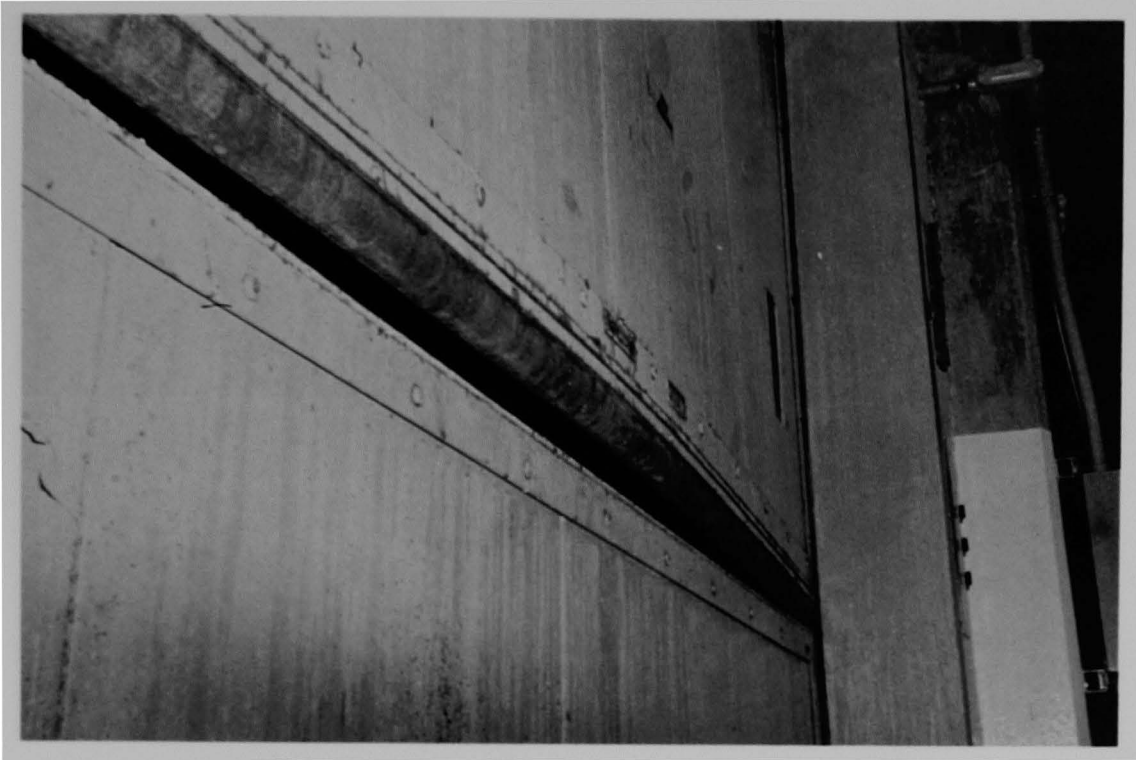
Figure 13 (6A). Close-up of gap in elevator door.

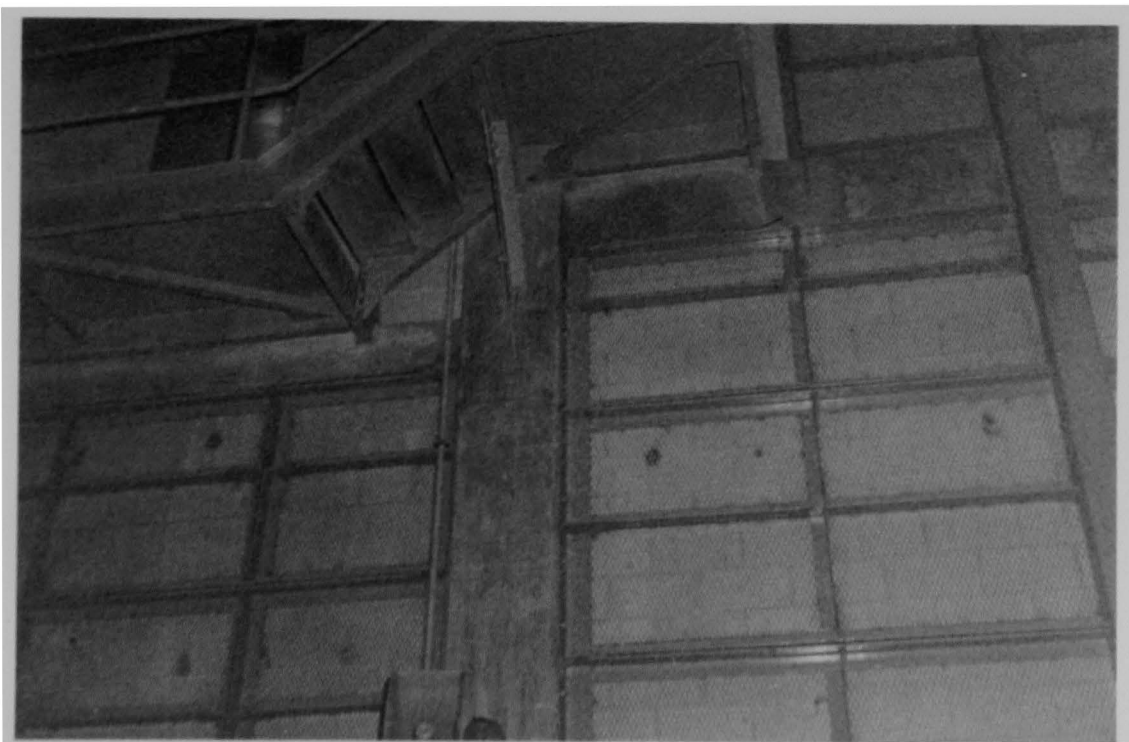
Figure 14 (6A). Platform on the enclosed elevator-stairwell, view up from elevation 305.

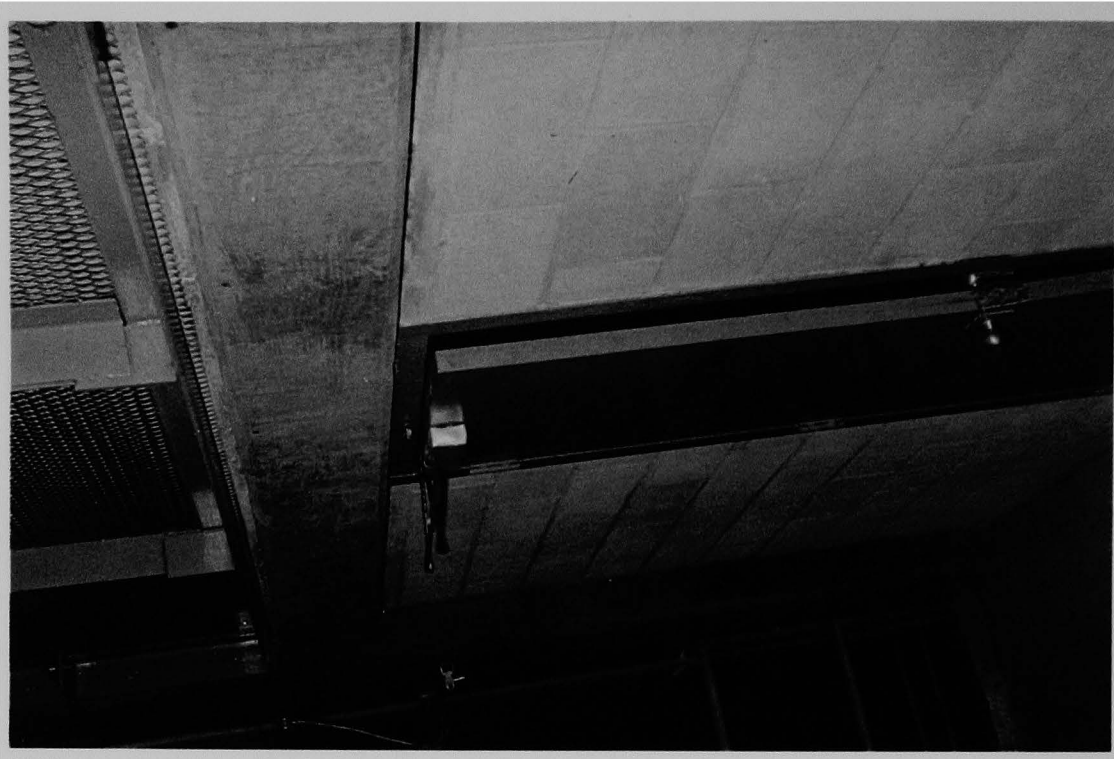
Figure 15 (6A). Door and corner of platform on the enclosed elevator-stairwell (photograph turned sideways).

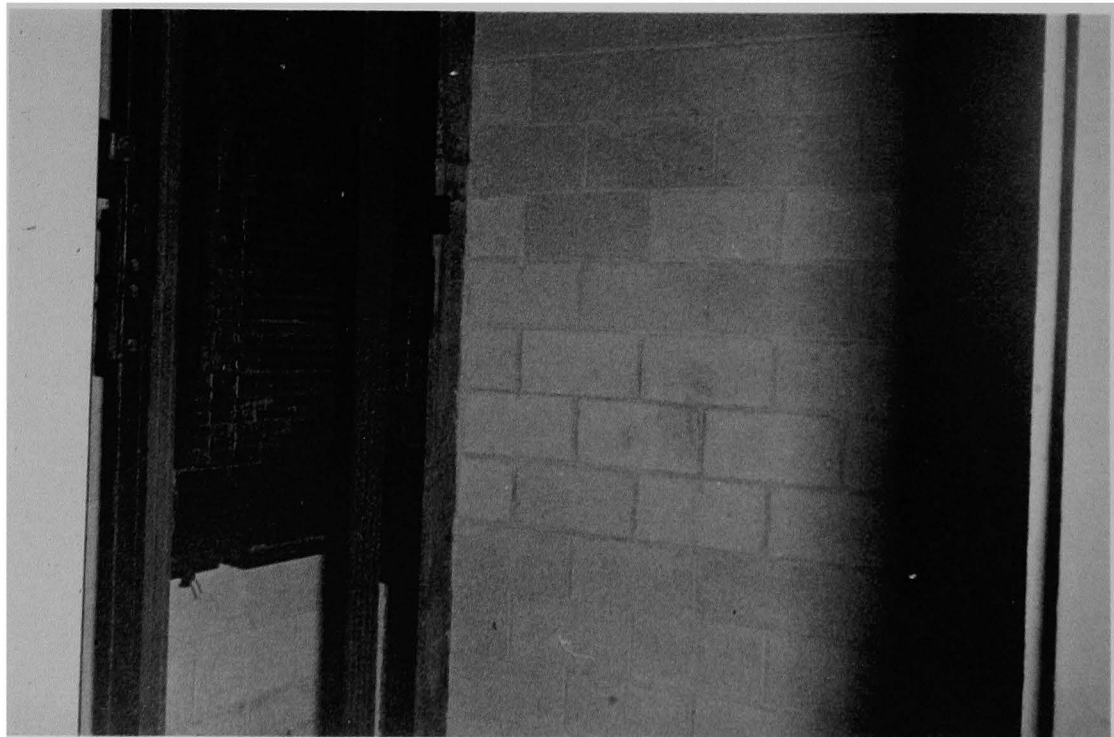
Figure 16 (6A). Inside of the elevator shaft, view through door shown in Figure 15.

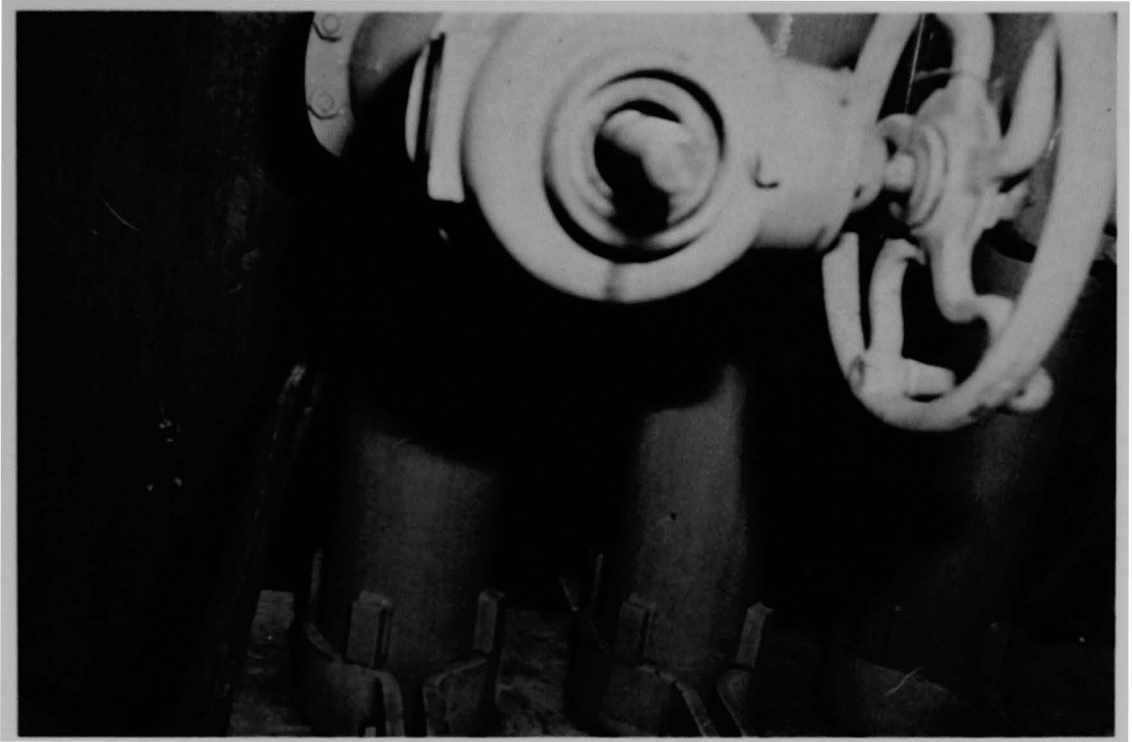
Figure 25 (2A). Bottom corner of door to enclosed stairwell, thrust against structure of river water piping.

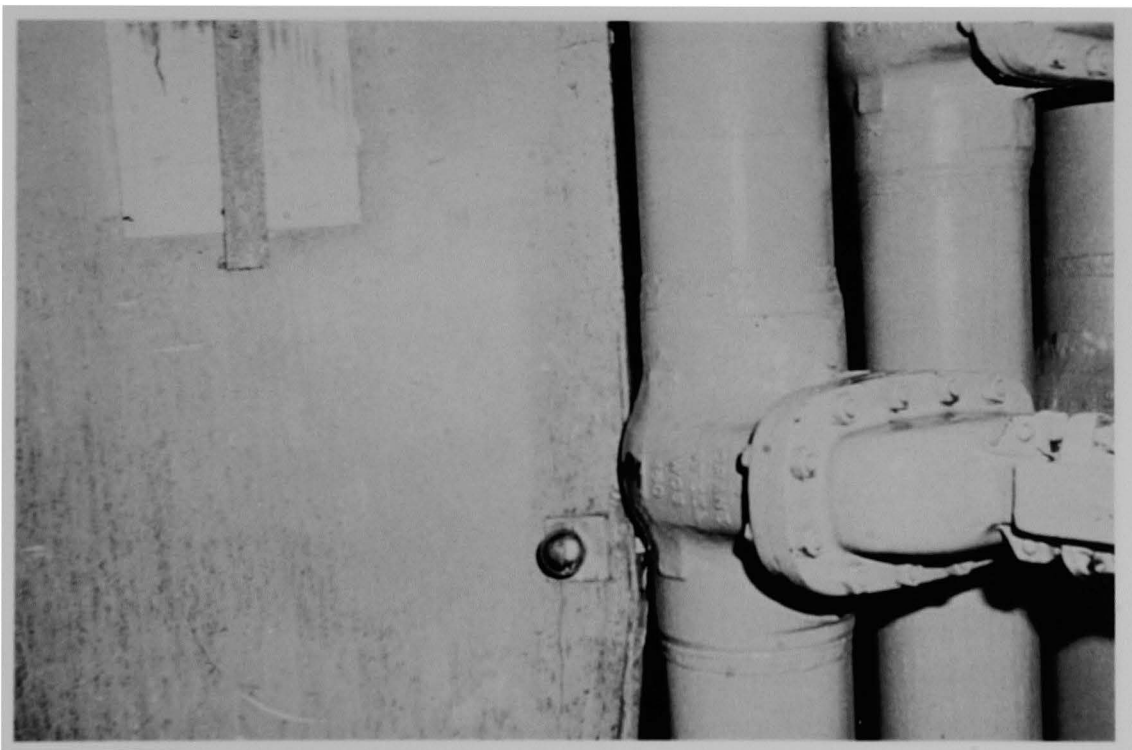
Figure 26 (1A). Close view of door to enclosed stairwell and river water piping to air cooling assembly.

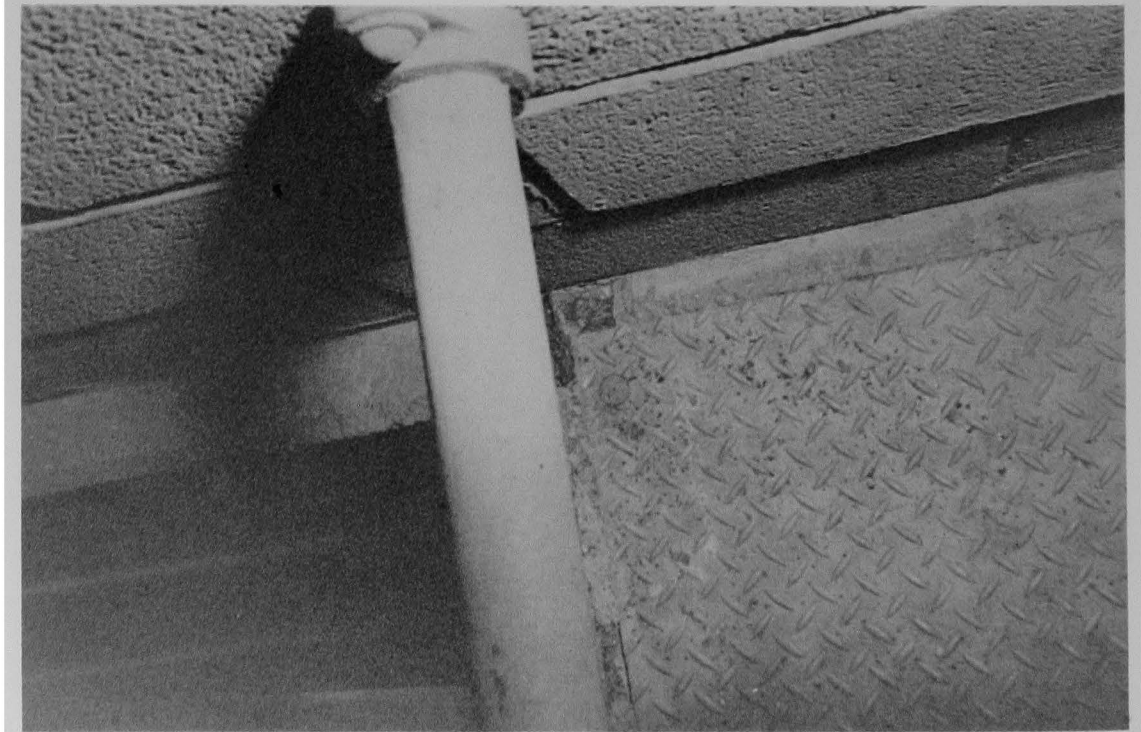
Figure 29 (6A). Close-up of landing within the enclosed stairwell.

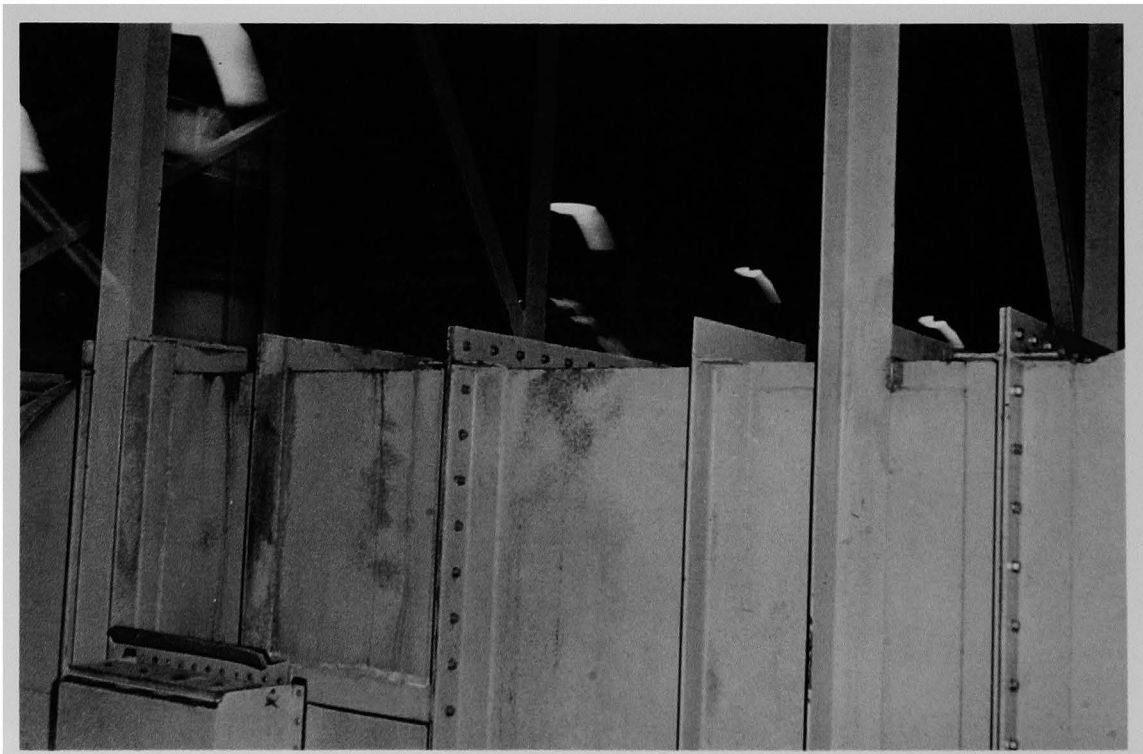
Figure 32 (6A). Portion of top section of the air coolers, view from platform on enclosed stairwell.

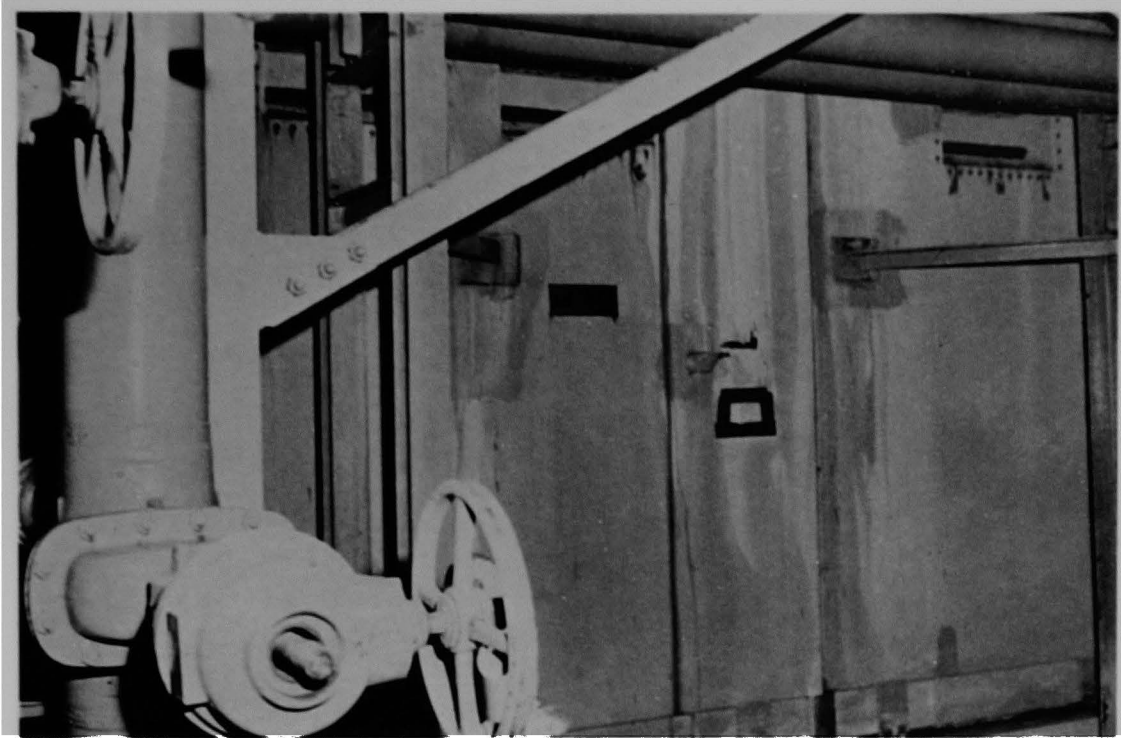
Figure 33 (1A). East units of air cooling assembly; river water piping at left.

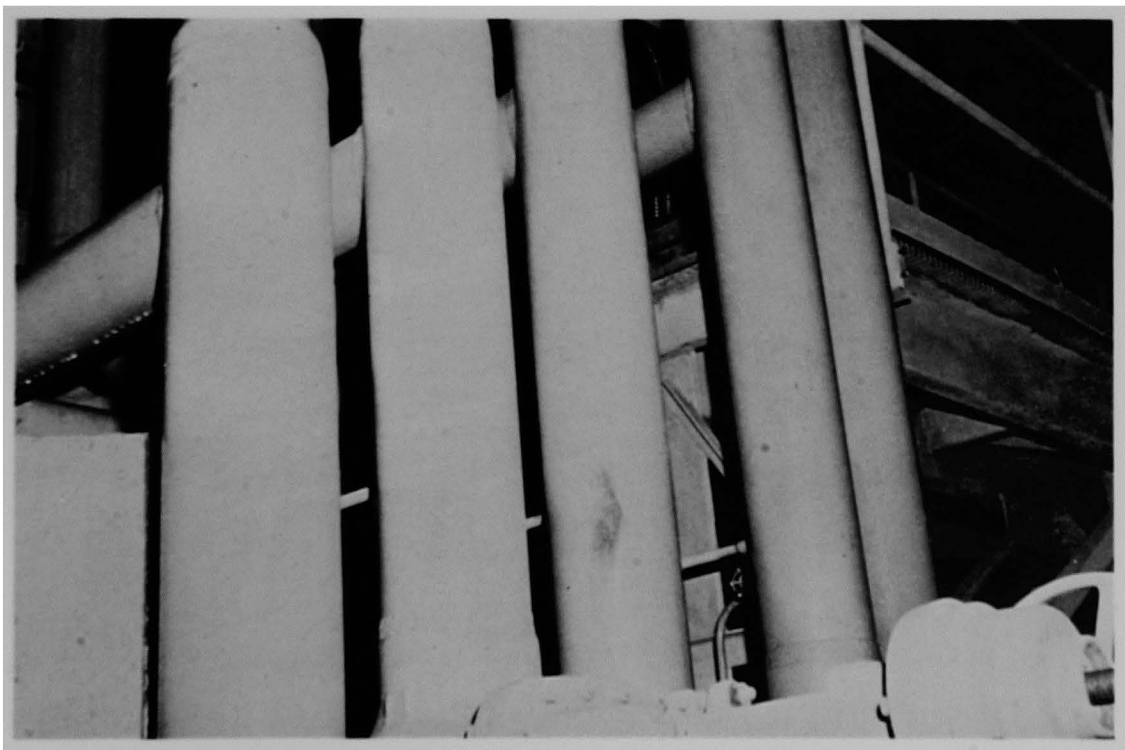
Figure 34 (1A). Close-up of river water piping associated with air coolers.

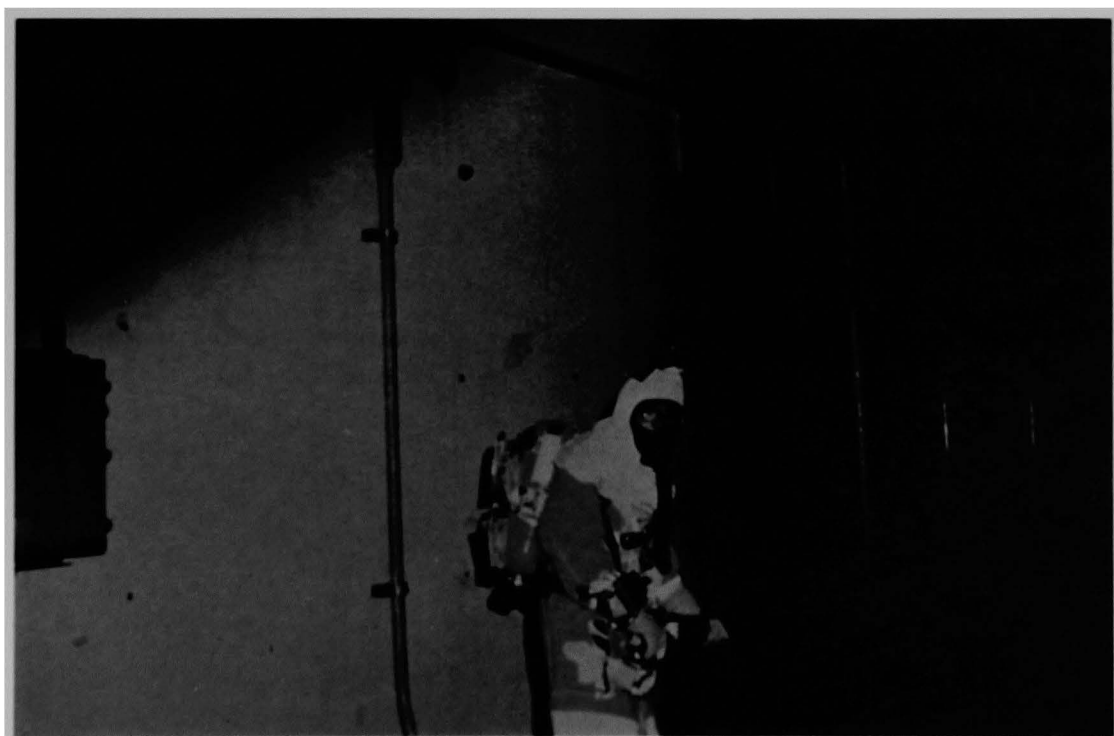
Figure 42 (1A). Technician in first-entry protective clothing holding teletector; D-ring in background, corner of enclosed elevator/stairwell right edge of photograph.

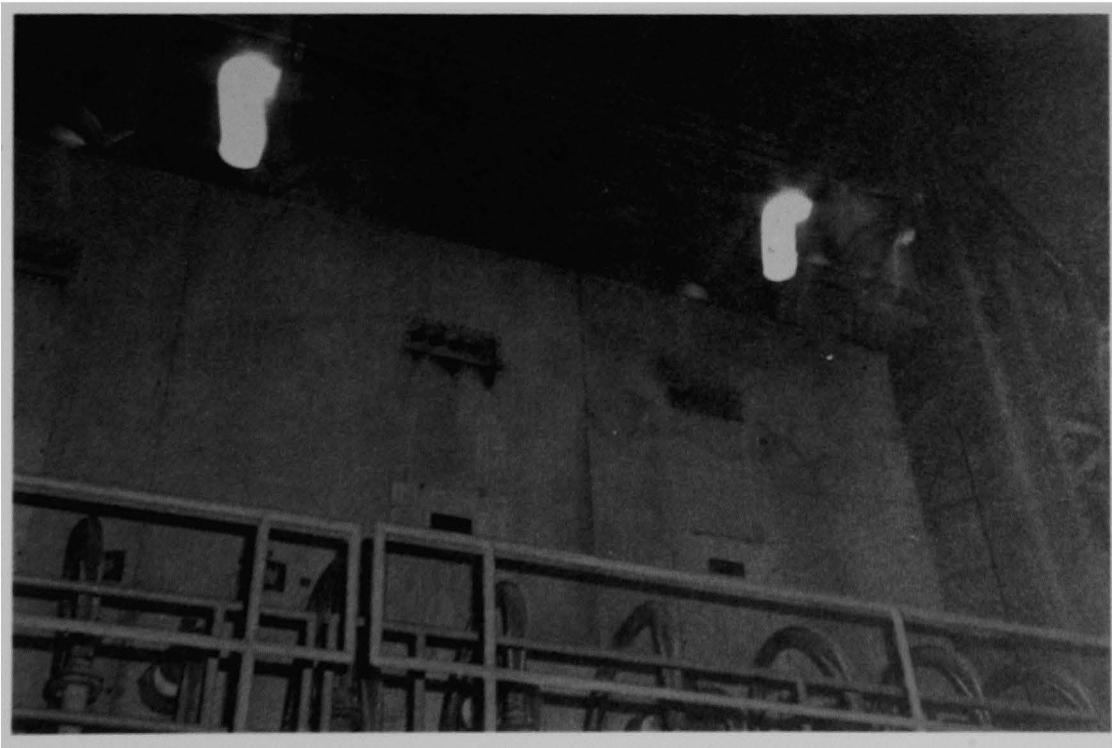
Figure 45 (6A). West upper end of air cooling assembly.

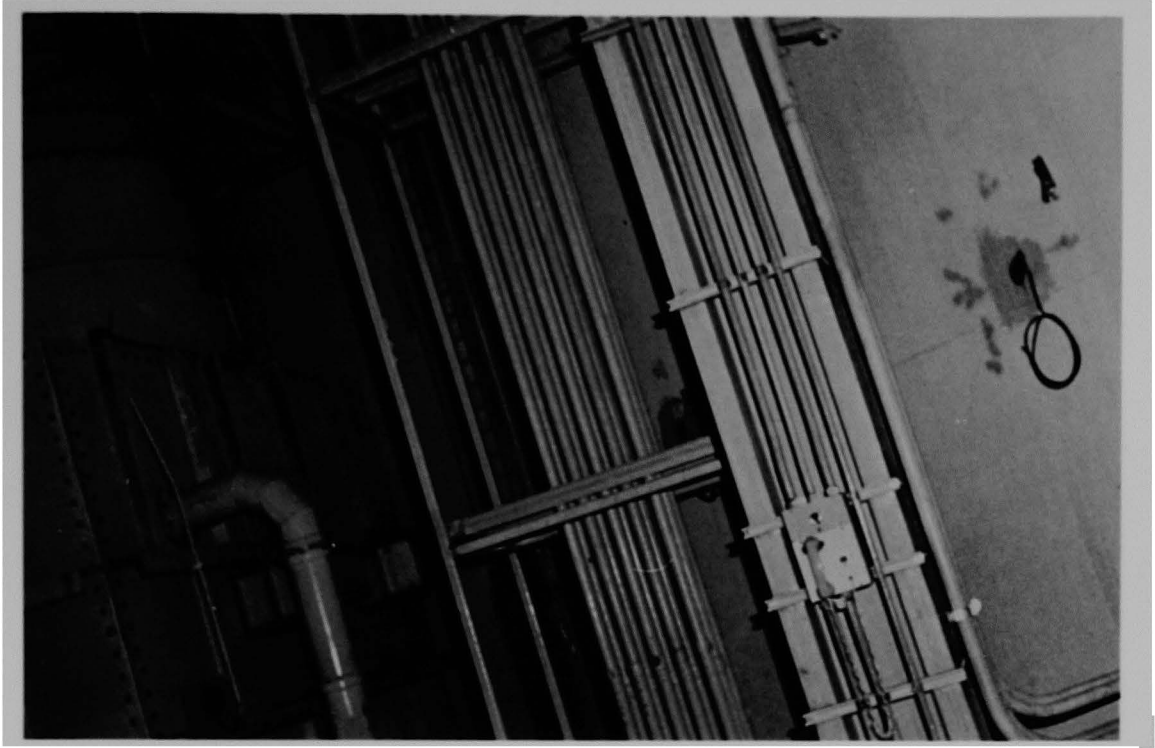
Figure 48 (1A). Conduit runs, plenum at west end of air cooling assembly left.

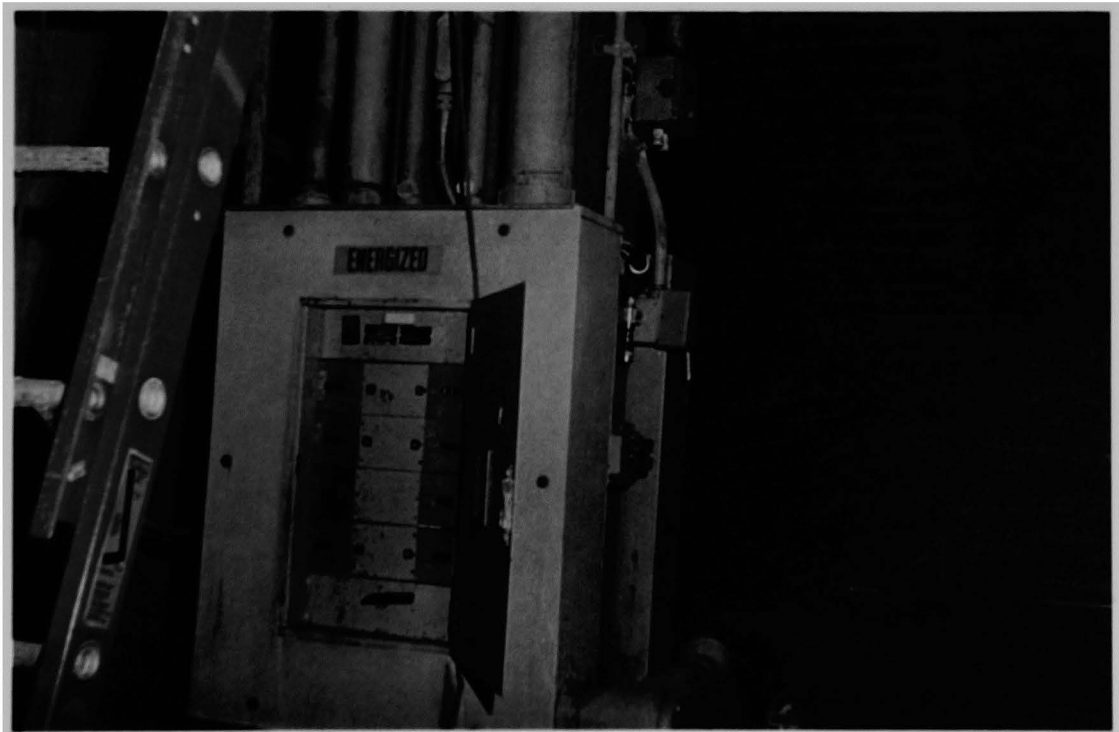
Figure 53 (2A). Power panel on I beam; open stairway in background.

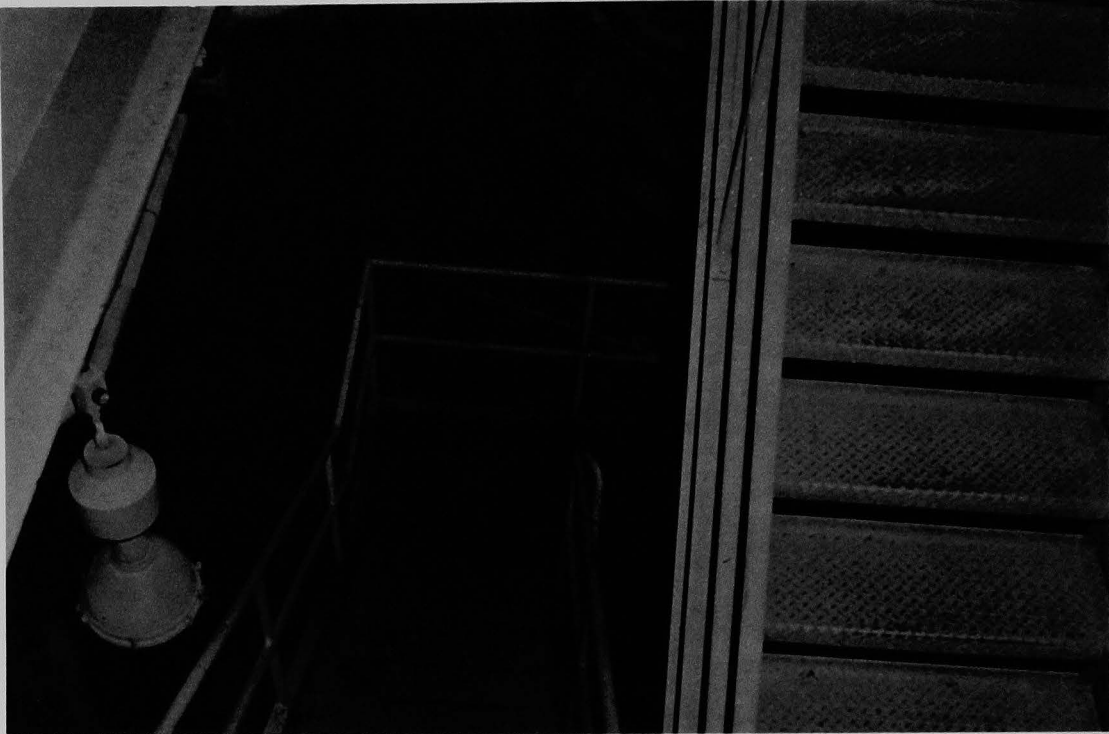
Figure 68 (2A). View down open stairway to water in basement. Note that the water appears to be 1 to 2 inches above the lower landing.

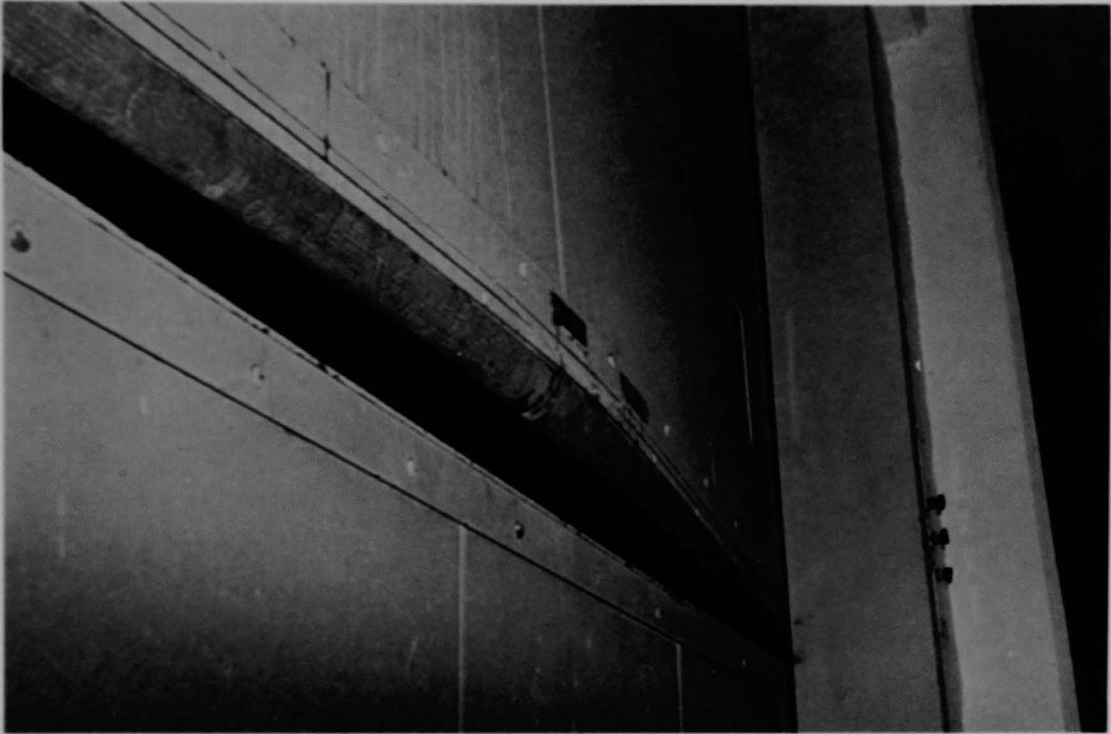
Figure 109 (6A). Close-up of gap in elevator door (elevation 347).

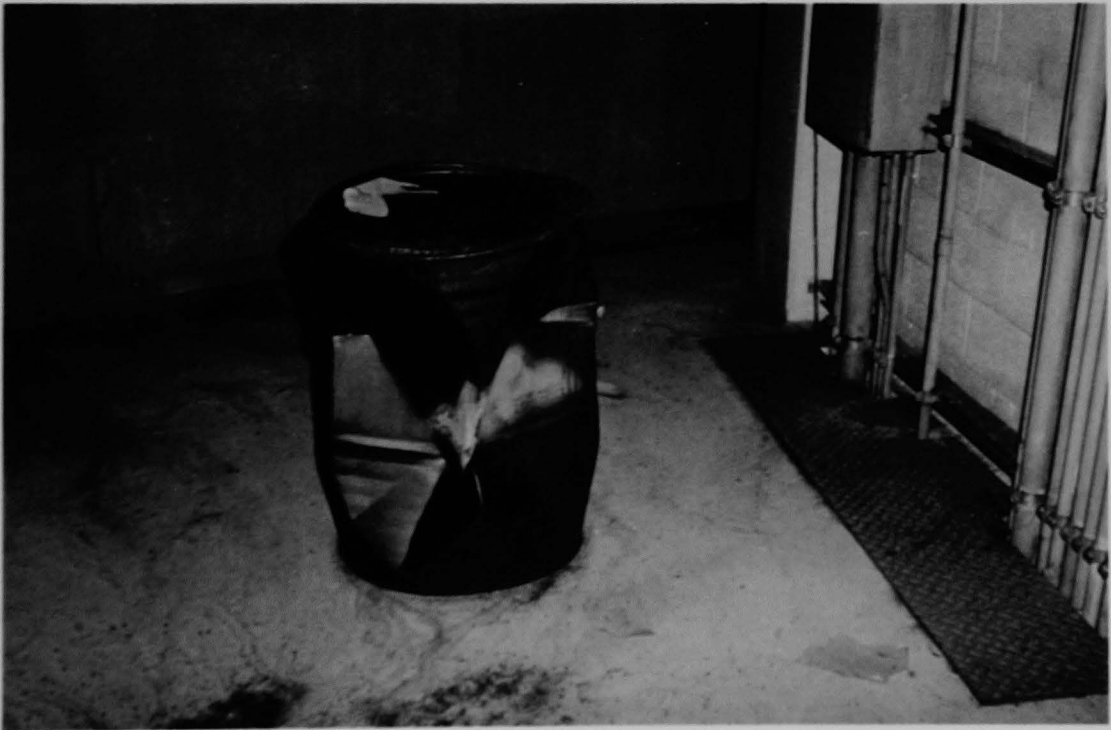
Figure 110 (4A). Fifty-five gallon drum; northeast elevator wall right, containment liner background.

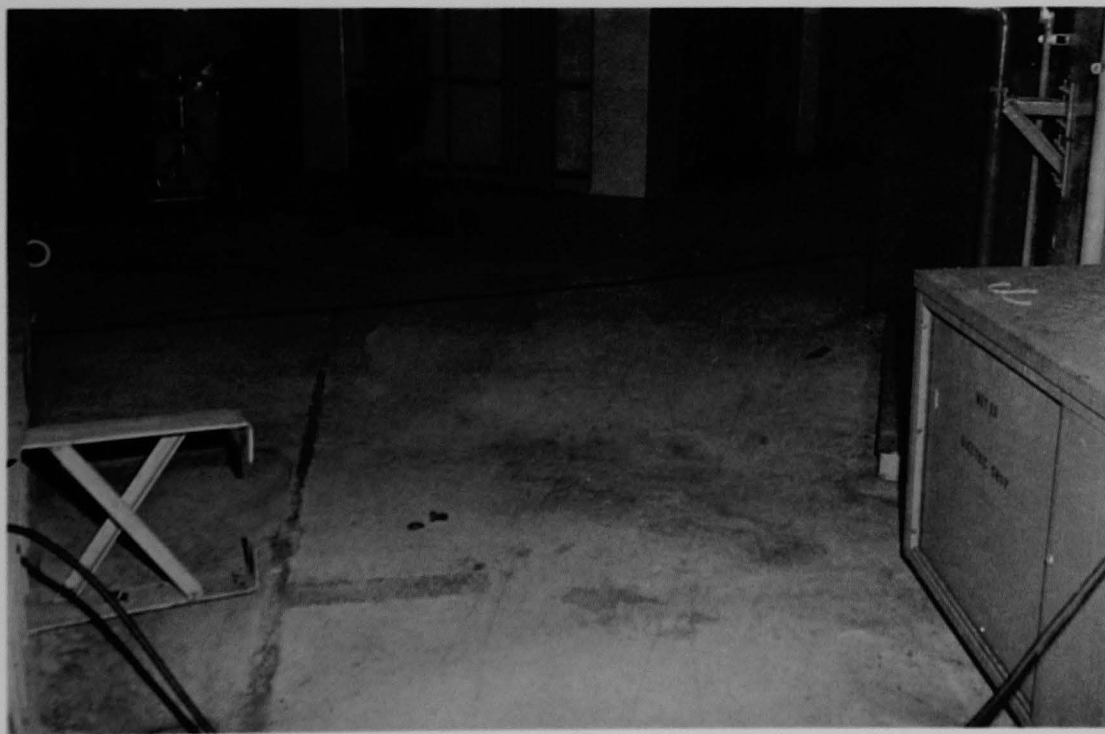
Figure 114 (6A). General view of floor north of the enclosed stairwell; video camera on cart, fifty-five gallon drum, and elevator door in background.

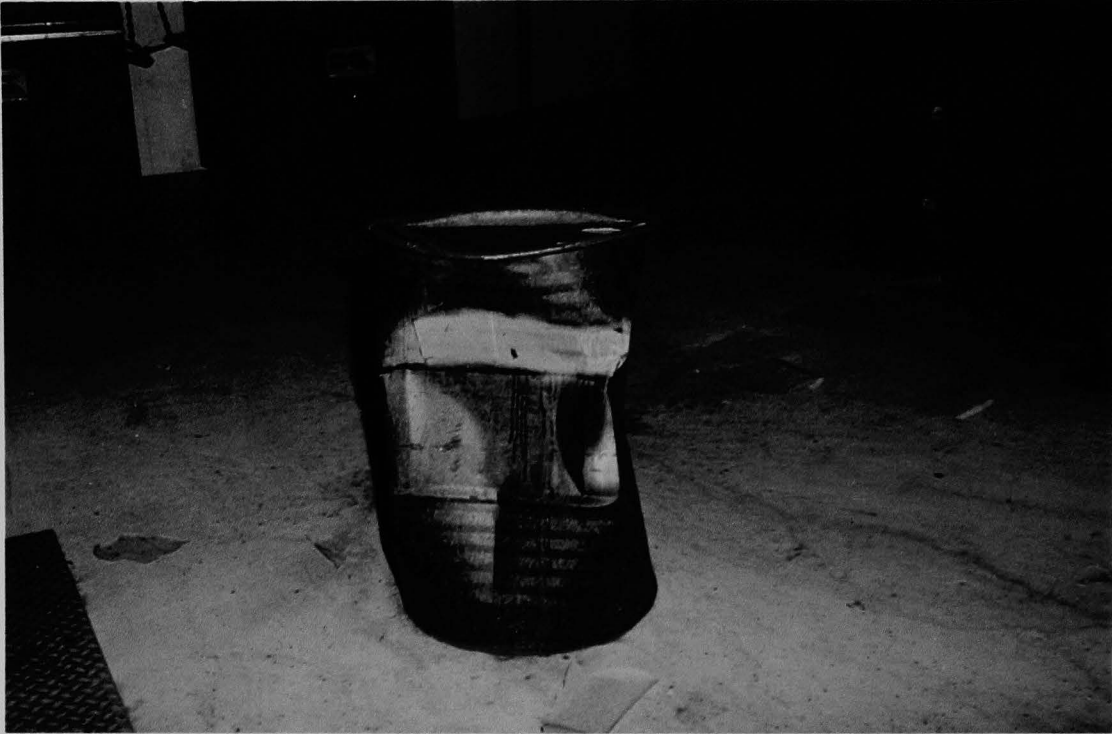
Figure 115 (4A). Fifty-five gallon drum; corner of elevator wall left, D-ring wall background. Patches of paint lie on the floor.

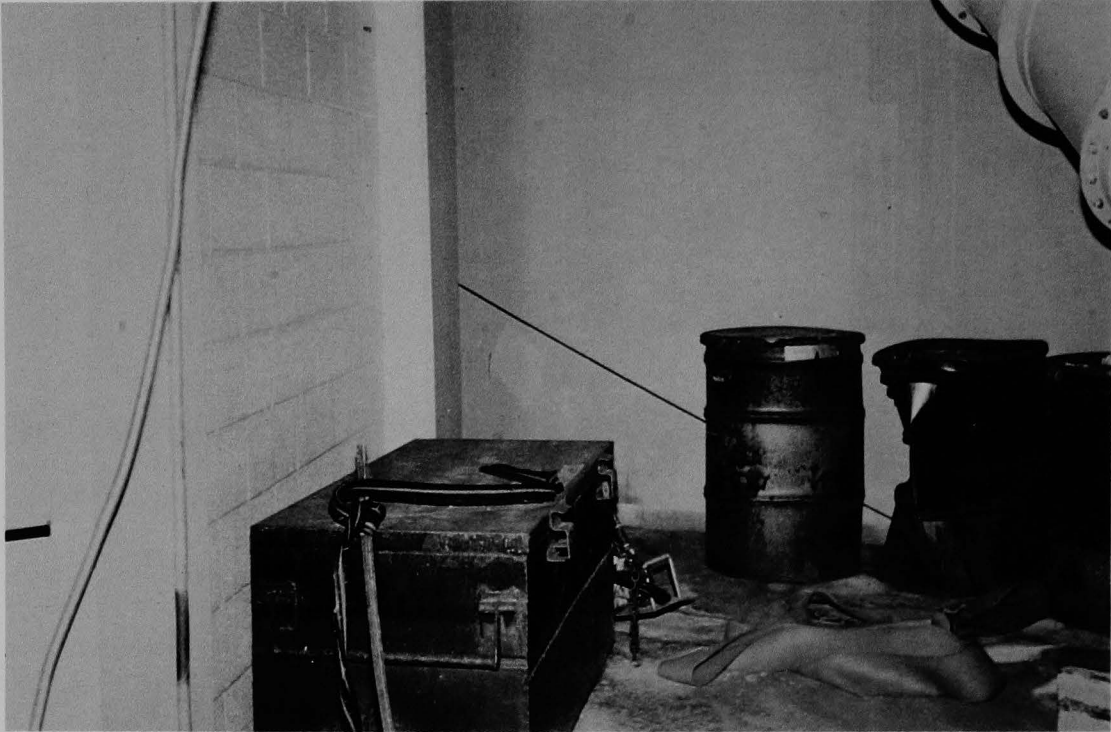
Figure 119 (2B). Area between south wall of enclosed stairway and air duct.

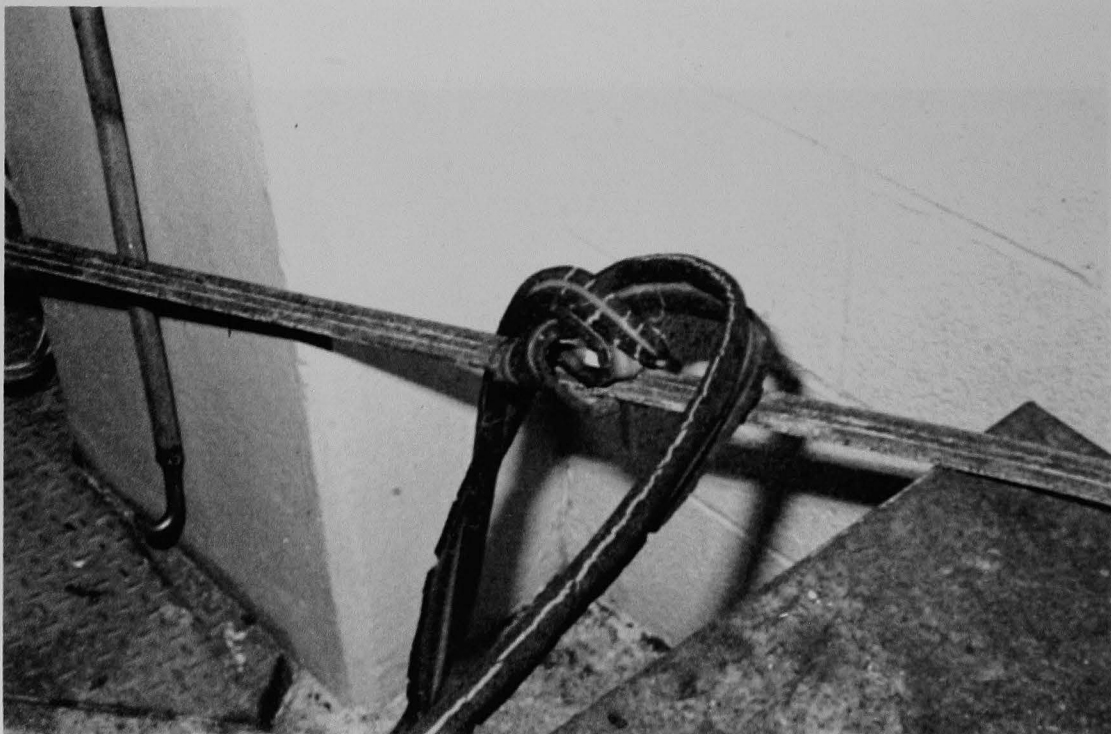
Figure 120 (4). Crane power cable and insulation lying over tool box south of enclosed stairwell (see Figure 119).
