**Color Photographs
Of The Three Mile Island Unit 2
Reactor Containment Building:
Volume 1—Entries 1, 2, 4, 5, 6**

October 1981

**EG&G Idaho, Inc.
Idaho Falls, Idaho 83415**

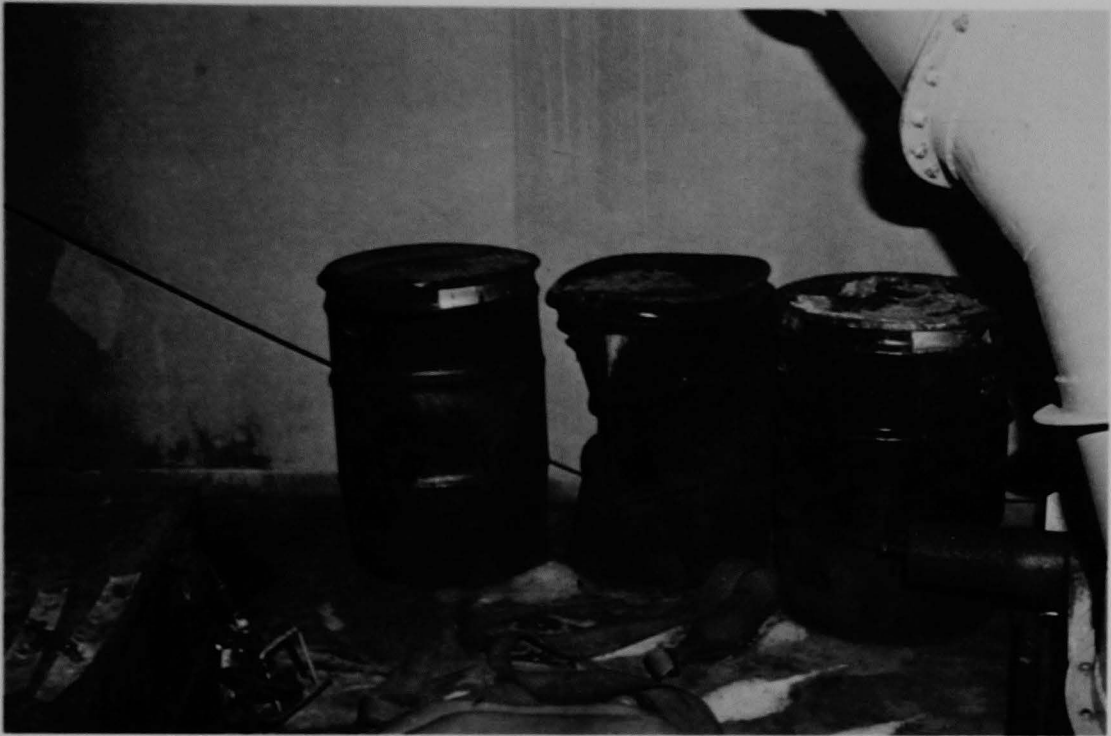
Figure 121 (4A). Tool box and drums between enclosed stairwell and air duct.

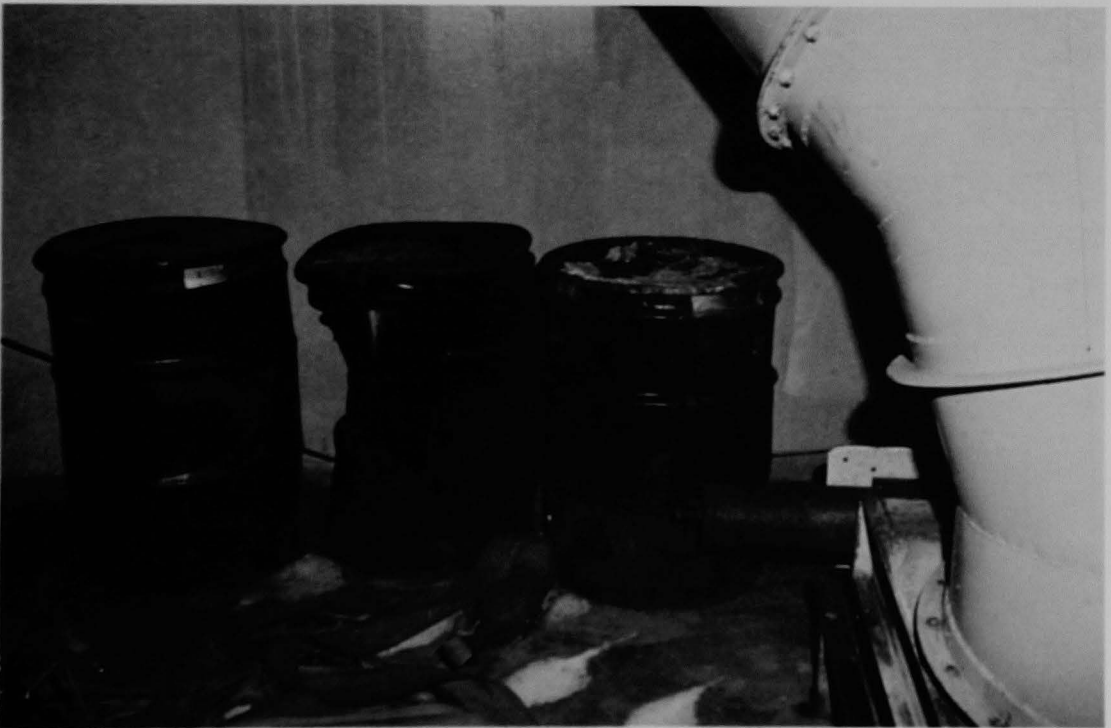
Figure 122 (4A). Fifty-five gallon drums between enclosed stairwell and air duct.

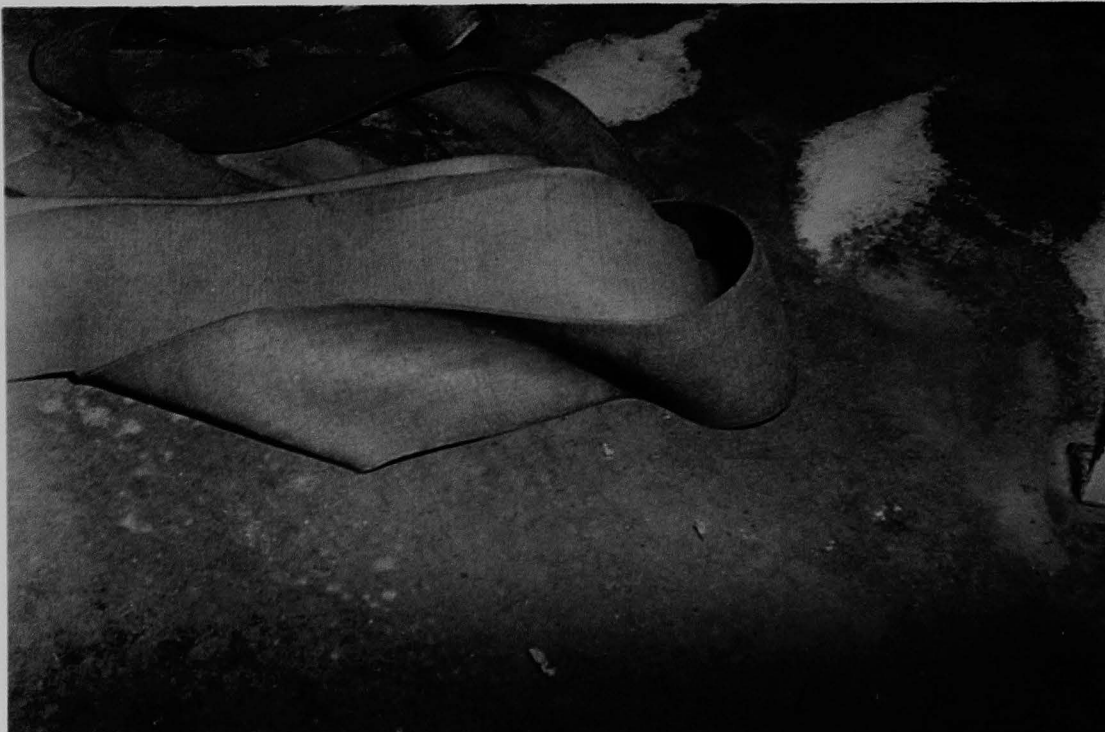
Figure 123 (6A). Lifting sling lying on floor south of enclosed stairwell (see Figure 118).

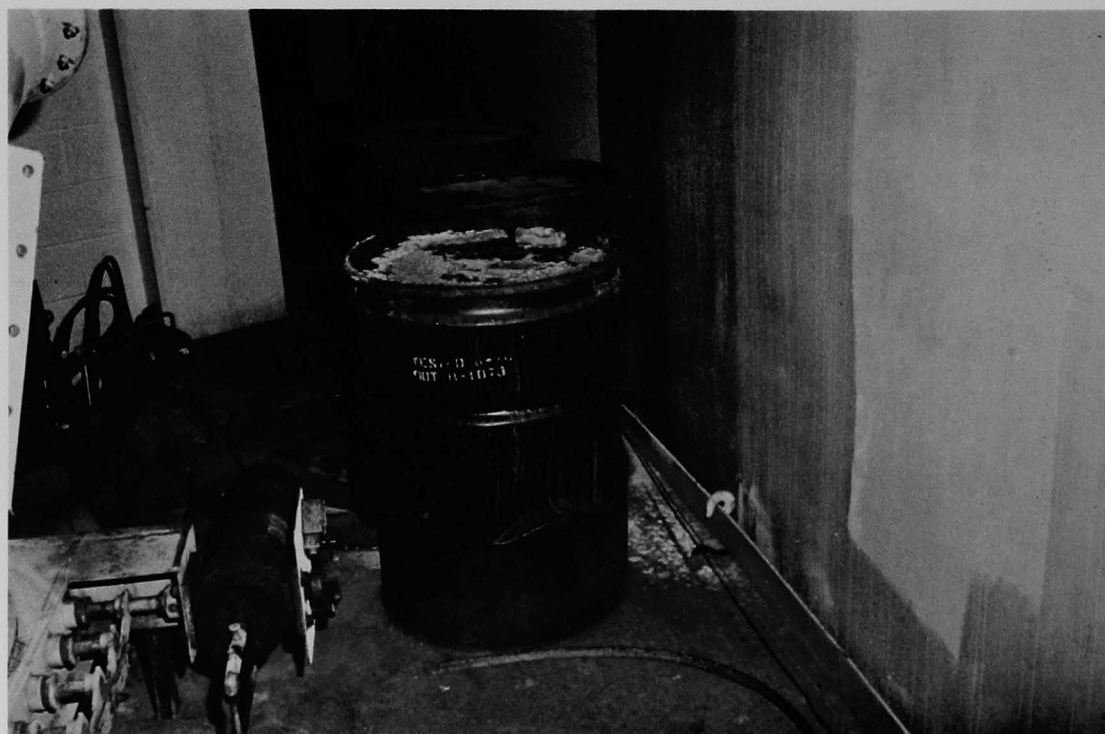
Figure 124 (4A). Fifty-five gallon drums; air duct and enclosed stairwell left, containment liner right.

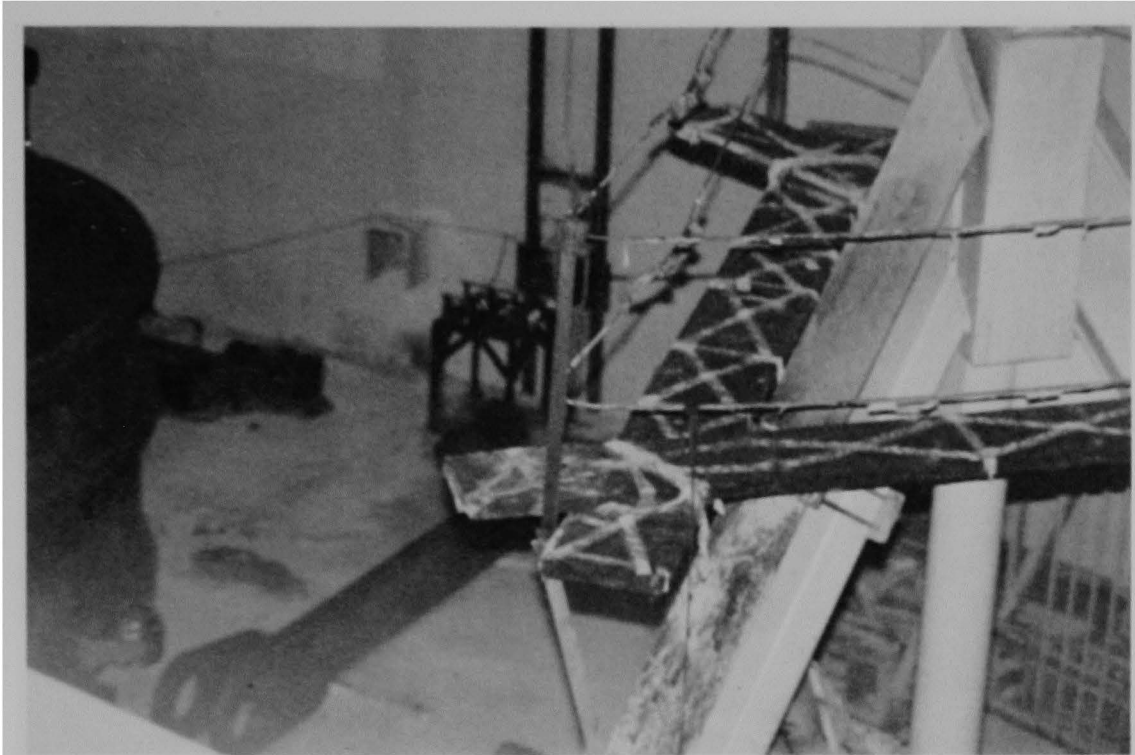
Figure 130 (4B). Scaffolding around top of head lifting rig (plastic covered); internals indexing fixture left, telephone bench background.

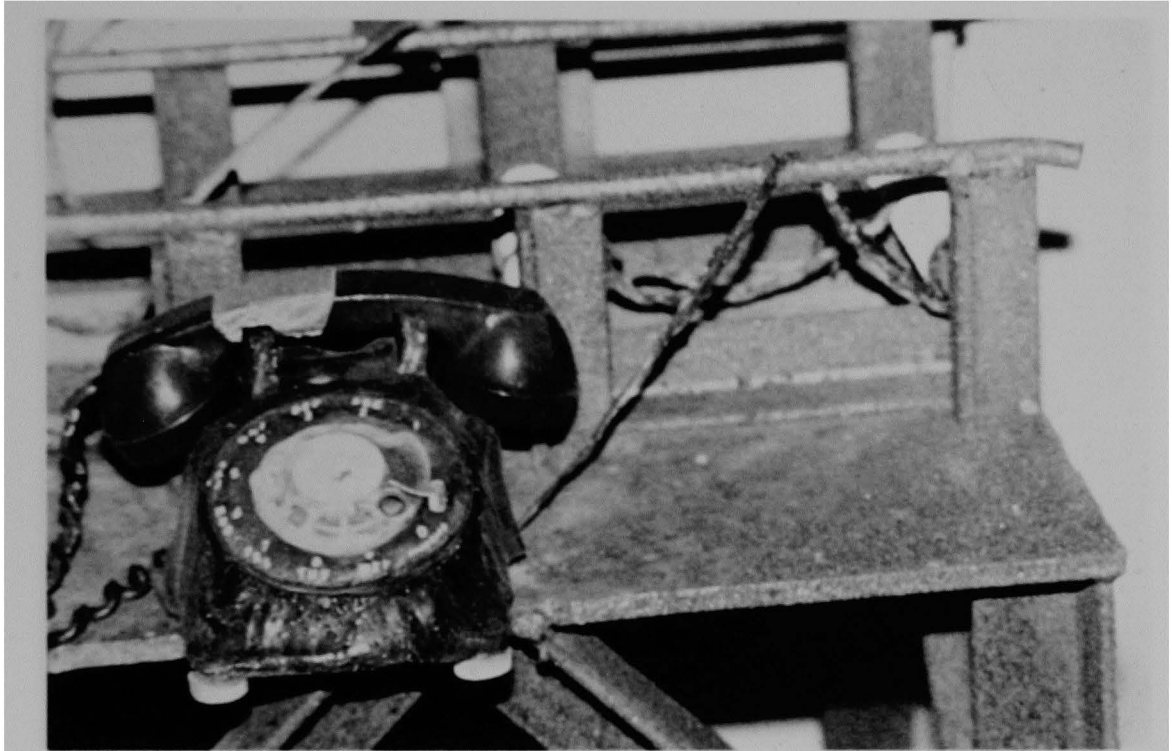
Figure 138 (5B). Close-up of Bell Telephone.

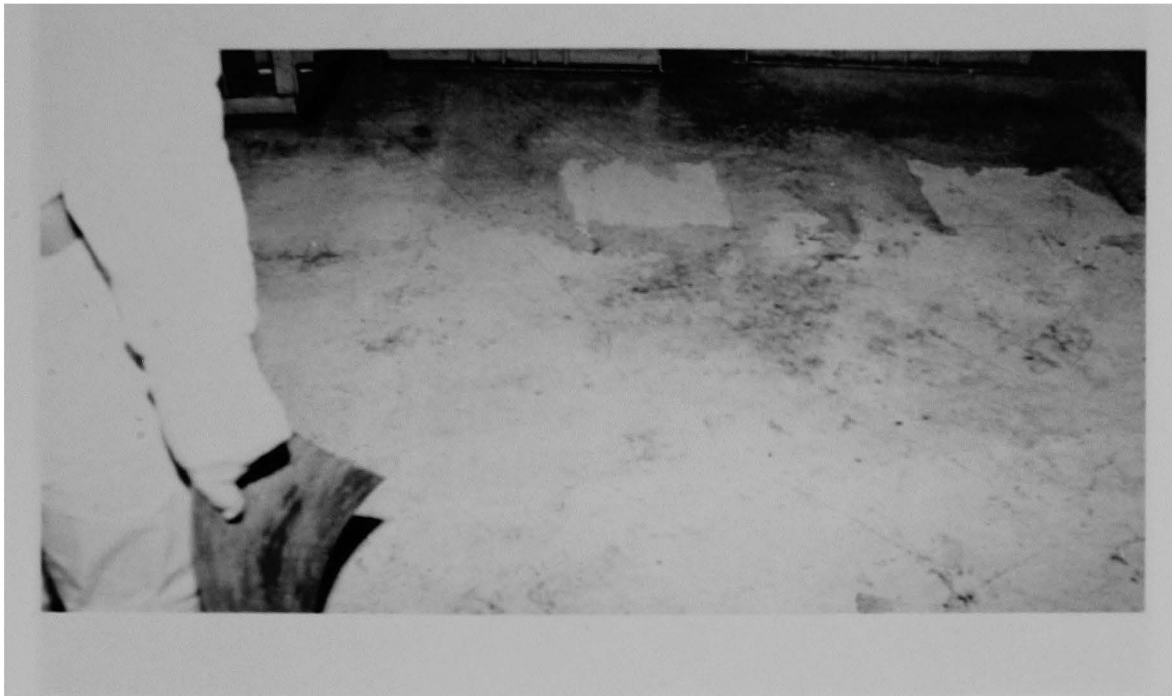
Figure 142 (5C). Close-up of decontamination test (see Figure 141).

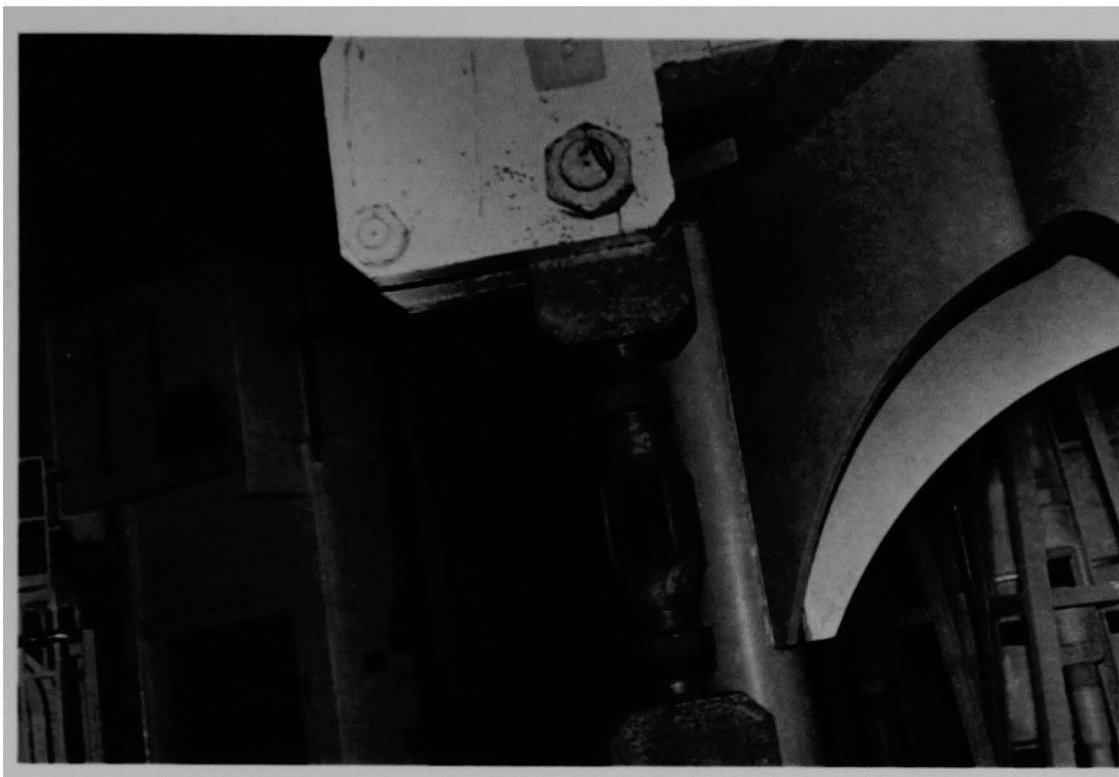
Figure 169 (4A). Polar crane power cable and insulation on grating over core flood tank B.

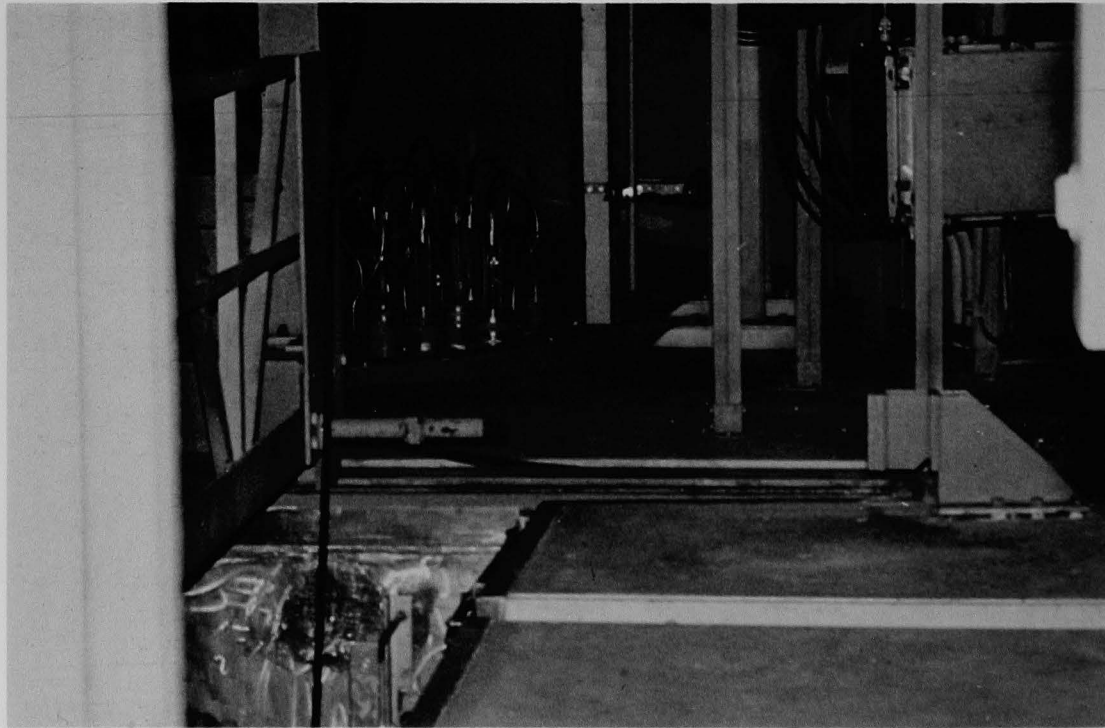
Figure 181 (5C). A northeast portion of the incore seal table (this photograph was taken to document boron crystal accumulation).

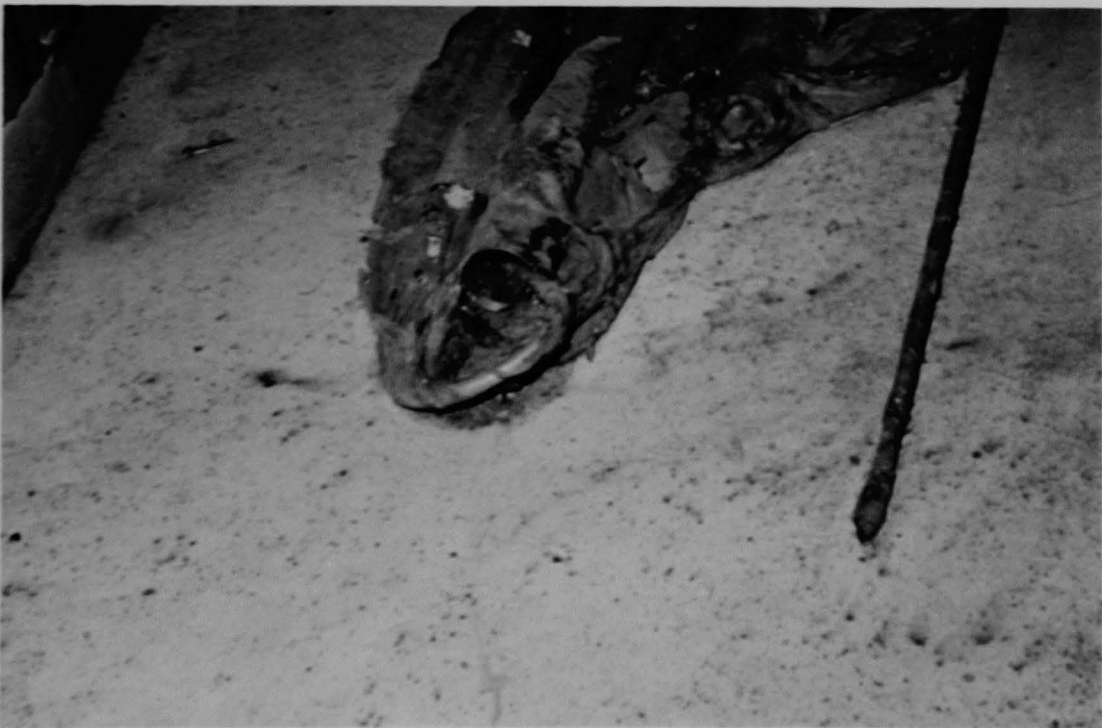
Figure 189 (4). Plastic wrapped equipment lying on floor near liner north of enclosed stairwell.

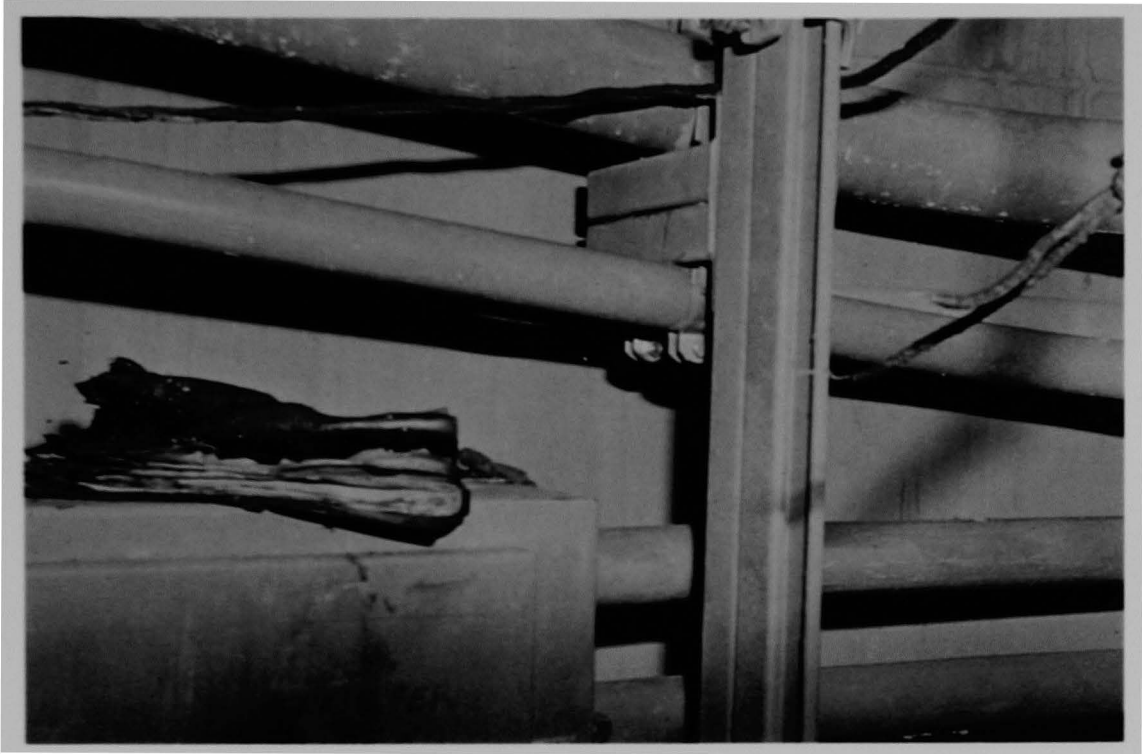
Figure 200 (6A). Charred manual lying on top of electrical box.

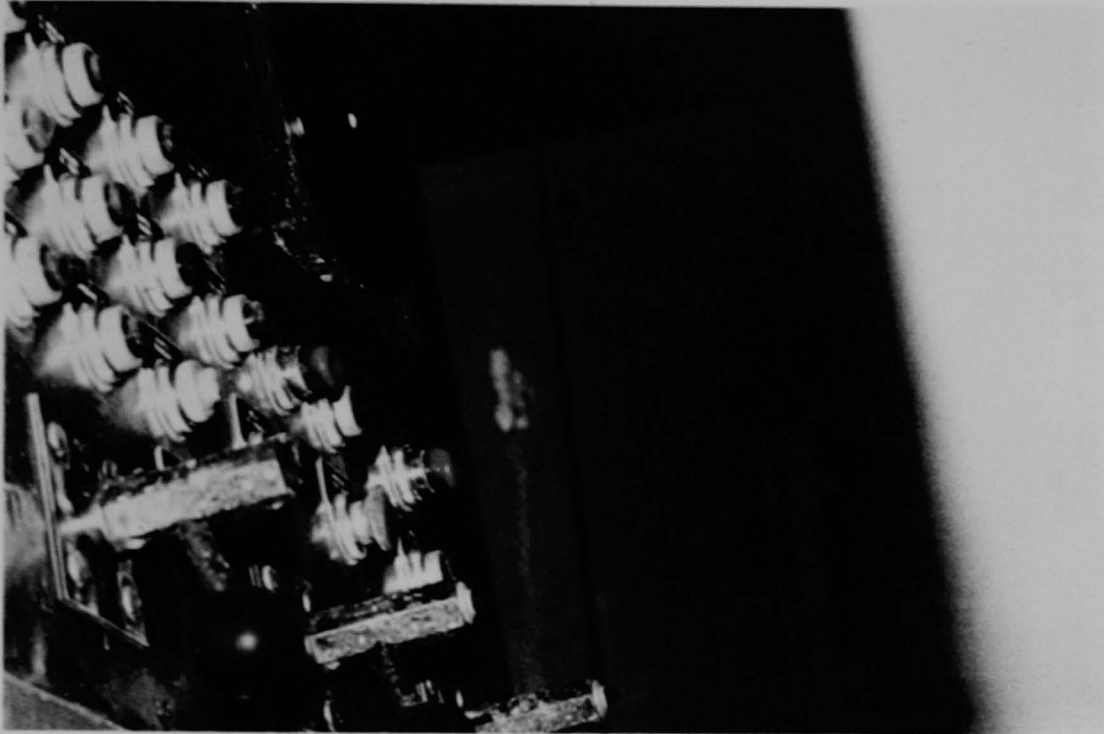
Figure 237 (5B). Close-up of the control panel on the auxiliary fuel handling bridge, second view.

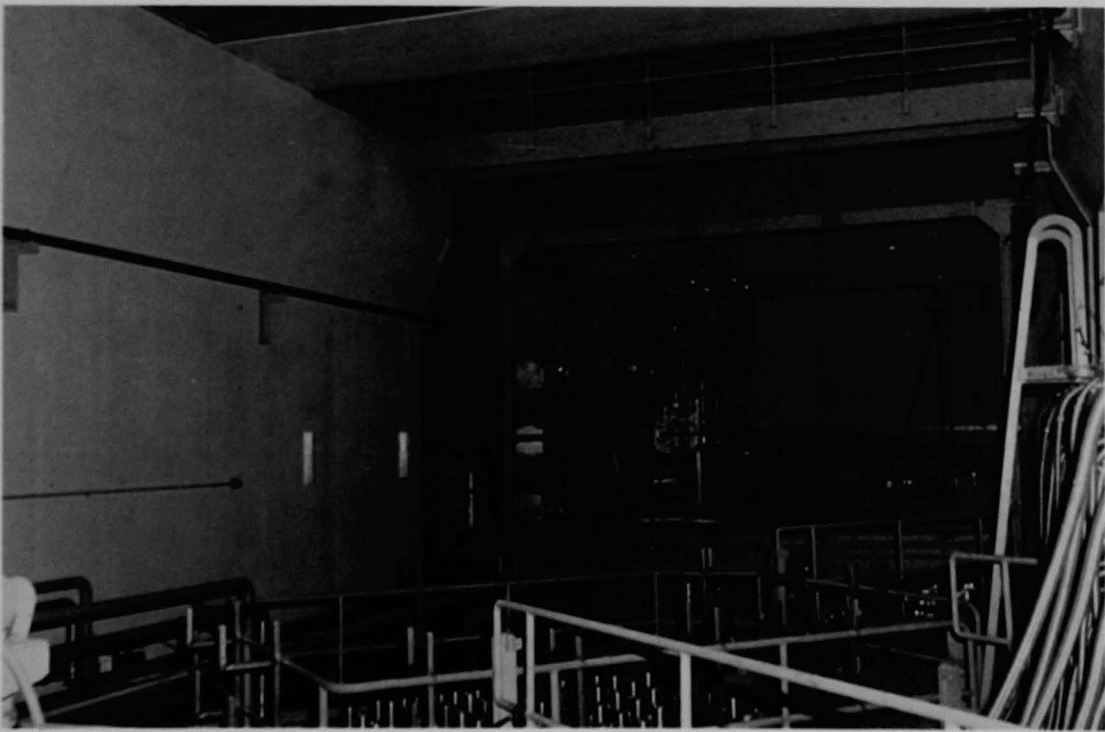
Figure 242 (2A). CRDM platform and incoming power cables, third view.

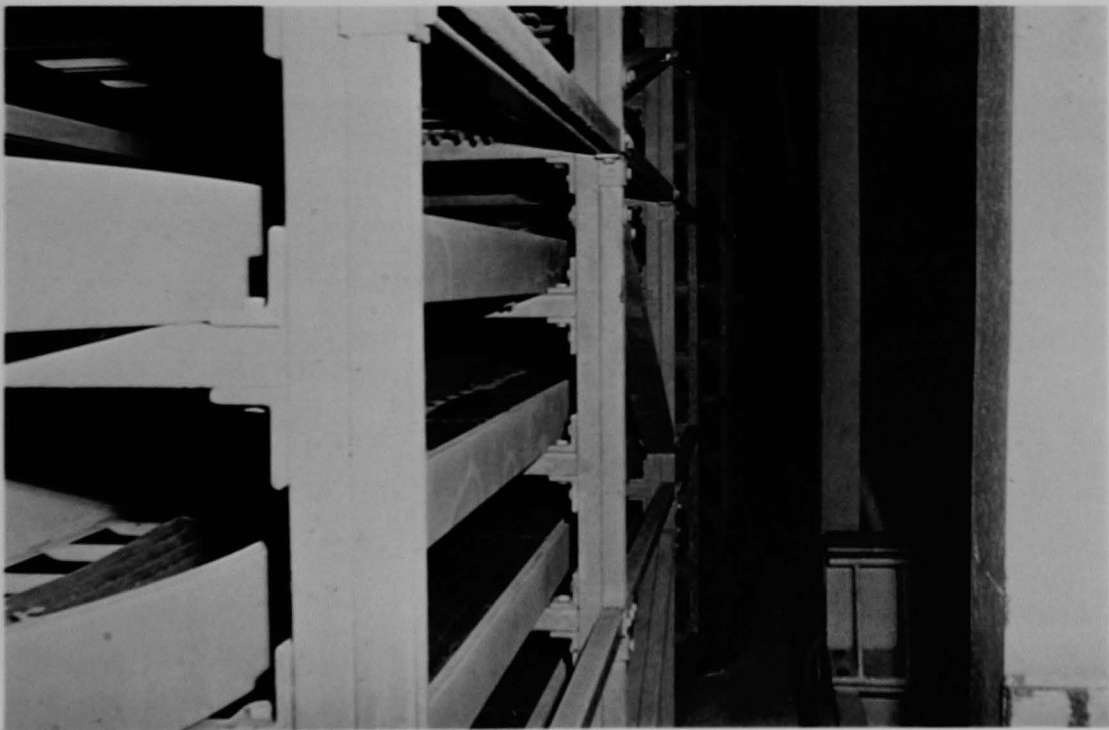
Figure 250 (6A). View south along CRDM cable trays; CRDM cables protruding in background.

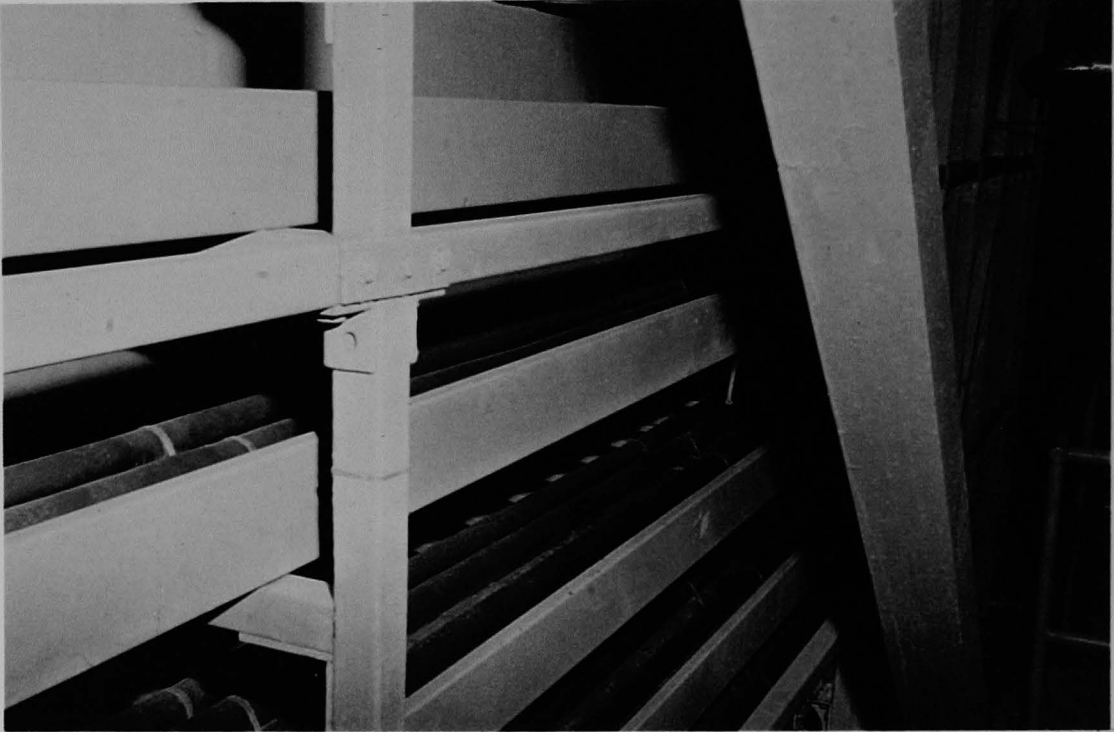
Figure 251 (6A). Close view of CRDM cable trays; hand rail to auxiliary fuel handling bridge right.

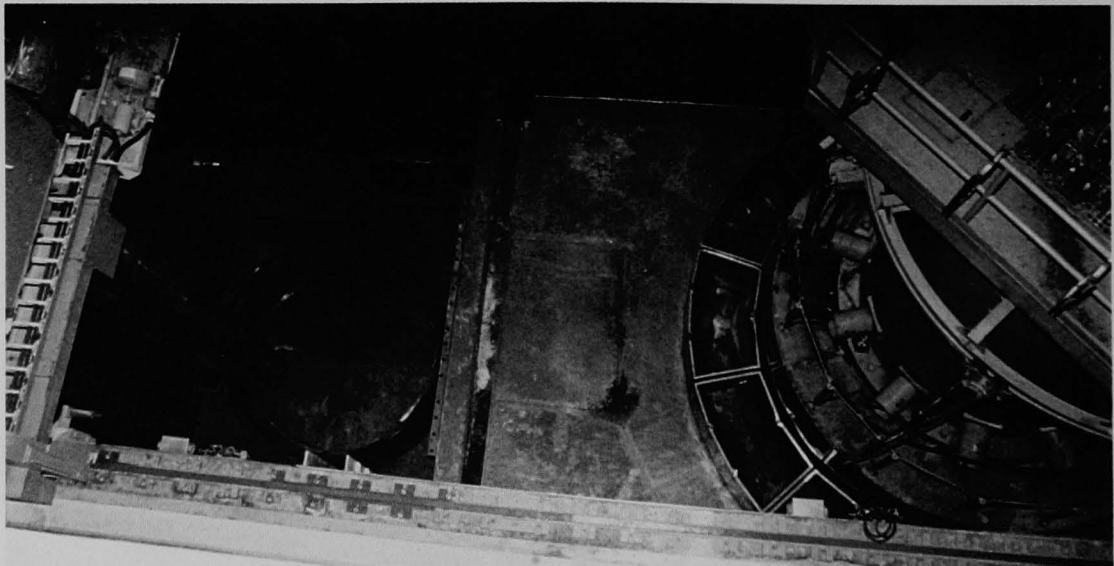
Figure 252 (5C). North end of fuel pool; main fuel handling bridge left, up ender and internals storage stand left center in deep portion of the pool.

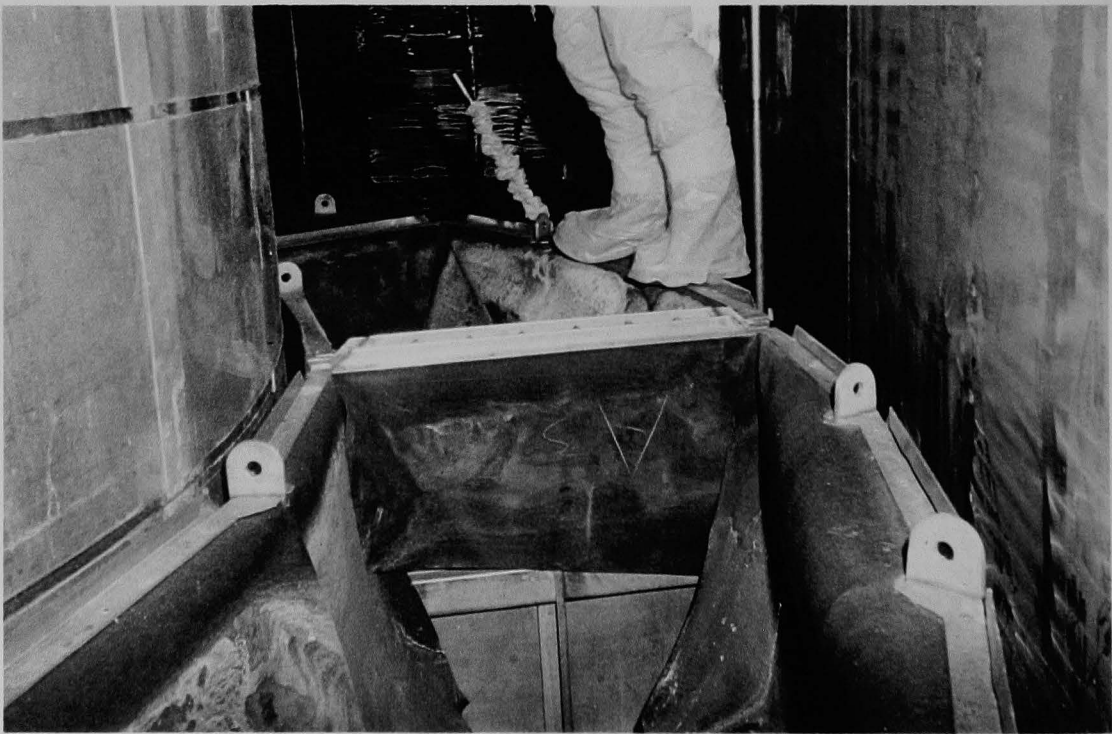
Figure 256 (5A). View inside of neutron shield tank (technician on shield tank to gain access to the north side of the reactor vessel).

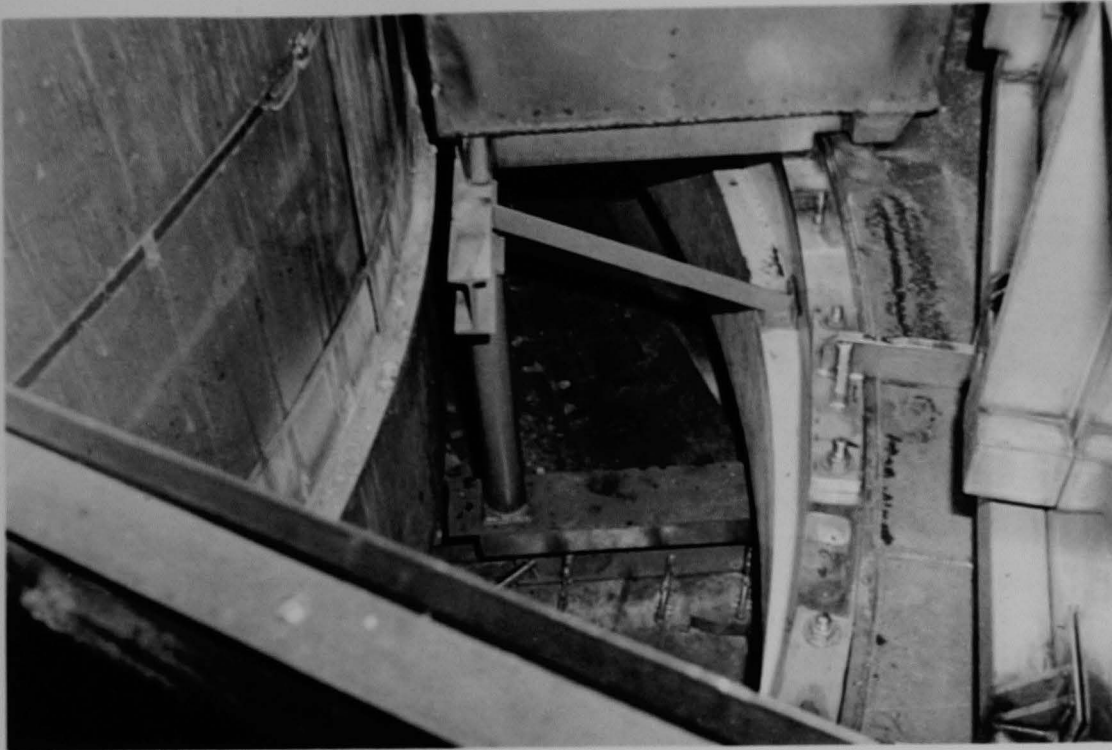
Figure 257 (5A). View underneath a neutron shield tank.

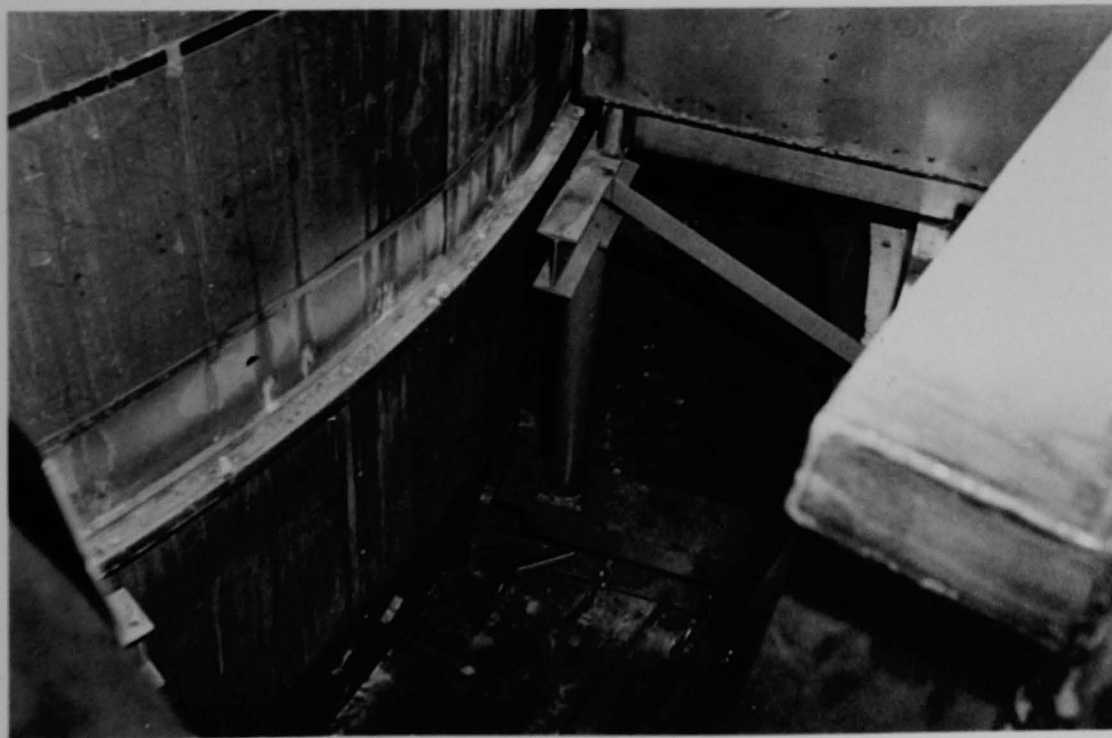
Figure 258 (5A). Second view underneath a neutron shield tank.

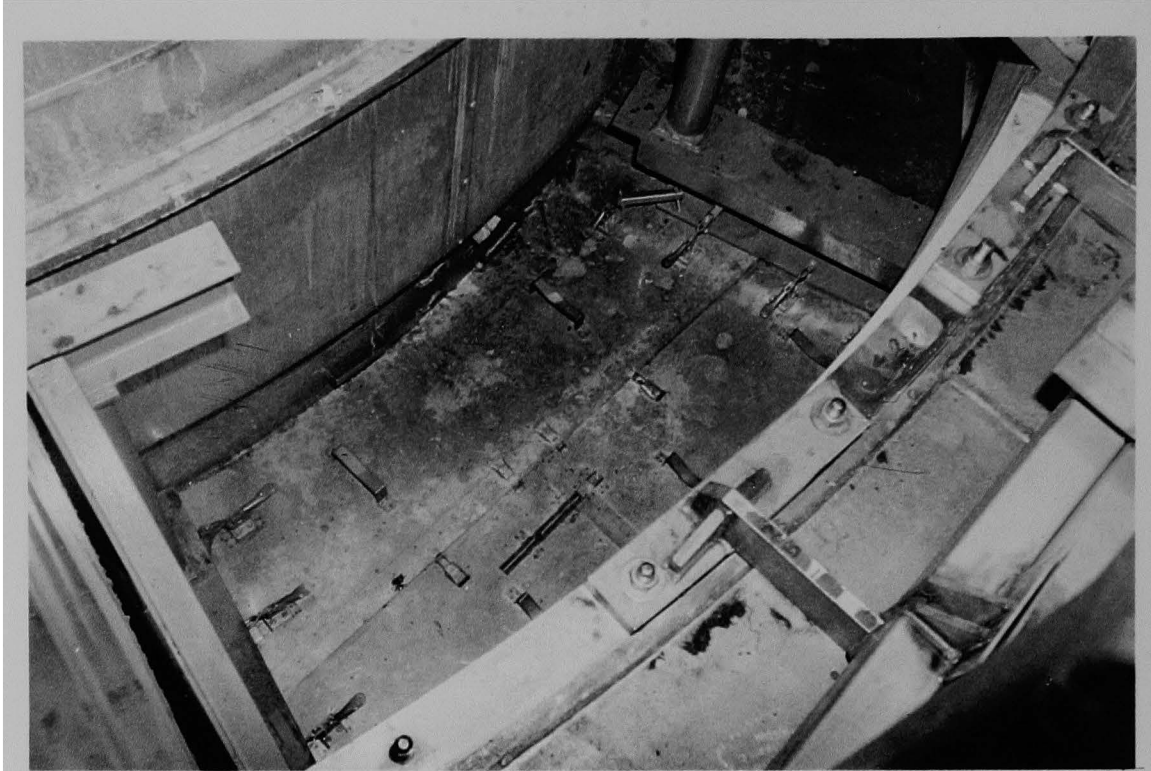
Figure 259 (5A). Close-up view under a neutron shield tank.

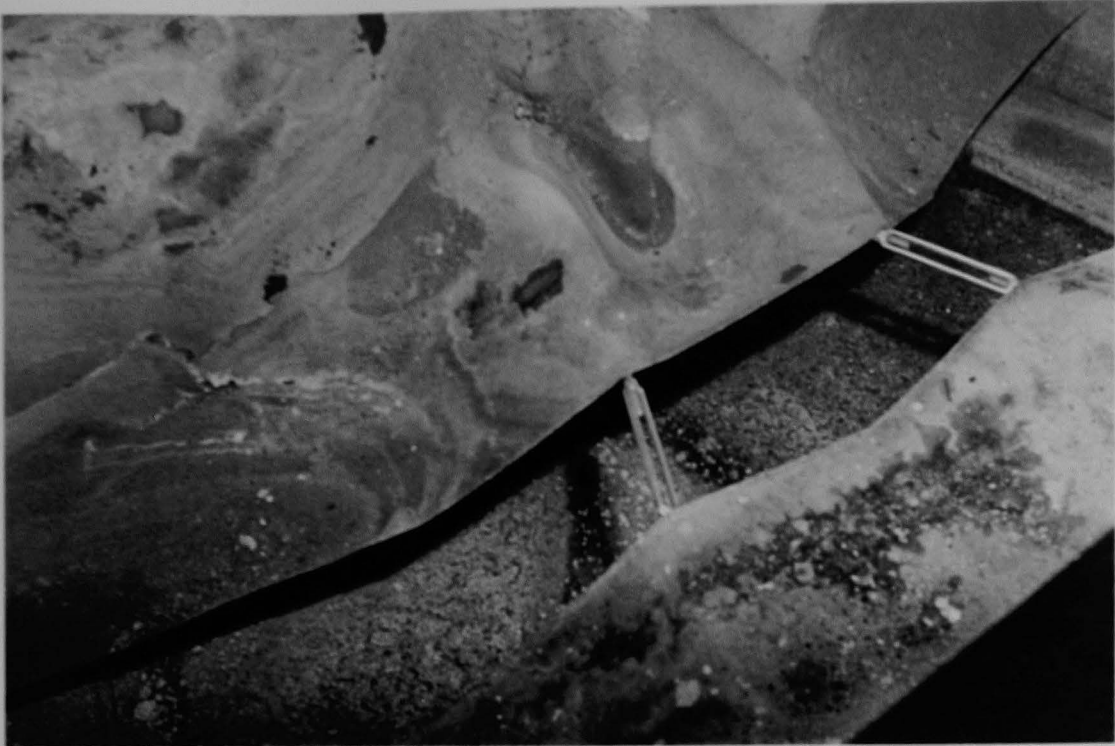
Figure 261 (5A). Close-up of a portion of a neutron shield tank (see Figure 260 foreground right center).

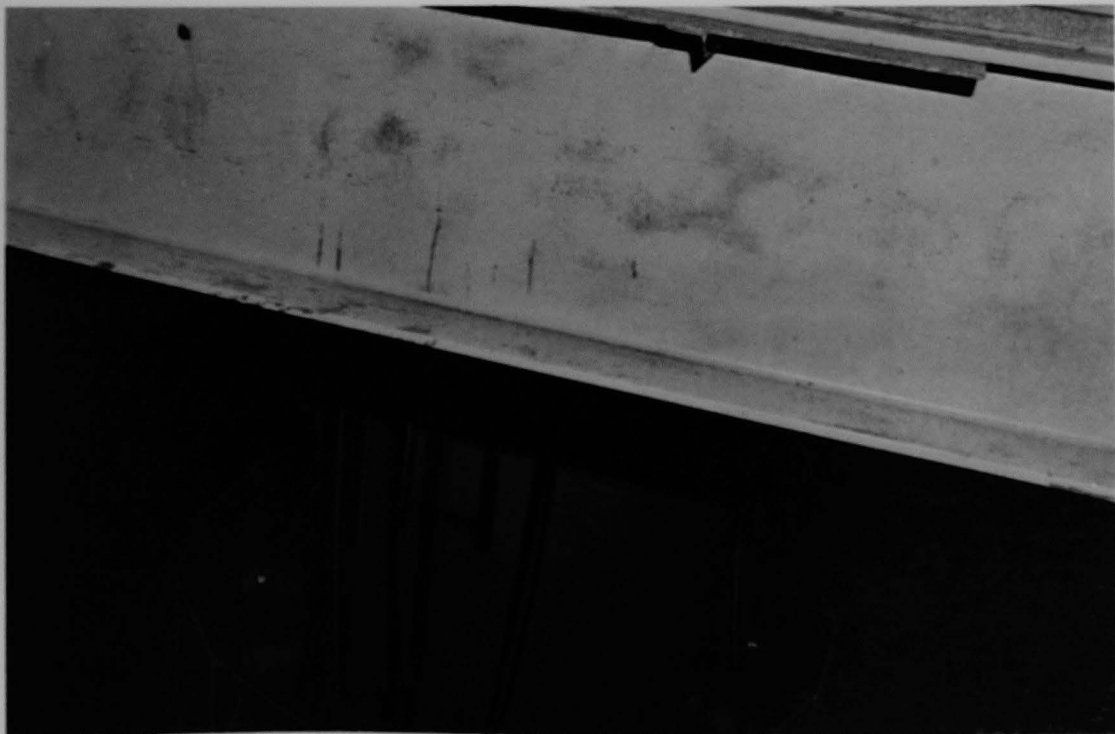
Figure 262 (2A). Reactor vessel head, fuel handling girder above

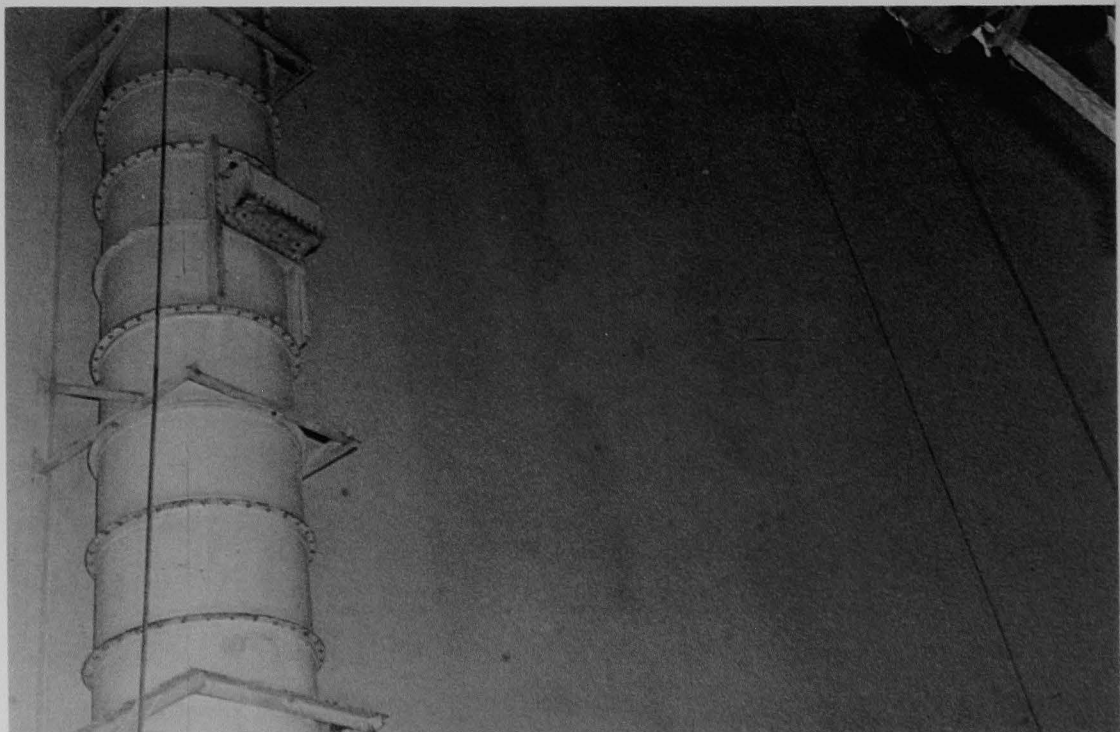
Figure 271 (6A). Ventilation duct on the containment wall, southwest quadrant.

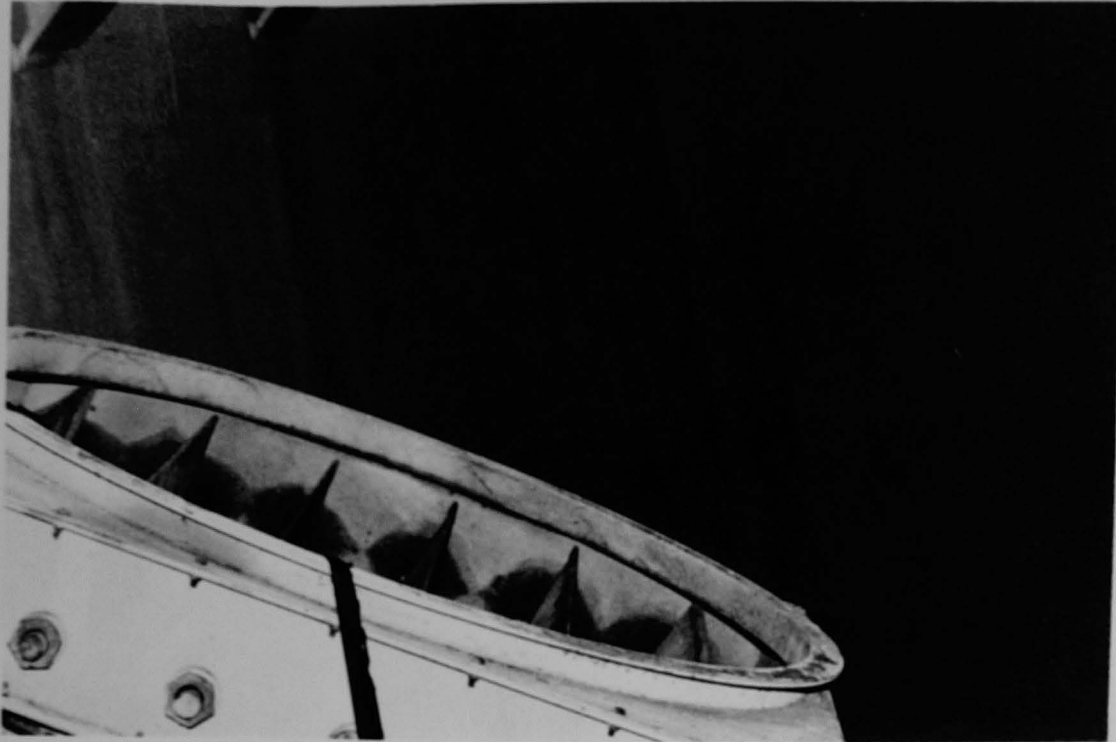
Figure 276 (5B). Top of ventilation duct near the enclosed stairwell.

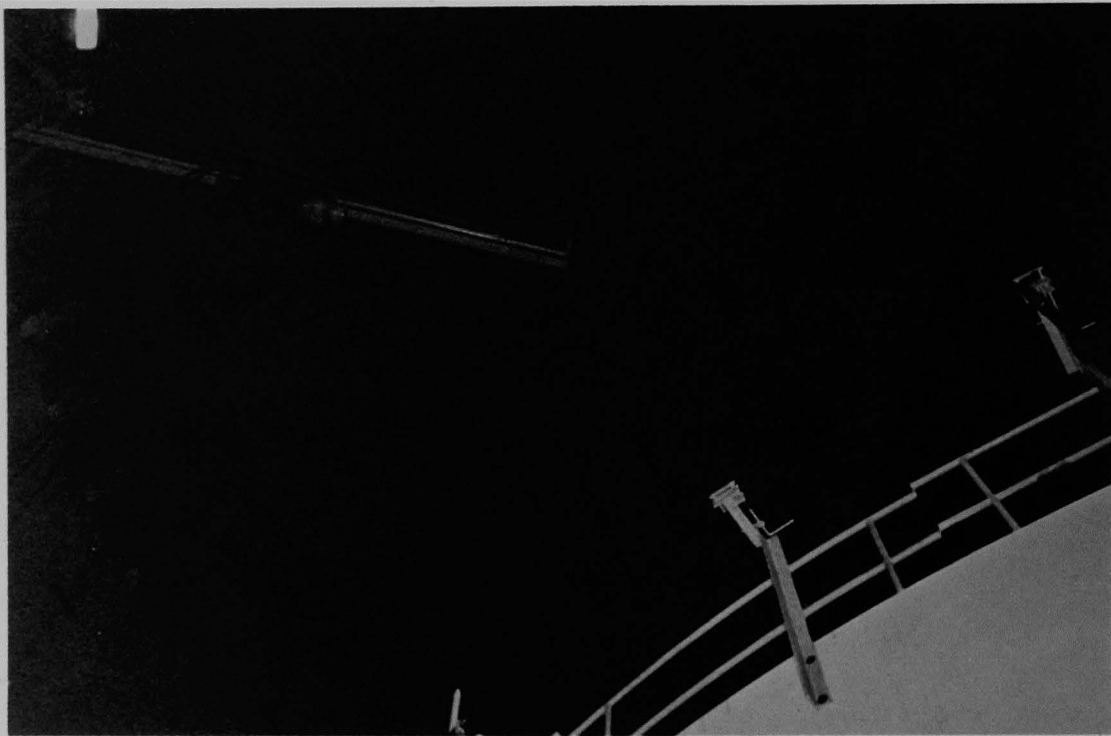
Figure 286 (2B). Jib crane and support box, southwest quadrant.

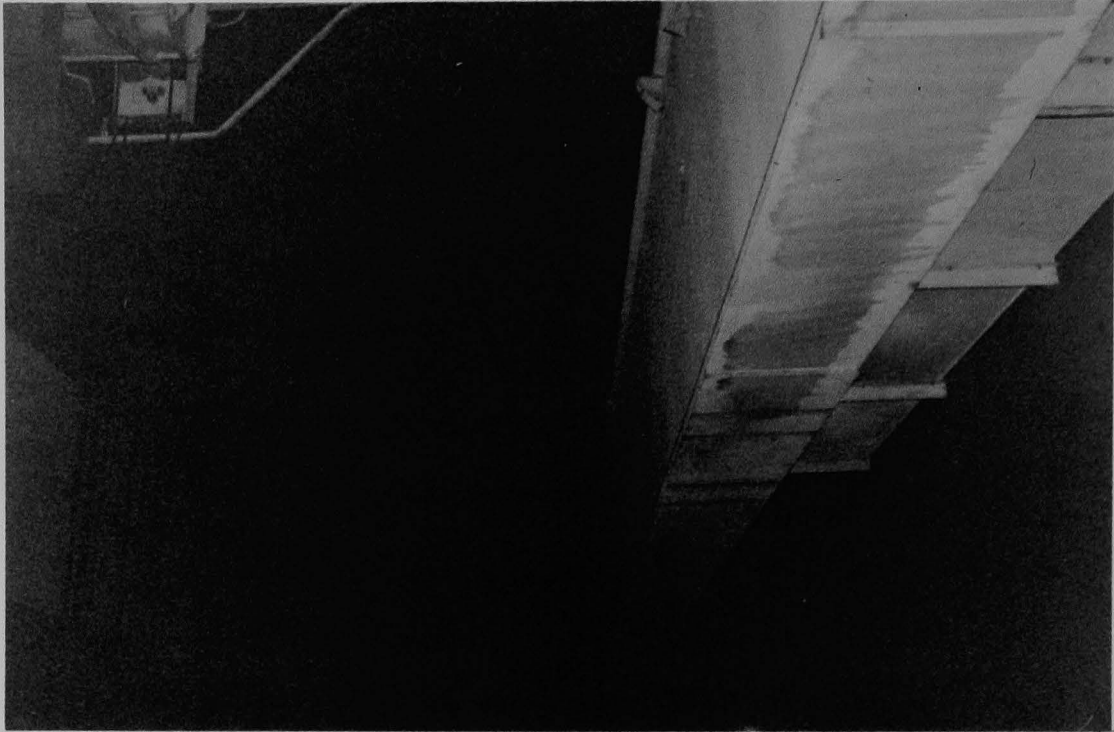
Figure 290 (5A). Girder B of the polar crane, with hook and cables.

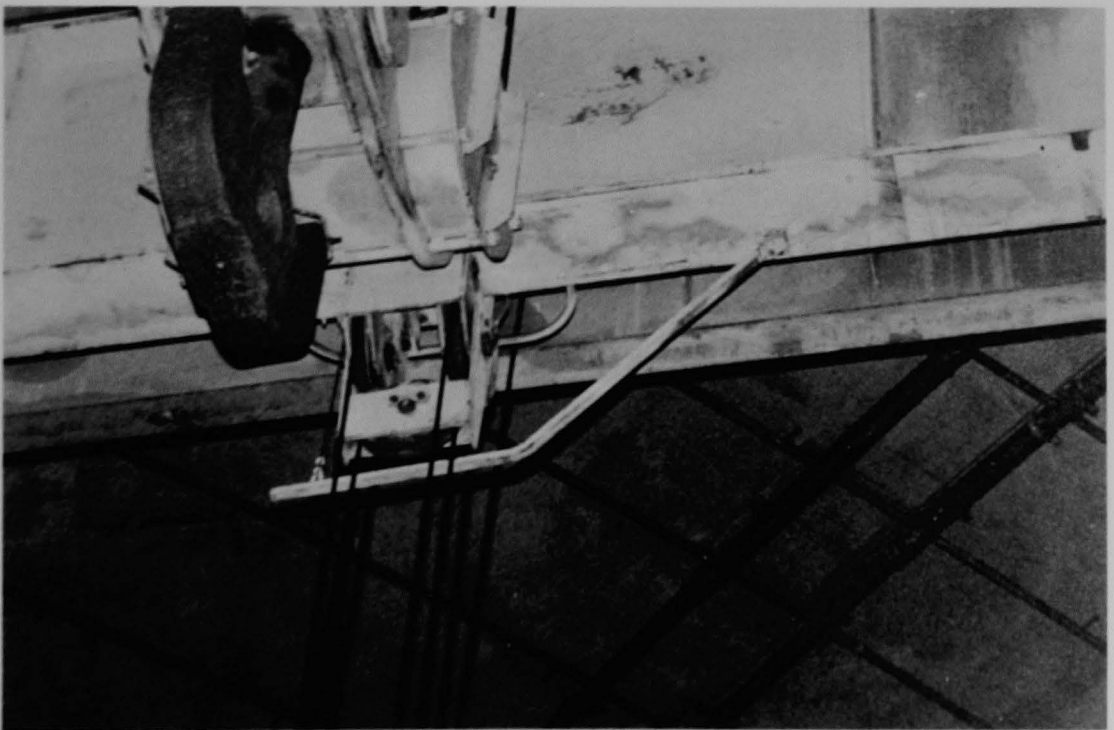
Figure 293 (5B). Main hook of the polar crane, second view.
