**Color Photographs
Of The Three Mile Island Unit 2
Reactor Containment Building:
Volume 1—Entries 1, 2, 4, 5, 6**

October 1981

**EG&G Idaho, Inc.
Idaho Falls, Idaho 83415**

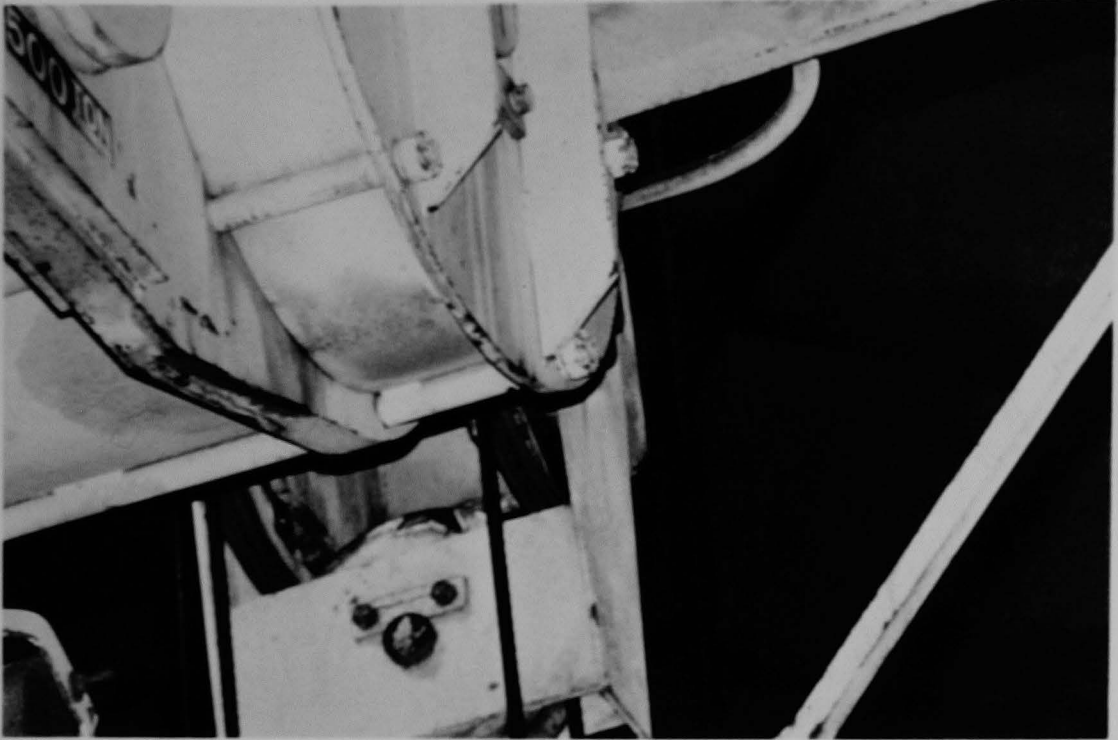
Figure 296 (5B). Main hook of the polar crane, fifth view.

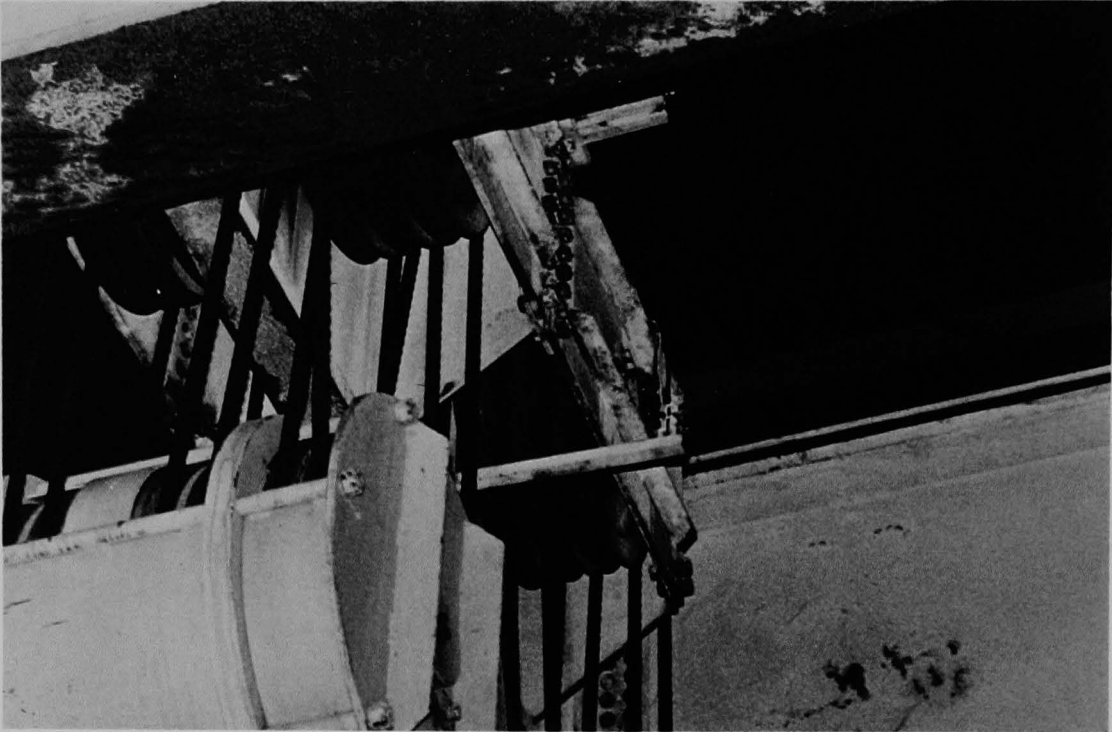
Figure 298 (5B). Cable drum and the main block of the trolley on the polar crane, second view.

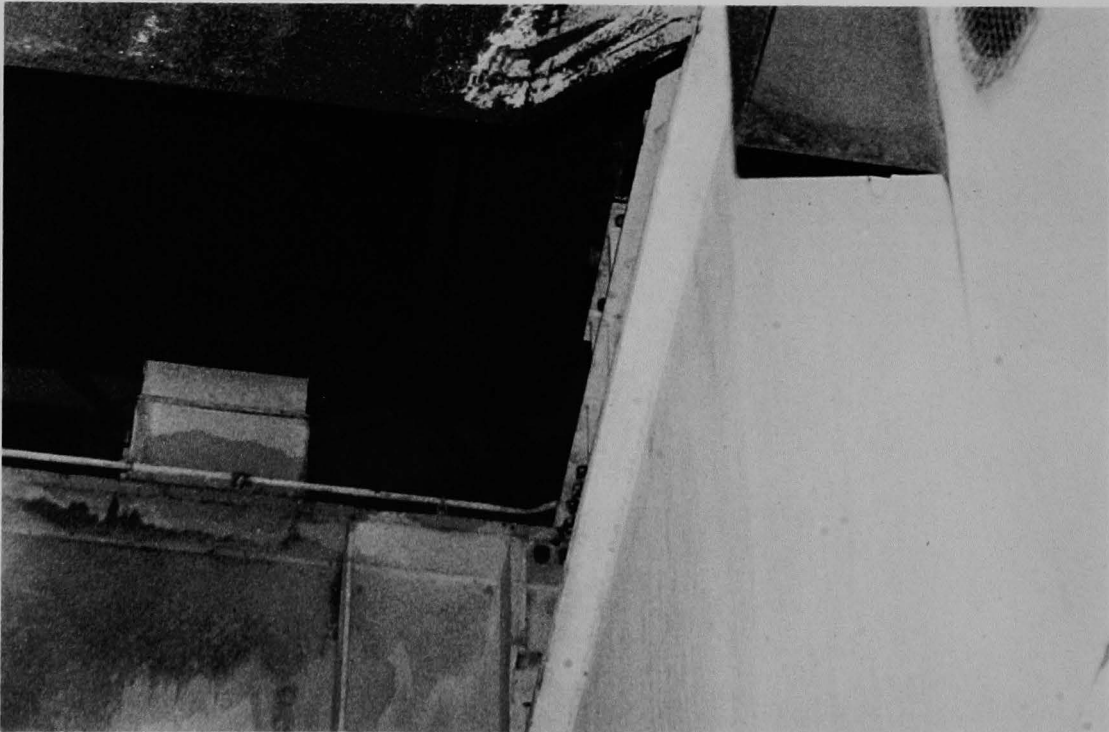
Figure 299 (5B). Cable drum on right side of the trolley over girder B (cf. Figures 297 and 298).

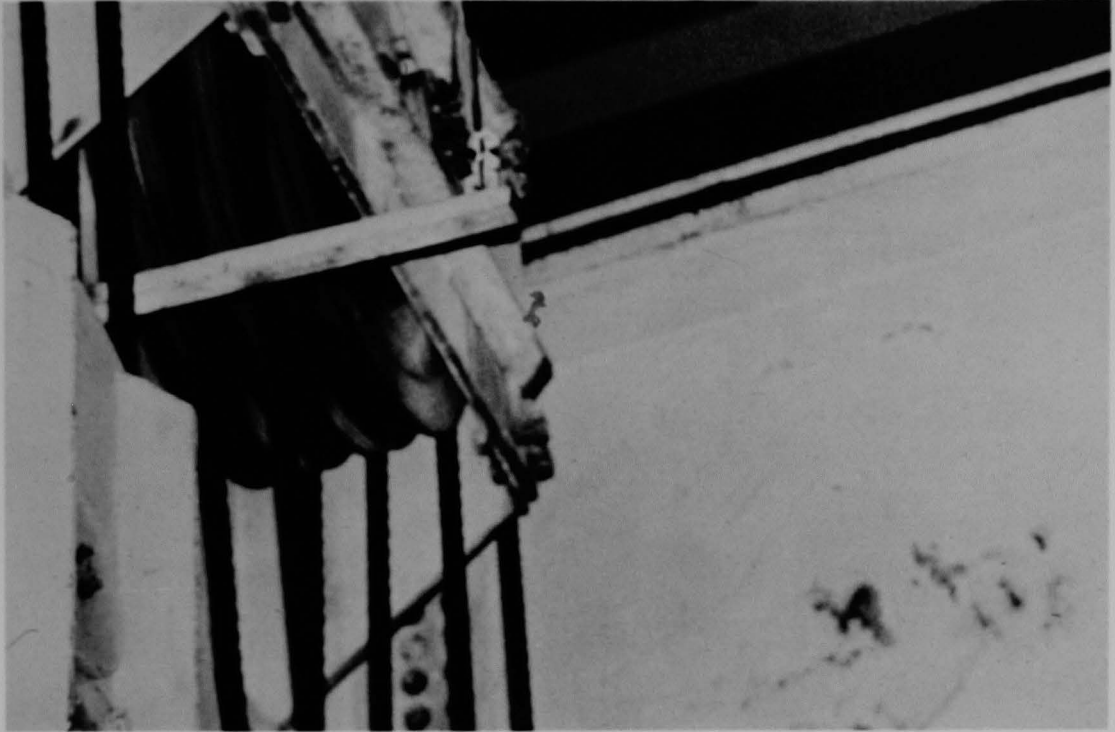
Figure 300 (5B). Close-up of cables for the main hook.

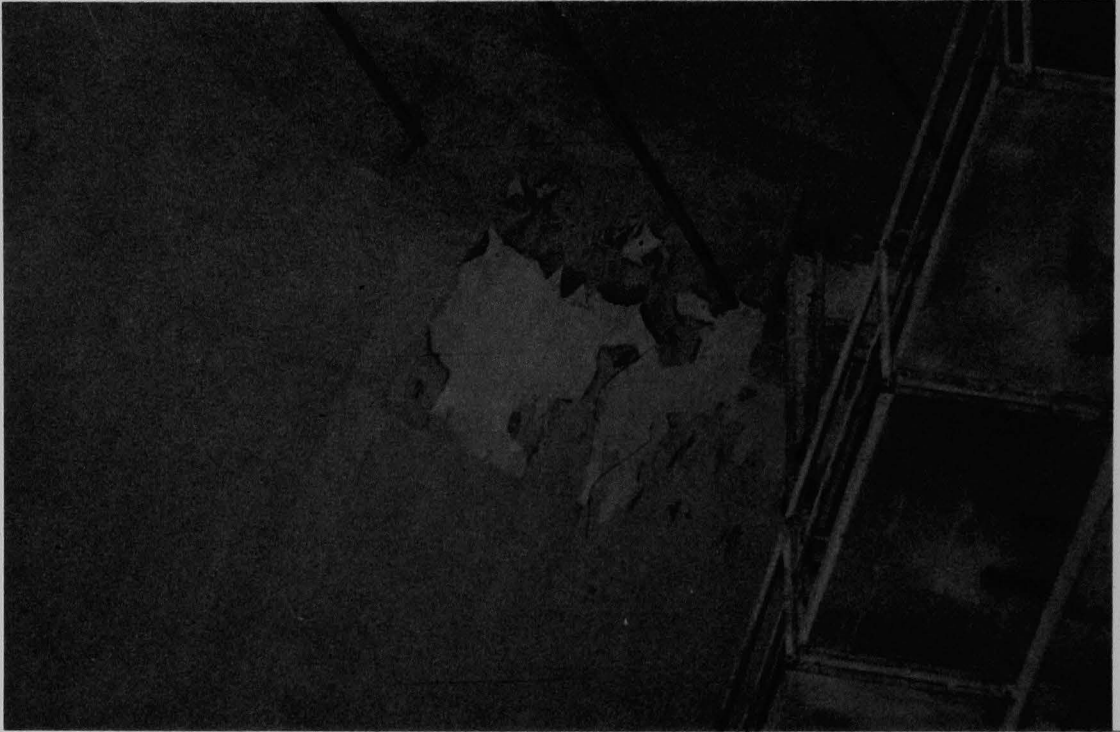
Figure 302 (4B). Containment dome north of the enclosed stairwell.

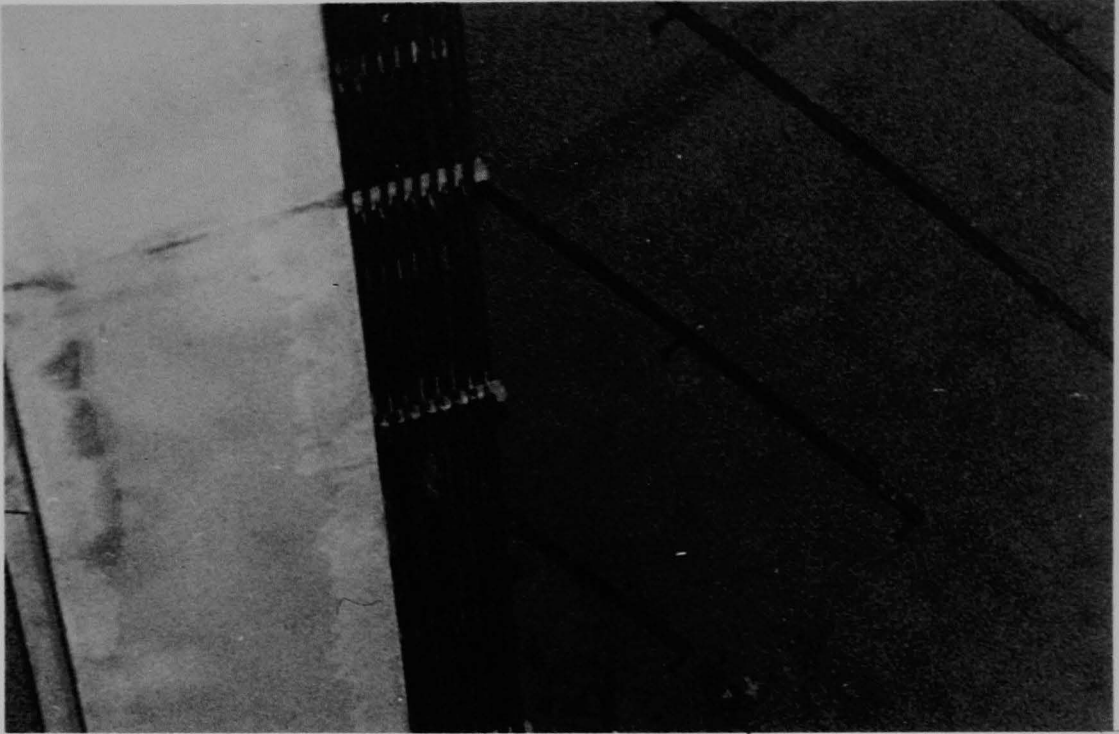
Figure 306 (5B). Trolley power and controller buss bars, view from the midpoint of the polar crane access ladder.
