August 1981

QUICK LOOK REPORT
ENTRY 6
THREE MILE ISLAND UNIT 2

**QUICK LOOK REPORT
ENTRY 6
THREE MILE ISLAND UNIT 2
February 3 and 5, 1981**

**Bechtel Northern Corporation/
General Public Utilities Nuclear Corporation**

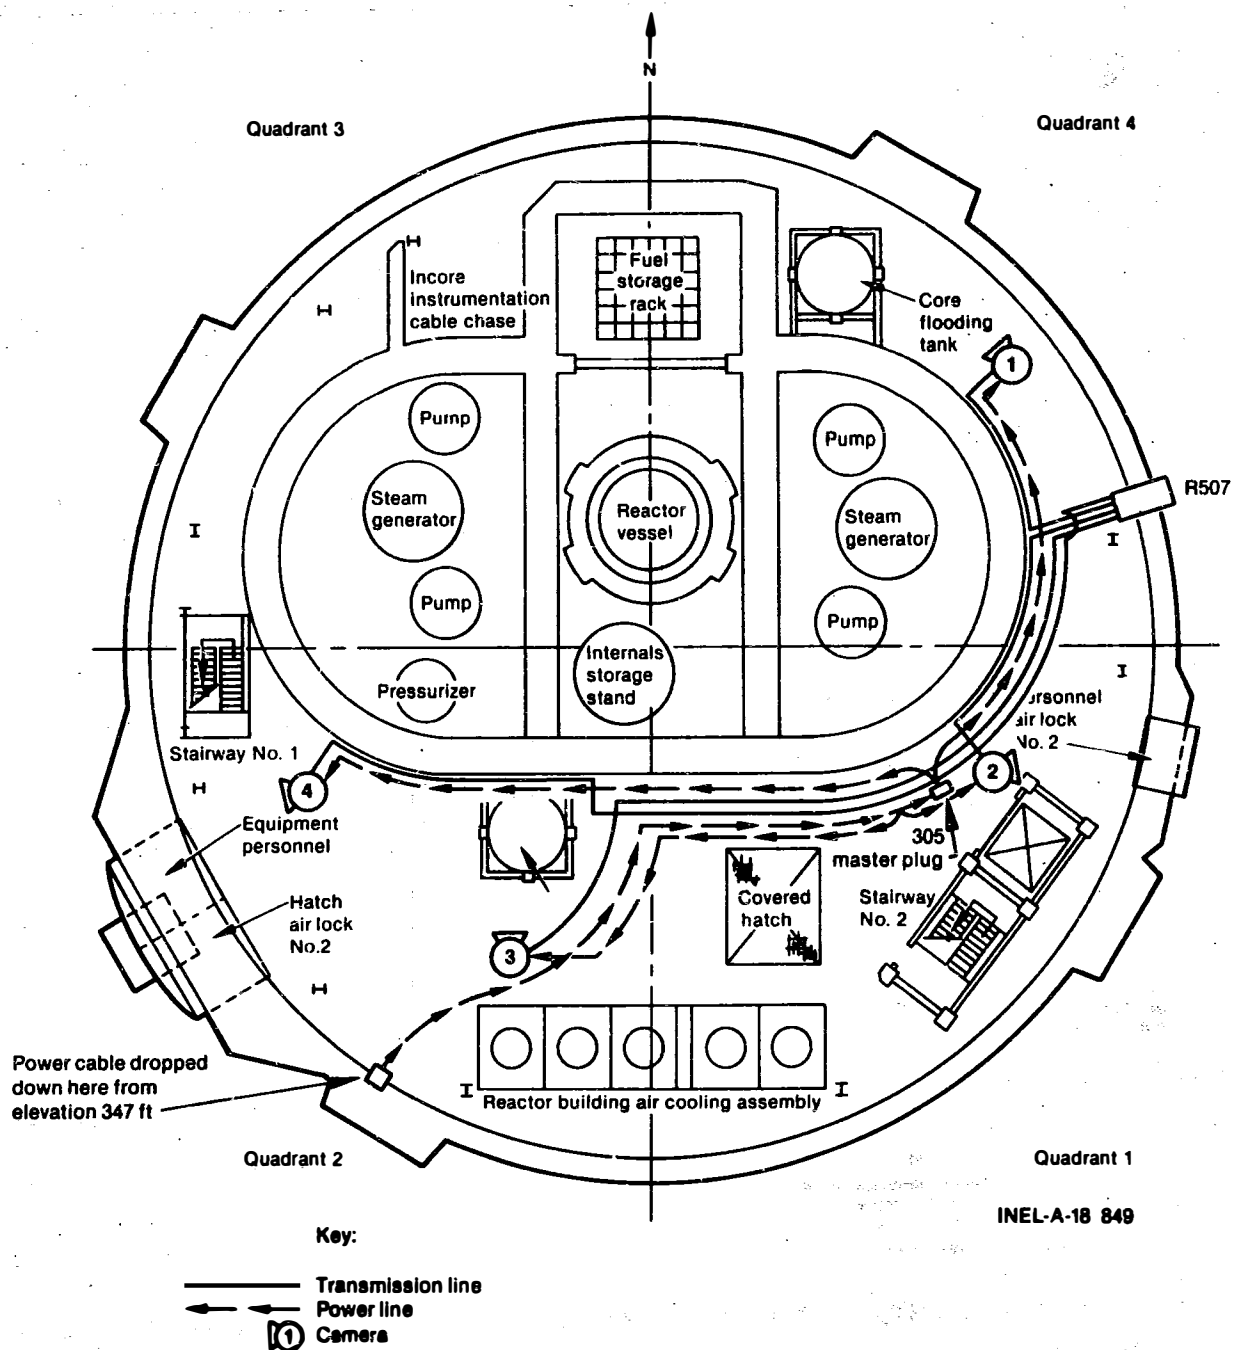
Figure 3. Entry 6, Elevation 305 camera cable routing diagram.

During Entry 6, phase one of the closed circuit television system was completed. Figure 3 shows the cable routing and camera placement diagram for Elevation 305. Figure 4 shows the cable routing and camera placement diagram for Elevation 347. Cameras had a 360 degree field of view.
