EGG-TMI-7385, Rev. 1
February 1987

TMI-2 CORE BORE ACQUISITION SUMMARY REPORT

Published February 1987

EG&G Idaho, Inc.
Idaho Falls, Idaho 83415

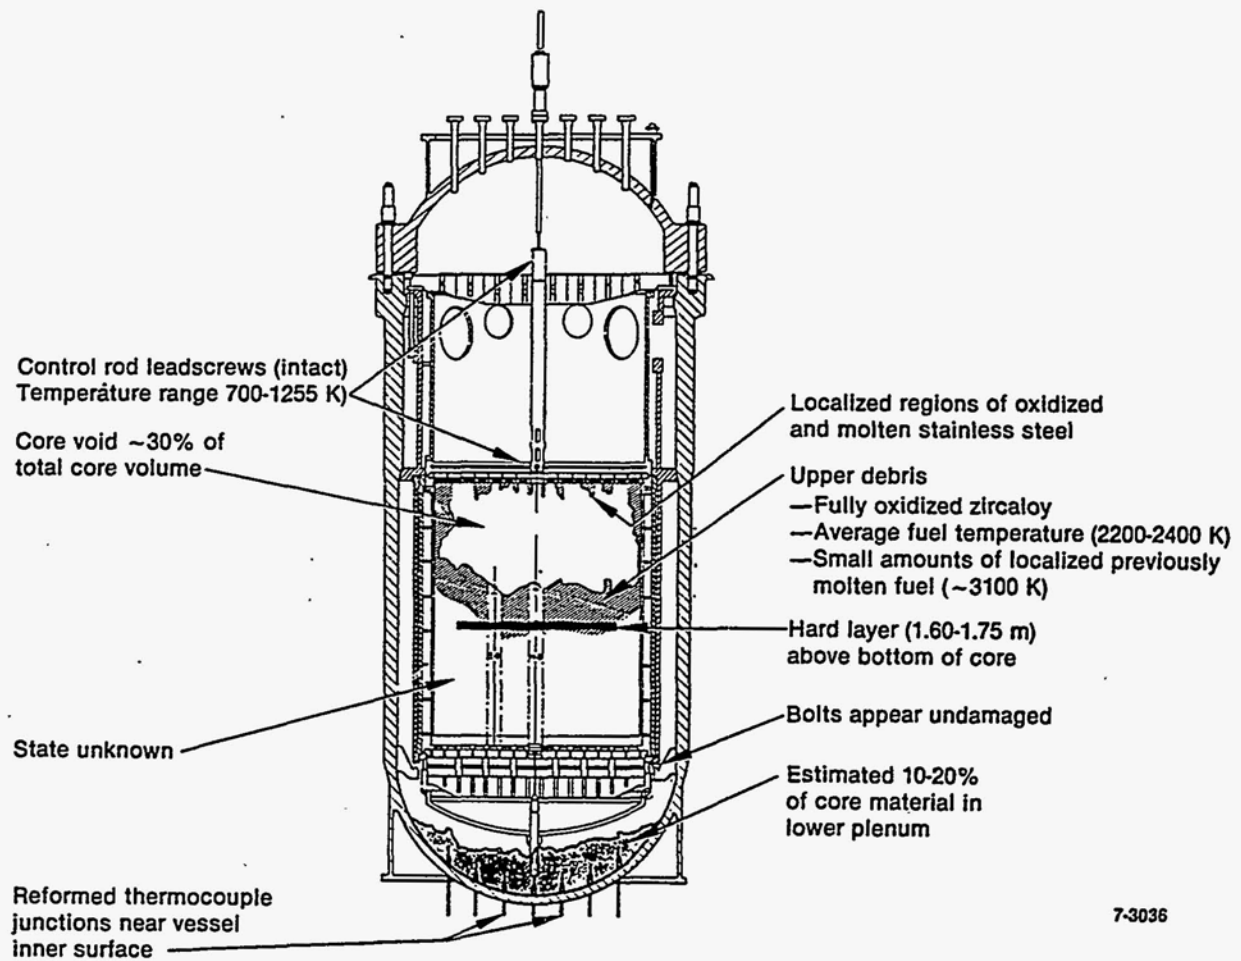
Figure 4. Known core and reactor vessel conditions prior to core bore acquisition.

Prior to core boring, it was known that the upper core consisted of an upper voided region almost entirely surrounded by standing peripheral assemblies and a region of loose debris resting on a hard crust, as illustrated in Figure 4. Conditions within the confines of the core boundary but beneath the hard crust were unknown. The RV lower plenum contained an estimated 10 to 20 tons of core debris. Based on examination of loose debris from the lower plenum, it was known that the materials were primarily ceramic fuel and cladding and that some fuel particles had reached UO_2 melting temperatures. The bulk average temperature of the debris material was estimated to be from 2200 to 2400 K.

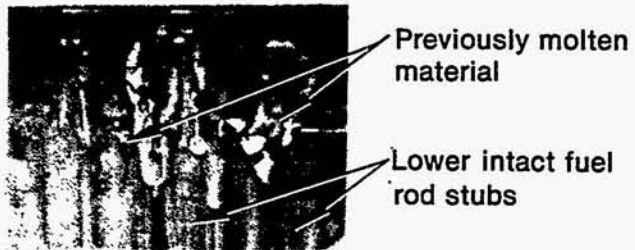
A summary of observations from a peripheral core bore location (N12) is shown in Figure 10. Previously molten homogeneous ceramic material was not observed in any of the peripheral core bore holes (D4, D8, N5, N12, O7, O9). Agglomerate material with vertical fuel rod structure extends from the top of the core bore hole to the transition region between agglomerate material and standing fuel rods. The agglomerate material is only about 14 in. thick, and standing fuel rods extend 48 in. above core bottom. The transition zone between the lower intact fuel rods and the agglomerate region in core bore hole N12 is shown in Figure 11, and standing fuel rods about 16 in. above the core bottom are shown in Figure 12.

Figure 11. Transition between intact rod bundle and agglomerated core material at top of third spacer grid (approximately 49 in. from fuel rod bottom) at core position N12.

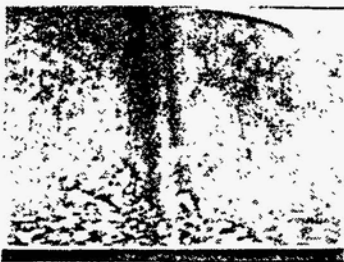
View from core position N5 of previously molten core material below the lower grid underneath core position 05 (86-417-1-6)

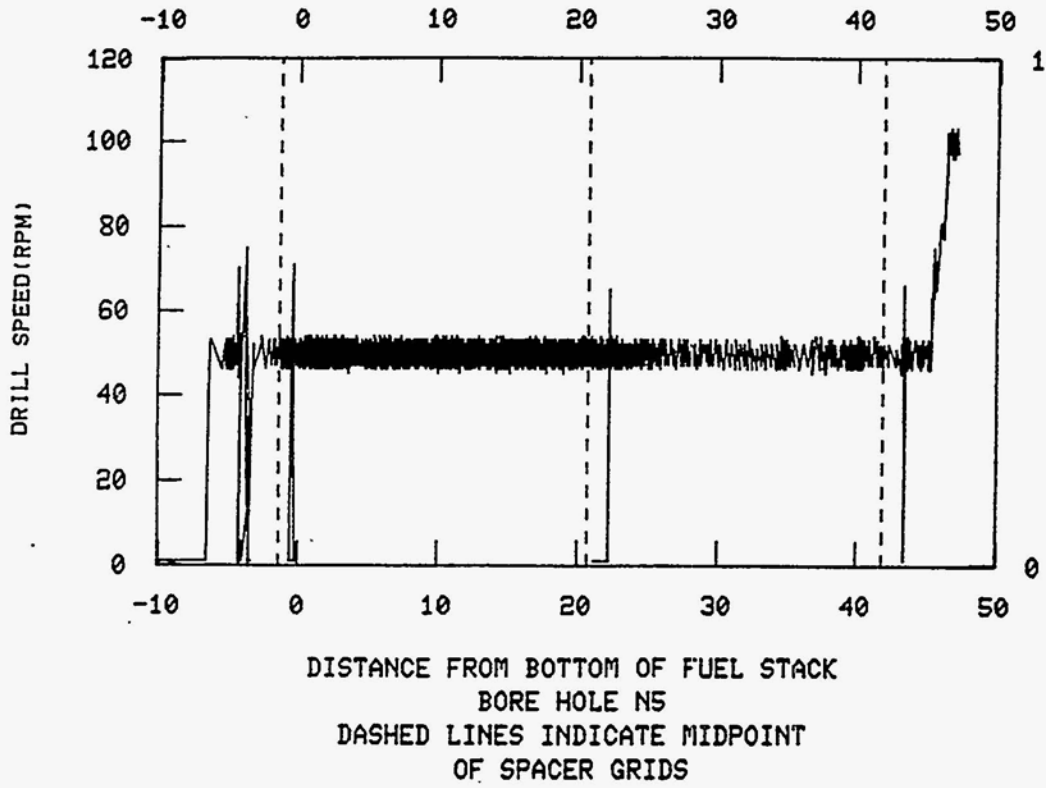
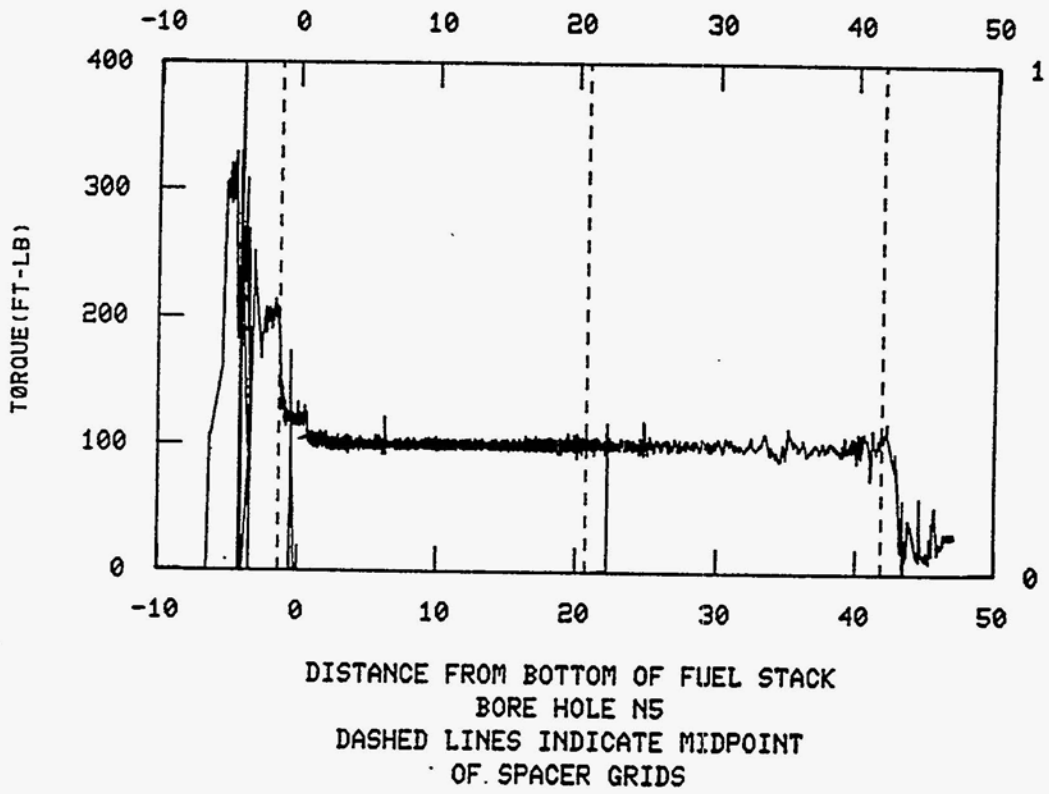
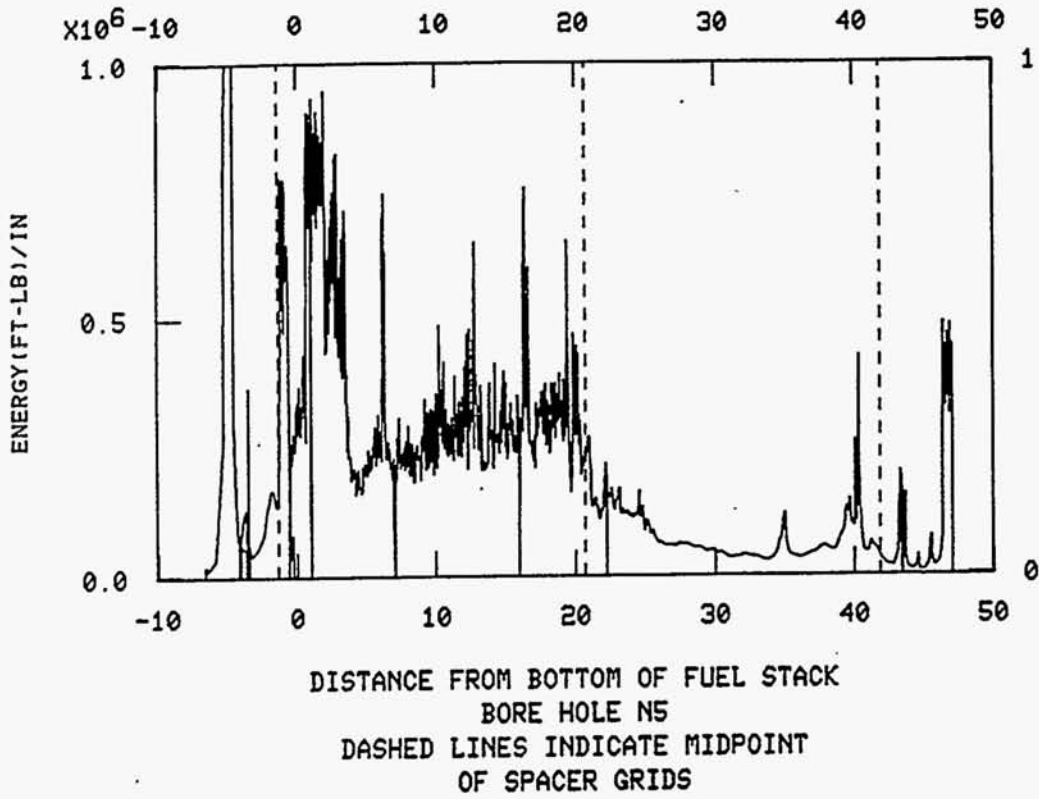
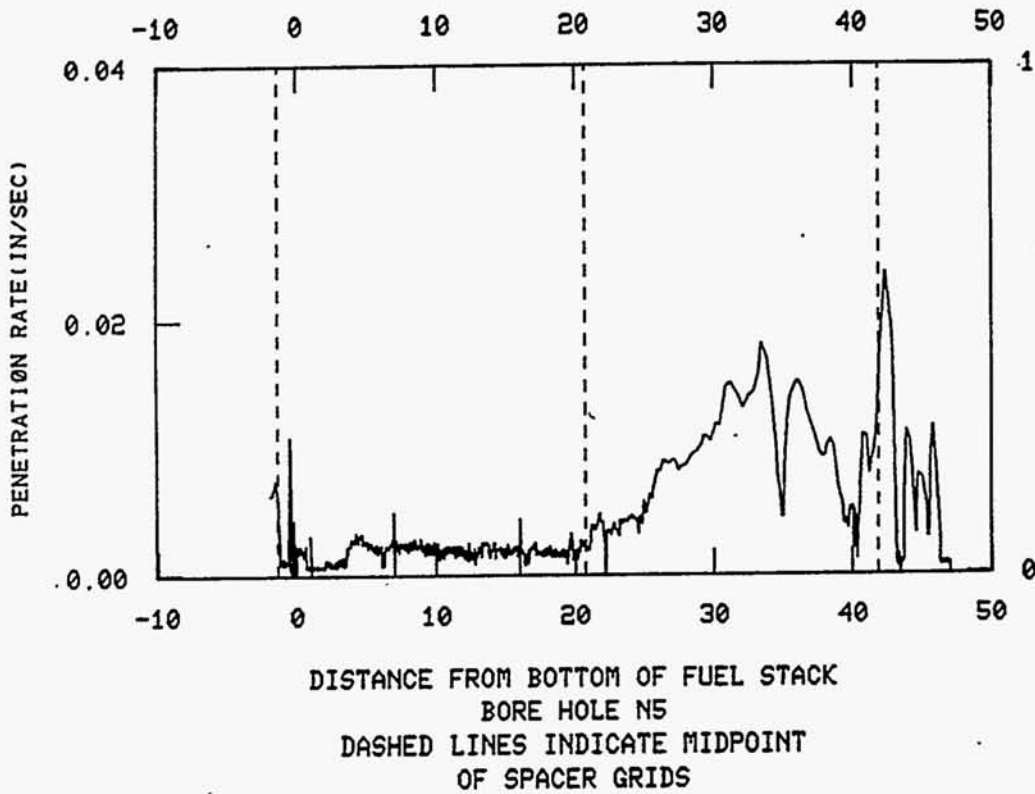
Figure B-3. On-line drilling data for N5.

The on-line (automatic mode) drilling data are shown in Figure B-3. The automatic drilling started in the lower agglomerate region just above the third spacer grid. The torque and RPM data are uniform below the third spacer grid (until the lower fuel assembly endfittings are encountered).

The penetration rate and energy data show that the material between the second and third spacer grids has significantly lower drilling resistance than the material between the first and second spacer grids. This data trend suggests that the materials between the two spacer grids may be different. One source of this difference may be oxidation of the rods between the second and third spacer grid.

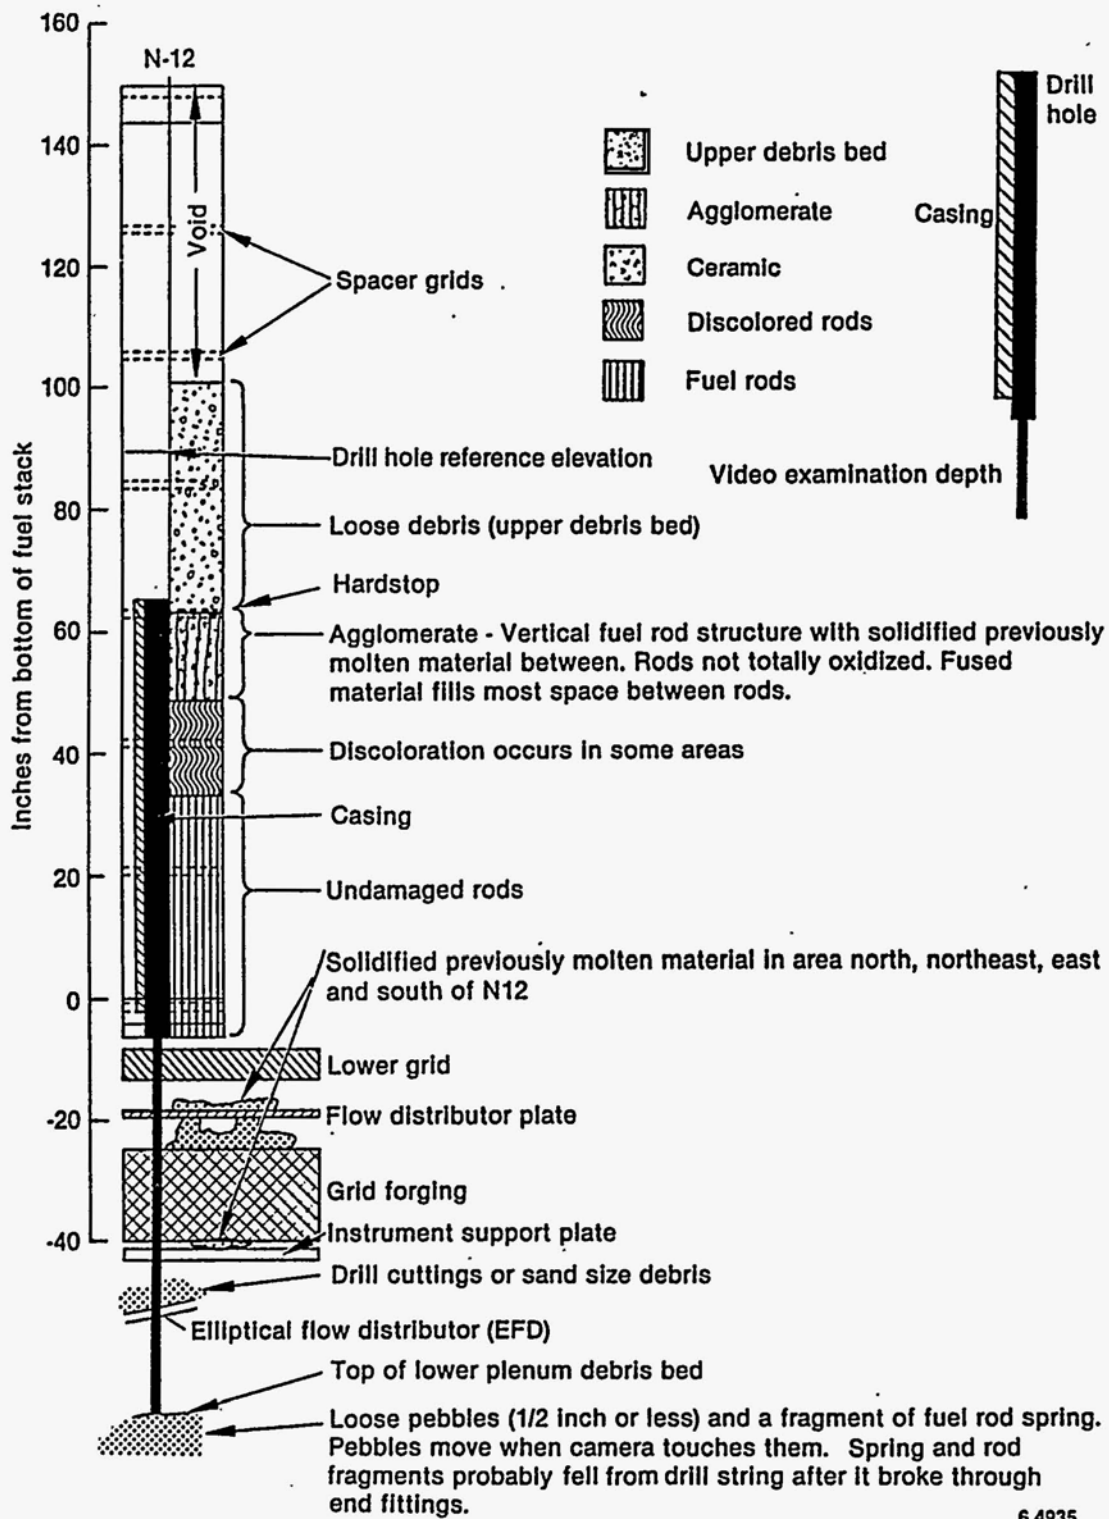
Figure B-4. N12 drill configuration and inspection summary.

Intact standing fuel rods are observed from the fuel assembly lower endfitting to slightly above the third spacer grid. Discoloration of the standing fuel rods is observed from below the third spacer grid to the rod/agglomerate interface. The discoloration appears to become more pronounced toward the agglomerate interface.

An agglomerate region of previously molten material surrounding fuel rod remnants is observed starting above the third spacer grid and extending to the top of the drill hole. The cladding is generally non-discernible from the surrounding previously molten material. There were a few metallic

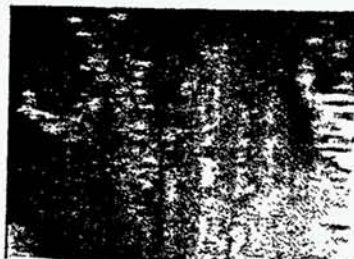
Possible previously molten core material
behind fuel rods just above core
position K9 fuel assembly lower spacer
grid (approximately 4 in. above core
bottom (86-417-2-9)

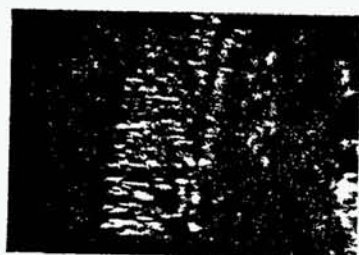
Individual rod decomposition
approximately 18 in. above core bottom
at core position K9
(86-417-2-10)

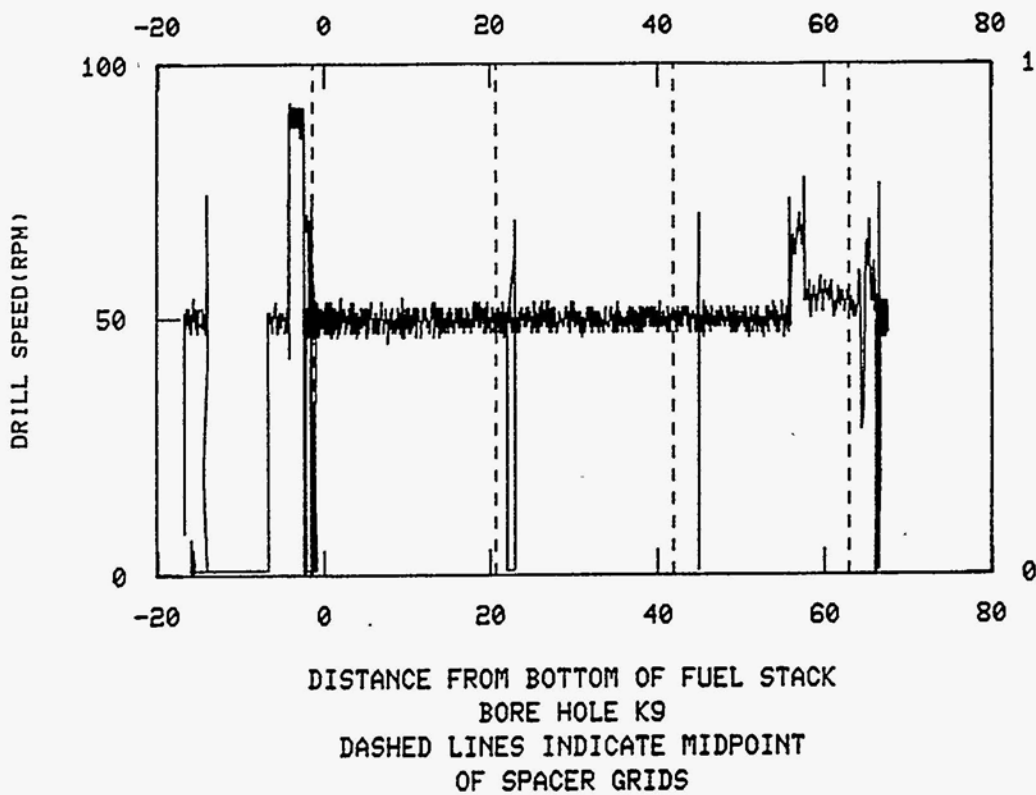
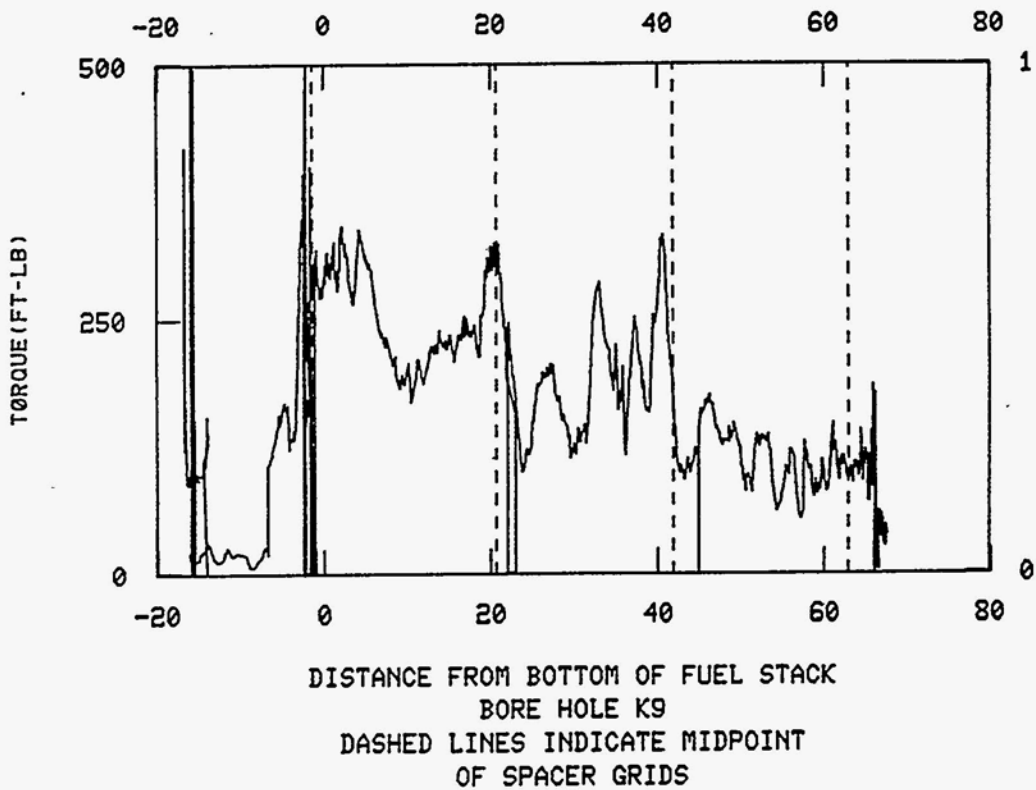
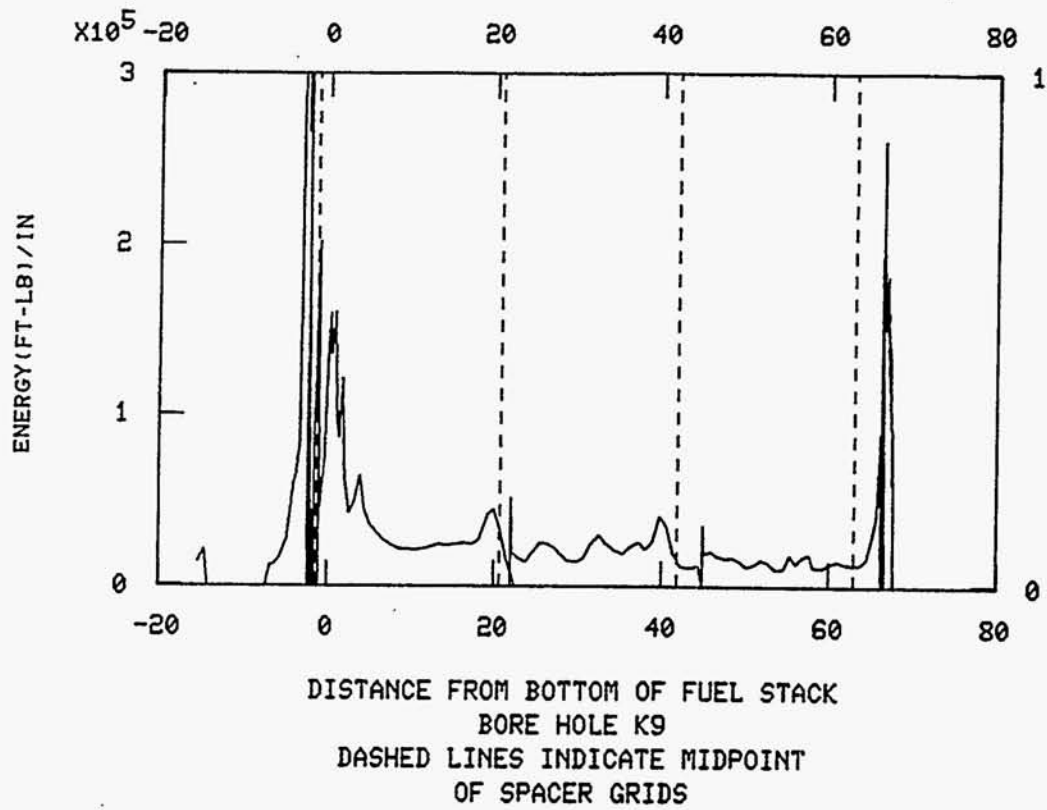
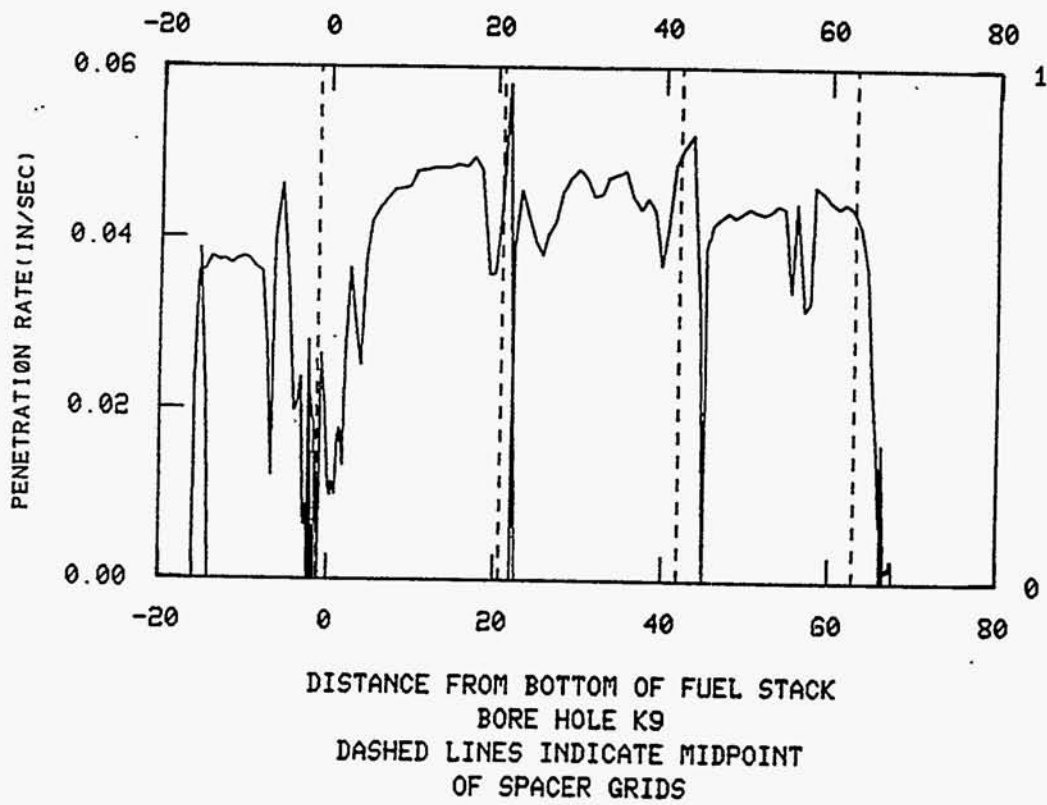
Figure B-14. On-line drilling data for K9.

The on-line (automatic mode) drilling data are shown in Figure B-14. The automatic drilling started at about 70 in. from the rod bottom near the top of the molten ceramic region. There appears to be some variability in the material composition, as inferred from the changes in the drilling parameters between the second/third and the third/fourth spacer grids. The localized changes in drill resistance are consistent with observed metallic-like structures interlaced with the ceramic material.

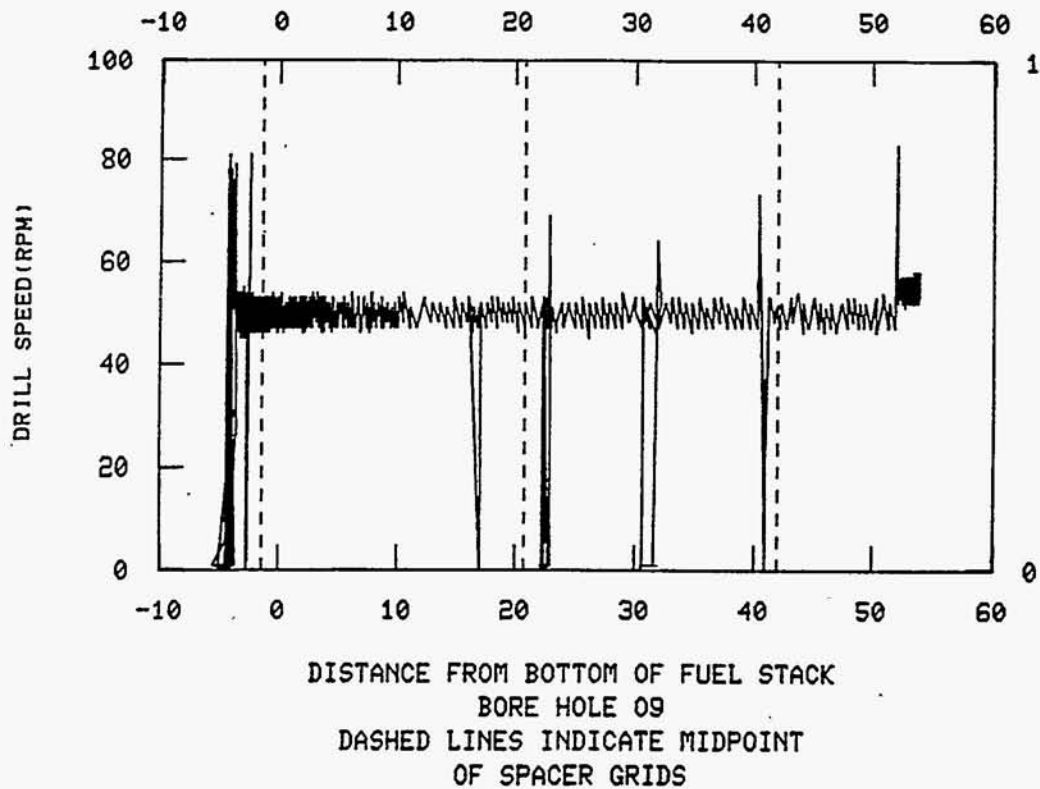
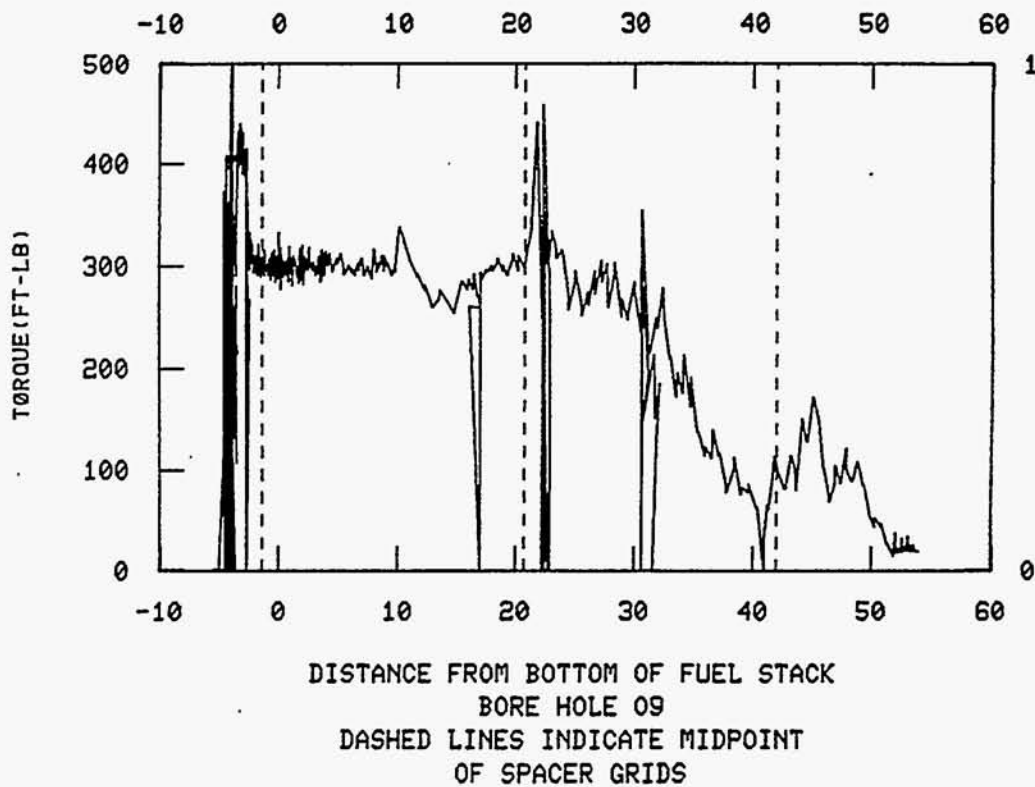
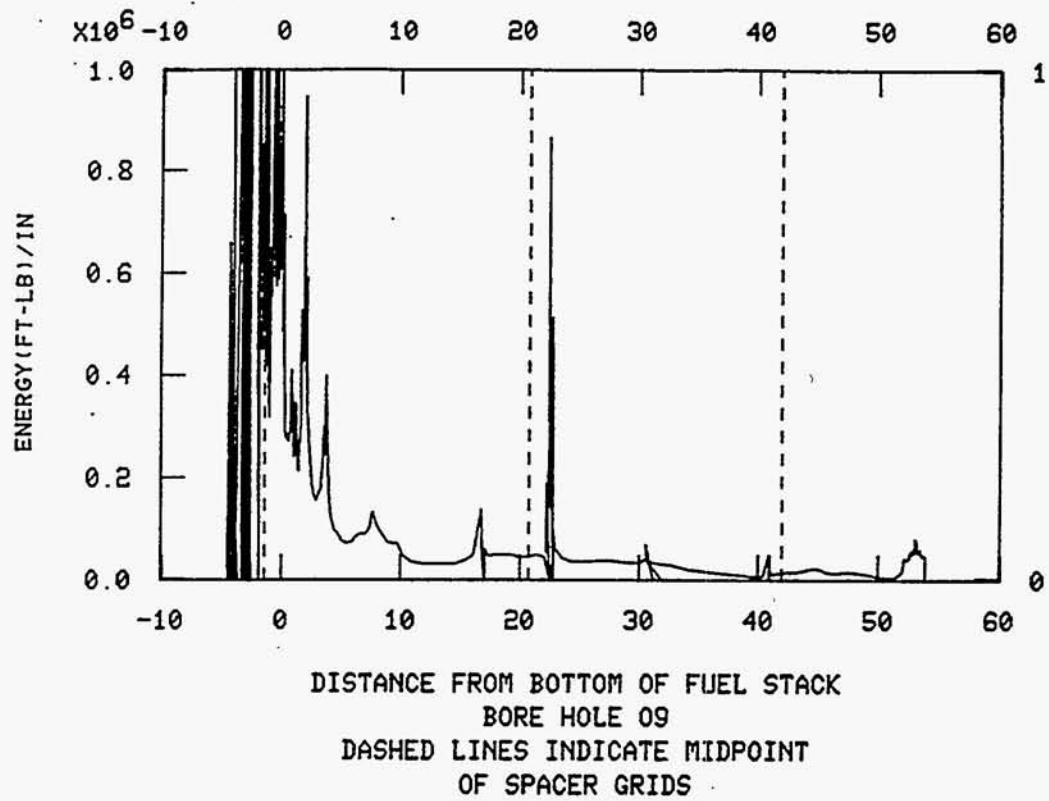
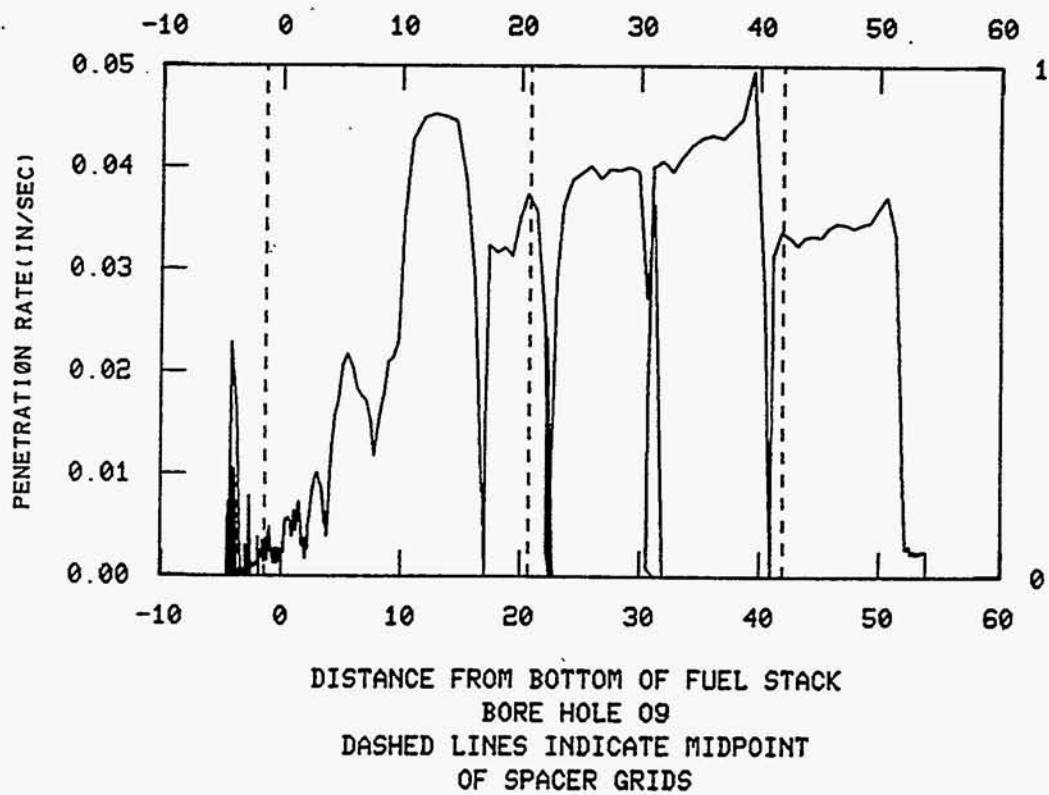
Figure B-29. On-line drilling data for 09.

The automatic mode data are shown in Figure B-29. Automatic drilling started at about 60 in. from the rod bottom, near the top of the agglomerate region. There were several shutdown periods, so possible differences in material structure are difficult to identify. One area between the second

and third spacer grids, between approximately 8-12 in., appears to have a significant increase in drilling resistance. This area may contain relocated metallic material.

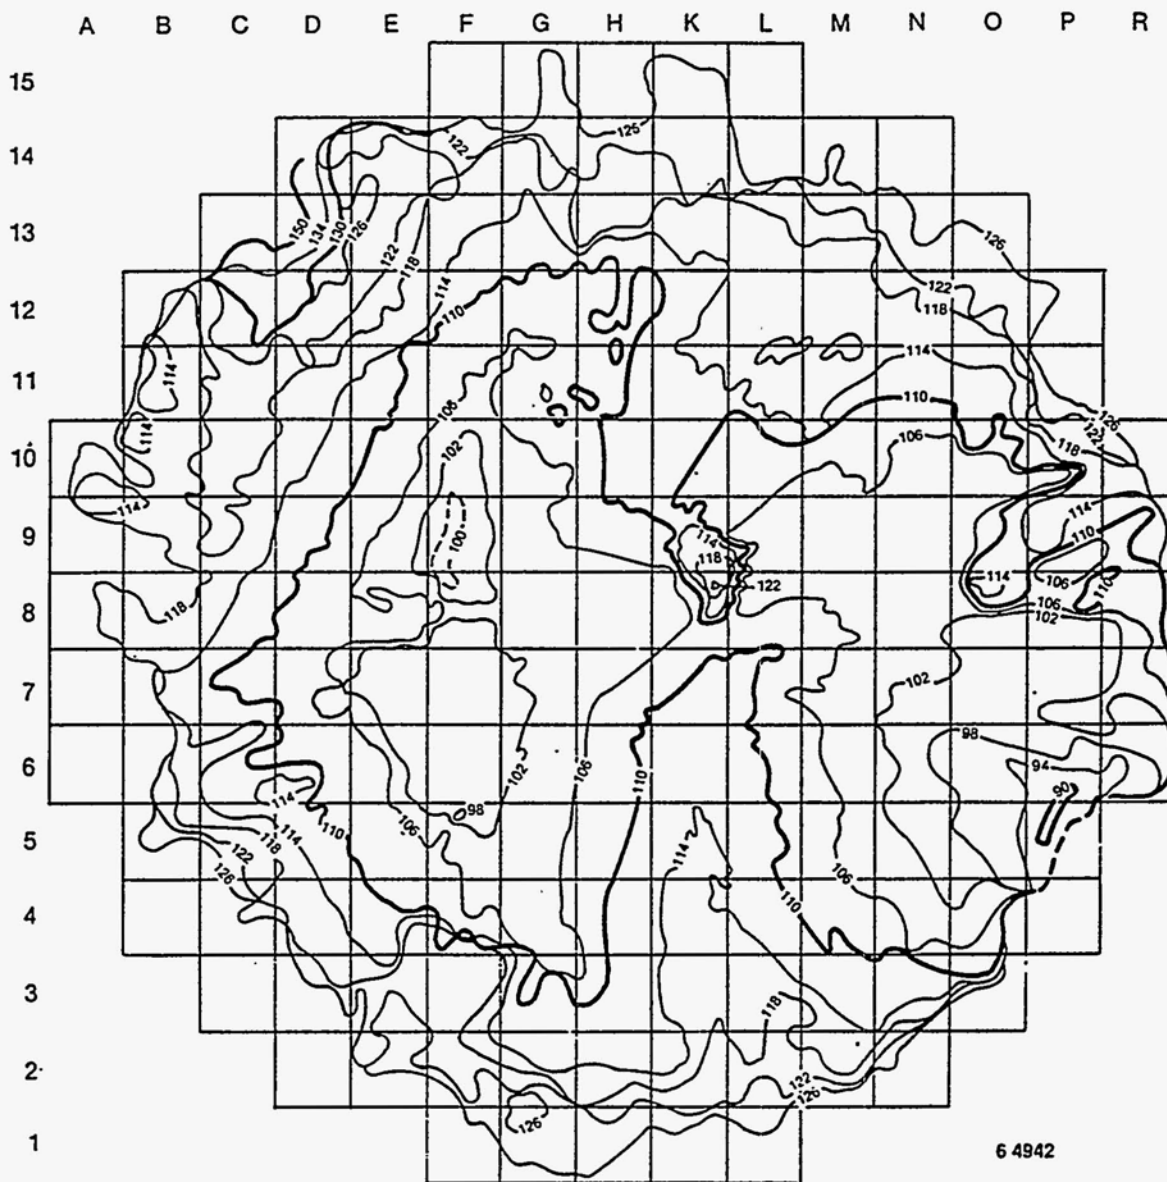
Figure D-1. Core debris upper surface contour map.

The contour map shown in Figure D-1 represents the top of the upper core debris surface. These data were used to define the core cross sections presented in Appendix B and the text.

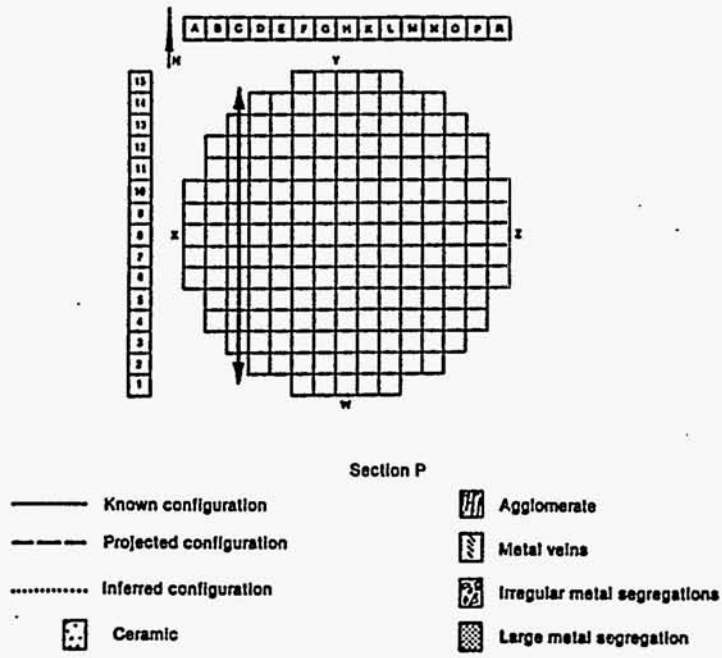
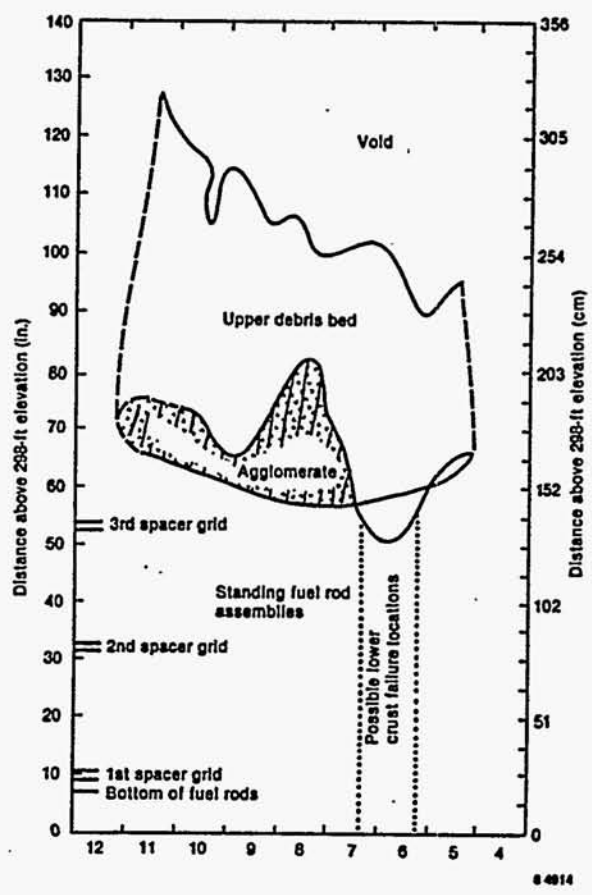
Figure E-13. Core cross section showing end-state damage configuration through P row of fuel assemblies.

09 is similar to N5 and 07, showing significant amounts of previously molten core material in the CSA regions, particularly in the 'P' row of fuel assemblies. These data suggest that core (crust) failure may have occurred extensively in the east quadrant of the core.
