EGG-TMI-7429
July 1987

TMI-2 LOWER PLENUM VIDEO DATA SUMMARY

James P. Adams
Richard P. Smith

Published July 1987

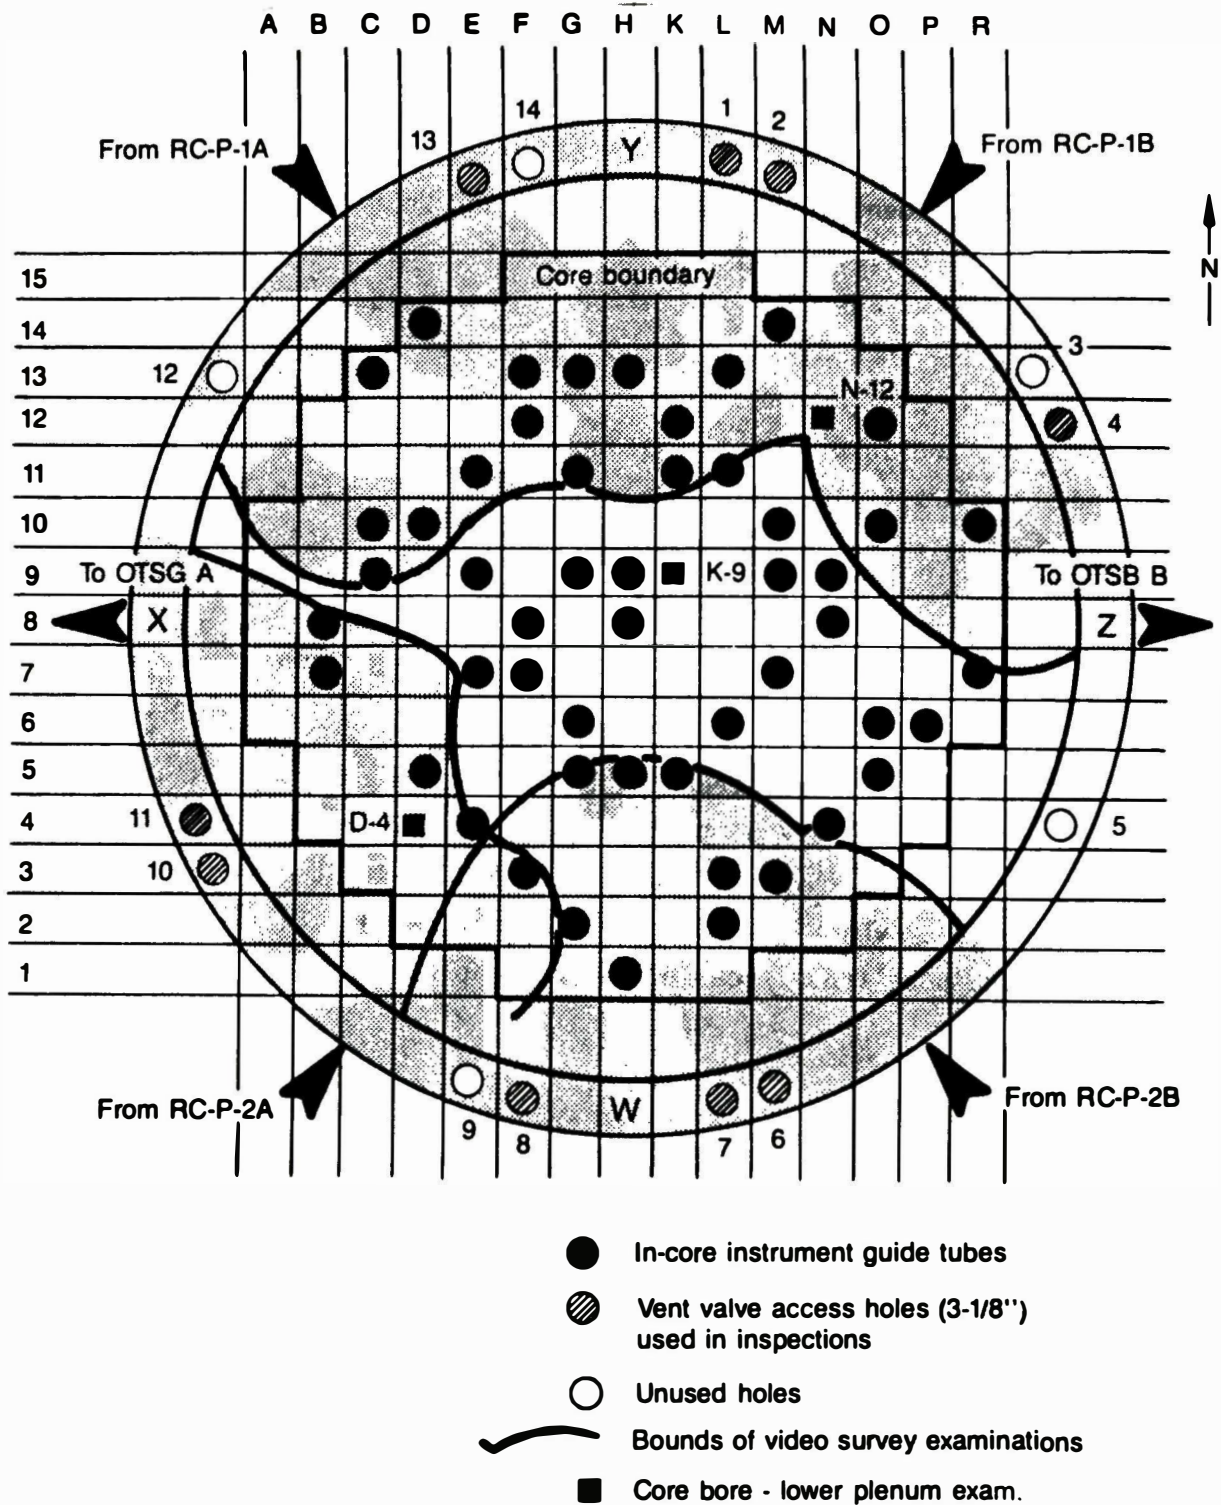
A total of five visual examinations have been made of parts of the lower plenum. The first examination occurred in February 1985^{1,2} when a camera was sequentially inserted into two different access holes in the downcomer. These holes are labeled 4 and 11 on Figure 1, which is a schematic of the reactor vessel cross section and illustrates those areas of the lower plenum which have been visually examined. This first examination included those areas of the lower plenum around the Z and X axes.

Figure 1. TMI-2 core map, illustrating the extent of video data.

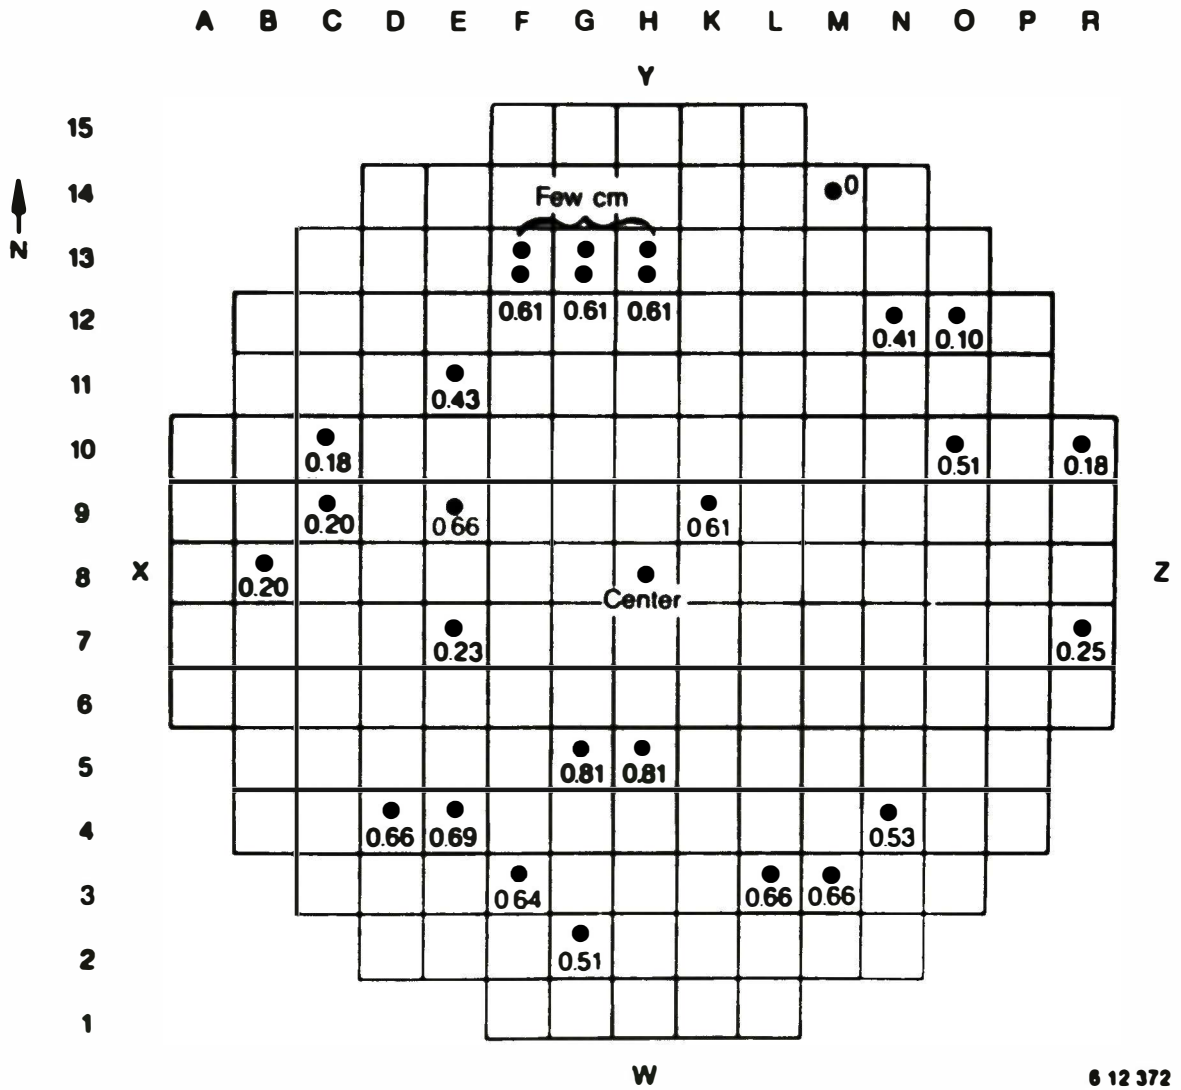
Figure 3 shows the measured and estimated lower plenum debris bed depths as derived from the video data. The core grid is superimposed for reference. The debris bed depth data shown in Figure 3 were estimated using two techniques. For those locations examined using a camera inserted into the downcomer annulus, the debris bed height was estimated by comparing the top surface of the bed to the instrument guide tubes at various locations. The depth could then be estimated using the known geometry of these guide tubes. The detailed geometries of all guide tubes used in this study are shown in Appendix A. For the three lower plenum locations examined during the core-boring operations, grid locations K-9, D-4, and N-12, the camera was lowered to the top of the debris bed and then

Figure 3. TMI-2 lower plenum debris bed depth measurements.

withdrawn to the bottom of the elliptical flow distributor plate, and the length of travel of the camera was measured. The debris bed depth at these three locations was then derived from the measured length of travel, using the known geometry of the lower head and elliptical flow distributor.

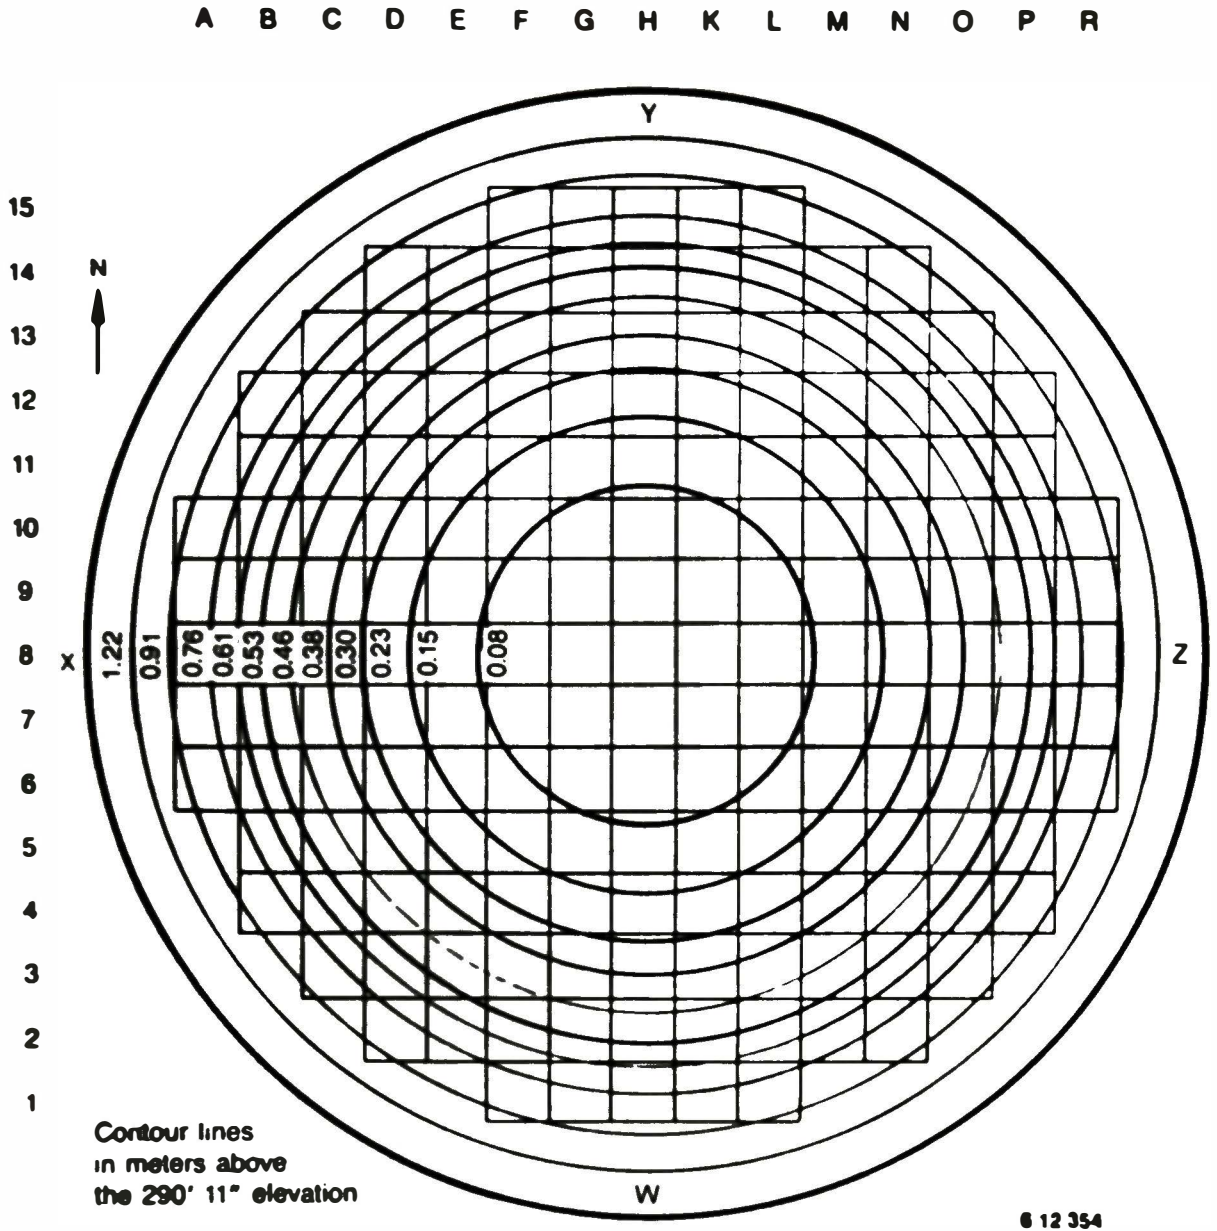
Figure 4. TMI-2 reactor vessel lower head contour map.

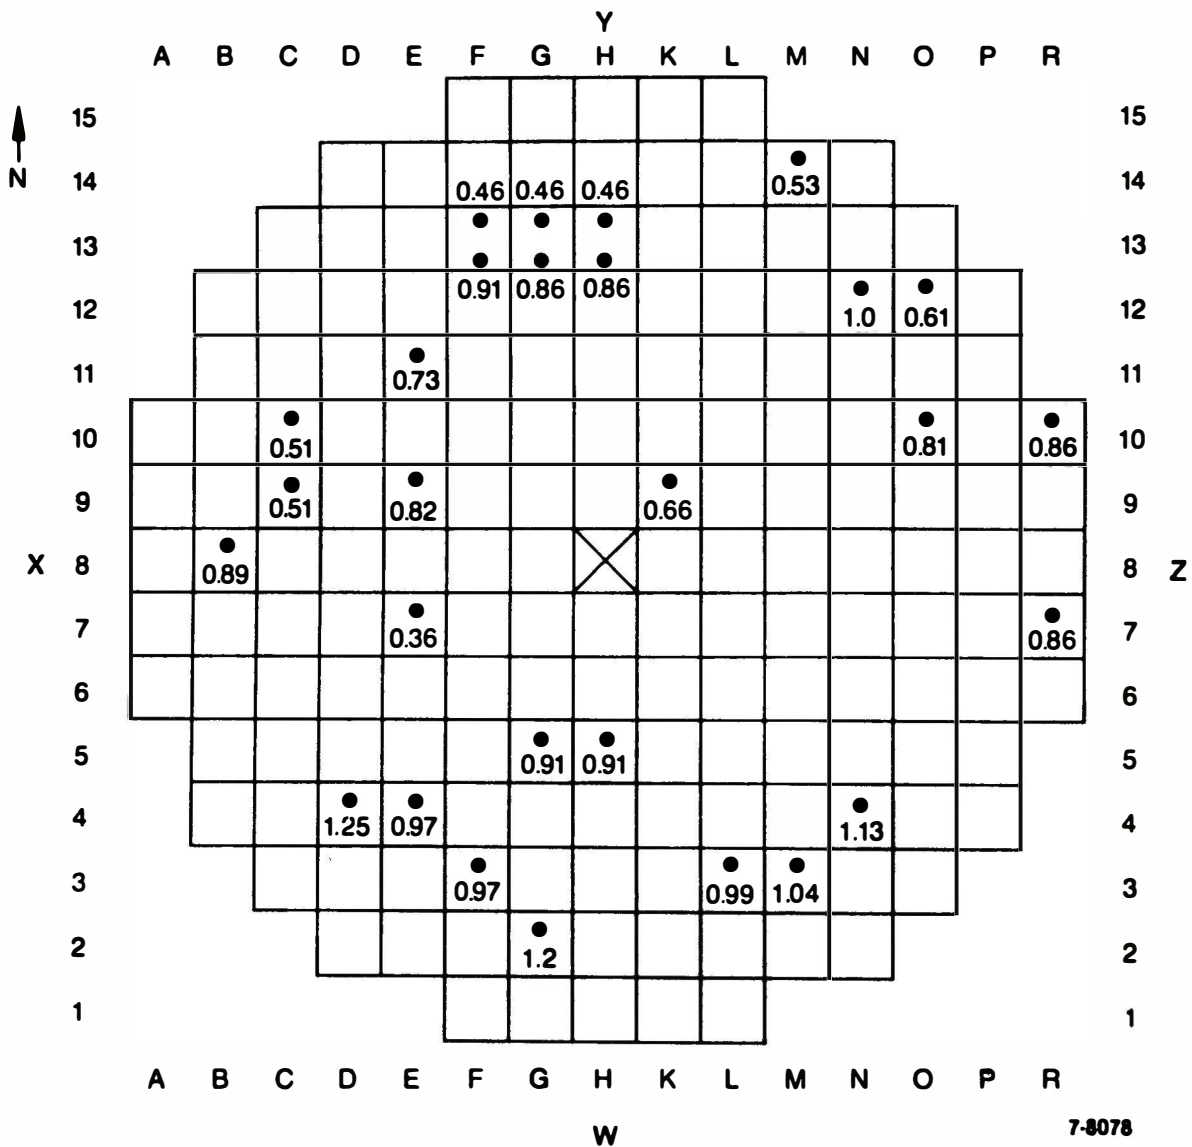
The contour lines for the spherical lower head of the reactor vessel were drawn using the design information for this component. These contours are shown in Figure 4, which is a plane view of the lower head with the core grid superimposed. The depth of the debris bed (at those locations shown in Figure 3) and the contour of the lower head were combined to provide estimates of the debris bed height above an arbitrary reference plane. The reference plane was chosen to intersect with the inside surface of the lower head at the reactor vessel centerline, the 290-ft, 11-in. elevation. These debris bed height estimates are shown in Figure 5.

Figure 5. TMI-2 lower plenum debris bed surface.
