**Quick Look Inspection: Report on the Insertion  
of a Camera into the TMI-2 Reactor Vessel  
through a Leadscrew Opening  
Volume I**

**Bechtel Northern Corporation**

**March 1983**

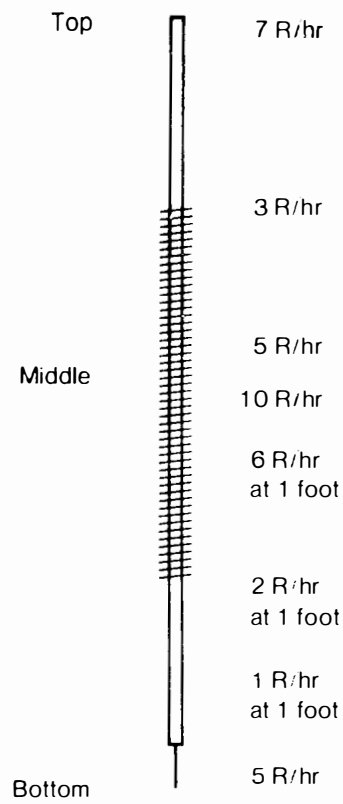
Figure 3-3. Leadscrew 8H dose rates.

Dose rate profiles of the three leadscrews that were removed are presented in Figures 3-3, 3-4, and 3-5.

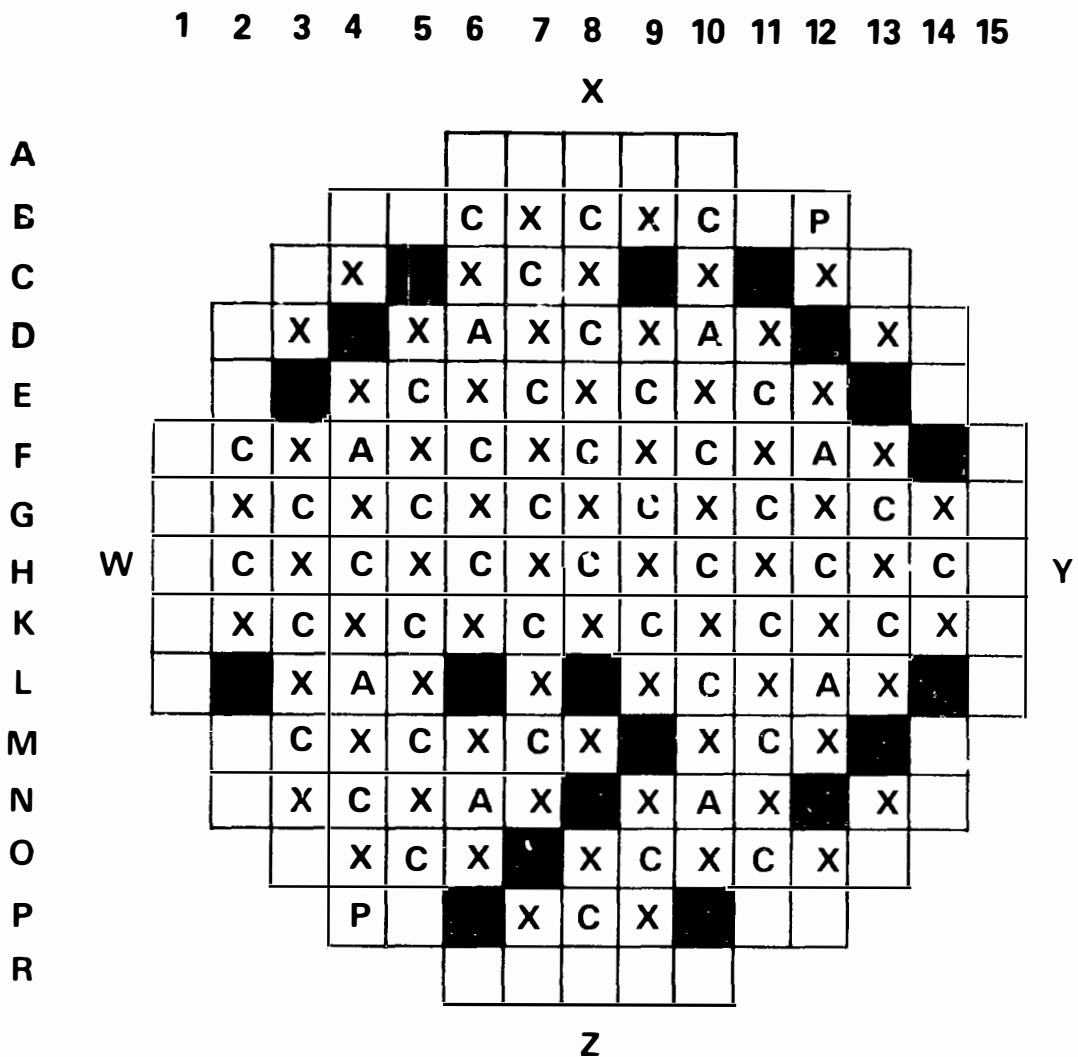
Figure 3-10. Locations where the control rod spiders never moved up or down.

3.5.3.1 Spiders Did Not Move Up or Down. Locations where the spiders never moved up or down (see Figure 3-10) were identified based on the following:

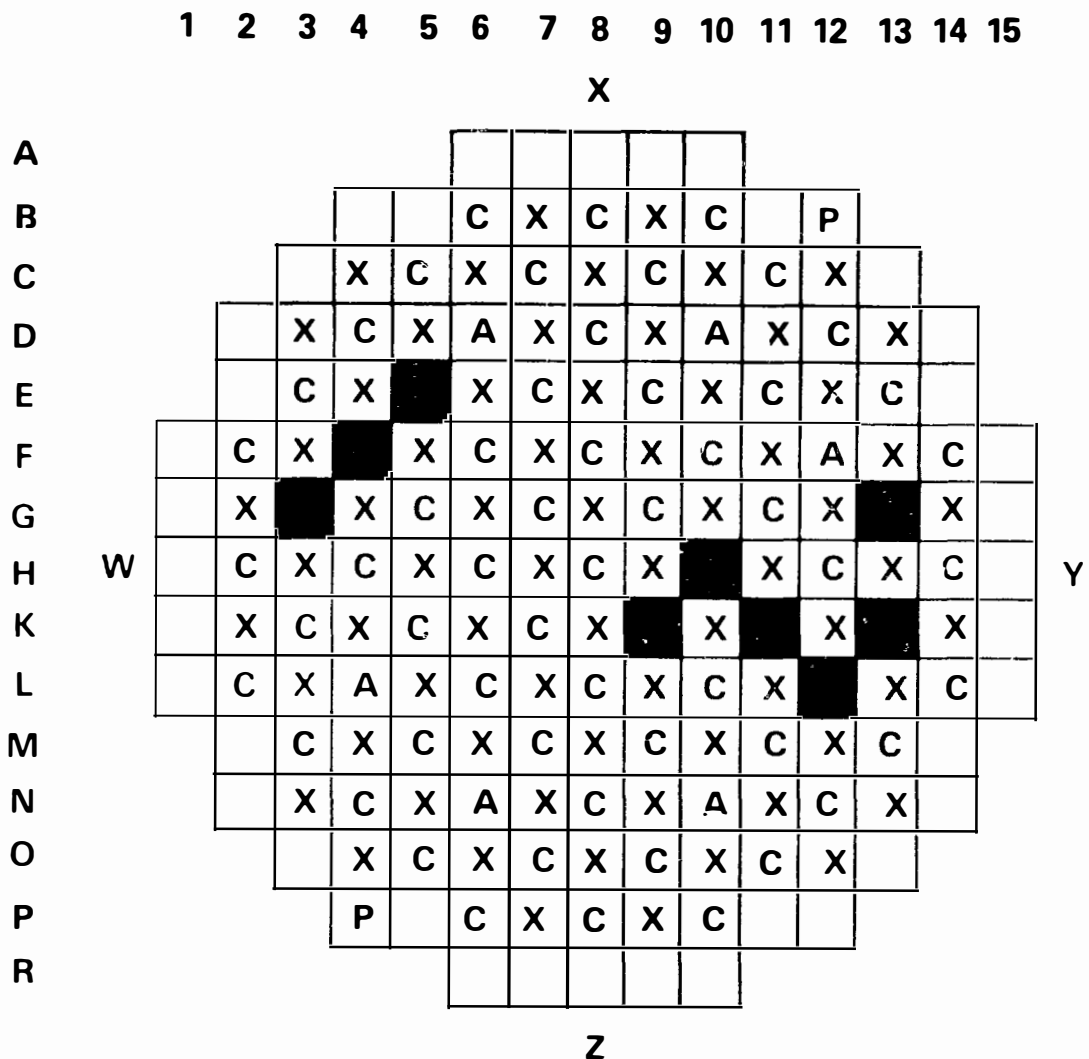
Figure 3-11. Locations where the spiders moved down less than 2 inches after uncoupling.

3.5.3.2 Spiders Moved Down Less Than 2 Inches. Locations where the spiders moved down less than 2 inches after uncoupling (see Figure 3-11) were identified based on the following:

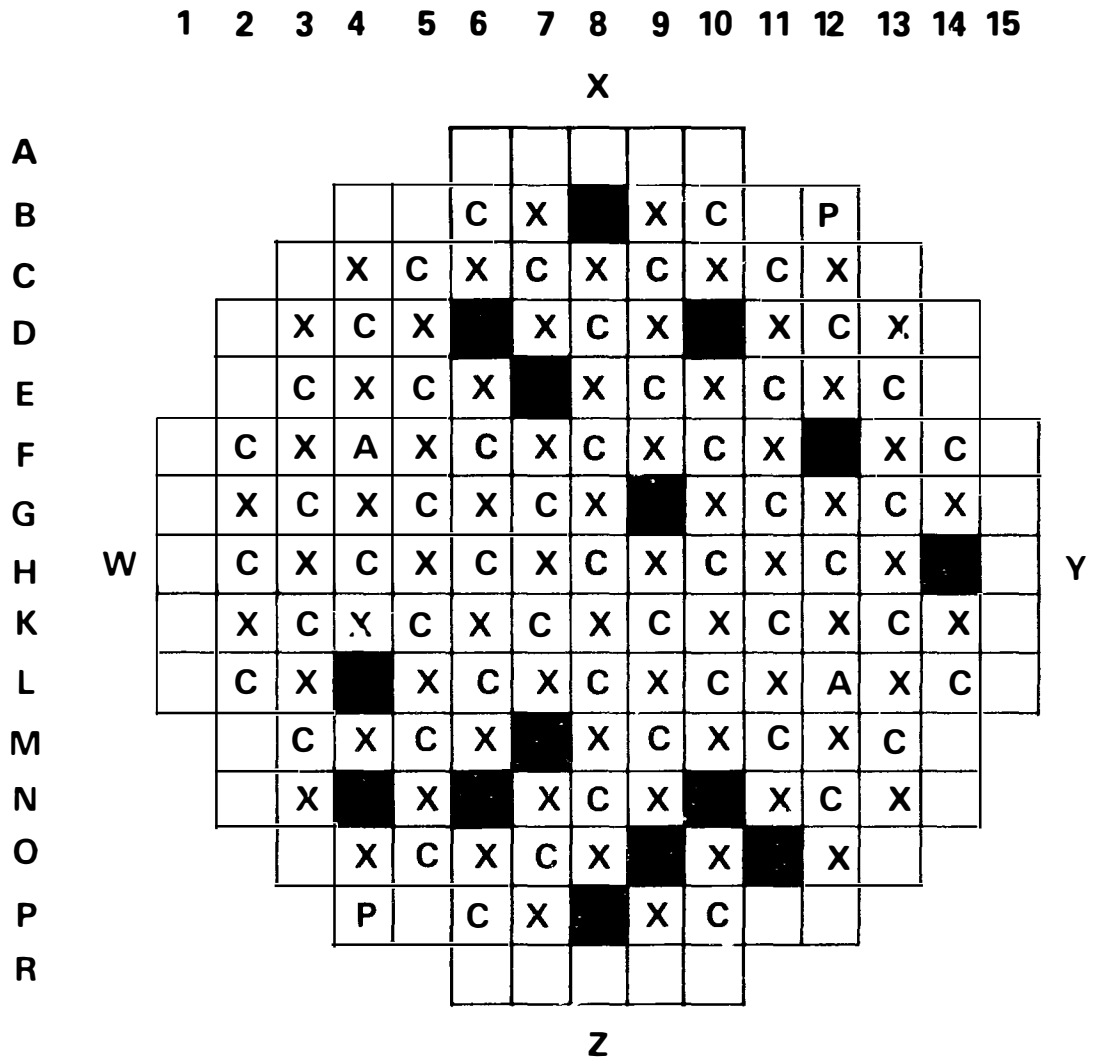
Figure 3-12. Locations where the spiders moved up when lifted, but did not move down after uncoupling.

Locations where the spiders moved up when lifted, but did not move down after uncoupling (see Figure 3-12), were identified based on the following:

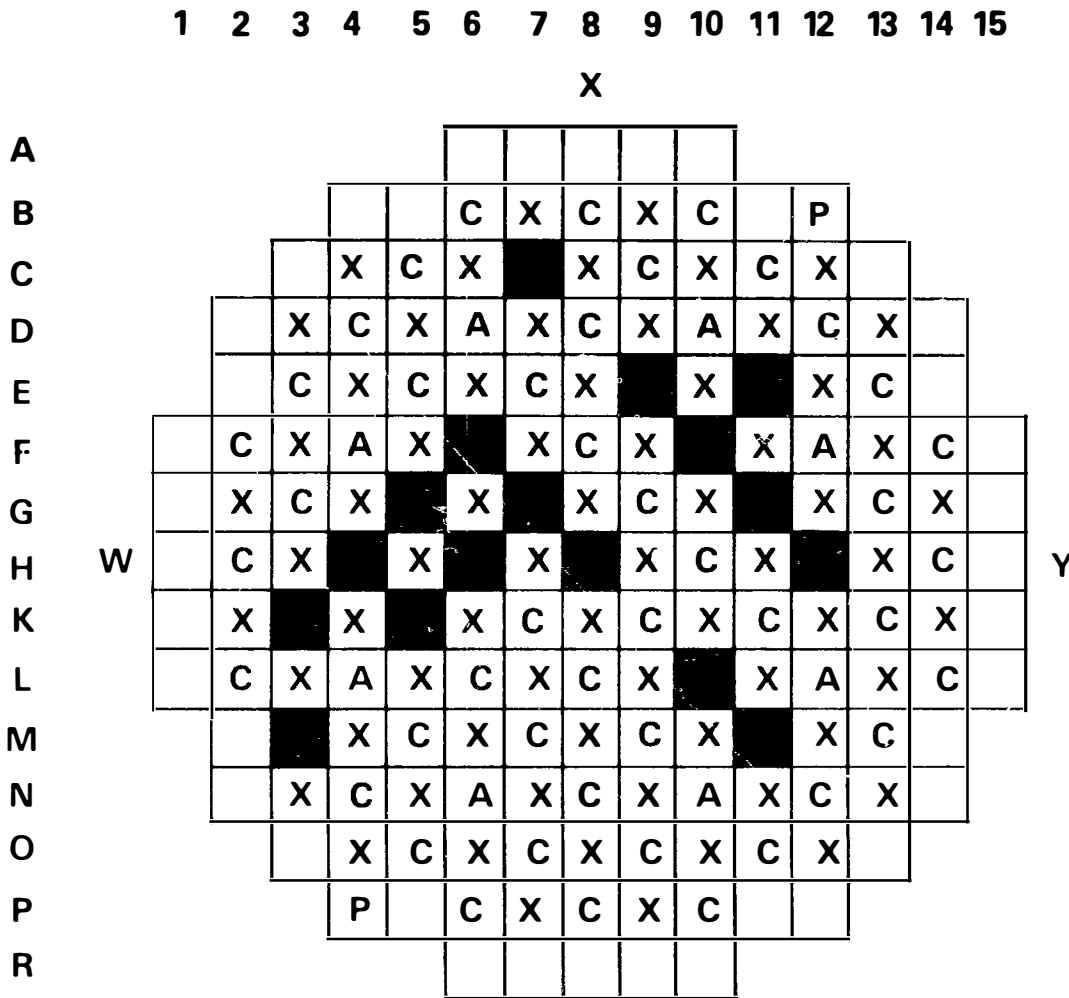
Figure 3-13. Locations where the spiders dropped greater than 2 inches after uncoupling.

3.5.3.4 Spiders Dropped More Than 2 Inches. Locations where the spiders dropped more than 2 inches after uncoupling (see Figure 3-13) were identified based on the following: during rotation the leadscrew rotated greater than 55 degrees, which indicated that the spider had fallen away and therefore there were no hard stops. This indication was verified at locations 8H and 9E during the Quick Look CRDM leadscrew uncoupling and removal.

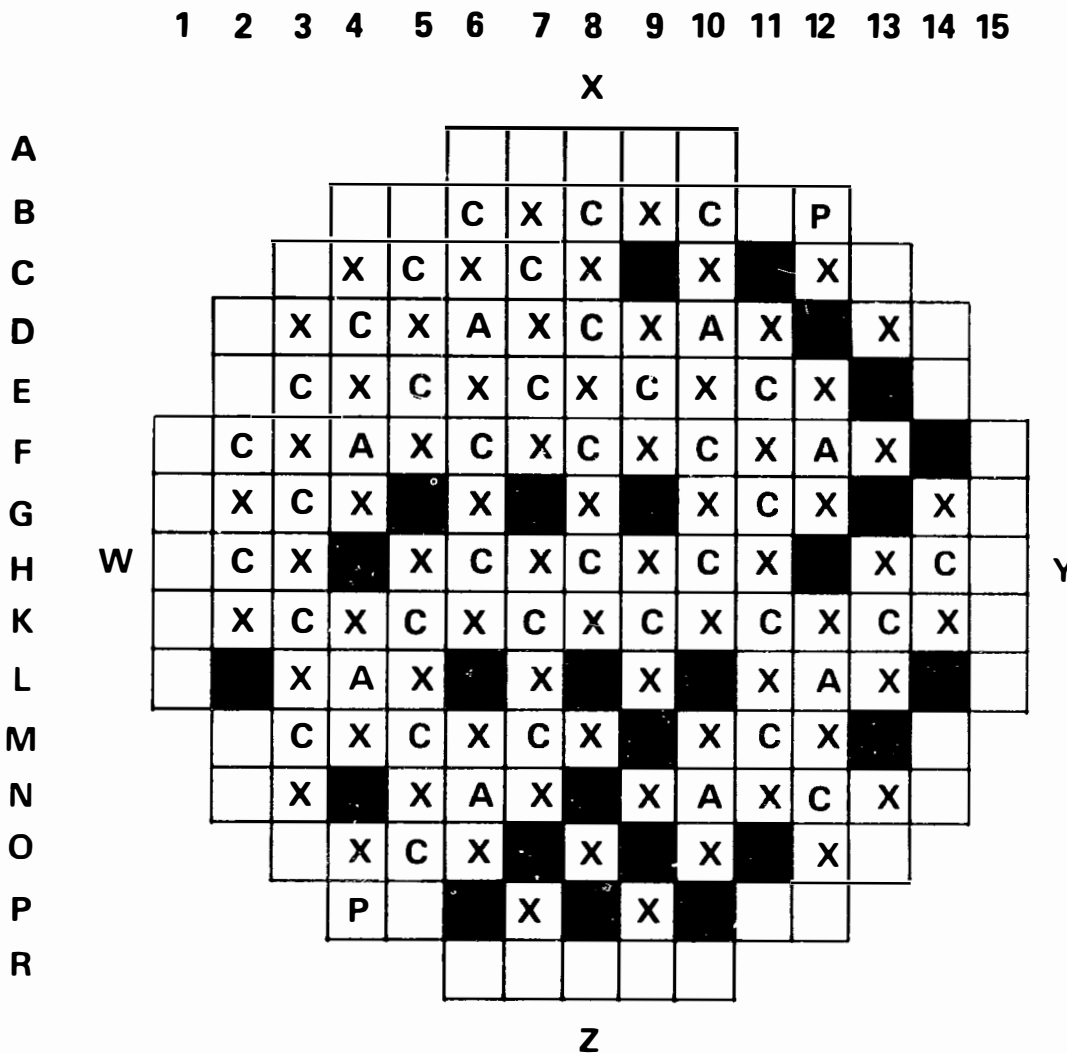
Figure 3-14. Locations where the leadscrews have been uncoupled, but parking the leadscrews may be difficult.

3.5.3.5 Uncoupled but Leadscrew May be Sticking. Locations where the leadscrew has been uncoupled but future parking of the leadscrew may be difficult (see Figure 3-14) were identified by the following:

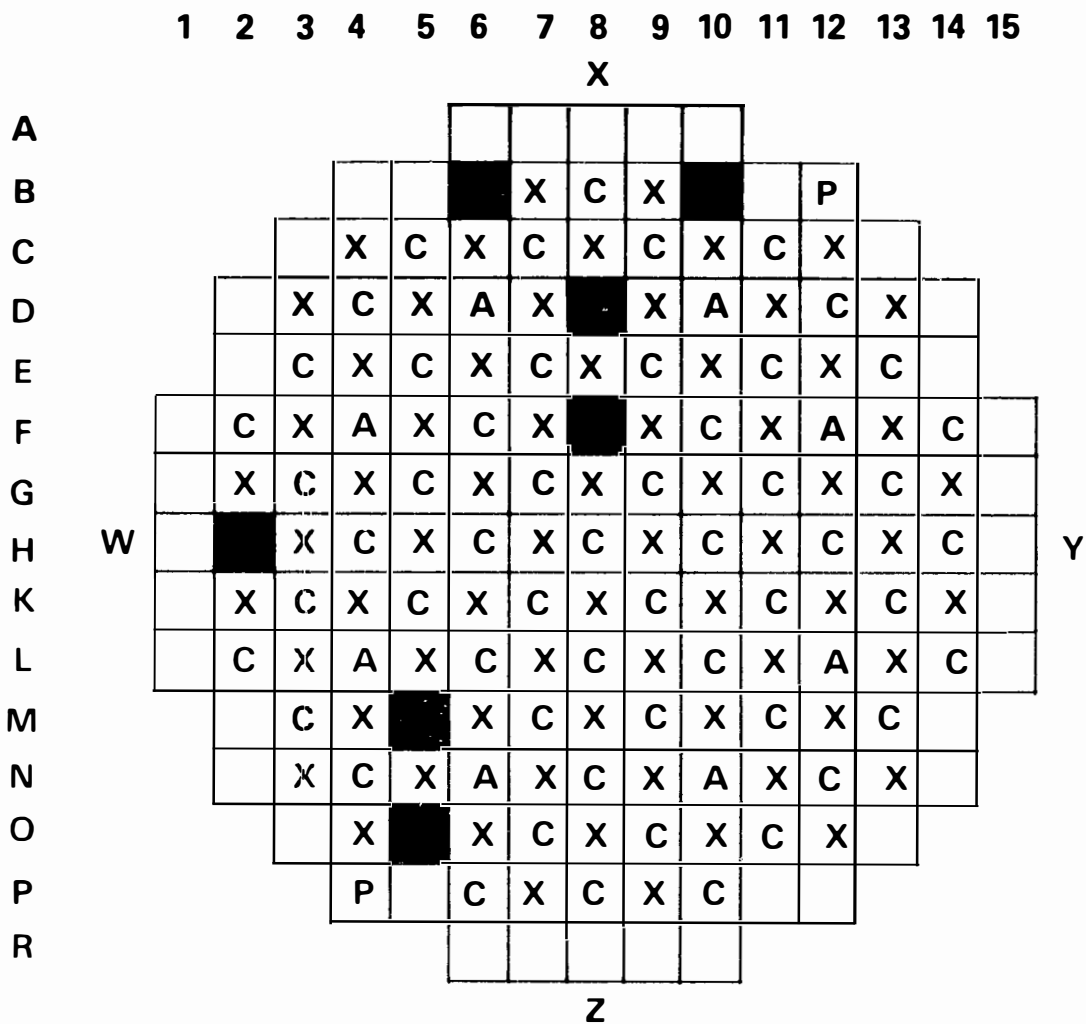
Figure 3-15. Locations where the leadscrews and torque takers are not bottomed on the torque tube belleville springs.

3.5.3.6 Torque Taker Not Bottomed on Springs. Locations where the leadscrew and torque taker were not bottomed on the torque tube belleville springs (see Figure 3-15) were identified by the following: all four gauge readings were approximately 28 psi, which indicated that the bottom of the torque taker was a minimum of 3/8 inch above the top of the belleville springs. This indication was verified by the gauge readings of APSR uncouplings. In the case of APSRs the leadscrews were held in this position by the CRDM roller nuts and the only component lifted and lowered was the torque tube (i.e., 28 psi). Because the leadscrew rotation on these drives indicated that the spider was still present, it was concluded that something was holding the spider (and control rod assembly) greater than 3/8 inch higher than the CRDM scram position. The exact height of the leadscrew was not known, although it could be determined by placing a dipstick in the top of the motor tube and measuring the distance from the top of the leadscrew to the top of the motor tube.
